HISTORIC AND DESIGN REVIEW COMMISSION

March 18, 2015

HDRC CASE NO: 2015-096
ADDRESS: 821 N PINE ST
LEGAL DESCRIPTION: NCB 540 BLK 11 LOT C & D ARB A4 & A5
ZONING: R5 H
CITY COUNCIL DIST.: 2
DISTRICT: Dignowity Hill Historic District
APPLICANT: Porter Dillard/Dillard Architect Group
OWNER: Tony Gradney
TYPE OF WORK: Window replacement

Gradney Residence – Historical House Restoration – Dignowity Hill
821 N. Pine St., San Antonio, Texas
Architect’s Project No. 2013-05

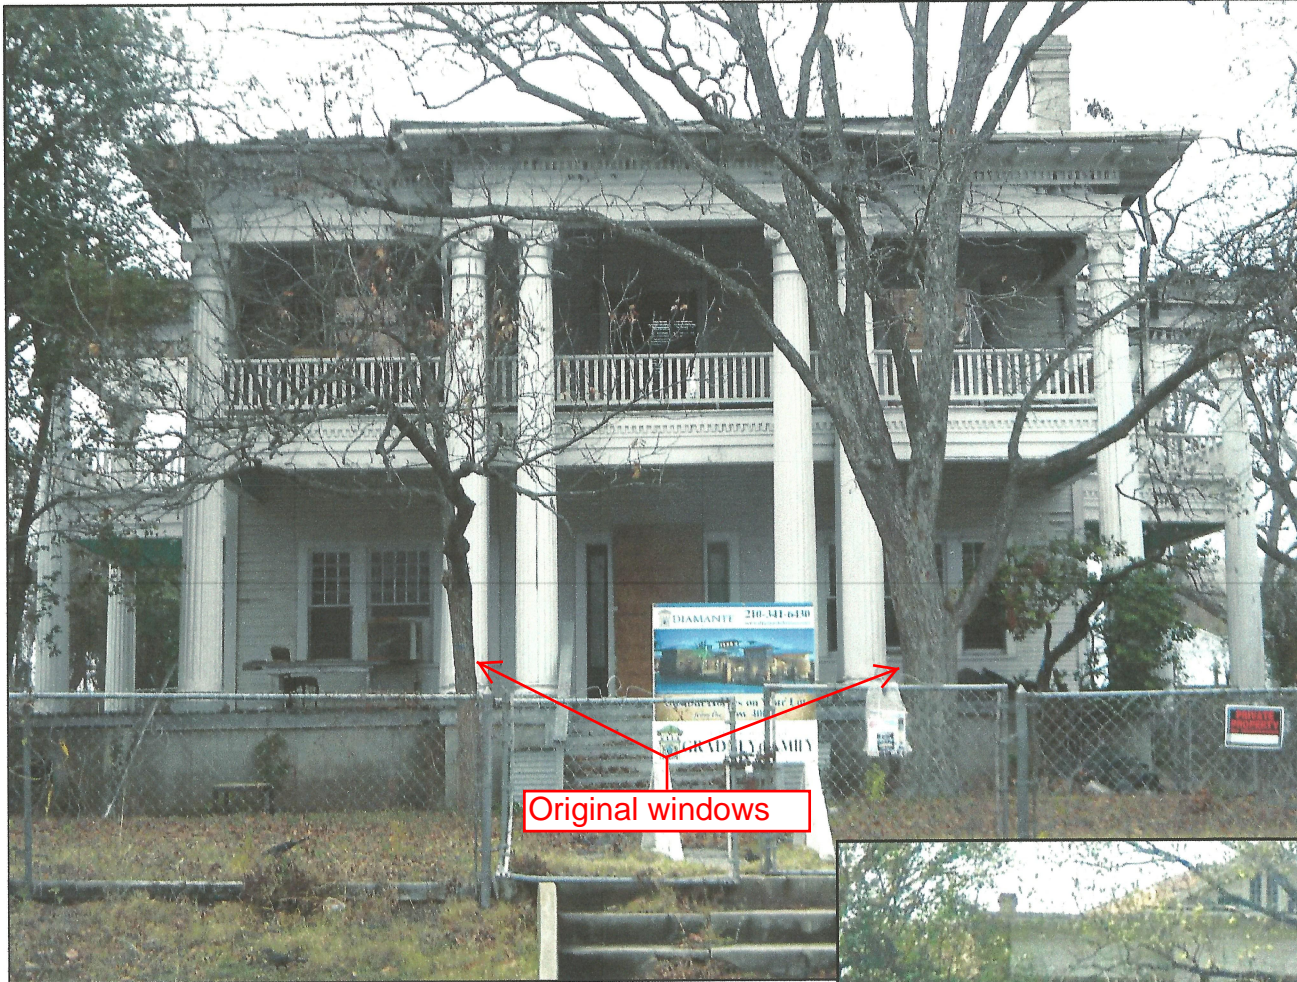
Post-Fire Pictures 2014

Original windows

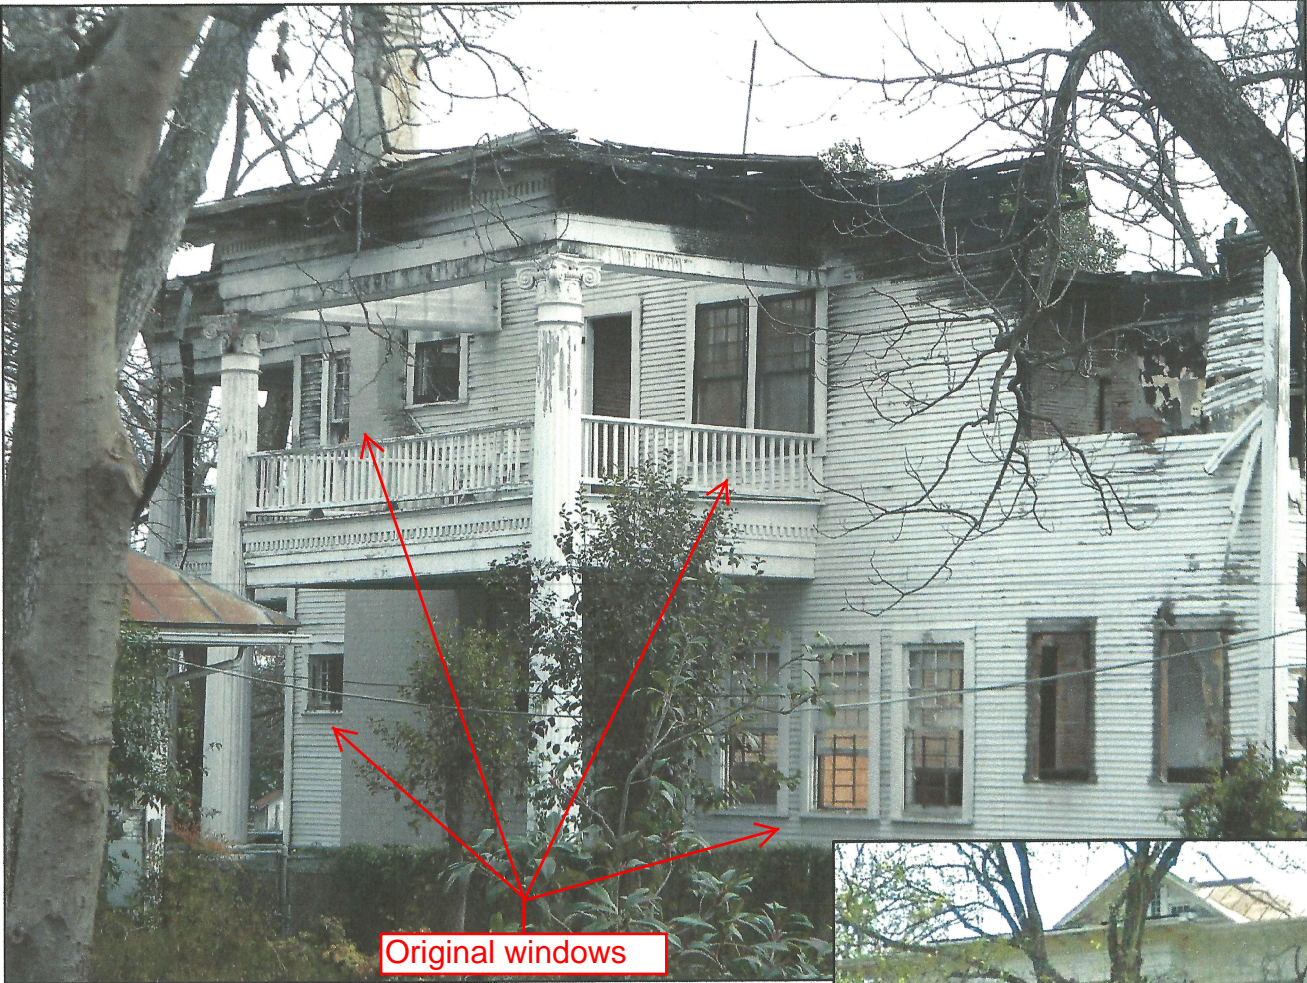
Post-Fire Pictures 2014

Original windows

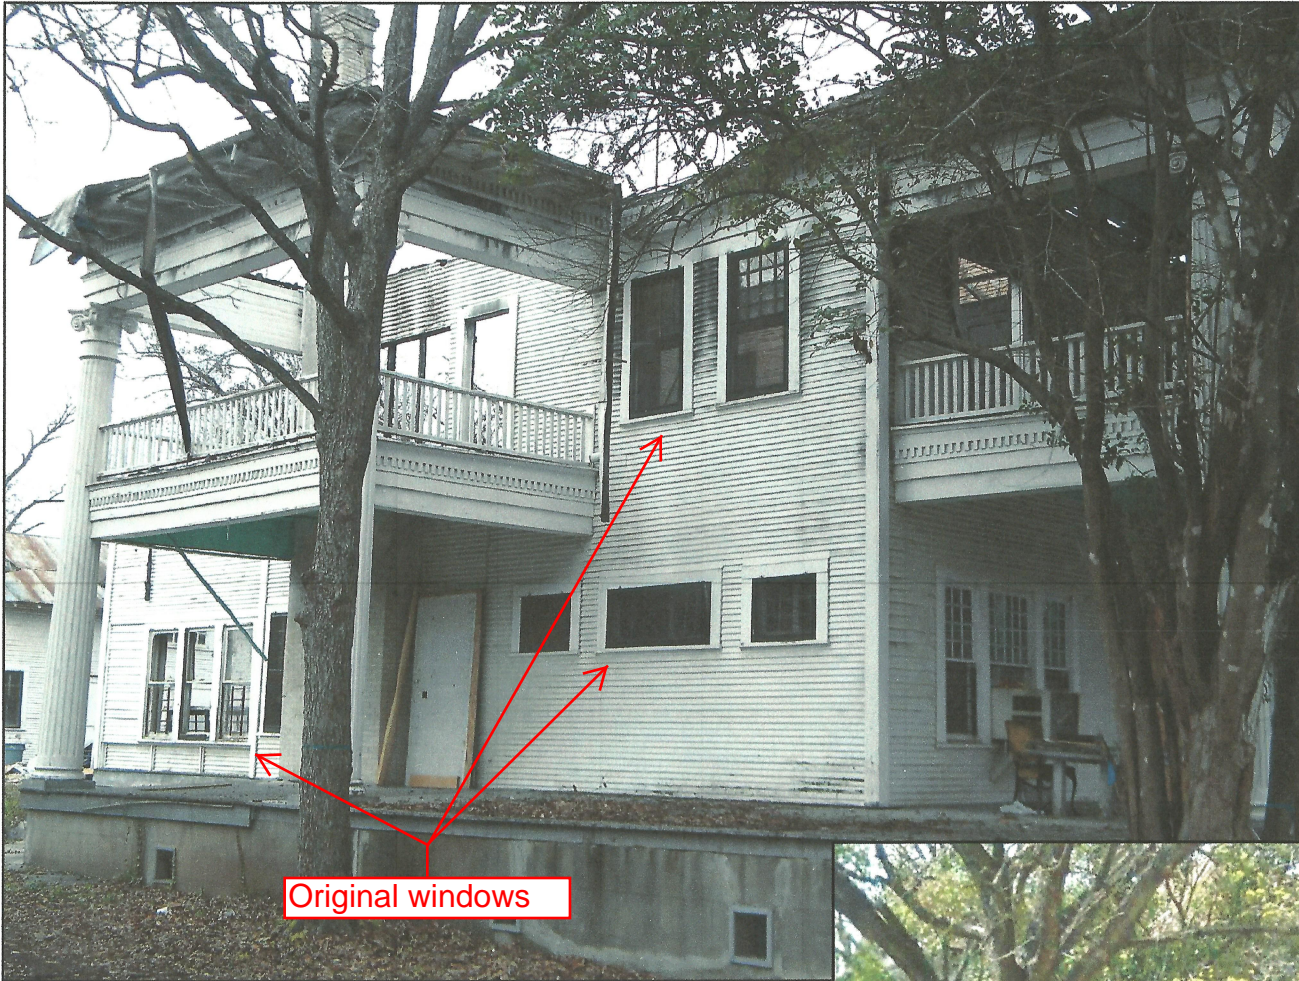
Post-Fire Pictures 2014

Original windows

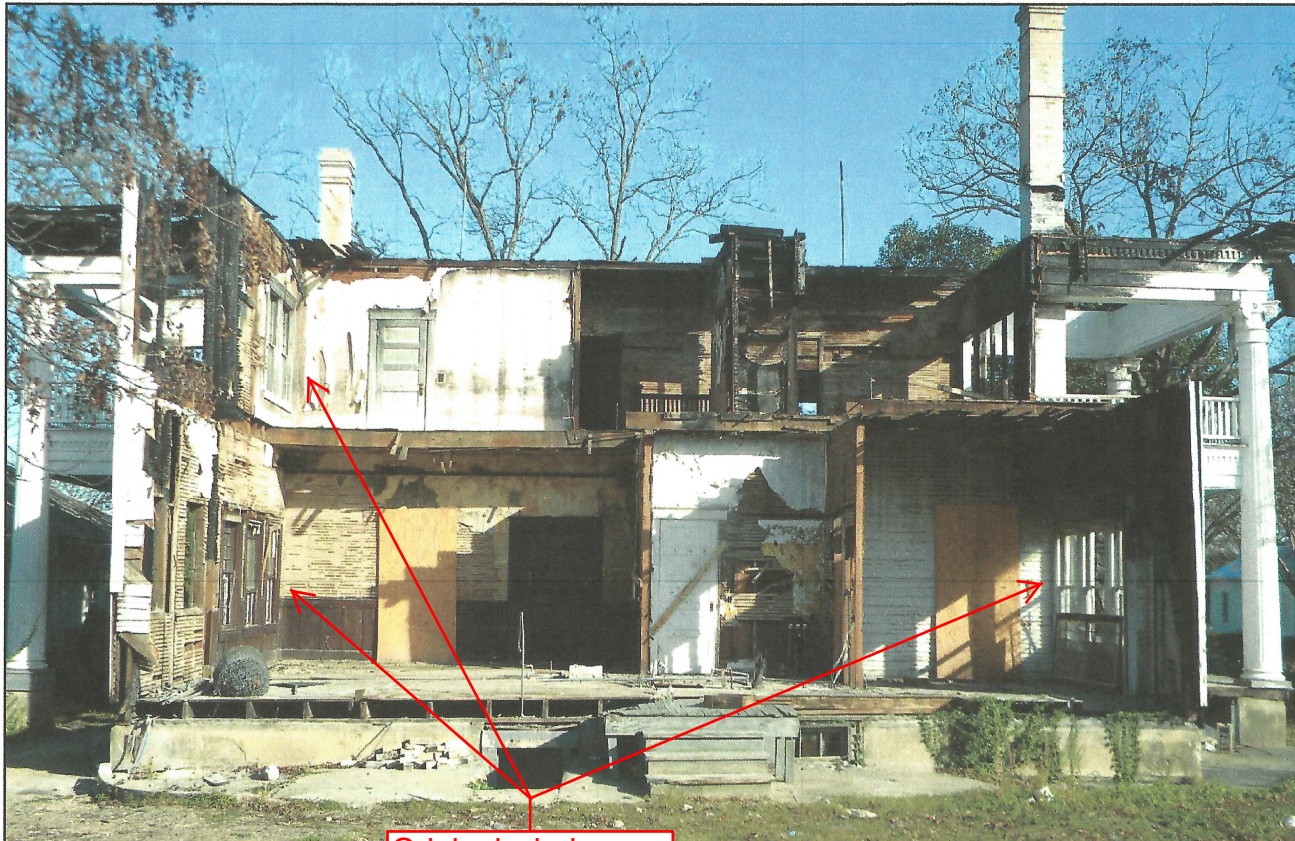
Post-Fire Pictures 2014

Original windows

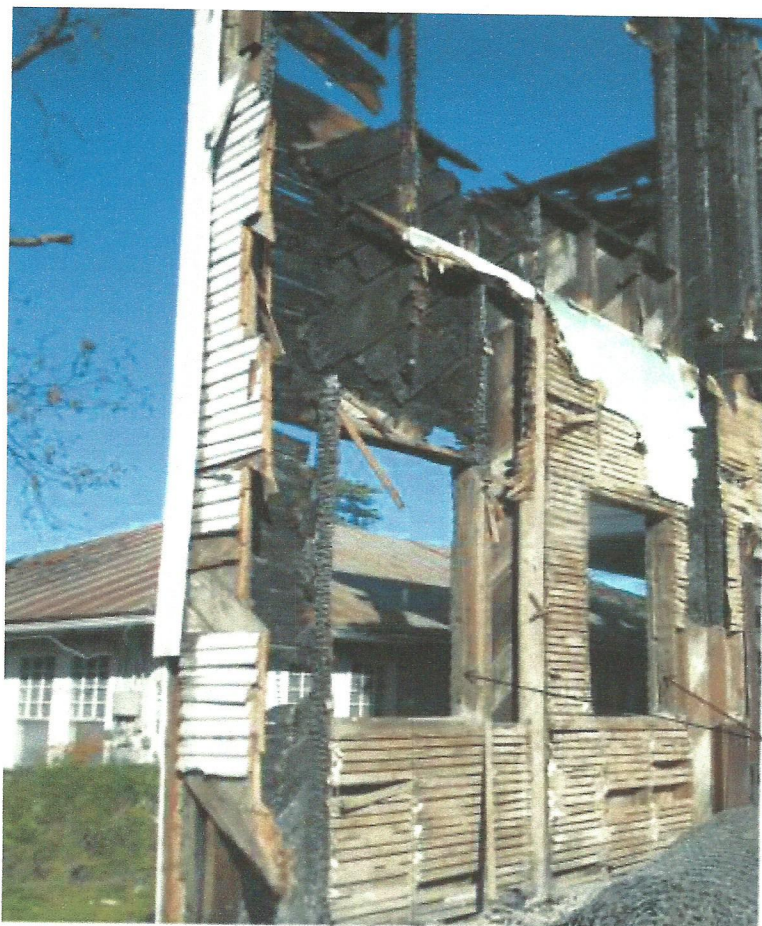
PHOTO - 1

EXISTING WINDOW
OPENINGS WITH WINDOW
FRAME, SASH AND TRIM
REMOVED DURING FIRE

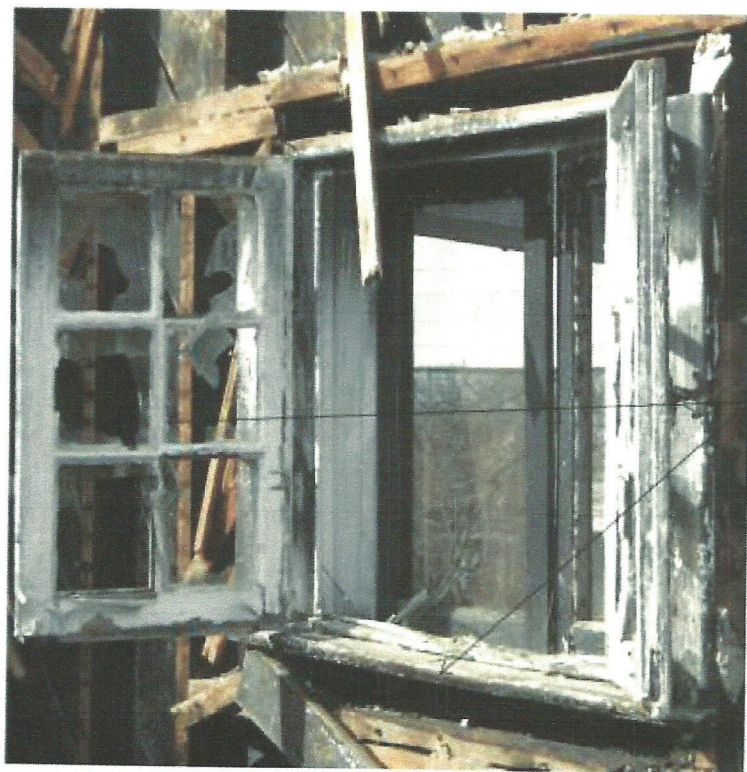
PHOTO - 2

EXISTING WINDOW
INTERIOR
CONDITIONS - FIRE
DAMAGE AND
CHARRED WOOD
