# HISTORIC AND DESIGN REVIEW COMMISSION

April 15, 2015

Agenda Item No: 22

**HDRC CASE NO:** 2015-112  
**ADDRESS:** 268 W MARIPOSA - Detached garage  
**LEGAL DESCRIPTION:** NCB 9013 BLK 7 LOT 11 12 AND 13  
**ZONING:** R4 H  
**CITY COUNCIL DIST.:** 1  
**DISTRICT:** Olmos Park Terrace Historic District  
**APPLICANT:** Jose Cueva  
**OWNER:** Janet Vasquez  
**TYPE OF WORK:** Demolish existing garage and construct small cottage  
**REQUEST:**

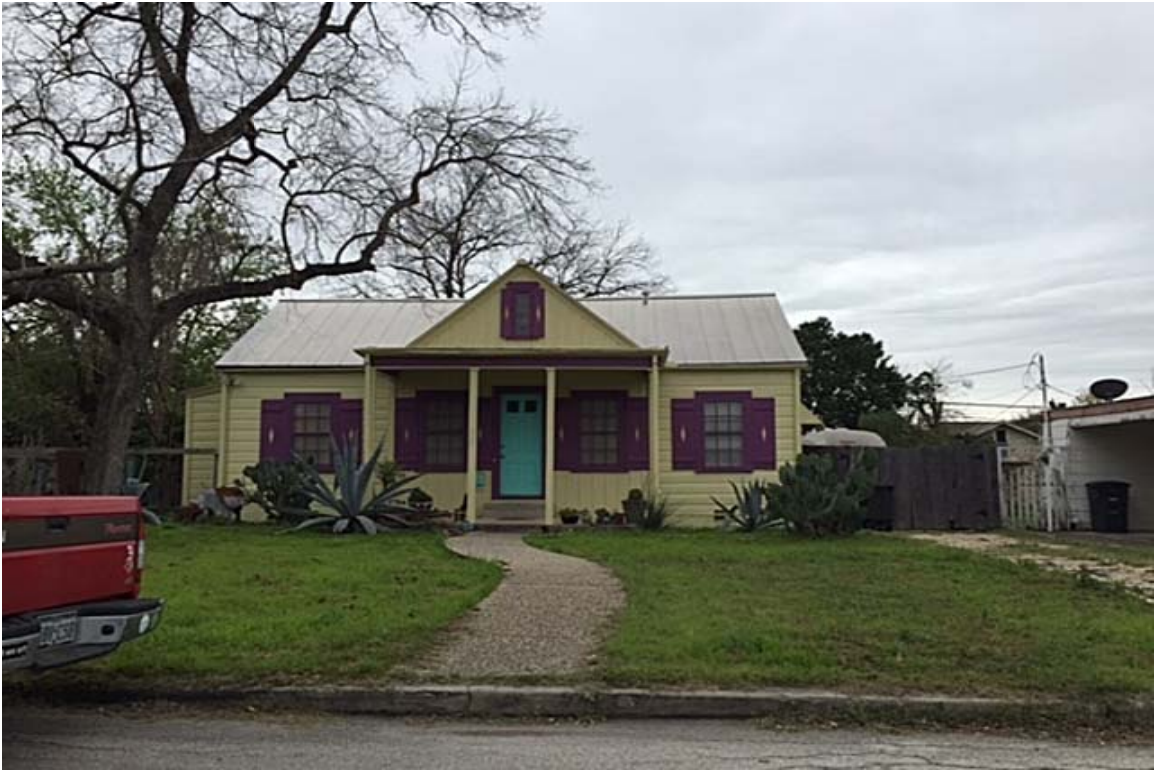
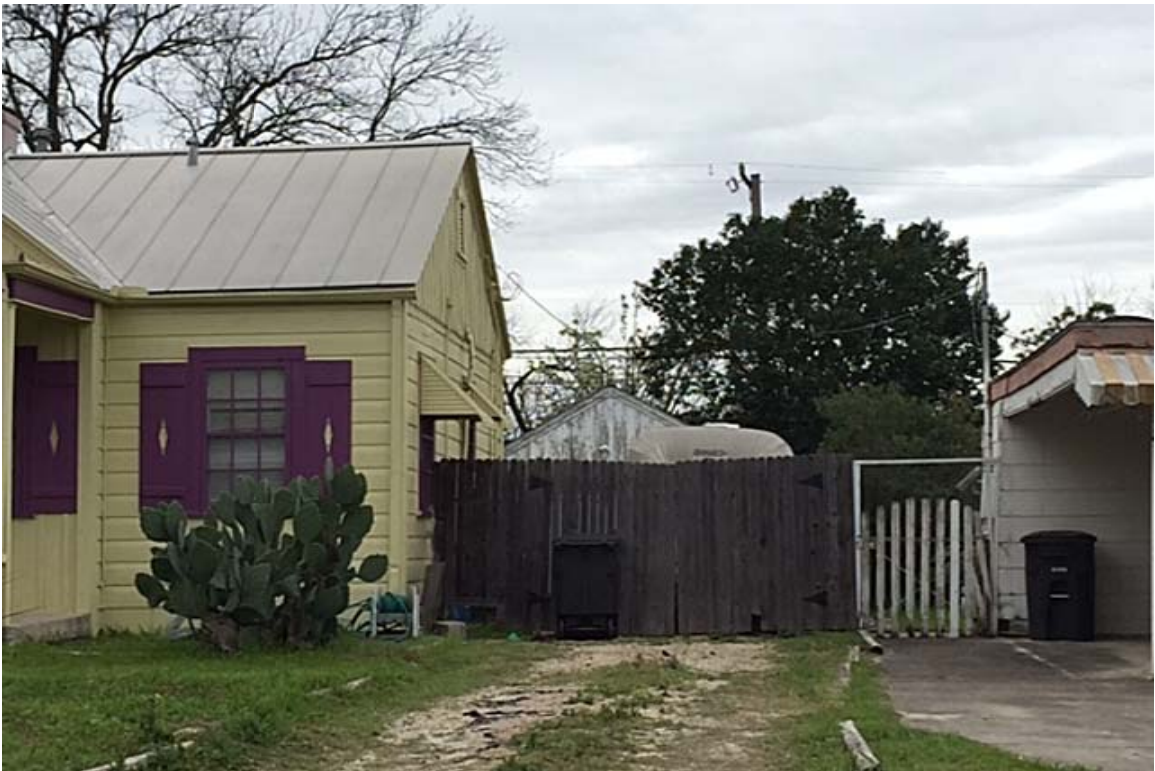
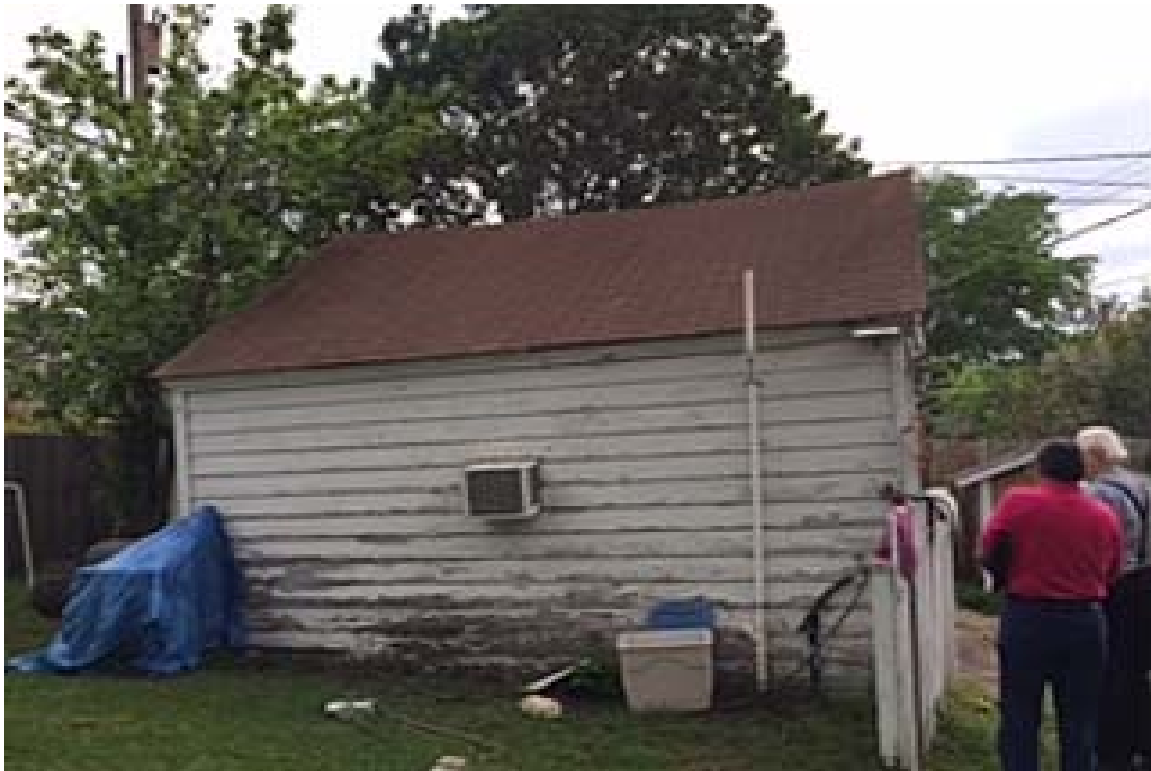
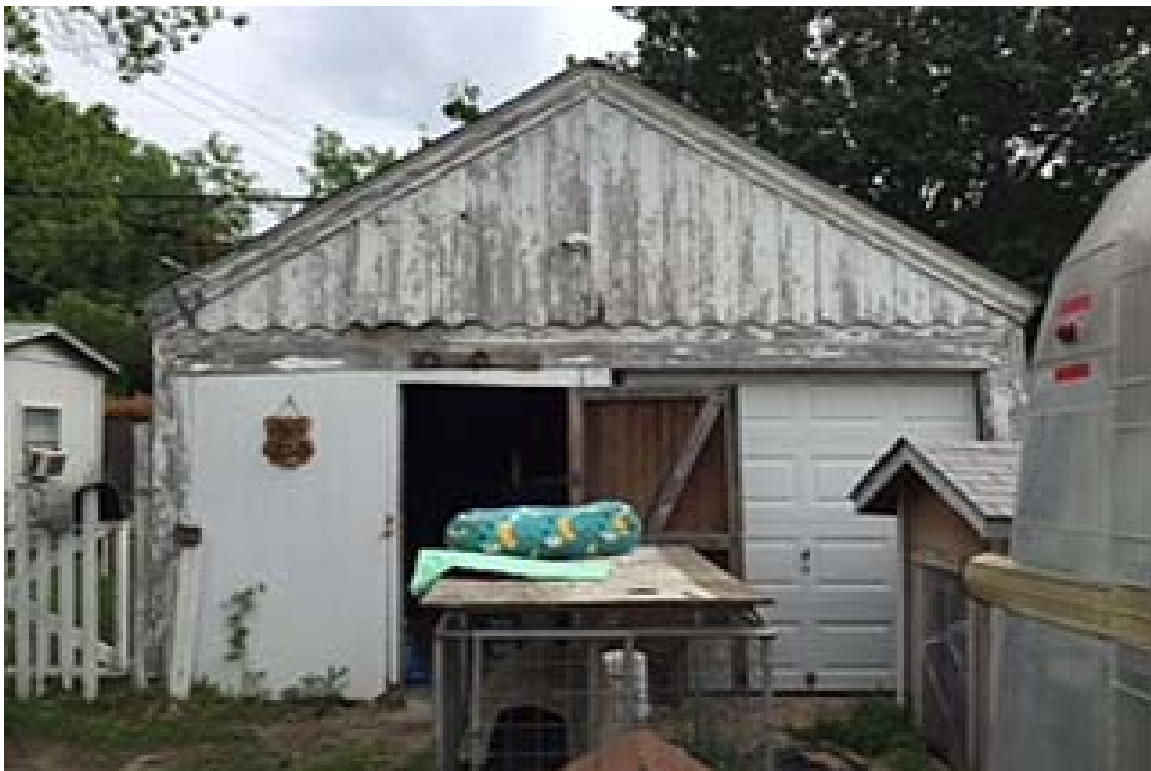
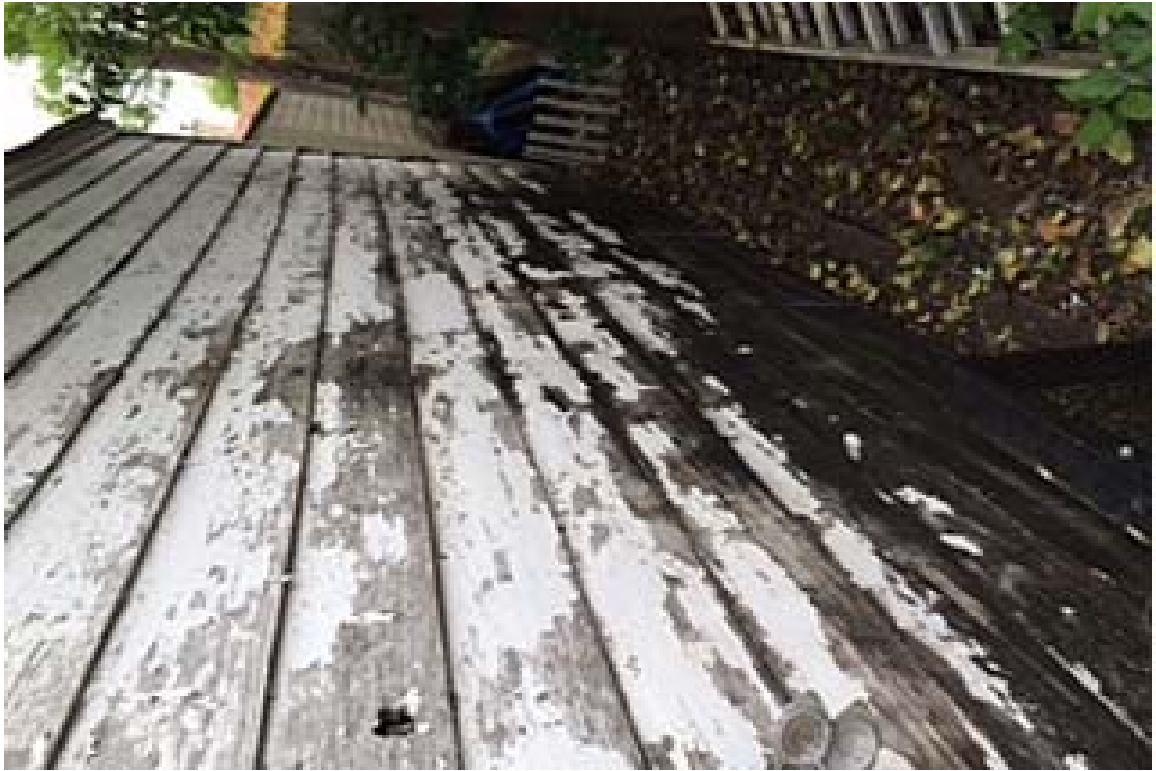
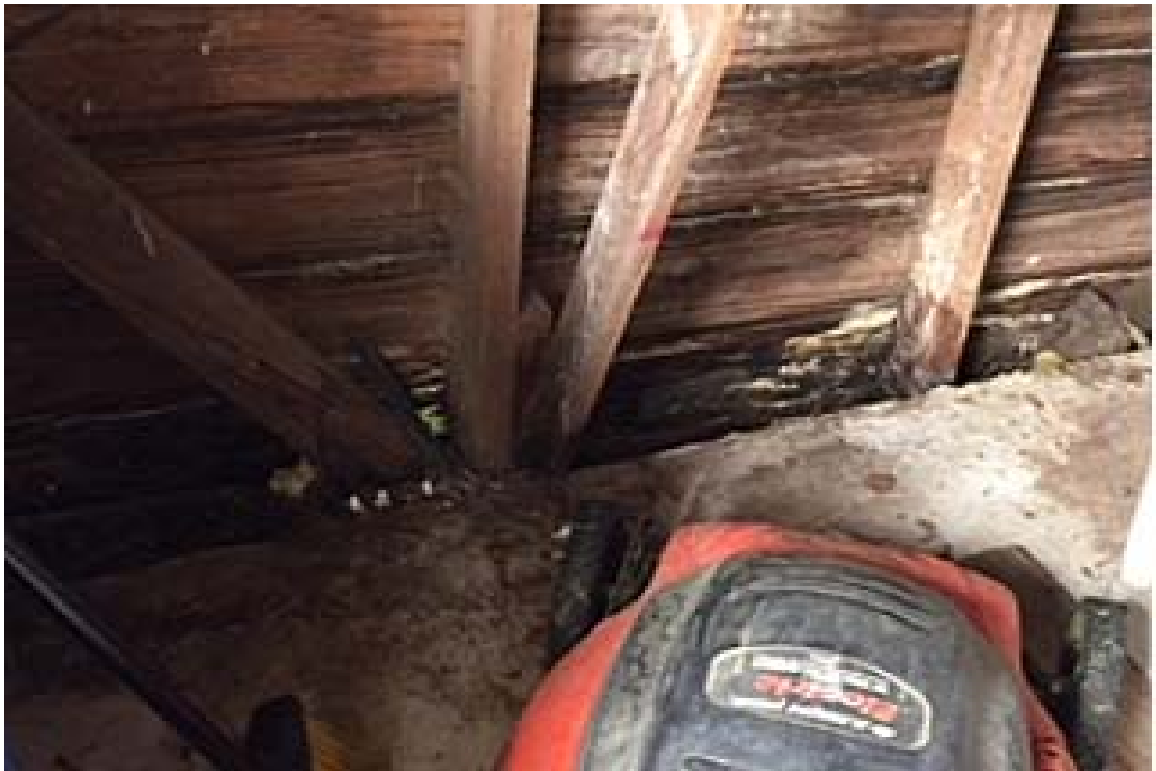
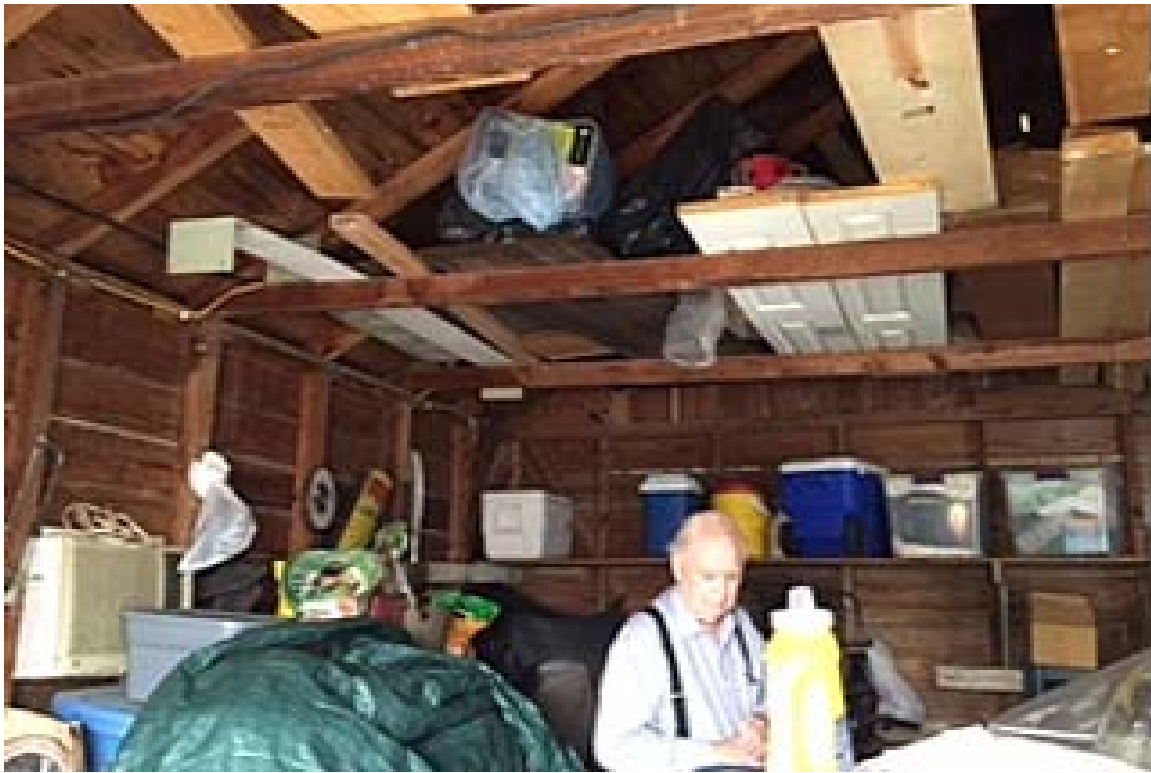
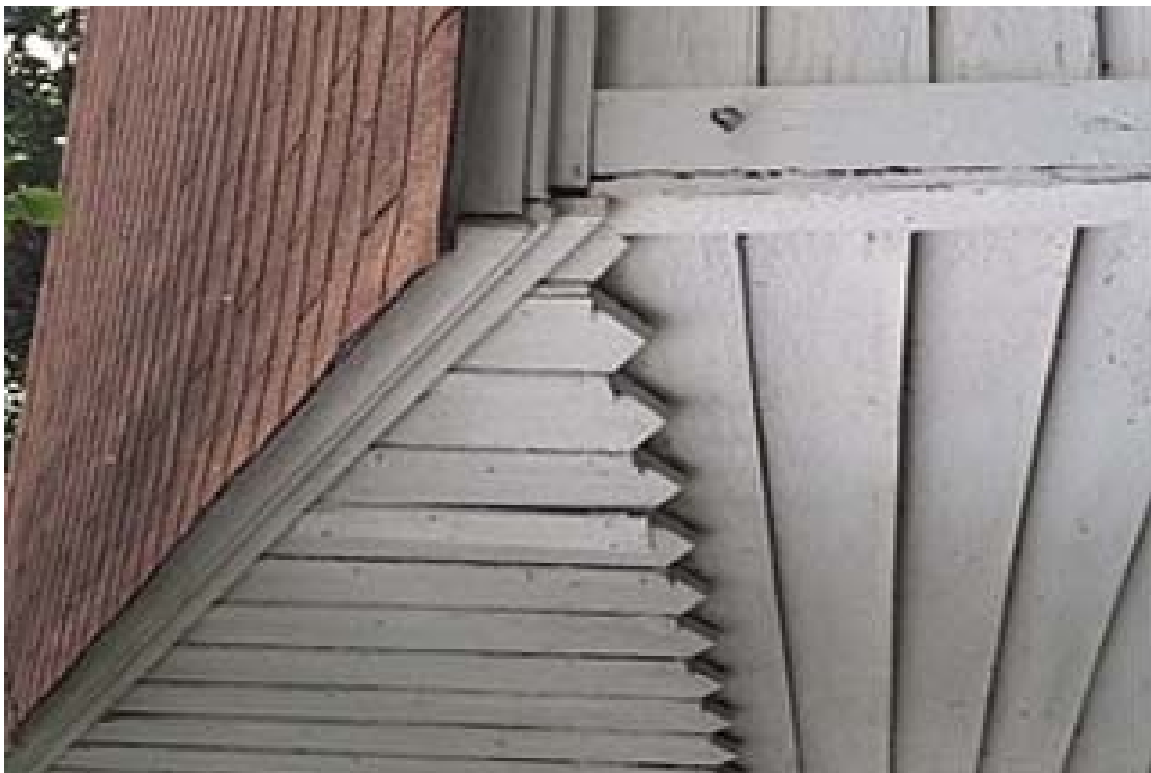
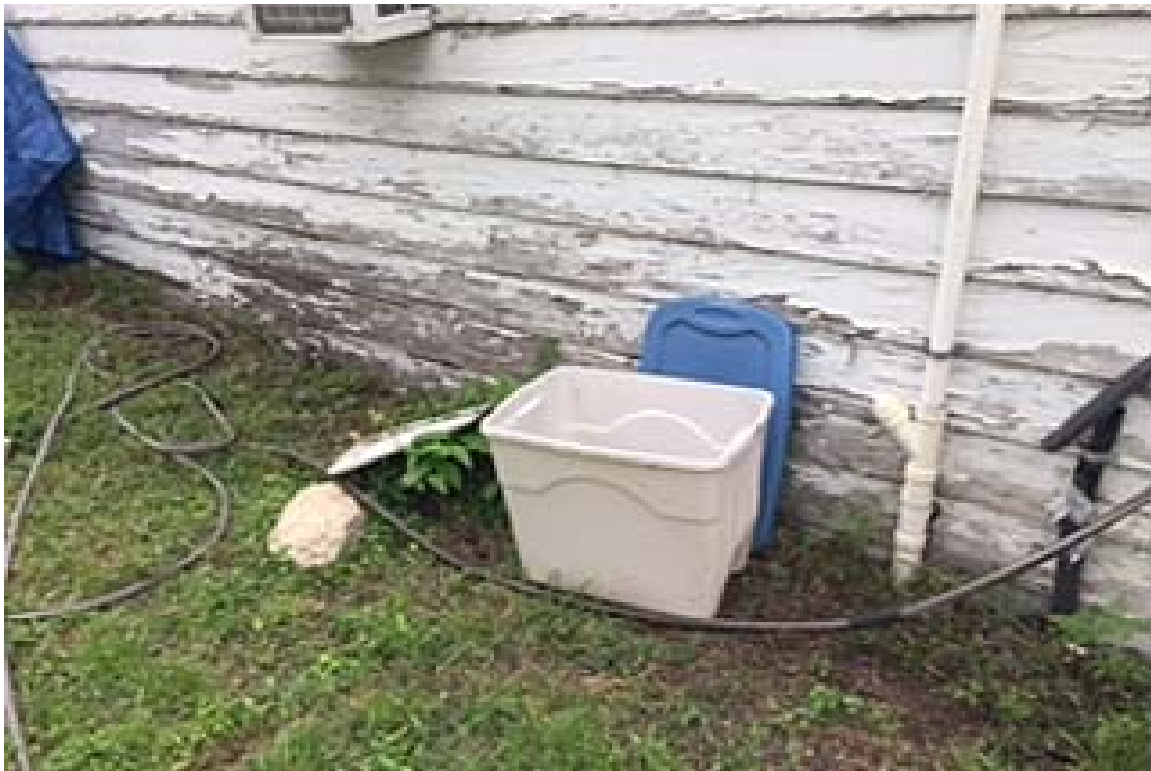
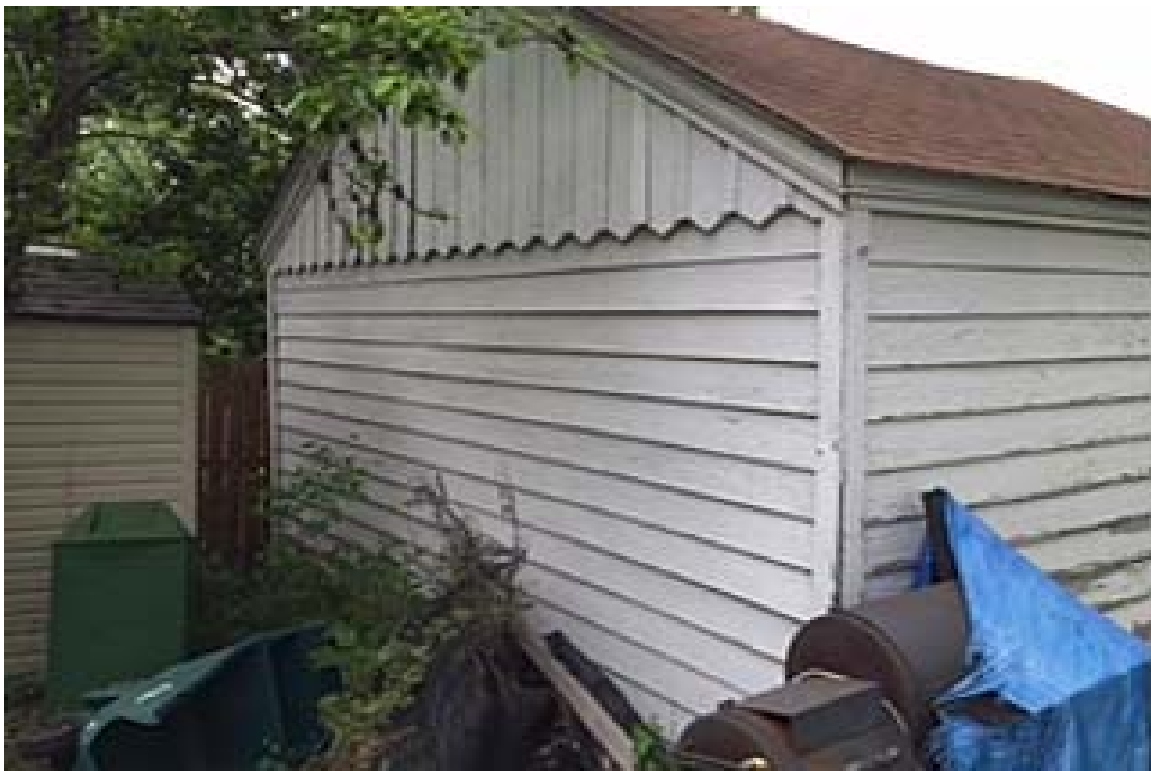
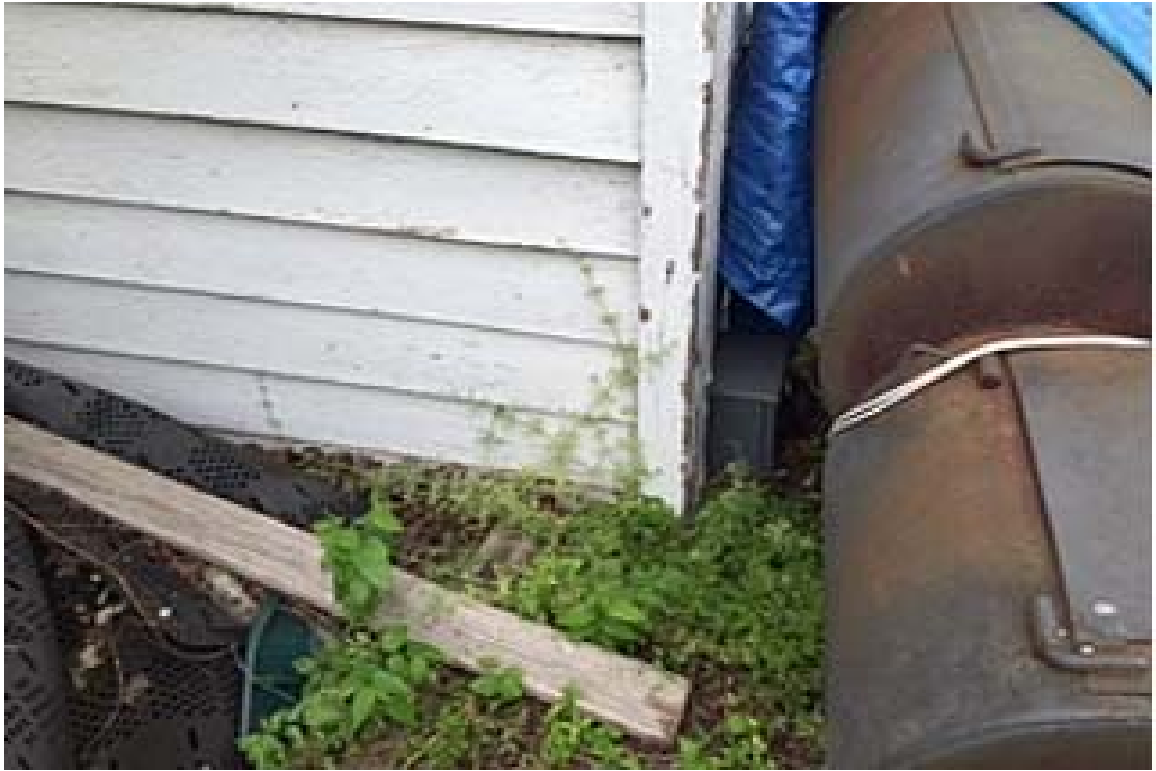
- c. The Demolition and Designation Committee visited the property on April 8, 2015. At that time the committee agreed that demolition would be an option if materials were salvaged and original details such as vertical battens at the gable were incorporated into the new design. The committee also noted that the garage structure is set on the ground and the existing slab was poured around it sometime after it was constructed.

- d. Demolition of a historic structure should only be used as a method of last resort when all other options have been exhausted. The existing structure appears to be sound and its rehabilitation and conversion into a living unit should be explored prior to demolition being approved.

COMMENTS/CONCERNS: JC: floating slab. is cracked.

JS: slab doesn't bother me, walls are the most important. A lot of bones that could be used. Just needs to be jacked up, pour a new slab, replace the wall plates & you got a nice place.

Staff does not recommend approval as submitted based on findings a-c. Staff recommends the existing structure is rehabilitated to accommodate the new use.

approve demo w/ all salvageable materials are reused & new bldg matches original details on gatehouse.

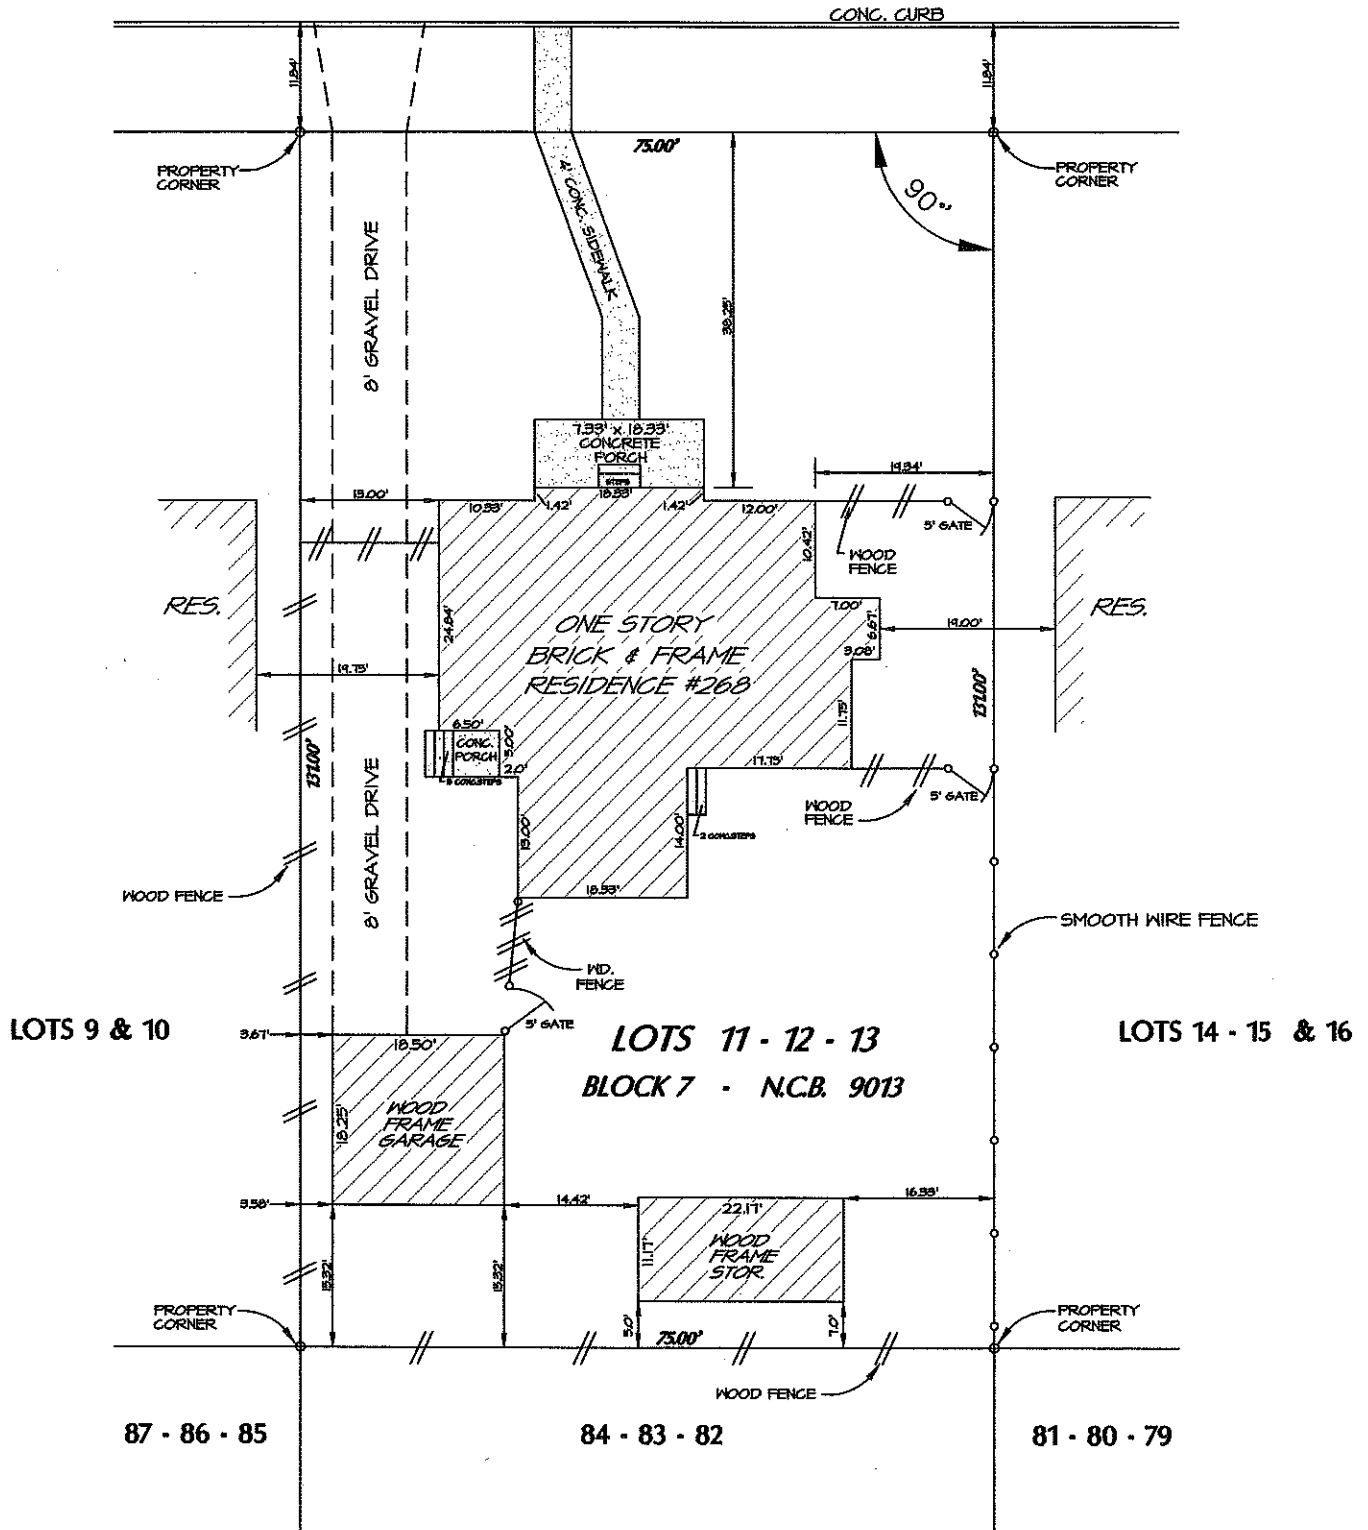
EXISTING SITE PLAN

- f. According to the Guidelines for New Construction, historic setback patterns should be followed for new outbuildings. The proposed cottage will match the side setback on the existing structure and expand the rear wall to meet the rear setback. The proposed setbacks are consistent with the guidelines. However, the new structure might encroach on the side setback which may require a variance.

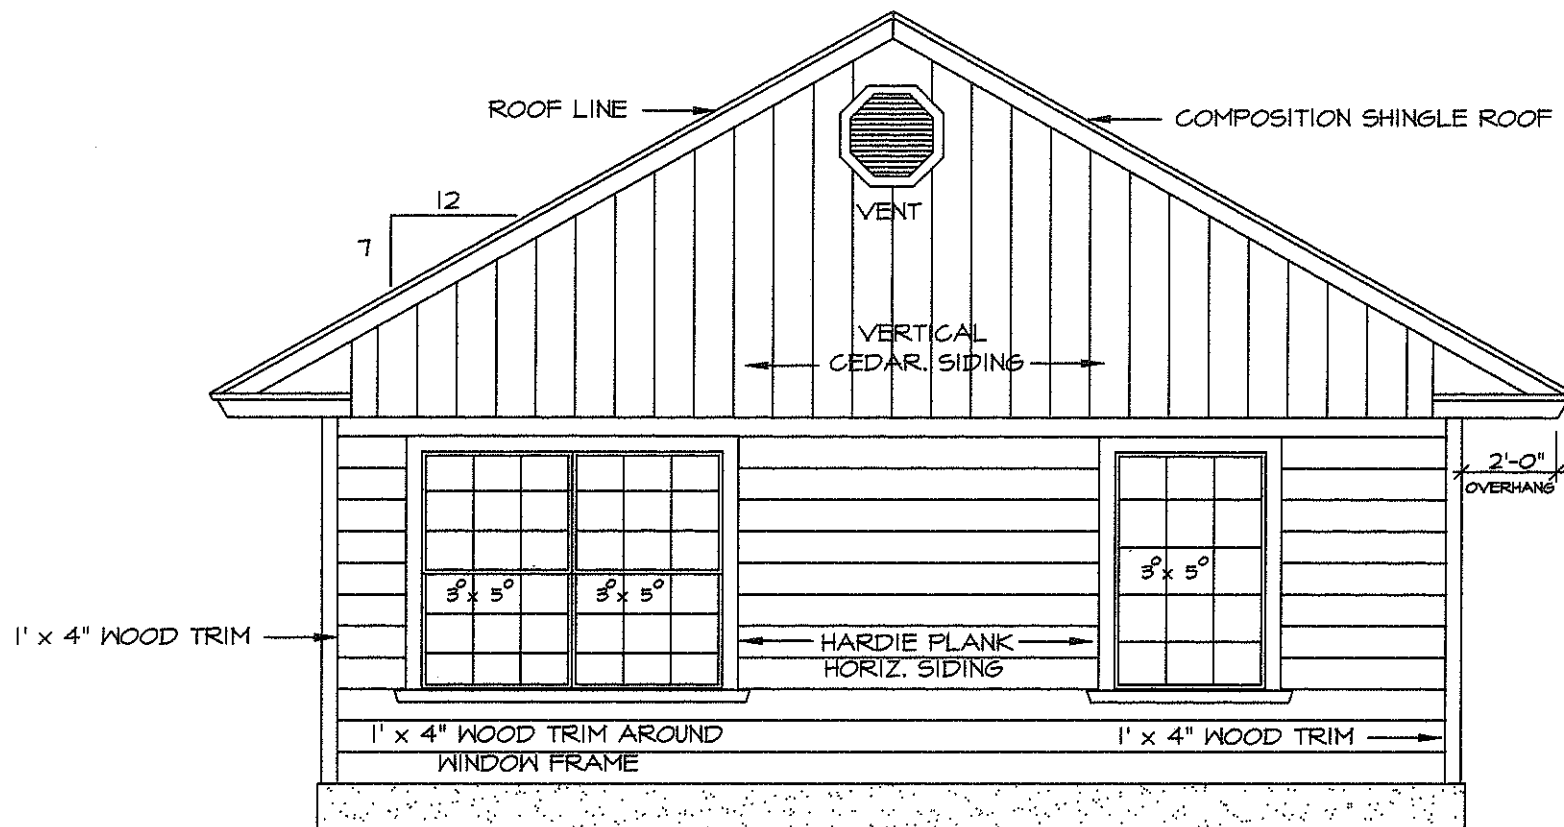
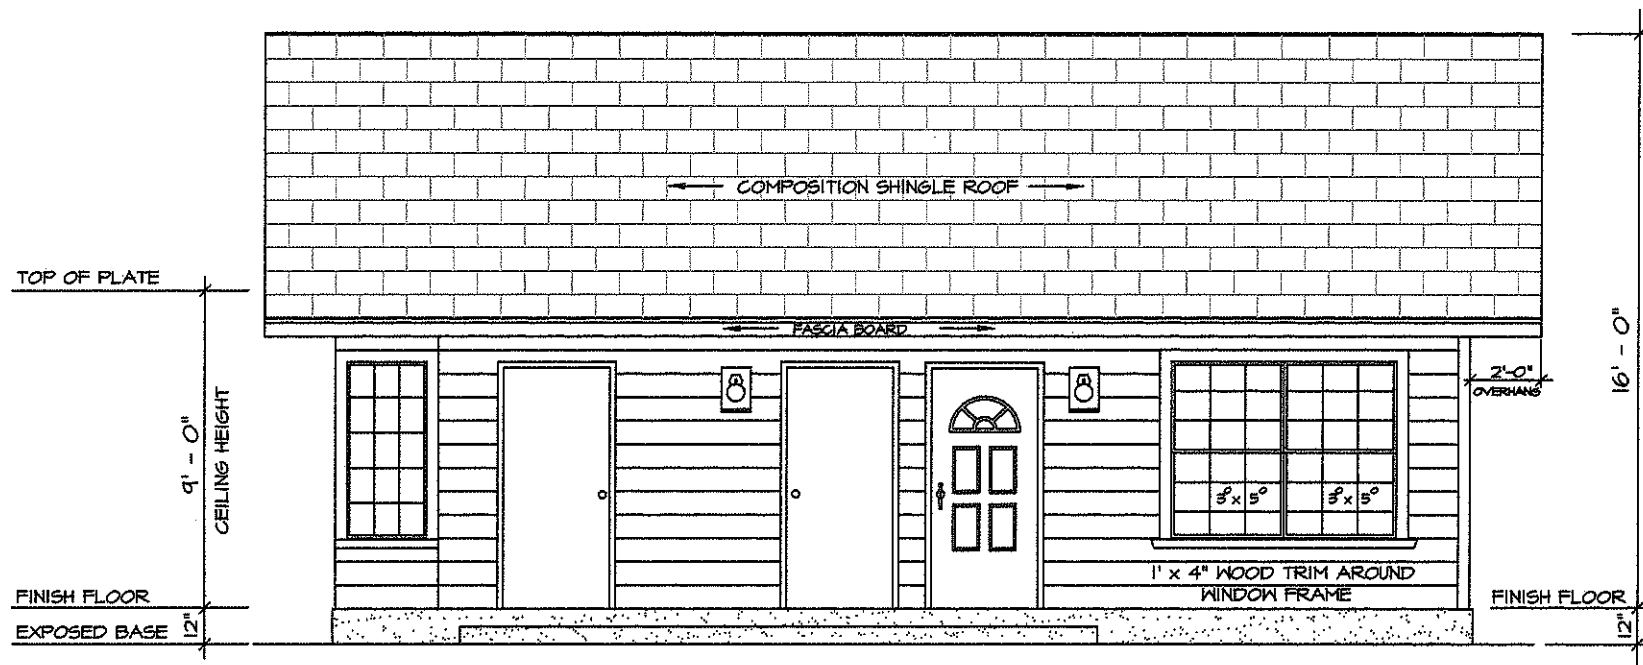
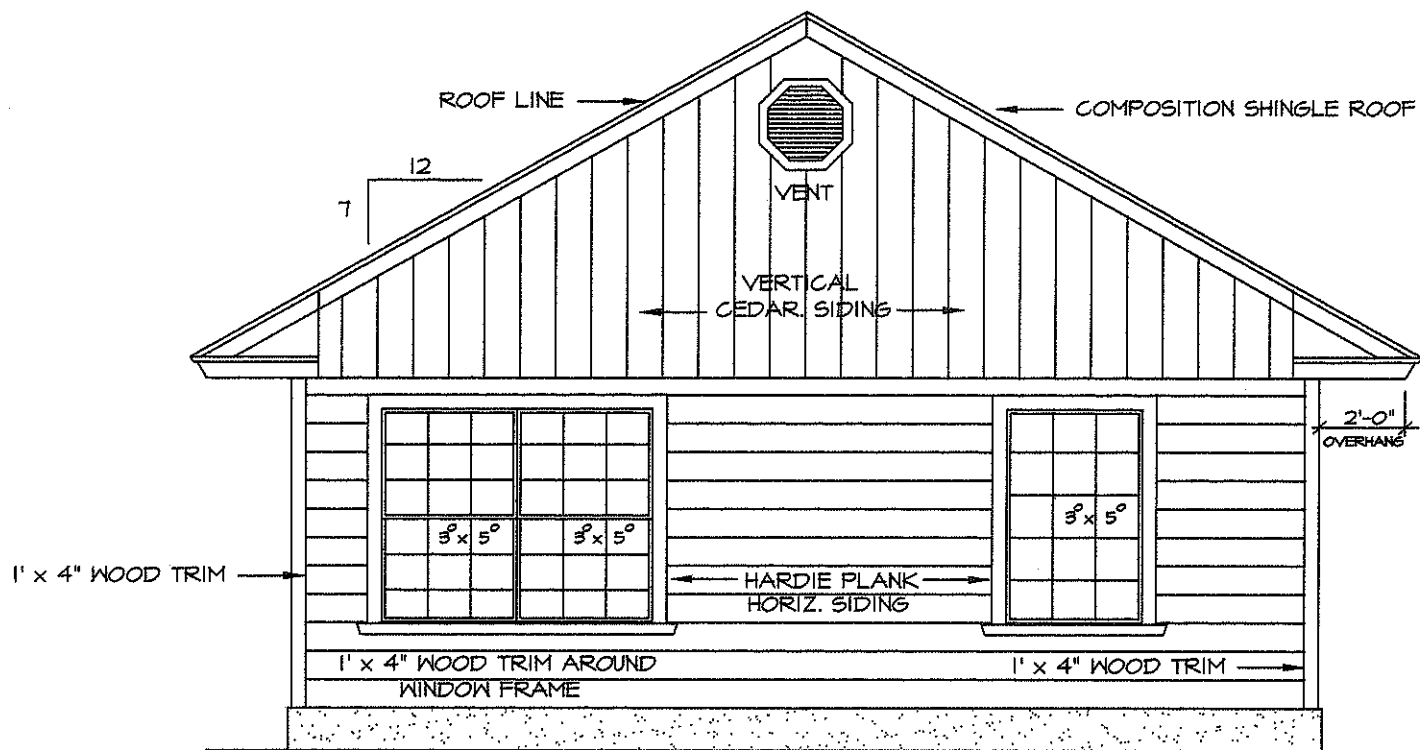
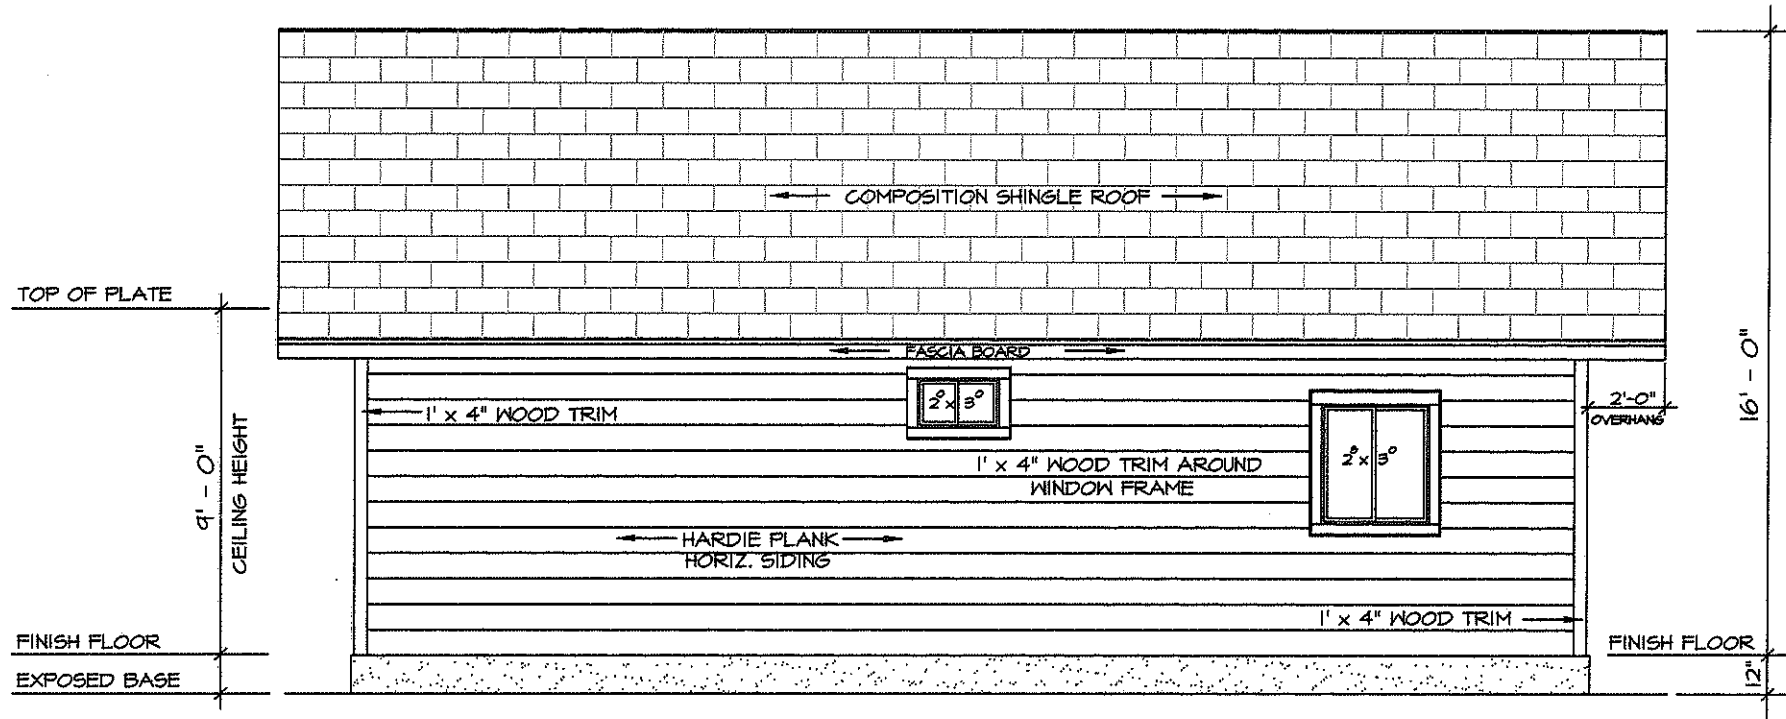
- g. The Guidelines for New Construction recommend new outbuildings to have window and door openings similar to those found on the principle structure in terms of spacing and proportions. The proposed windows are consistent in proportions to the main house. However, the proposed nine over nine aluminum windows will not match the six over six true divided lite windows on the house which should be avoided. In addition, the proposed doors are not a typically found door type in historic districts and does not relate to the historic home.

- h. New construction in historic districts should be complementary to historic structures found throughout the district. The applicant's proposal exhibits various details that are not consistent with the primary structure on the lot and therefore are not consistent with the Guidelines for New Construction which includes issues with the eave and rafter details and the design of the attic vents.

- a. A door type that is consistent with those found in historic districts is used
- b. If windows with divided lites are used, they should match the windows on the main house and use true divided glass.
- c. Eave and rafter detailing and appropriate attic vents.
