HISTORIC AND DESIGN REVIEW COMMISSION

May 06, 2015

HDRC CASE NO: 2015-161
ADDRESS: 106 W ROSEWOOD AVE
LEGAL DESCRIPTION: NCB 6458 BLK 9 LOT 74 AND 75 76
ZONING: R5 H
CITY COUNCIL DIST.: 1
DISTRICT: Monte Vista Historic District
APPLICANT: Mike Carte
OWNER: Dennis Ahlburg
TYPE OF WORK: Exterior alterations to existing garage
REQUEST:

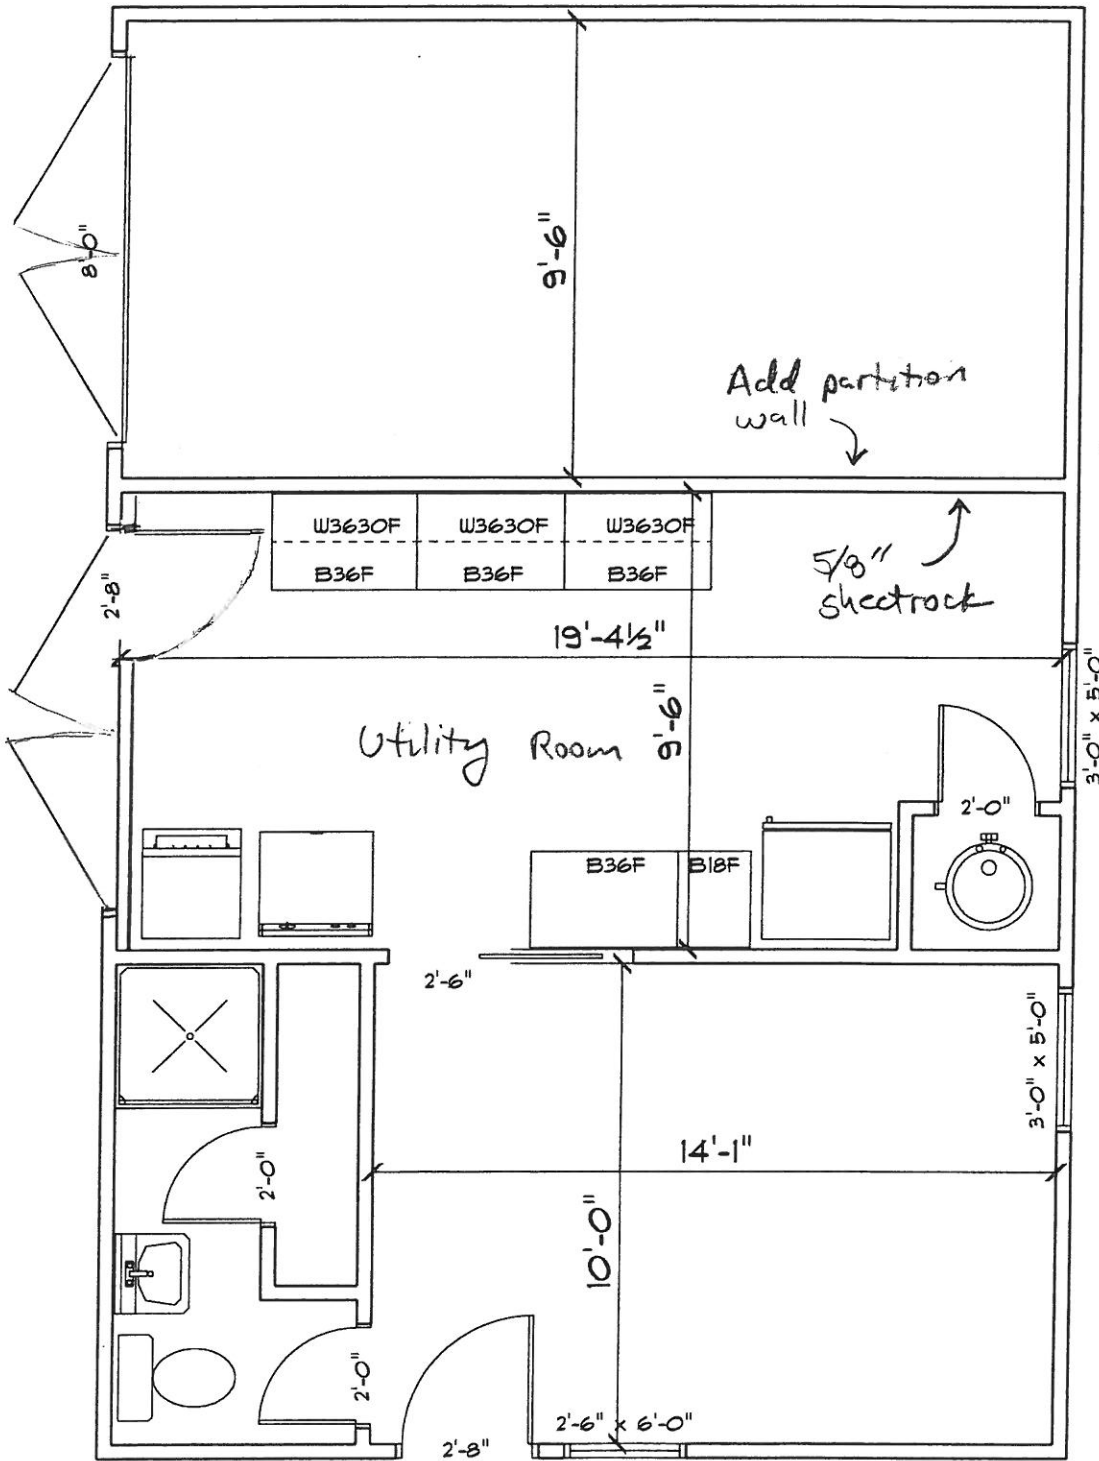
PROPOSED PLAN

Remove
existing
rotted
siding
&
install
new
T-111
pine
4'x8'
siding
this
ext
wall
