## HISTORIC AND DESIGN REVIEW COMMISSION

### Agenda Item No: 33

**HDRC CASE NO:** 2016-254  
**ADDRESS:** 327 W CRAIG PLACE  
**LEGAL DESCRIPTION:** NCB 1858 BLK 1 LOT 16, E 10 FT OF 15 & W 10 FT OF 17  
**ZONING:** O2 H  
**CITY COUNCIL DIST.:** 1  
**DISTRICT:** Monte Vista Historic District  
**APPLICANT:** William Triplett/H.E.B.  
**OWNER:** Respite Care of San Antonio  
**TYPE OF WORK:** Addition, exterior modifications  
**REQUEST:**

HDRC Application  
Respite Care of San Antonio  
327 W. Craig Place (Carriage House), Monte Vista  
Neighborhood  
San Antonio, TX

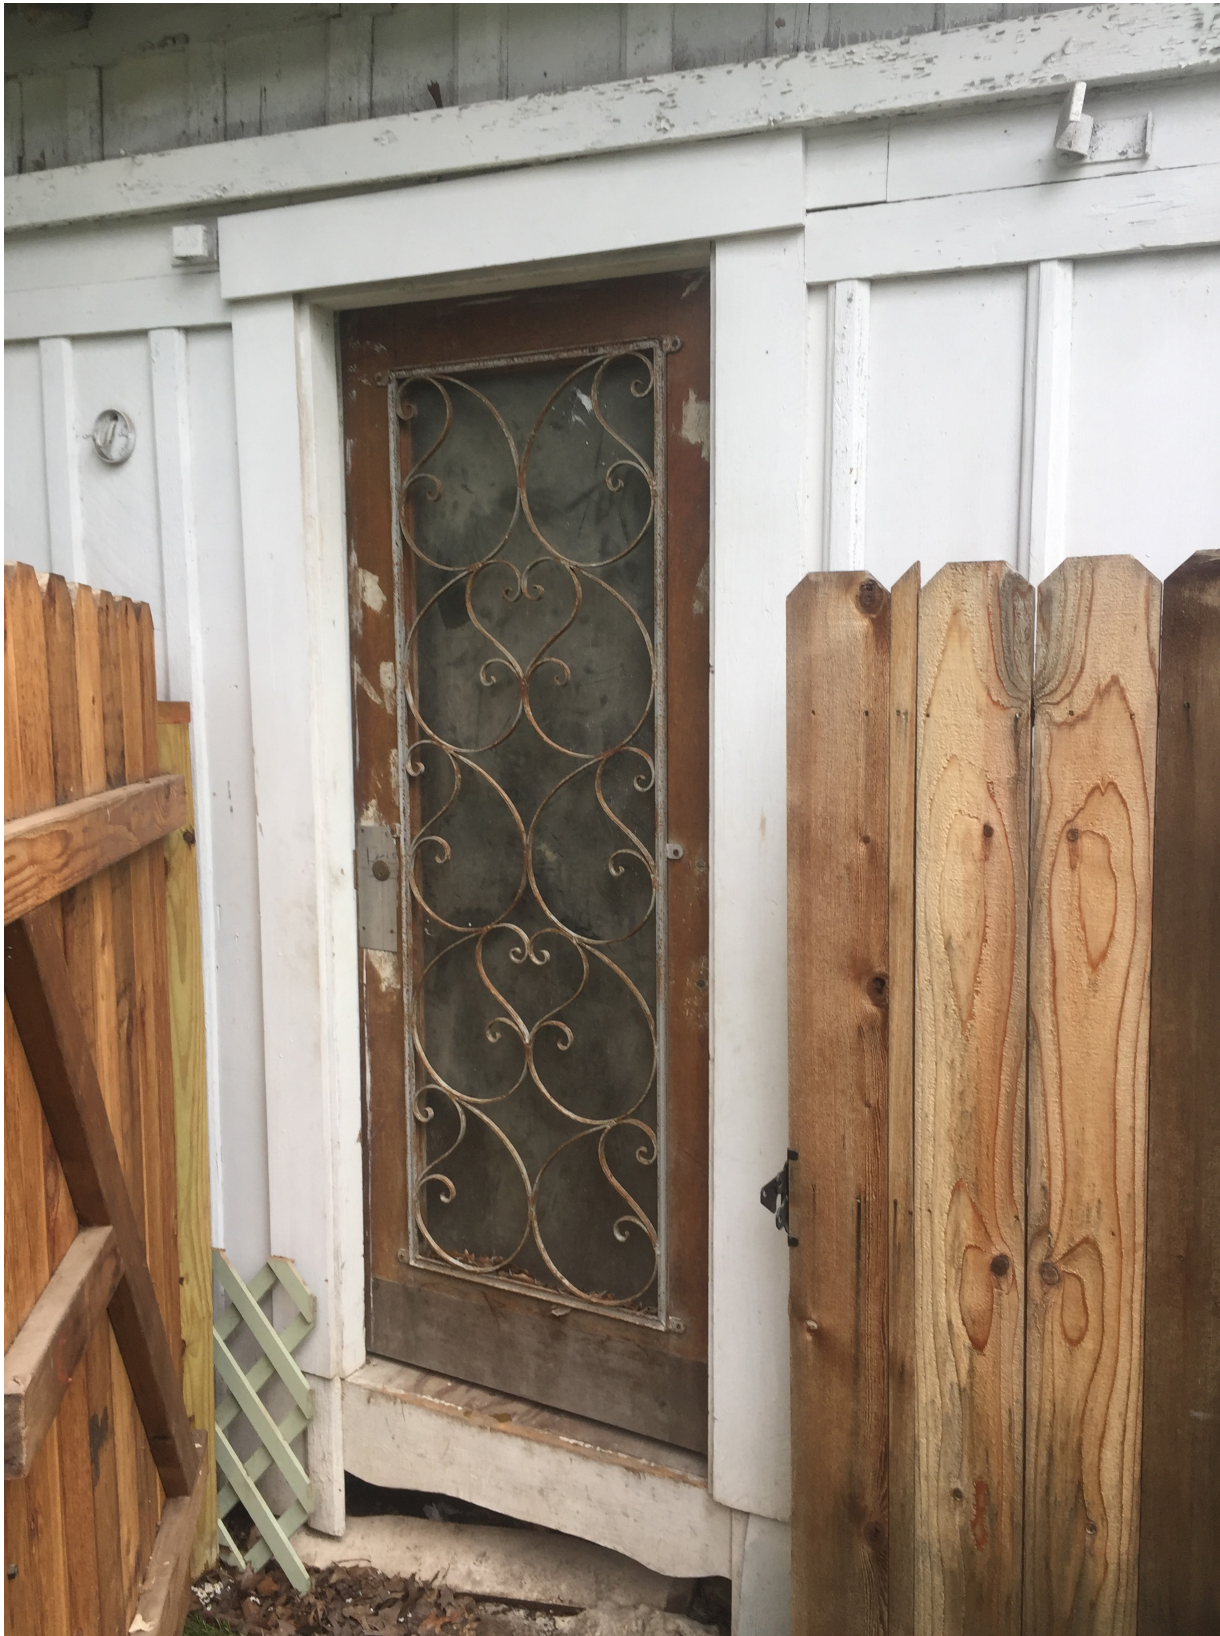
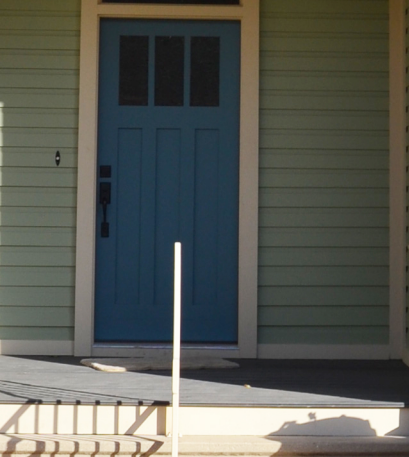
## 1 - Carriage House Door

-Door appears to not be original. Plan to replace with door similar the front door of the Main House.

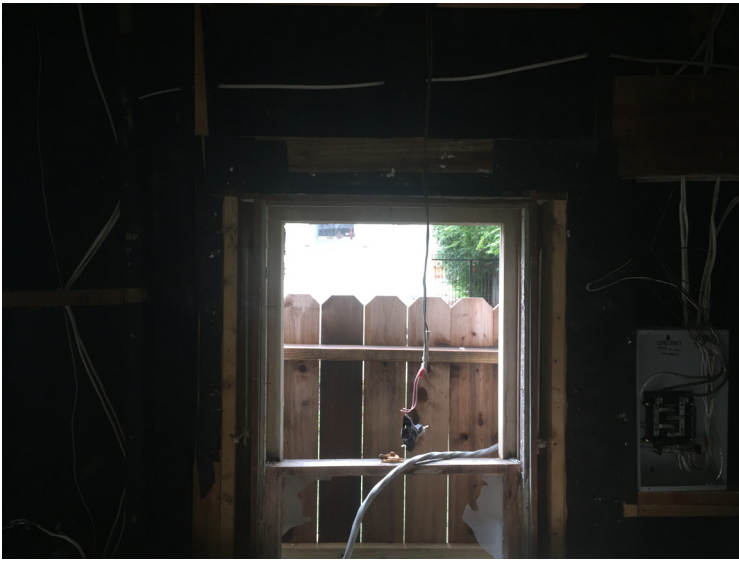
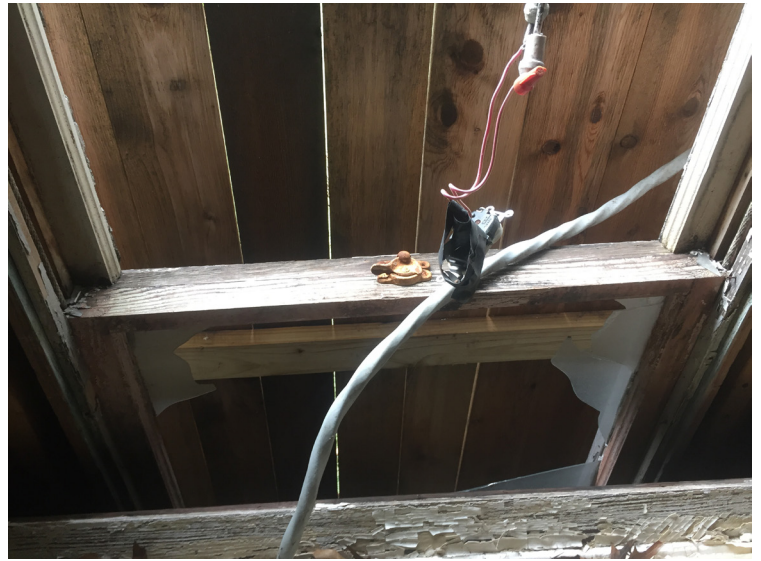
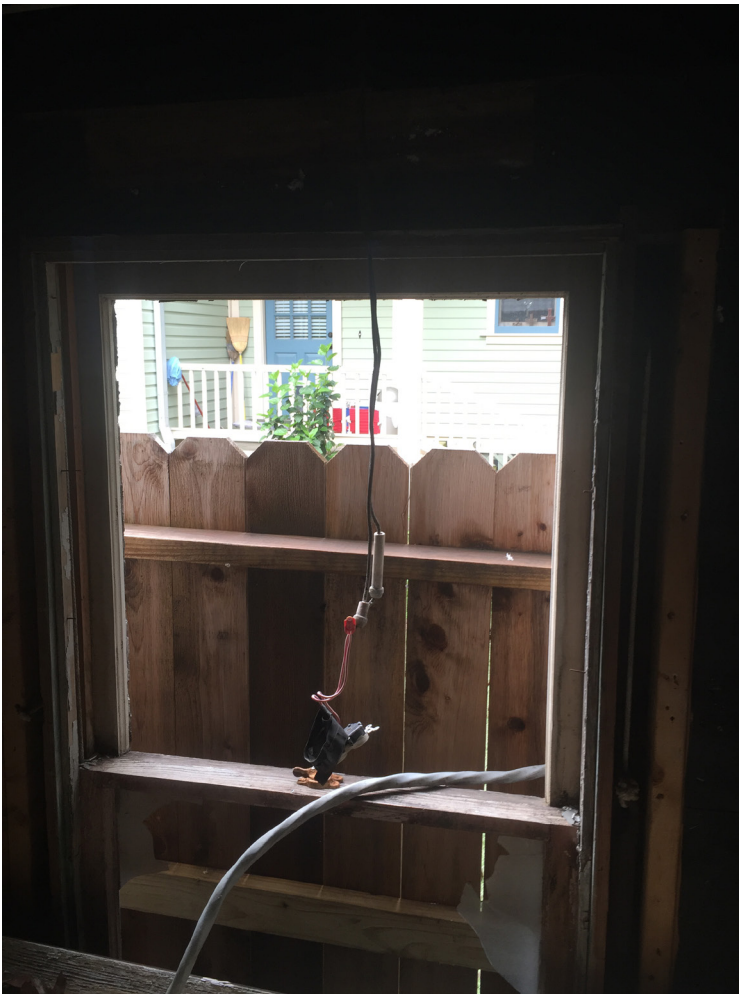
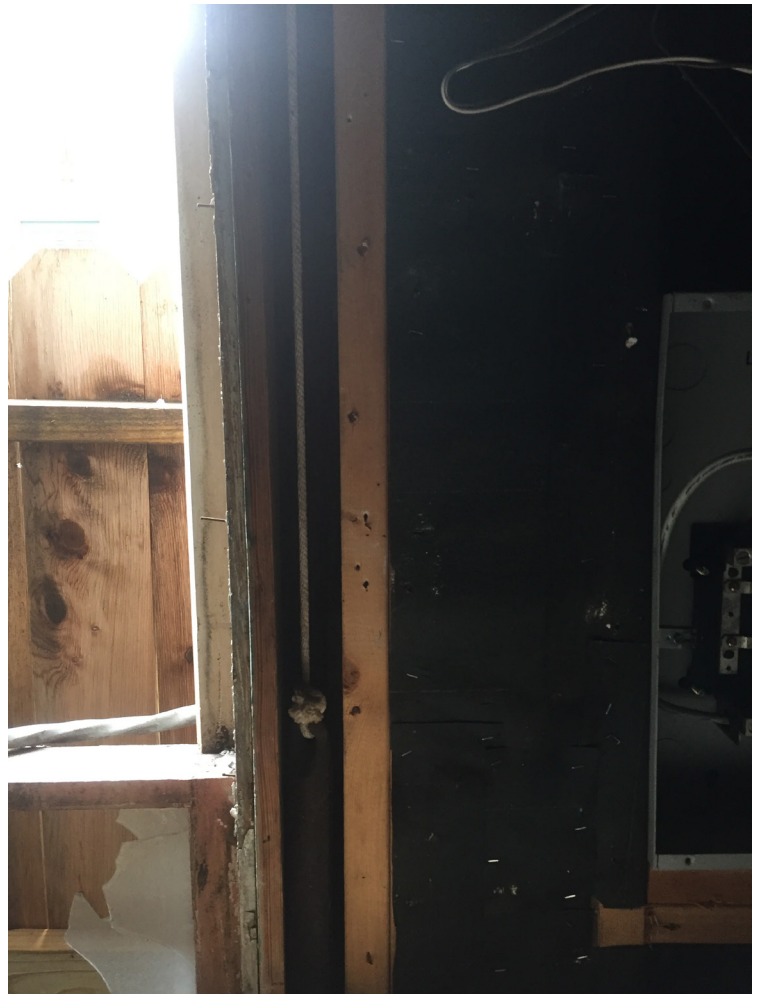
## 2 - Carriage House Window (South Facade)

- Window is in very poor shape. Plan to replace with window similar to the Main House (all main house windows were replaced with new wood windows).
- Window and Framing do not appear to be original.

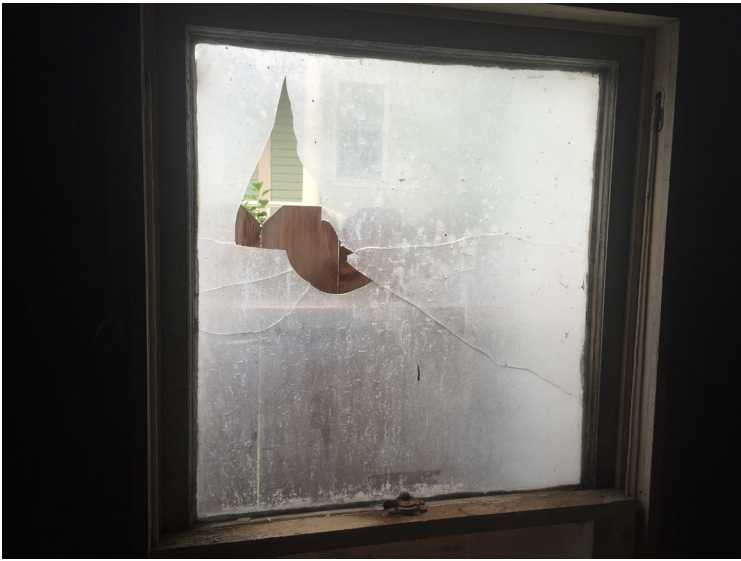
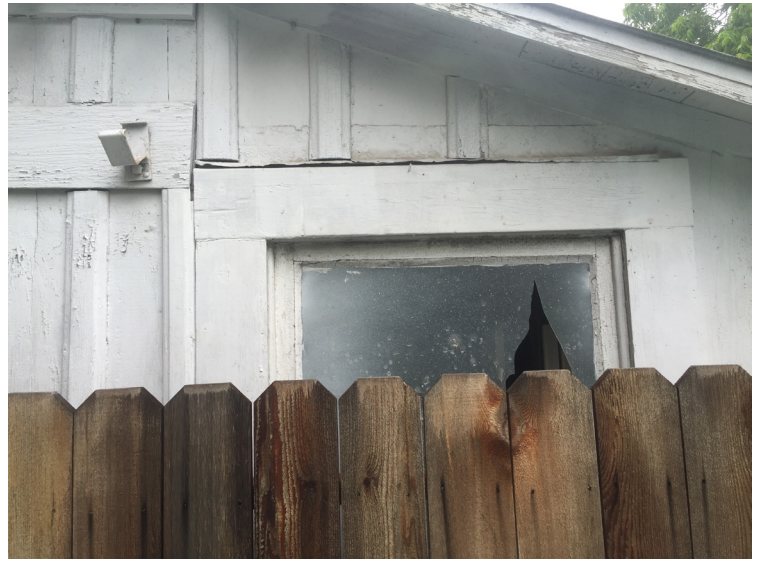
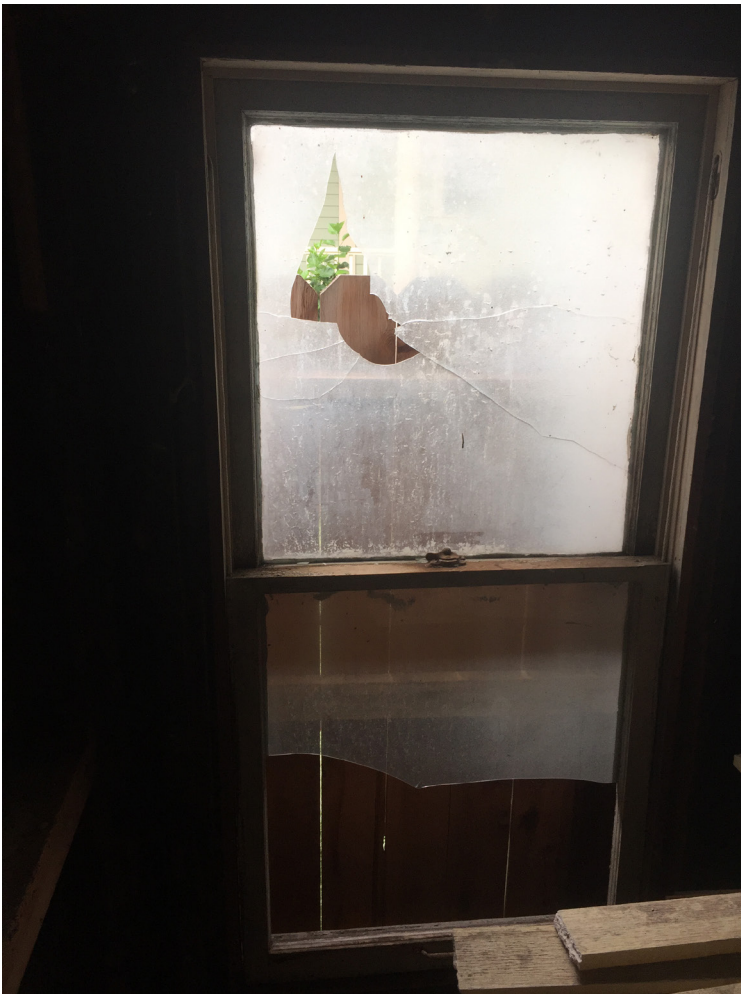
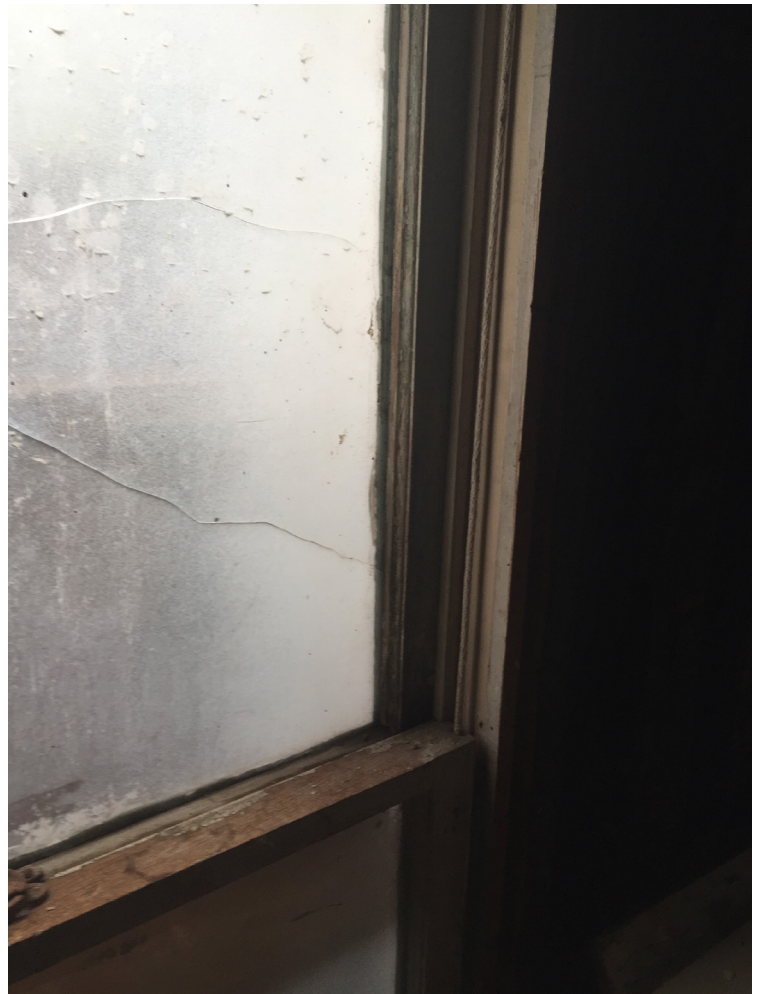
### 3 - Carriage House Window (South Facade)

-Window appears to not be original (part of the addition). Plan to eliminate the Window along with the addition.

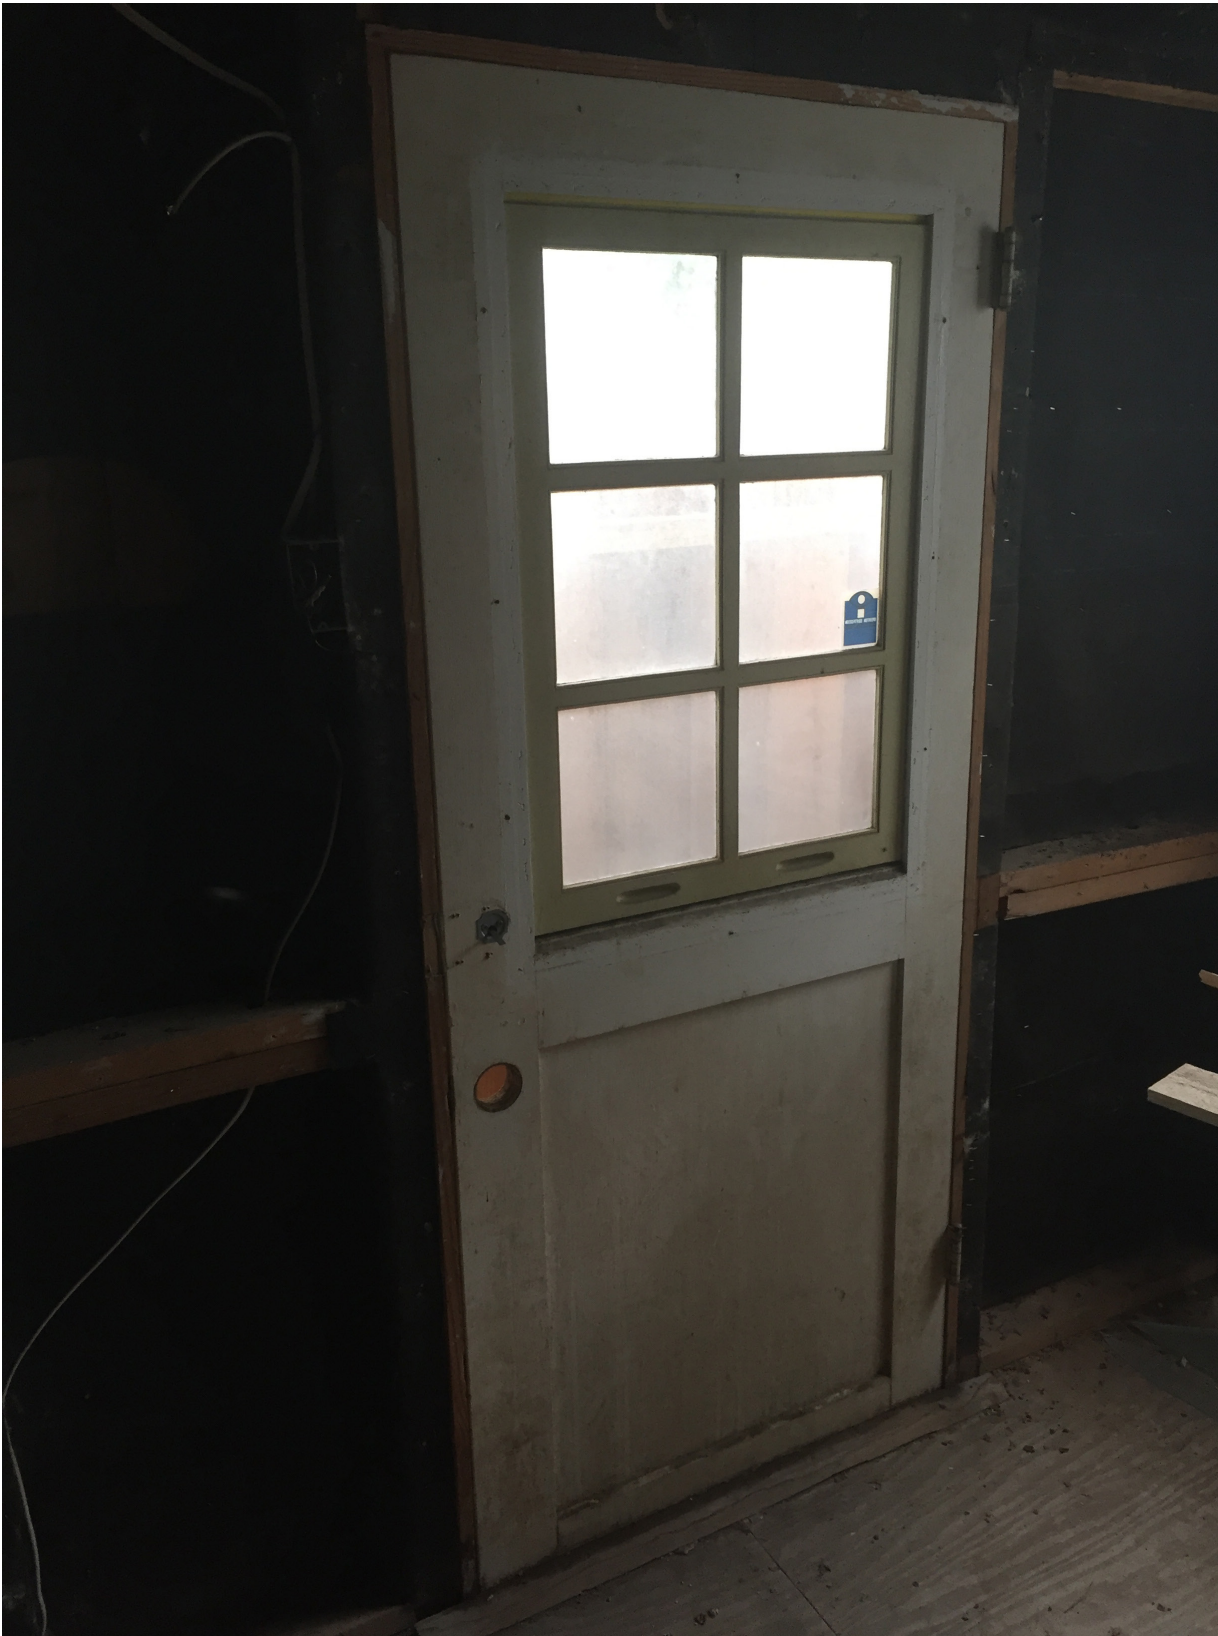
#### 4 - Carriage House Door (East Facade)

-Door appears to not be original (part of the addition). Plan to eliminate the door along with the addition.

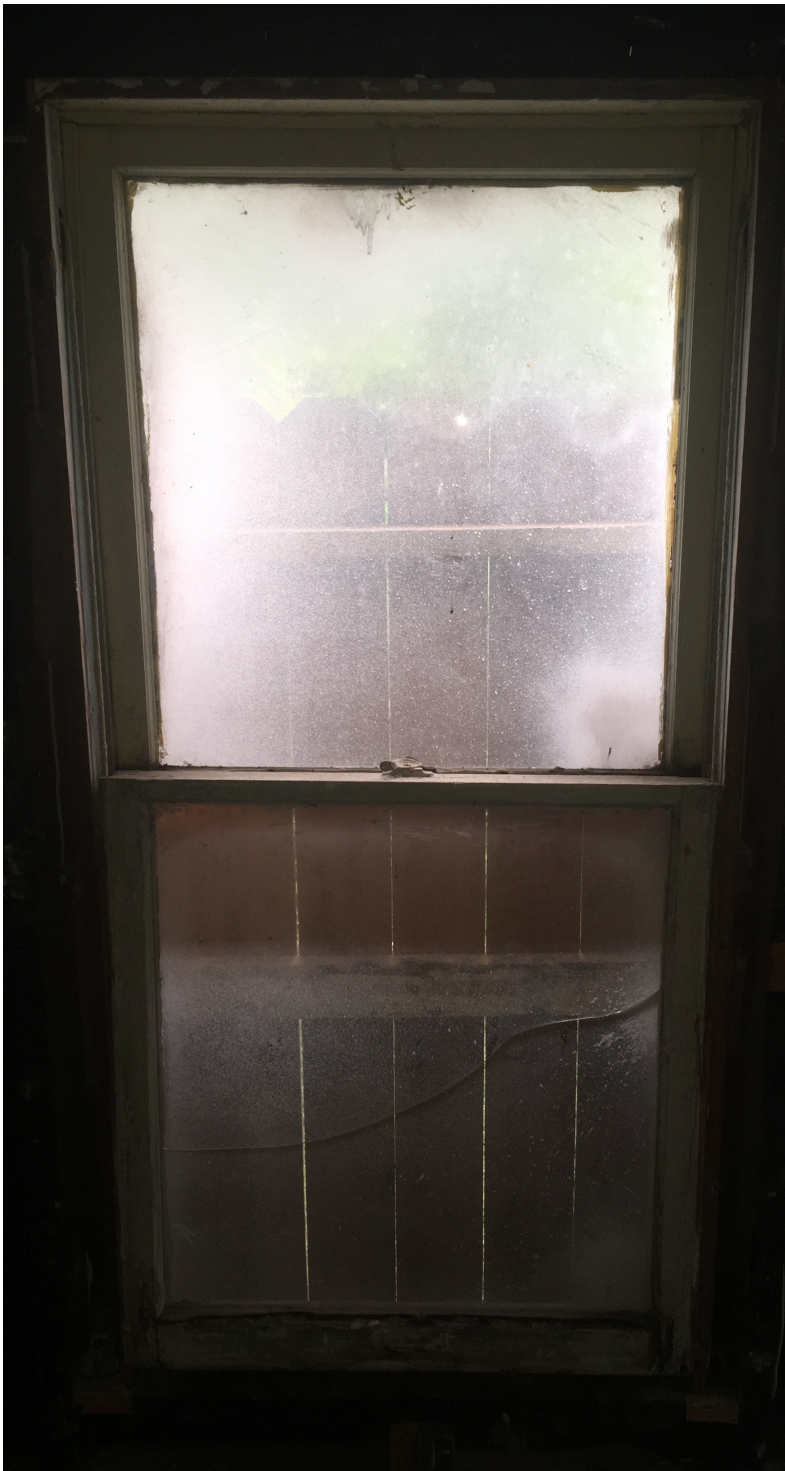
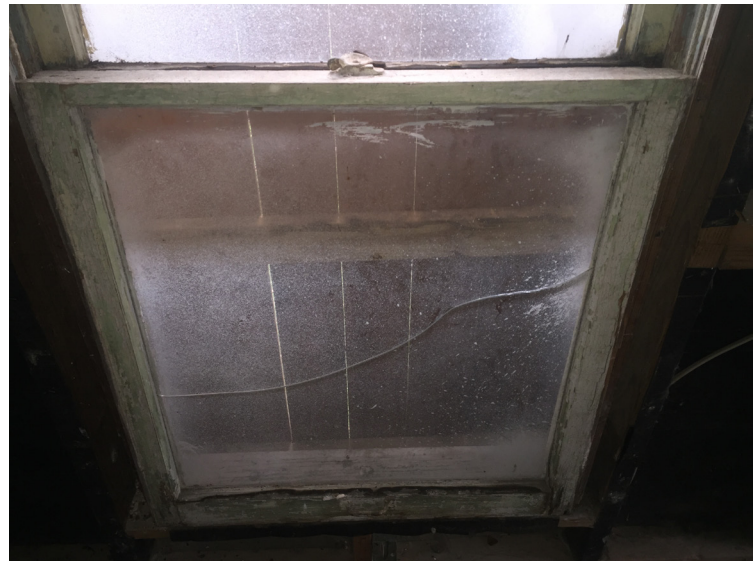
## 5 - Carriage House Window (East Facade)

-Window appears to not be original (part of the addition). Plan to eliminate the Window along with the addition.

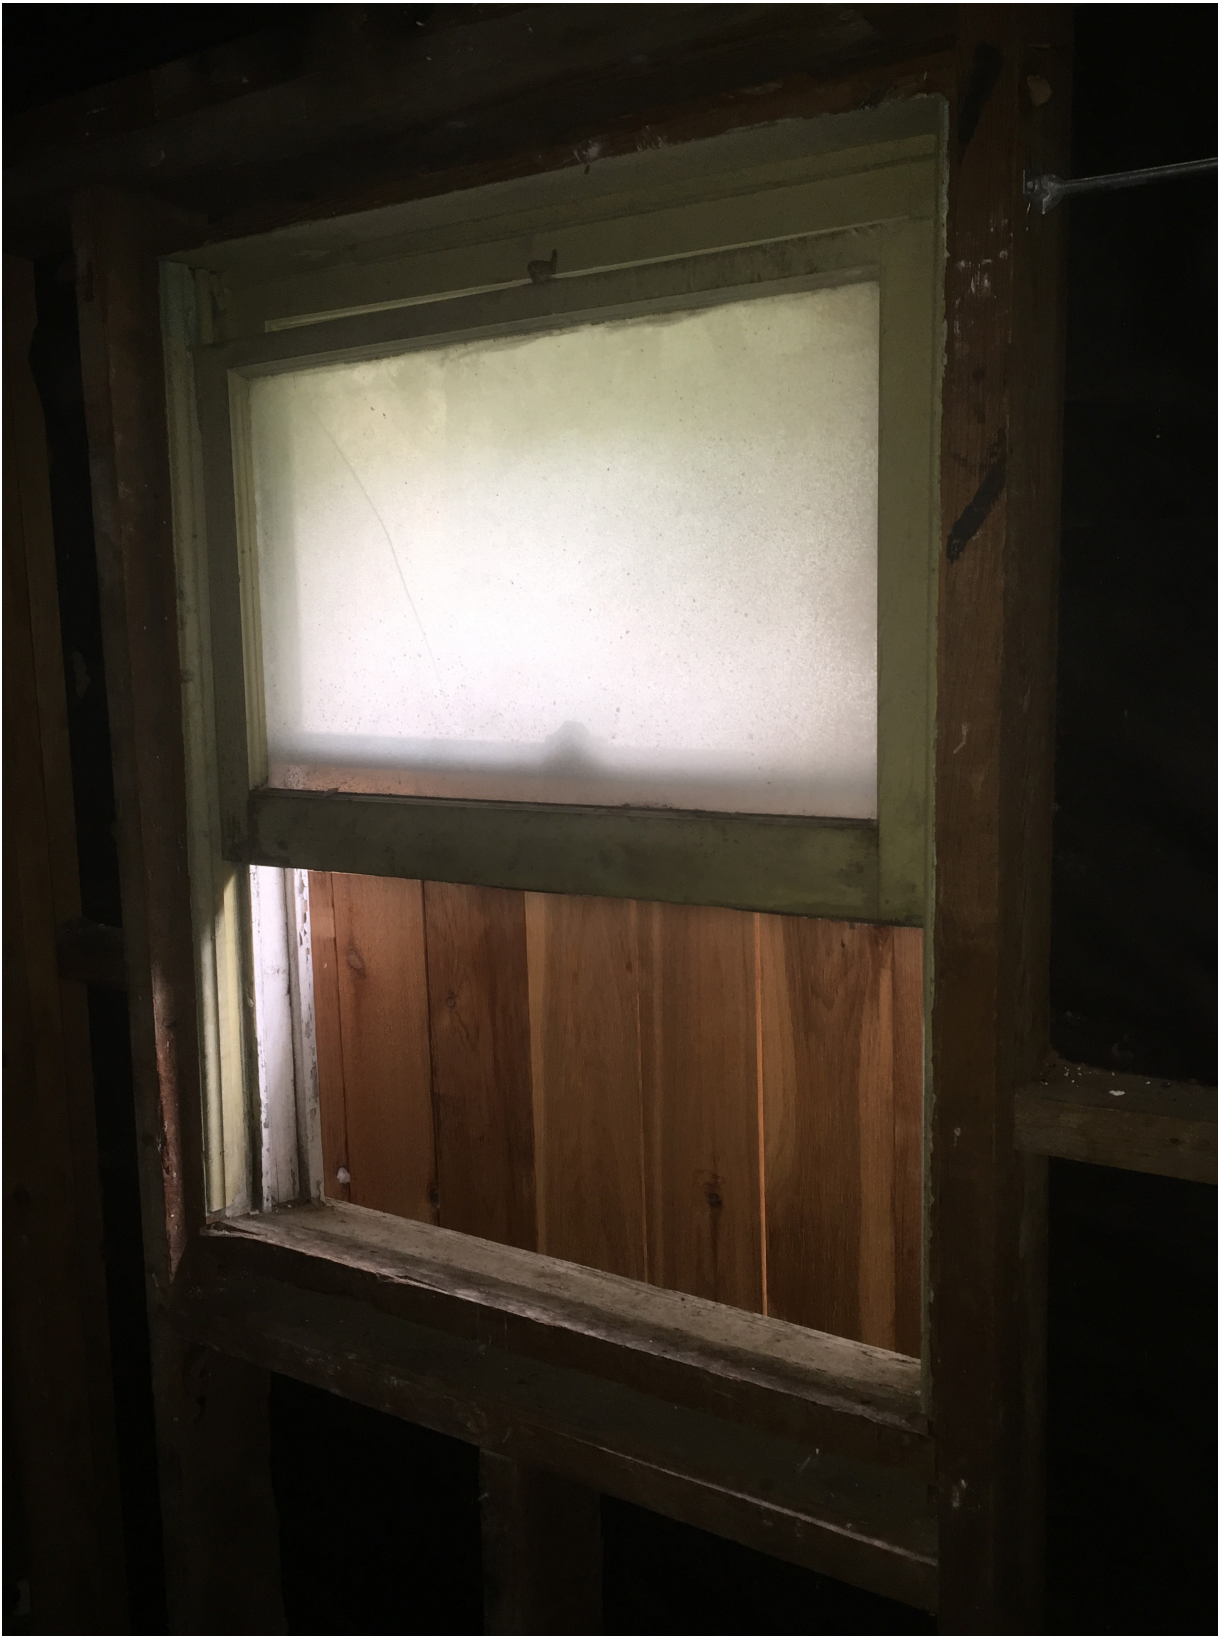
## 6 - Carriage House Window (East Facade)

-Window appears to not be original (part of the addition). Plan to eliminate the Window along with the addition.

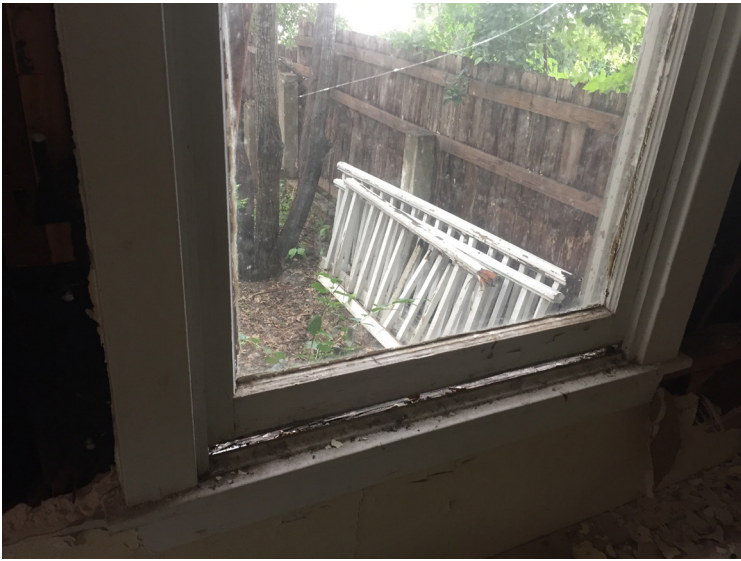
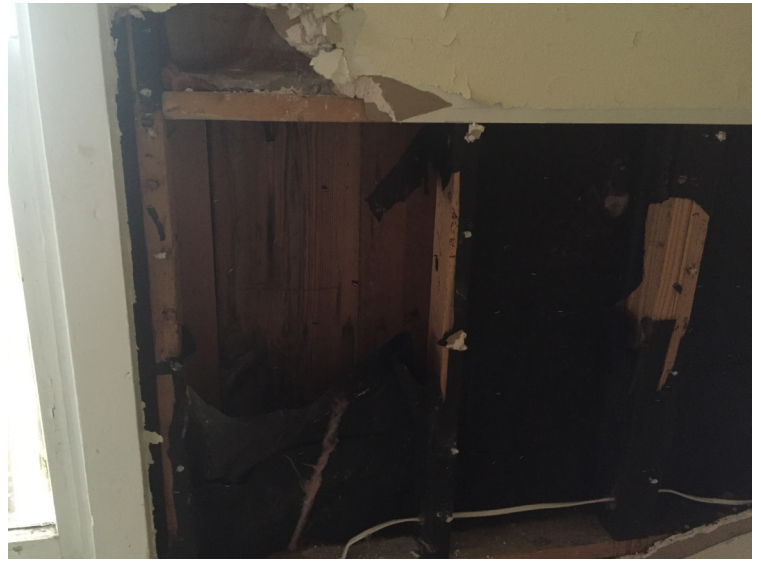
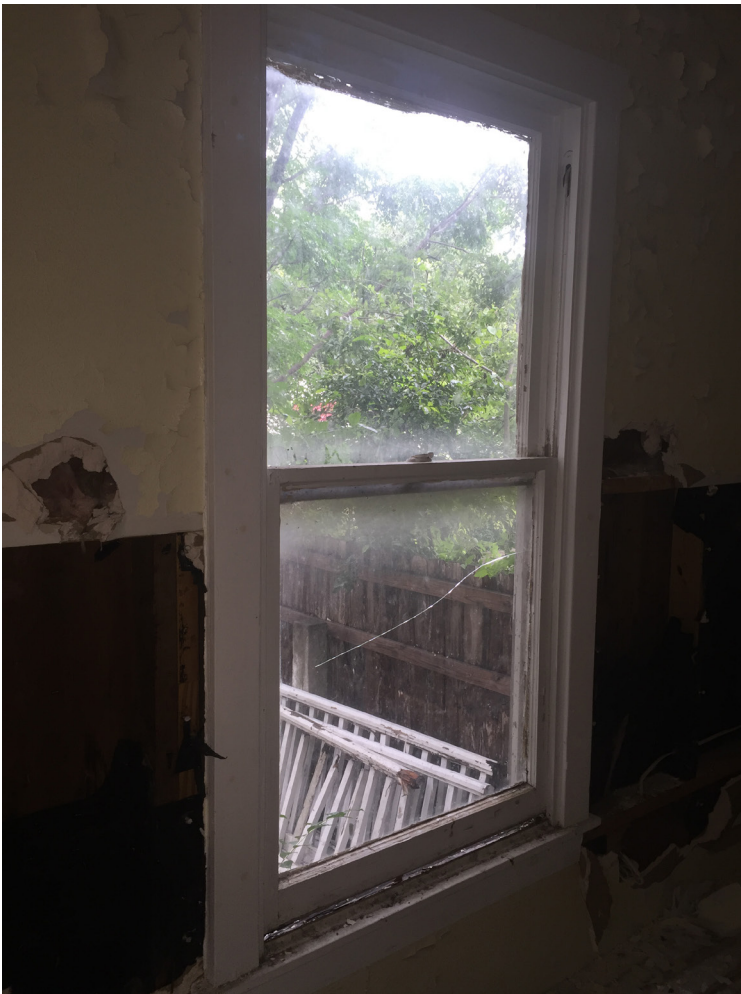
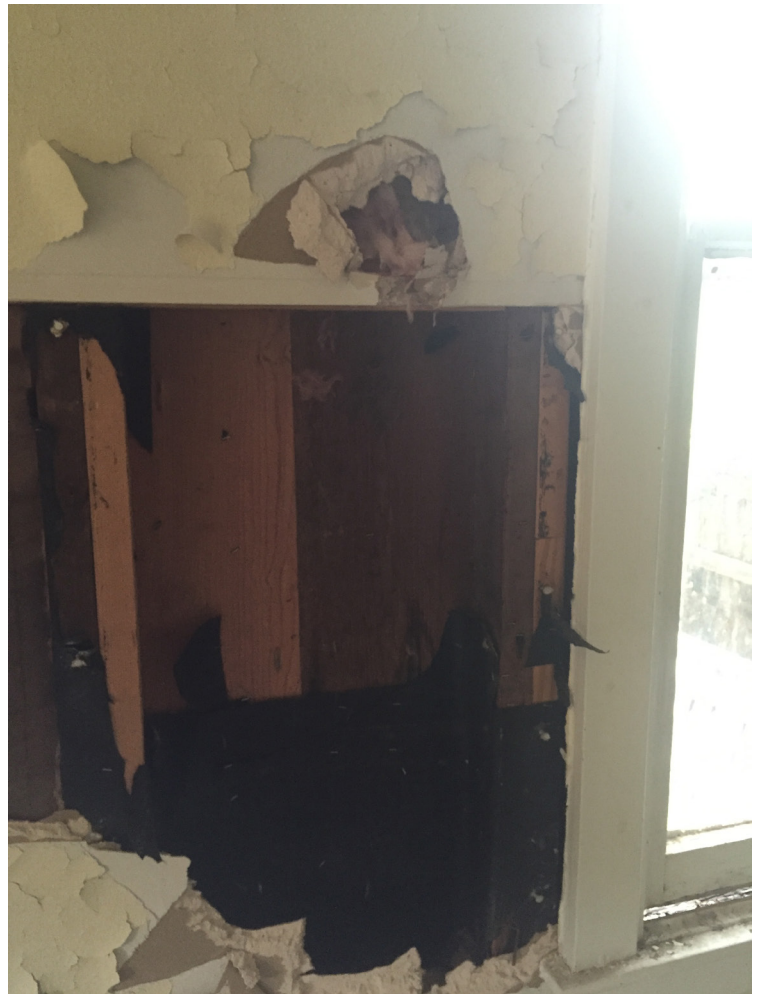
## 7 - Carriage House Window (West Facade)

- Window is in very poor shape.
- Window and Framing do not appear to be original.
- Due to the window having a direct view into the adjacent backyard, we plan to eliminate the window for the privacy and safety of the Respite Care Children.

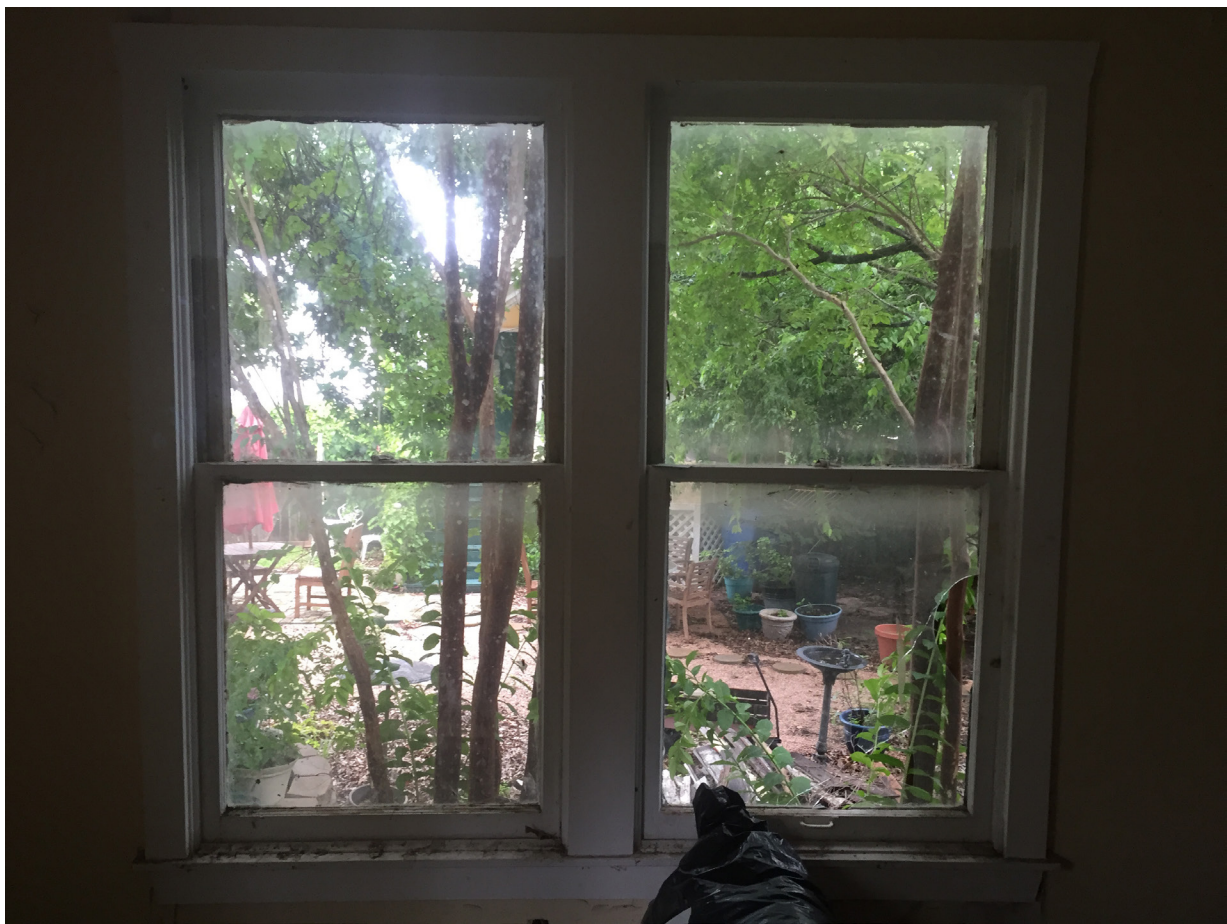
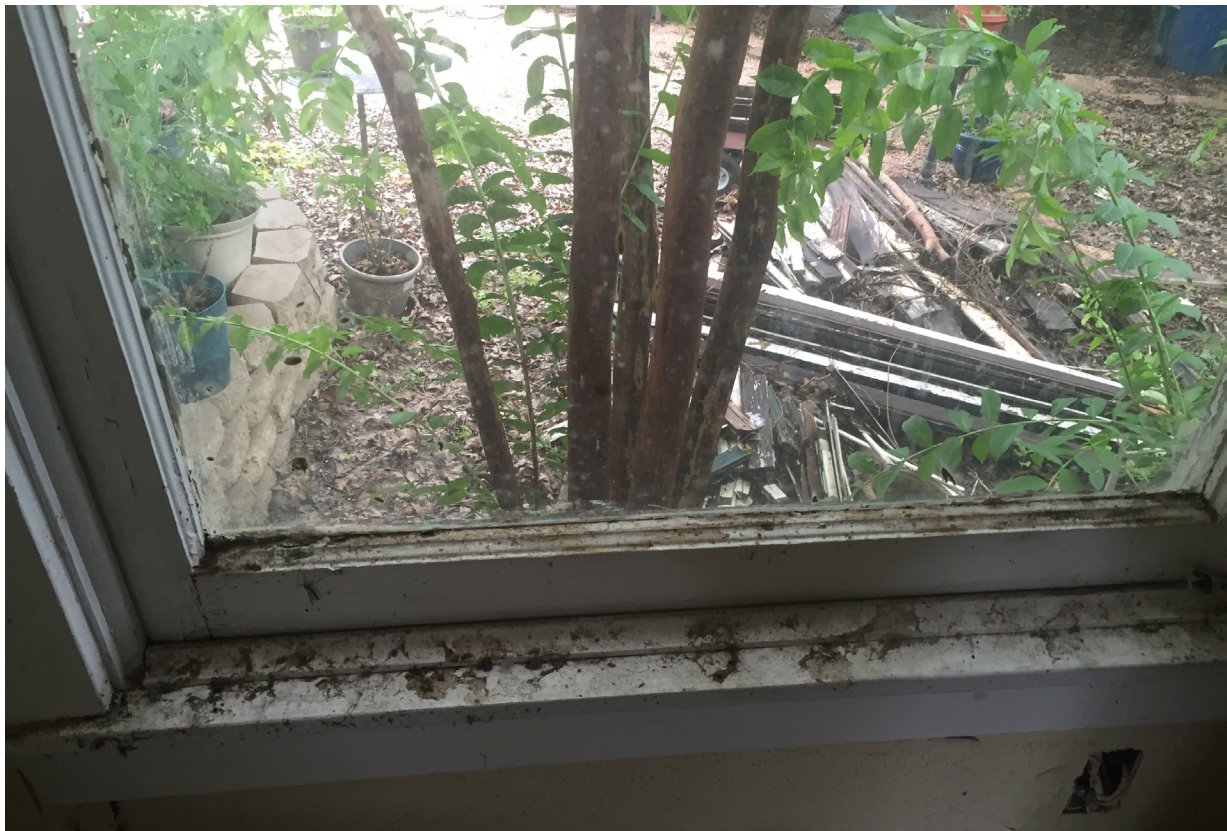
## 7 - Carriage House Window (West Facade)

- Window is in very poor shape.
- Window and Framing do not appear to be original.
- Due to the window having a direct view into the adjacent backyard, we plan to eliminate the window for the privacy and safety of the Respite Care Children.

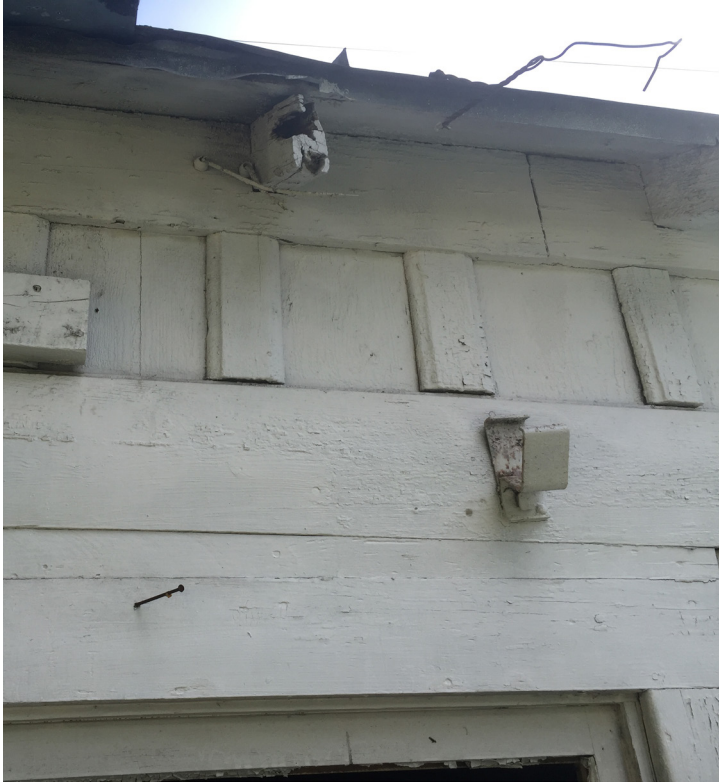
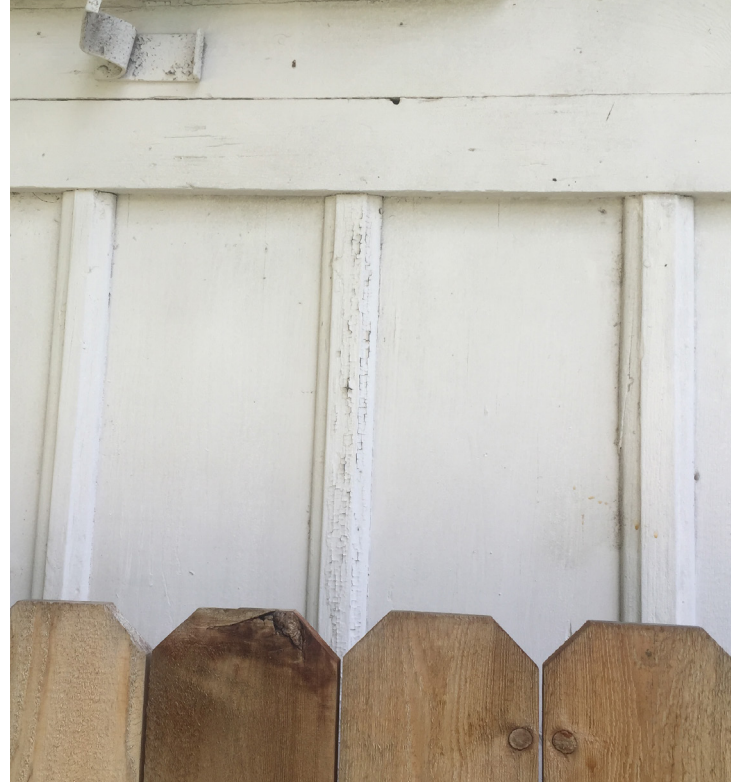
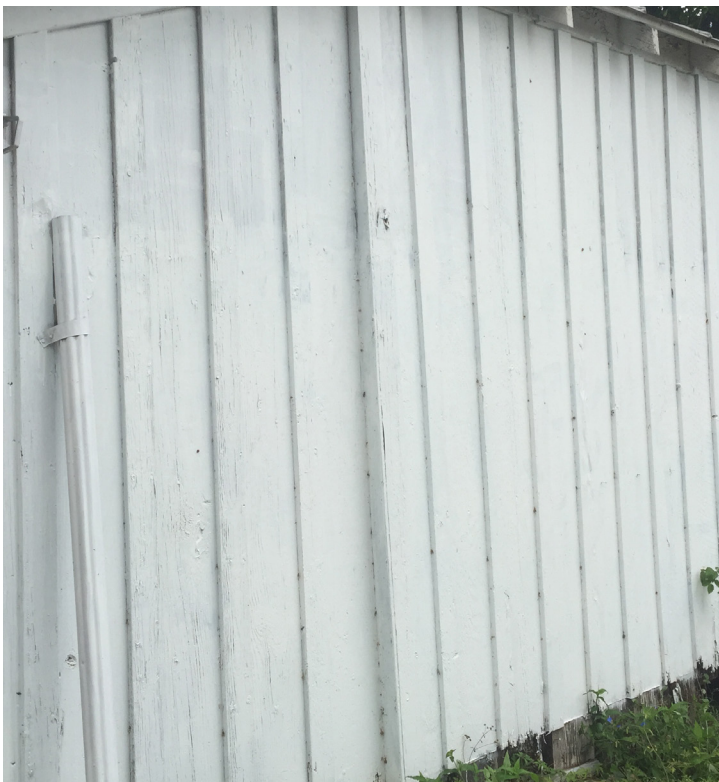
### Board & Batten Siding

- l. Staff visited the site June 22, 2016, and found the windows in tact with broken glass, and the board and batten had various profiles.

Due to the fact that there are 3 styles of Board & Batten Siding we are proposing to use the following:

-Board & Batten Siding - fiber cement board with 2" composite trim pieces every 12" on center .
