HISTORIC AND DESIGN REVIEW COMMISSION

HDRC CASE NO: 2016-266
ADDRESS: 458 FURR DR
LEGAL DESCRIPTION: NCB 6696 BLK 5 LOT 22 W 25 FT OF 23 E 25 FT OF 21
ZONING: R6 H
CITY COUNCIL DIST.: 7
DISTRICT: Monticello Park Historic District
APPLICANT: Eduardo Garcia
OWNER: David & Lydia Lerma
TYPE OF WORK: Window replacement
REQUEST:

WINDOW
SCHEDULES

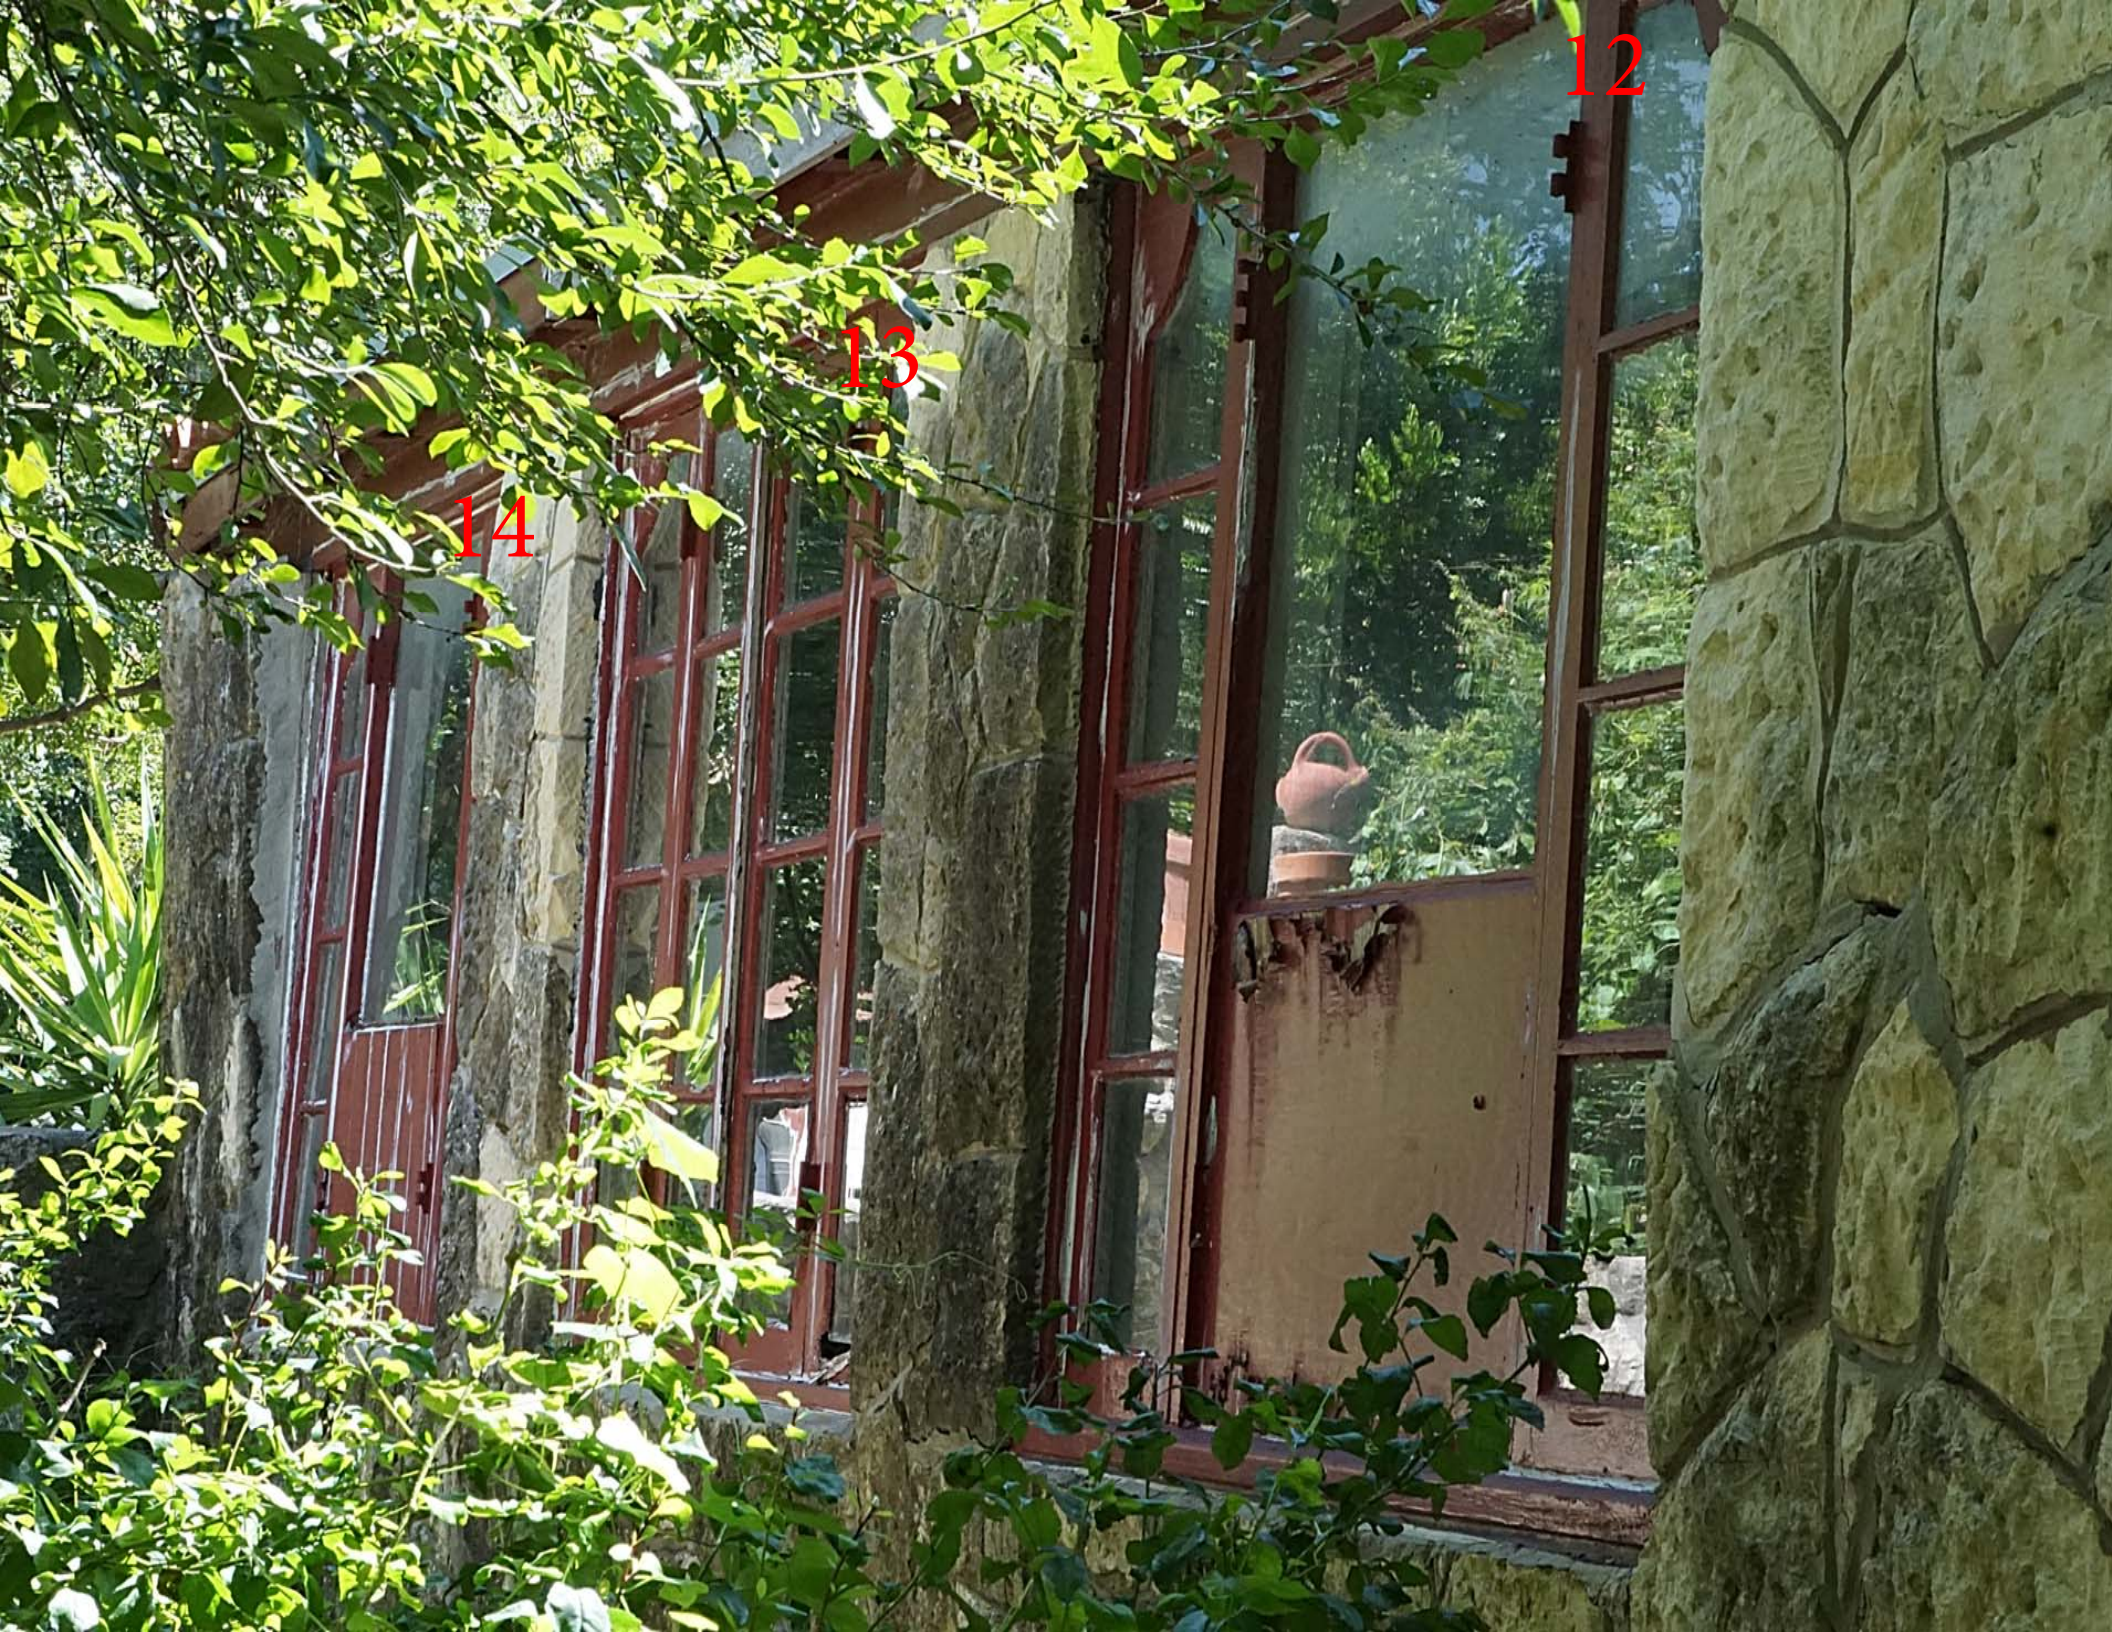
13. Repairable - wood 4 x 4 divided light with center casement

14. Repairable - wood divided light with center casement

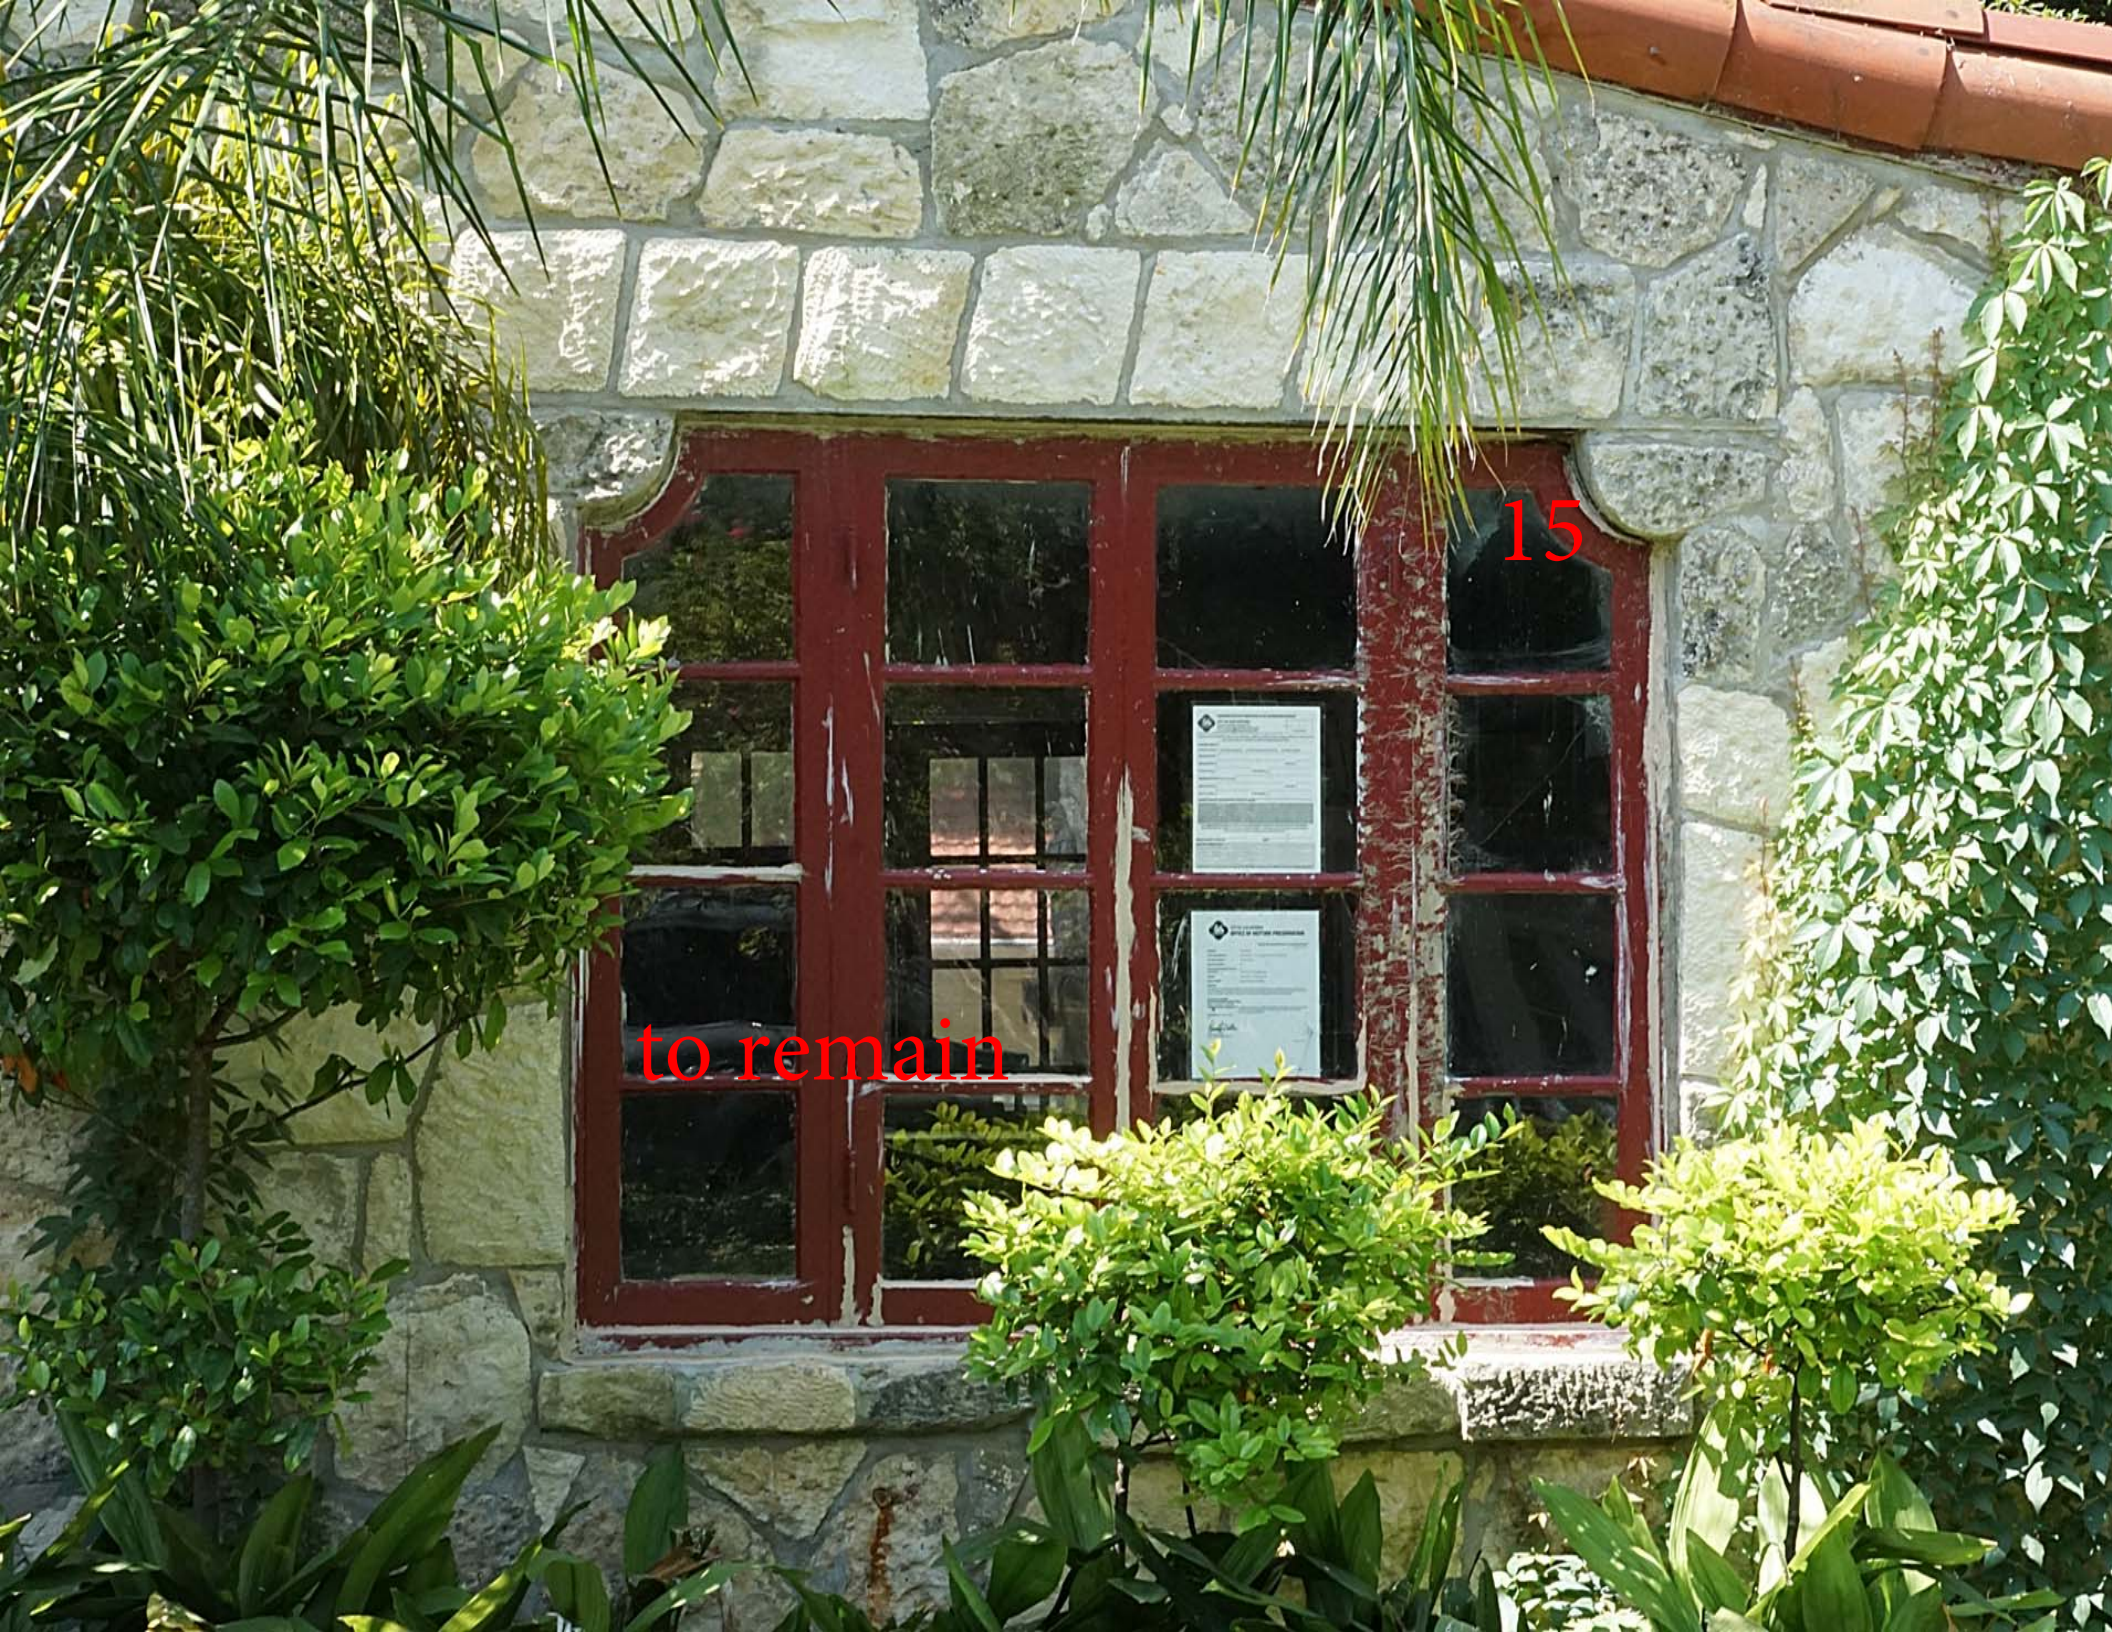
15

15. To remain - wood divided lights

to remain

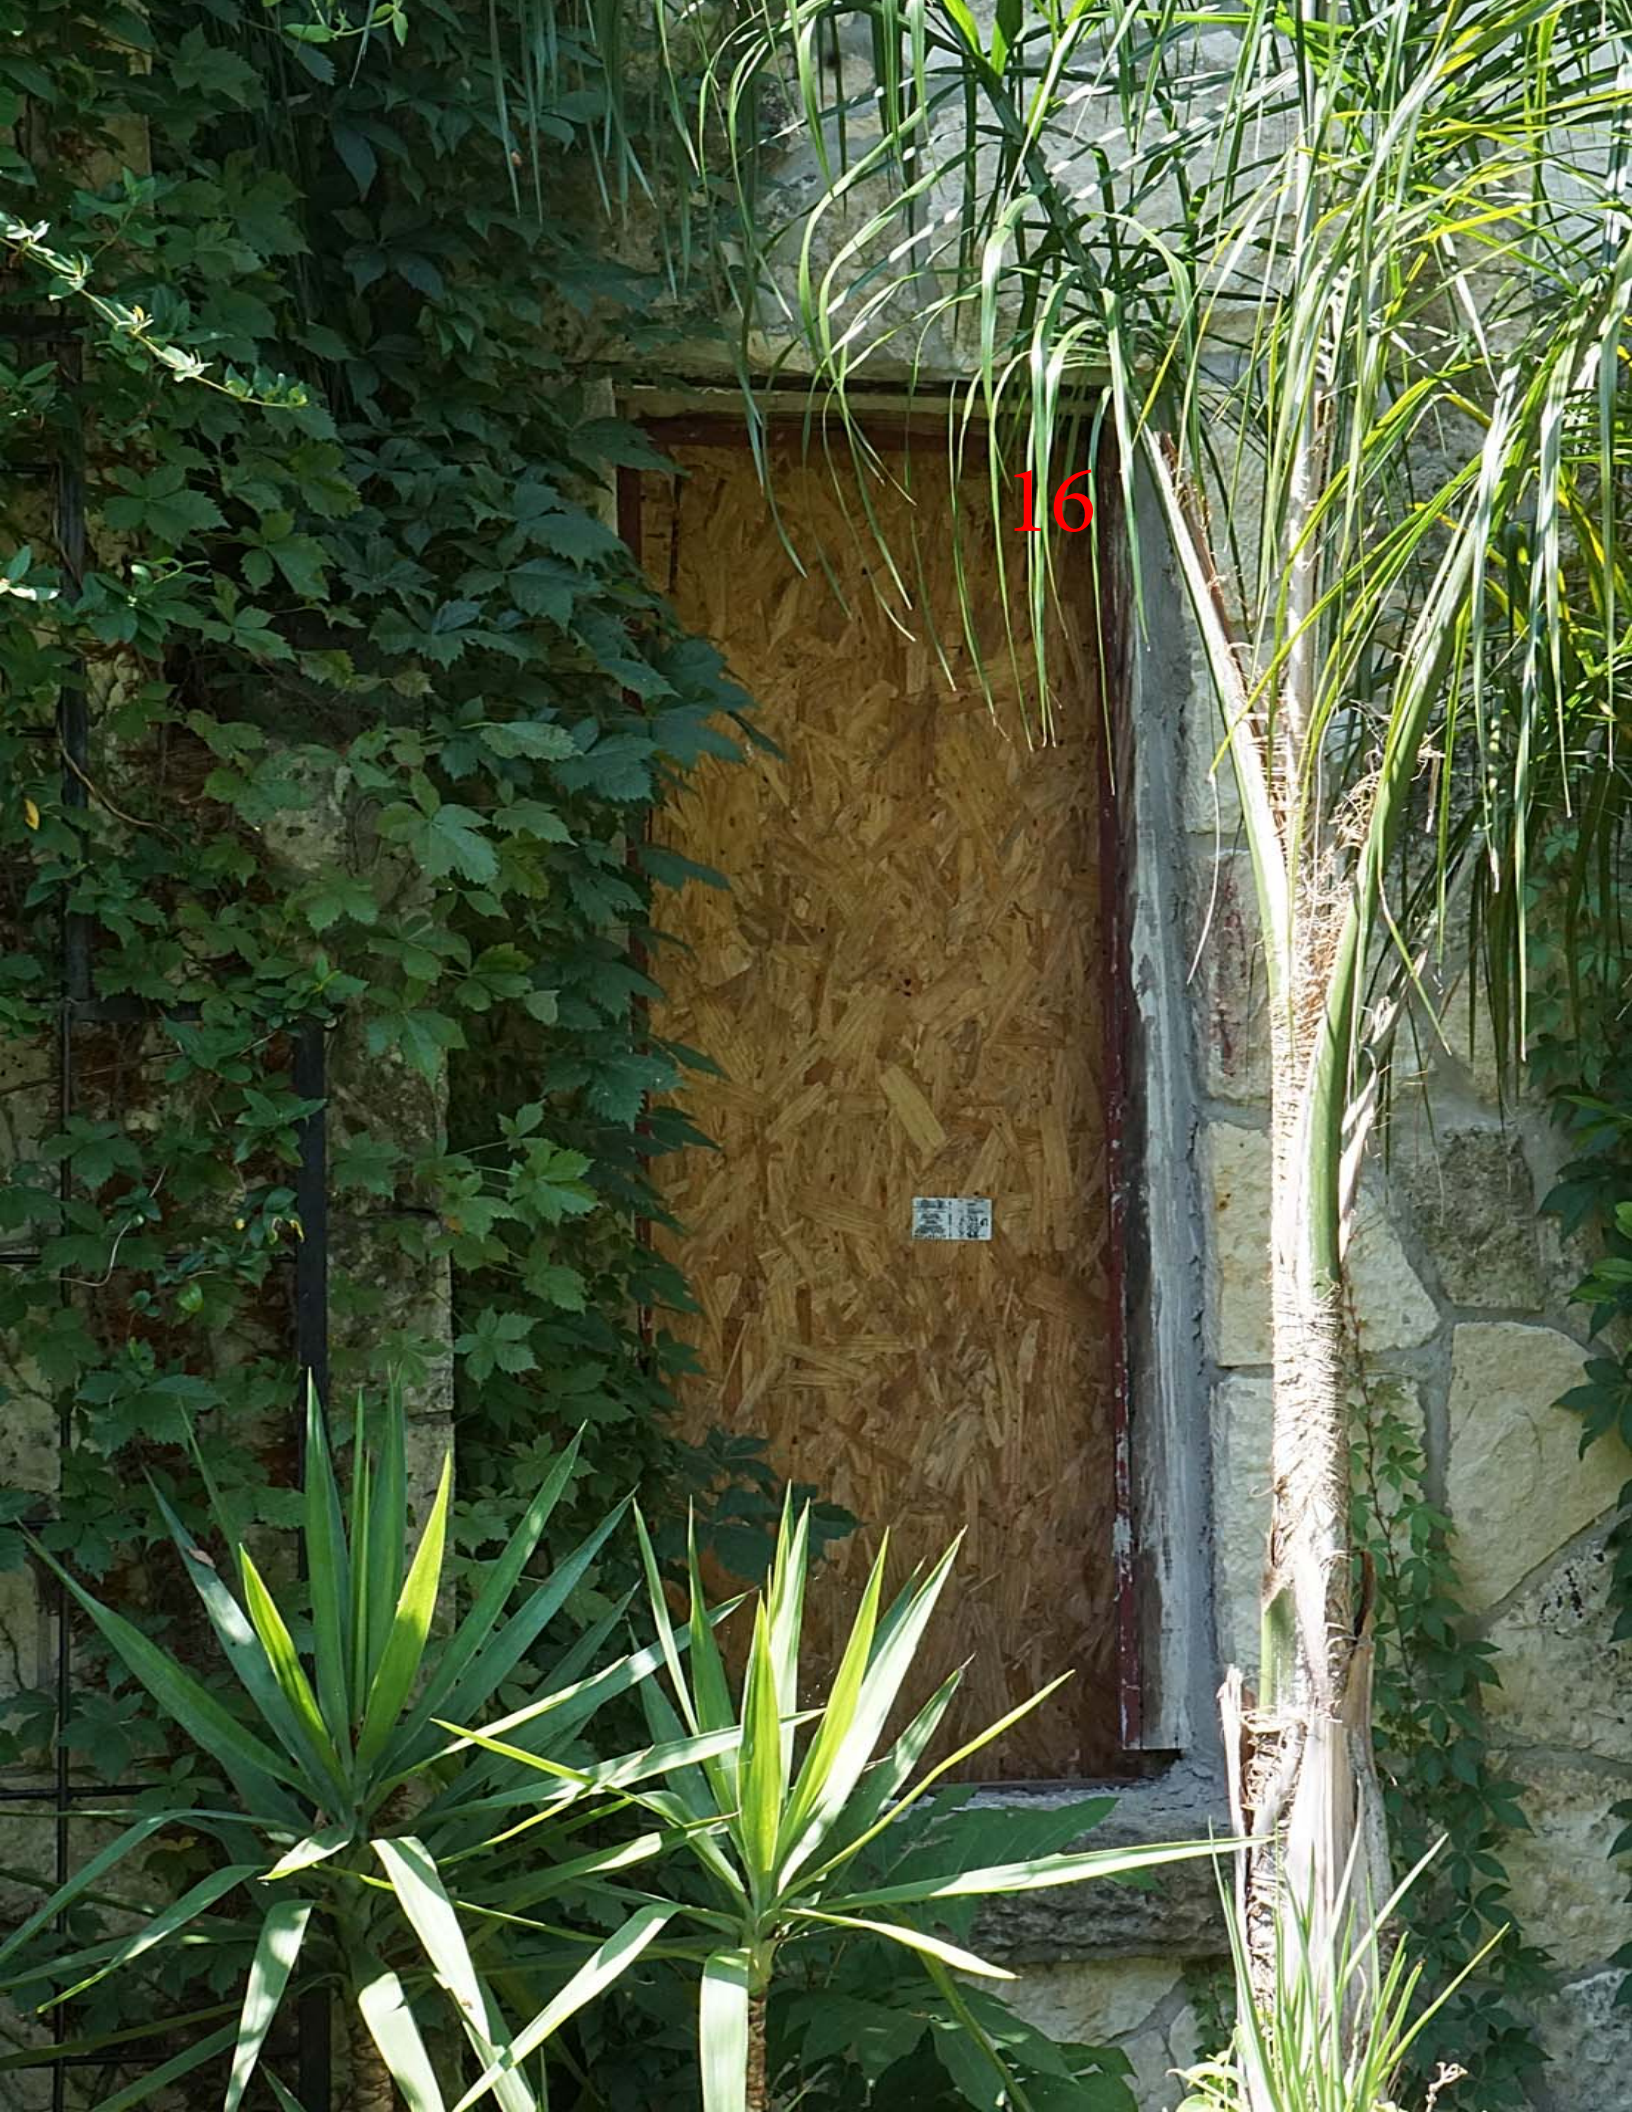
16

16. Deteriorated over 50% - wood one over one with 4 over 4 wood screens

17. Deteriorated over 50% - wood one over one with 4 over 4 wood screens

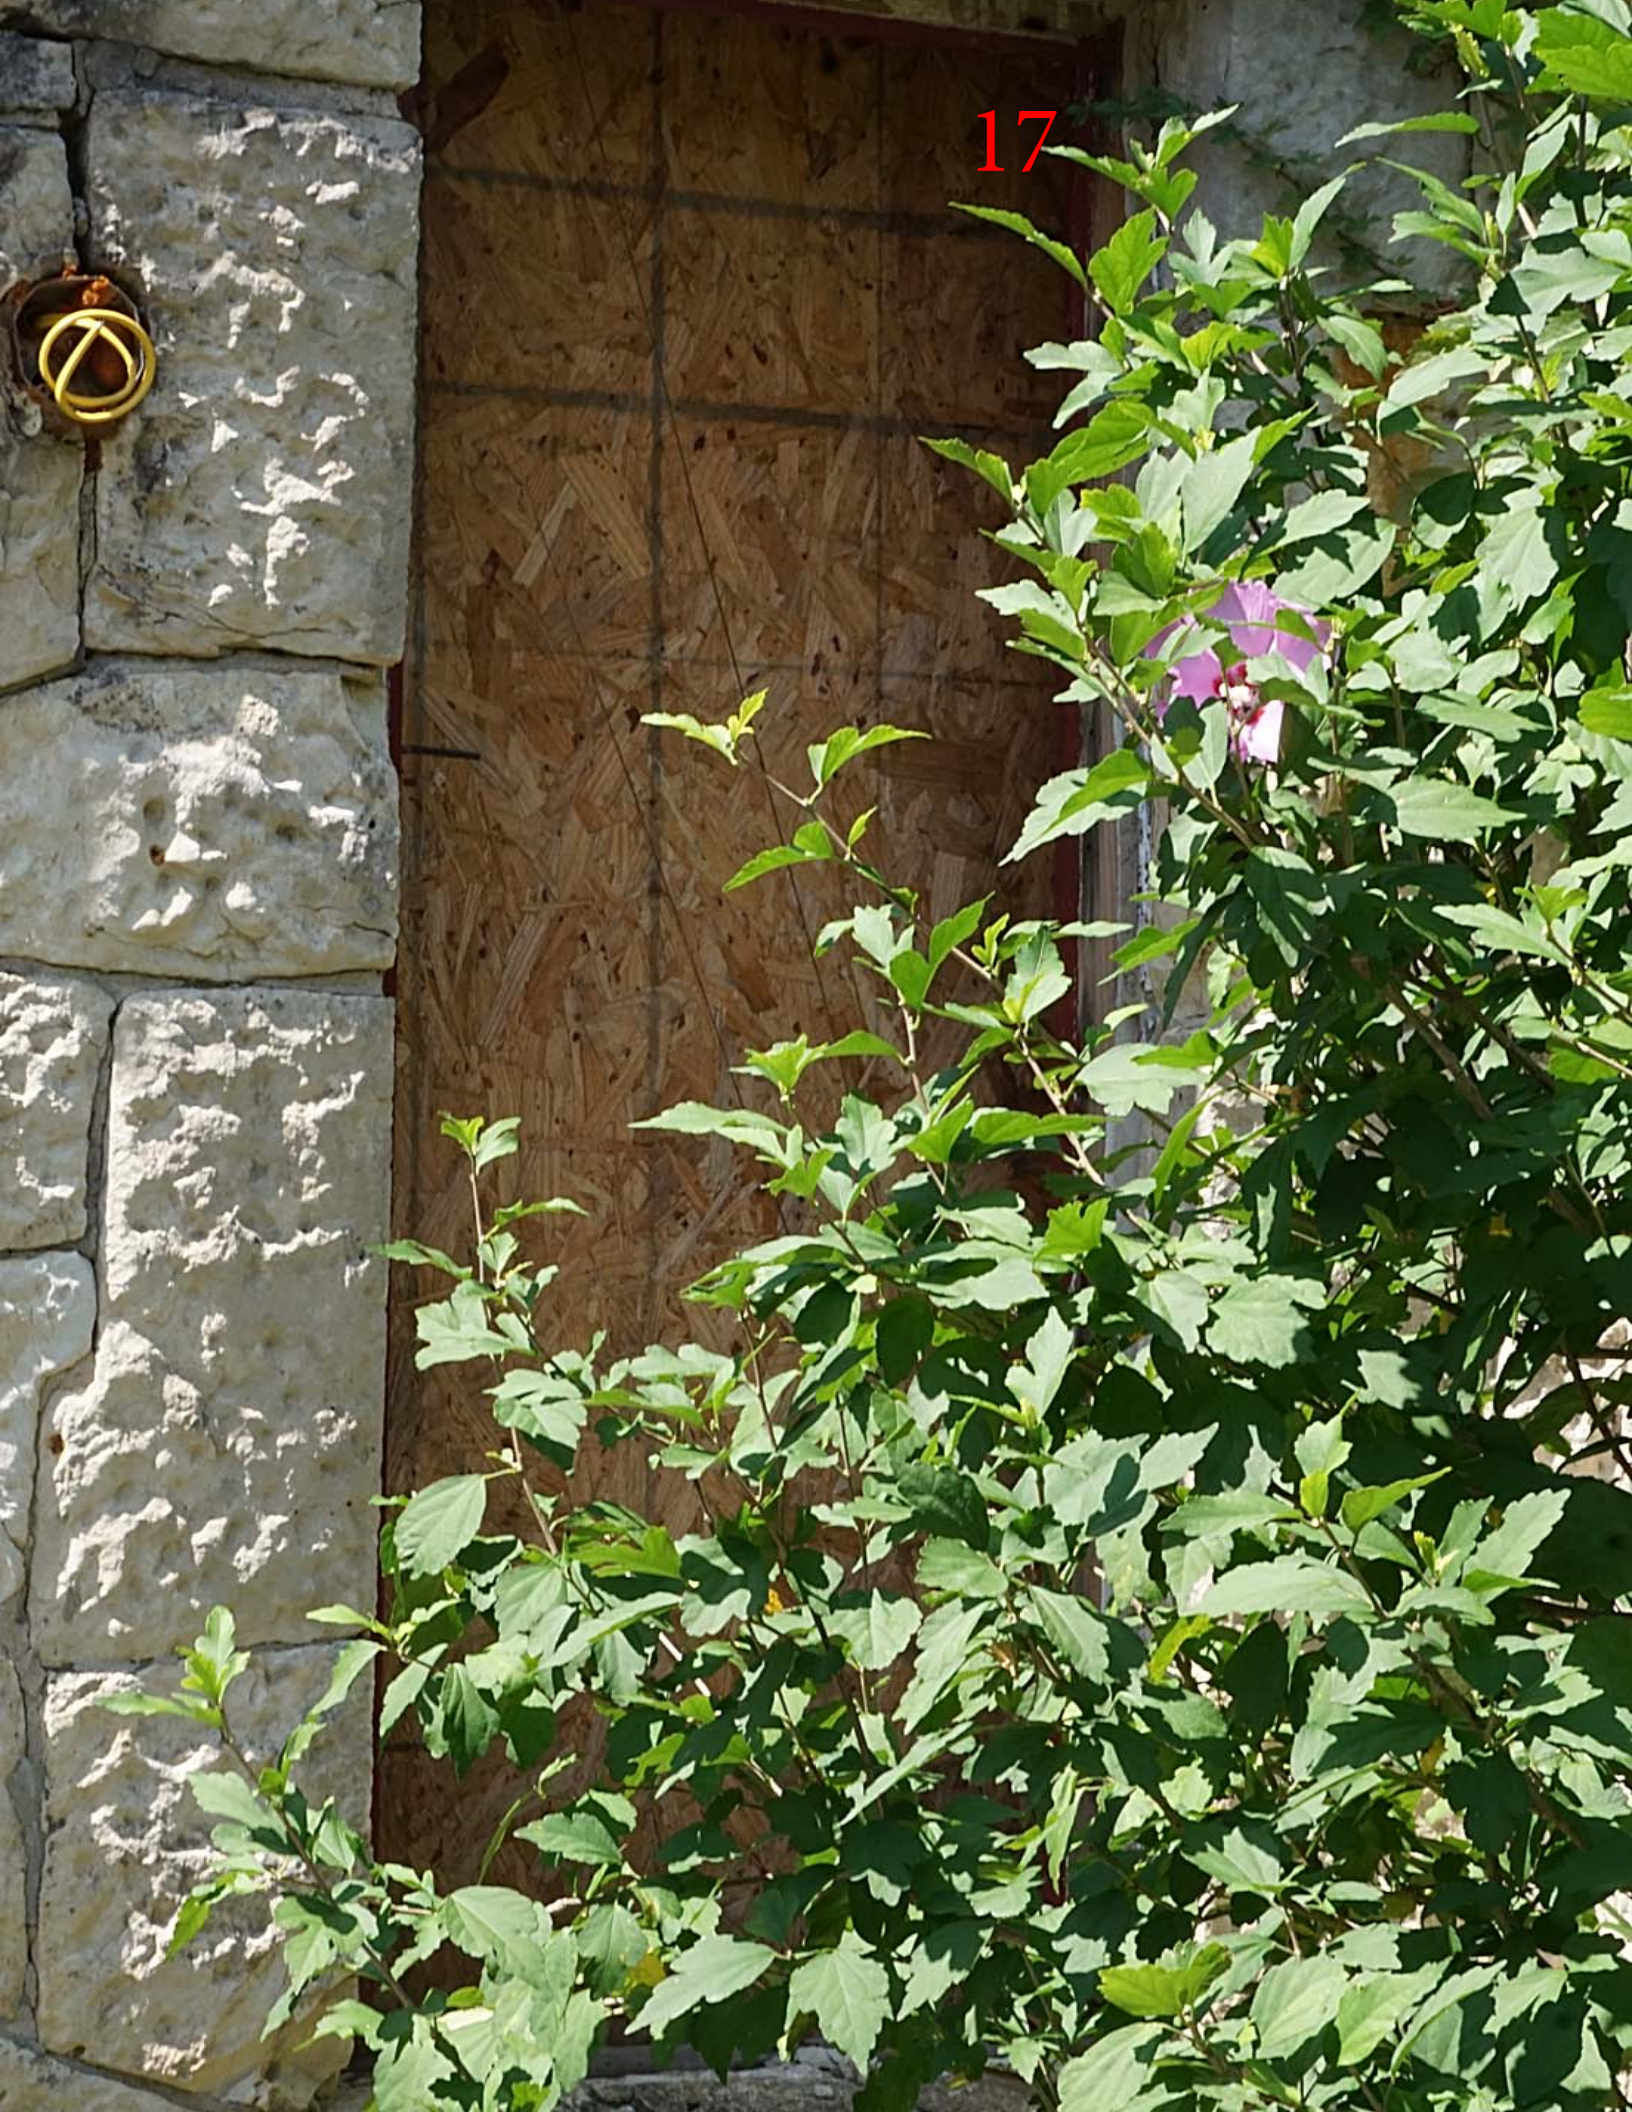
18

18. Deteriorated over 50% - wood one over one with 6 over 6 wood screens

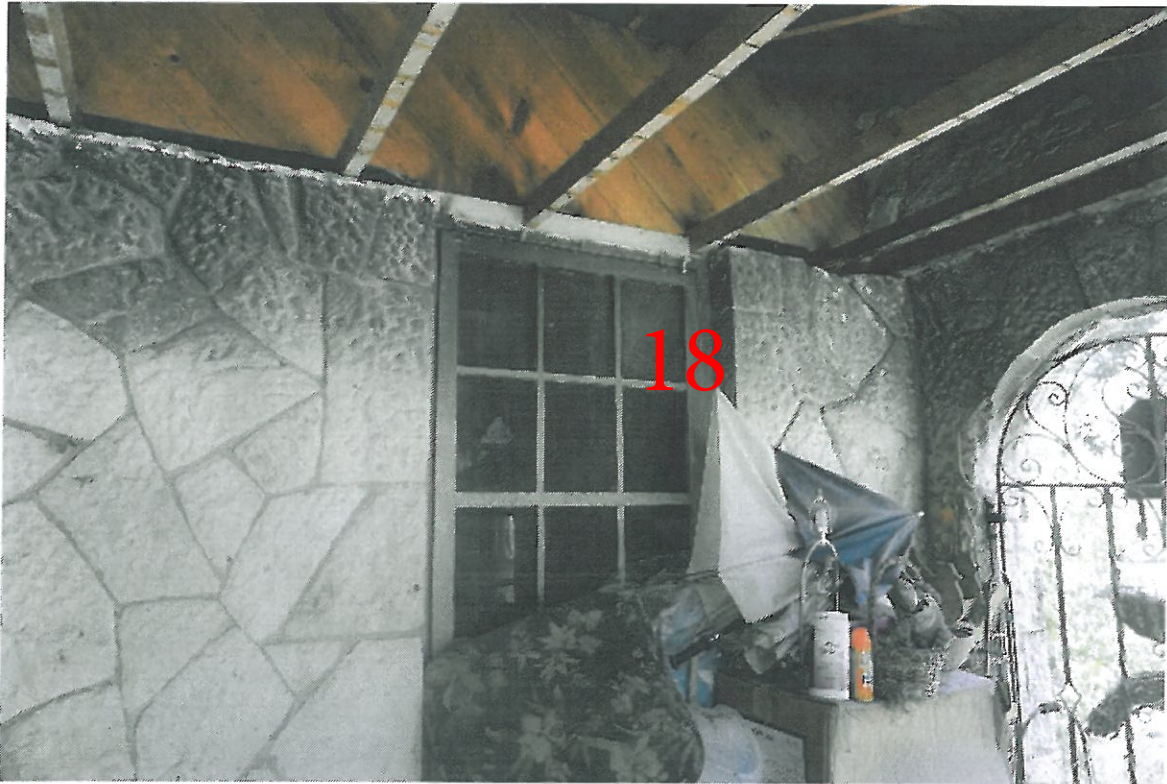
Existing Front Elevation. Windows are not visible due to muntins (sun screens)

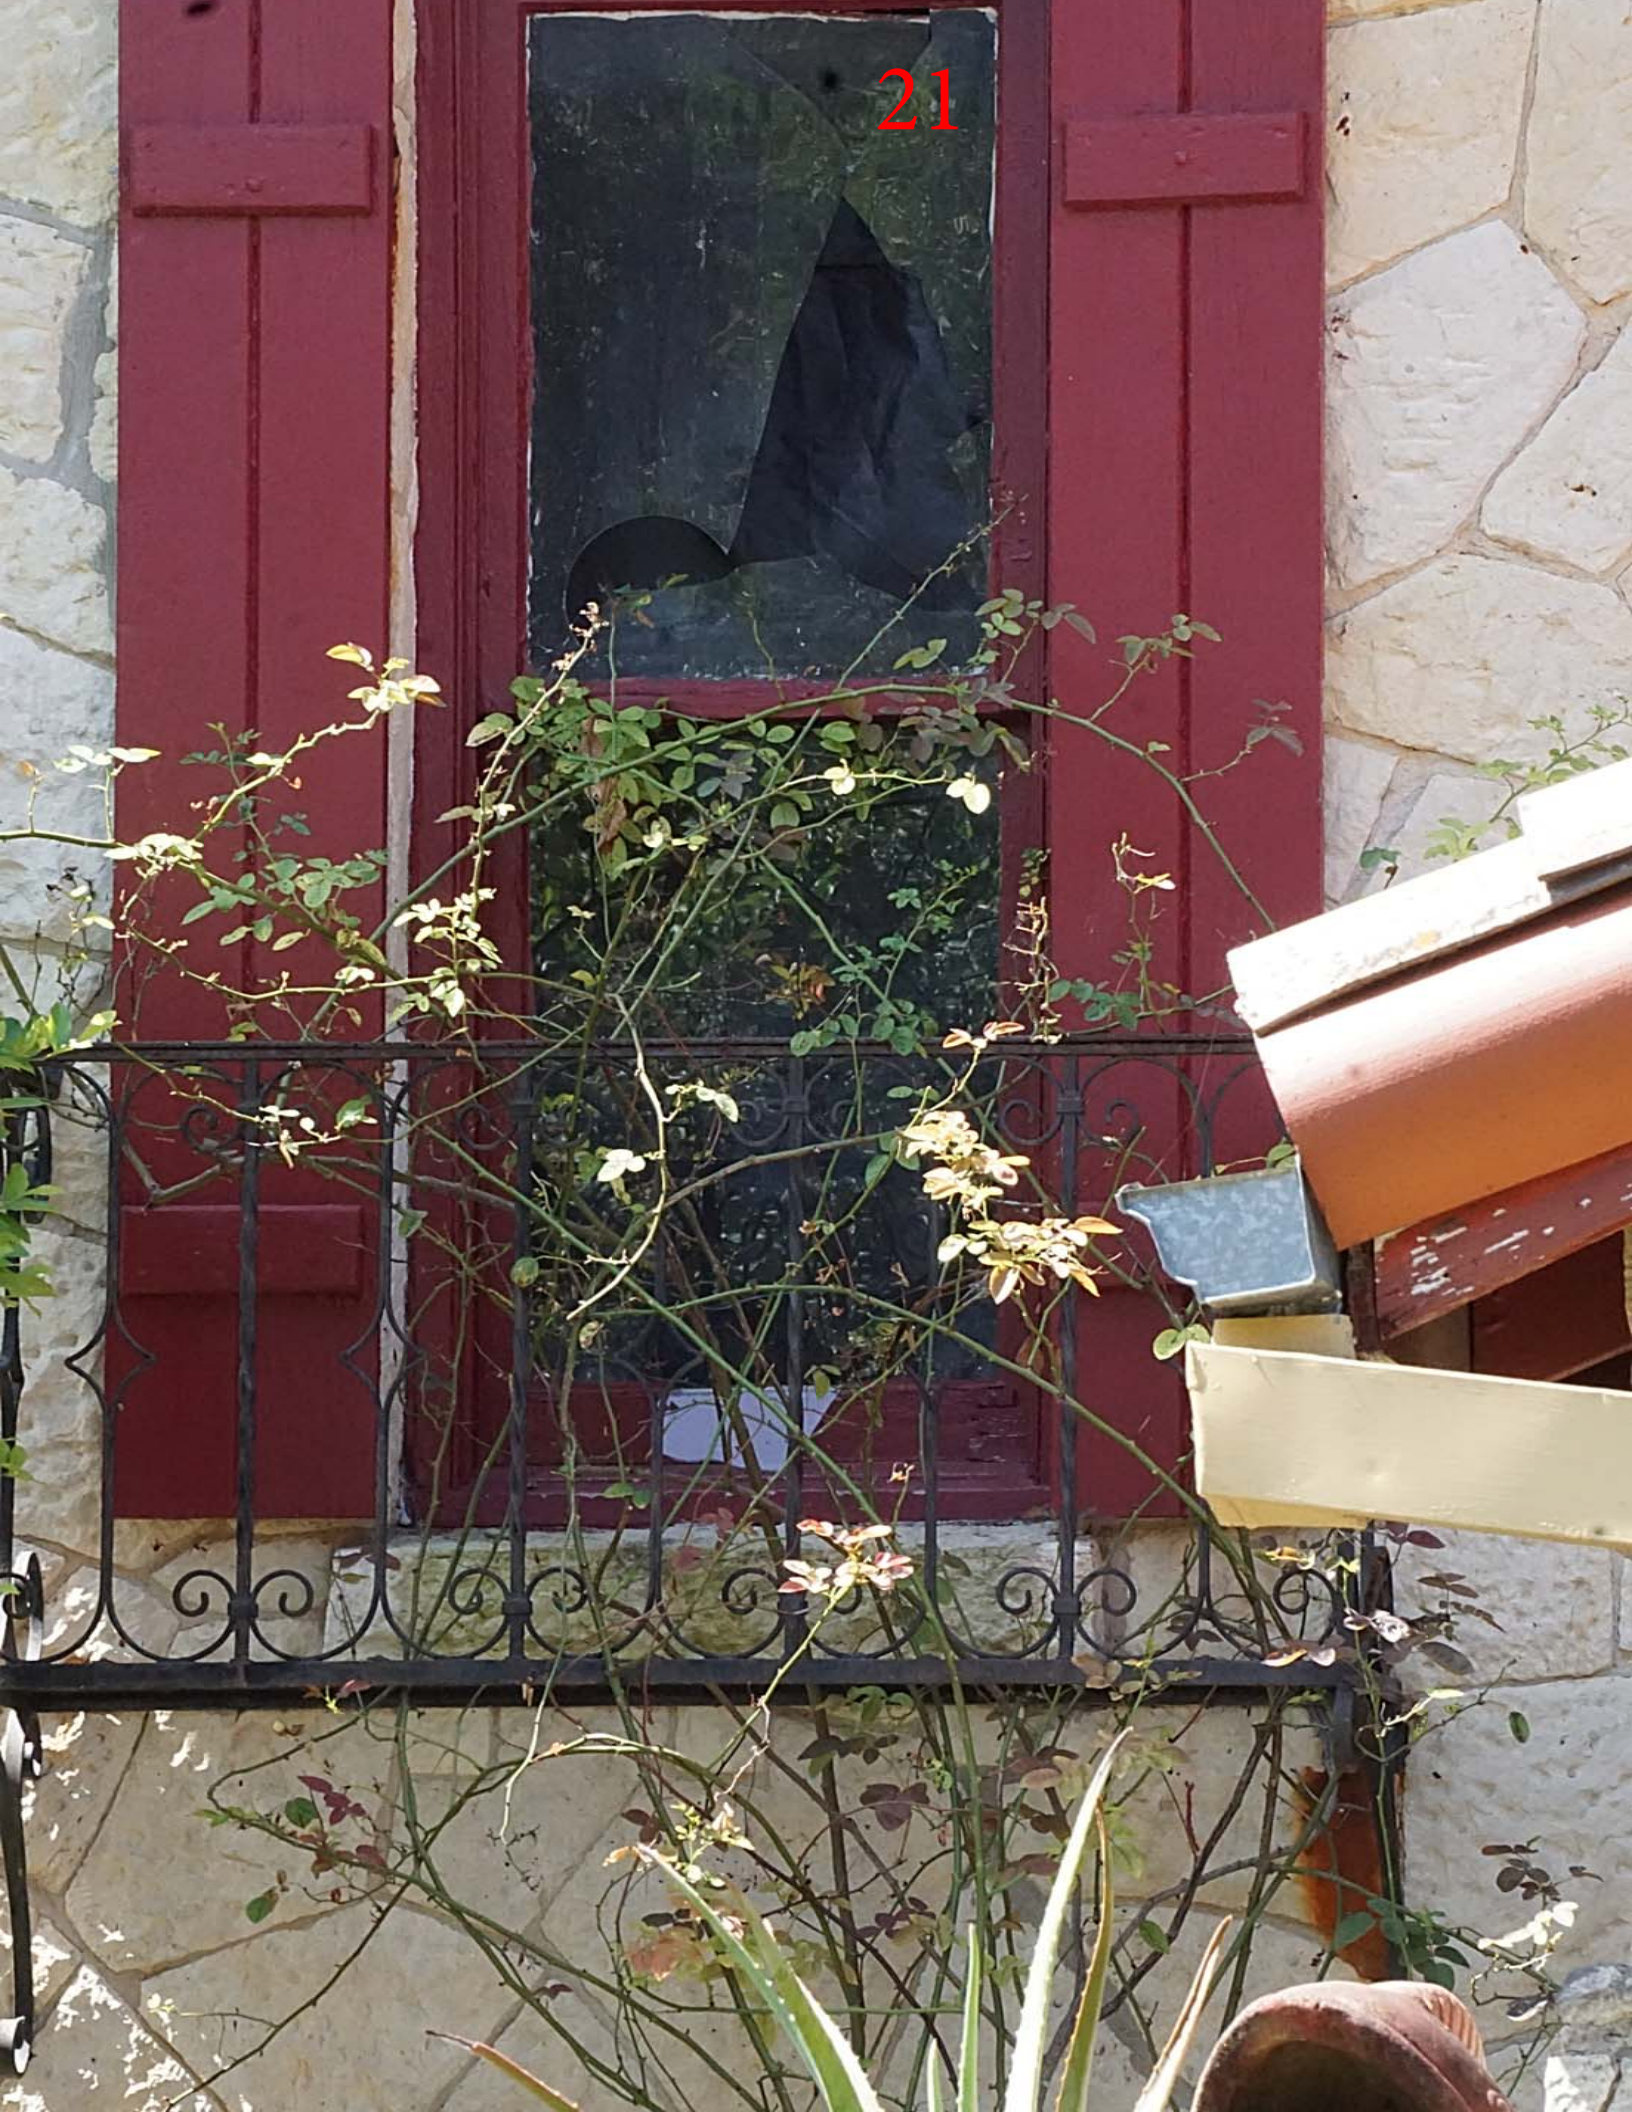
22

22. Repairable - wood one over one
