HISTORIC AND DESIGN REVIEW COMMISSION

HDRC CASE NO: 2016-319
ADDRESS: 1300 GUADALUPE ST
LEGAL DESCRIPTION: NCB 2444 BLK 1 LOT 19 AND 20
ZONING: C3 HL
CITY COUNCIL DIST.: 5
LANDMARK: Null
APPLICANT: Debra Dockery
OWNER: Guadalupe Cultural Arts Center
TYPE OF WORK: Window and door replacement
REQUEST:

GUADALUPE CULTURAL ARTS CENTER FORMER PROGRESO PHARMACY RENOVATION

CITY OF SAN ANTONIO GUADALUPE CULTURAL ARTS CENTER RENOVATION

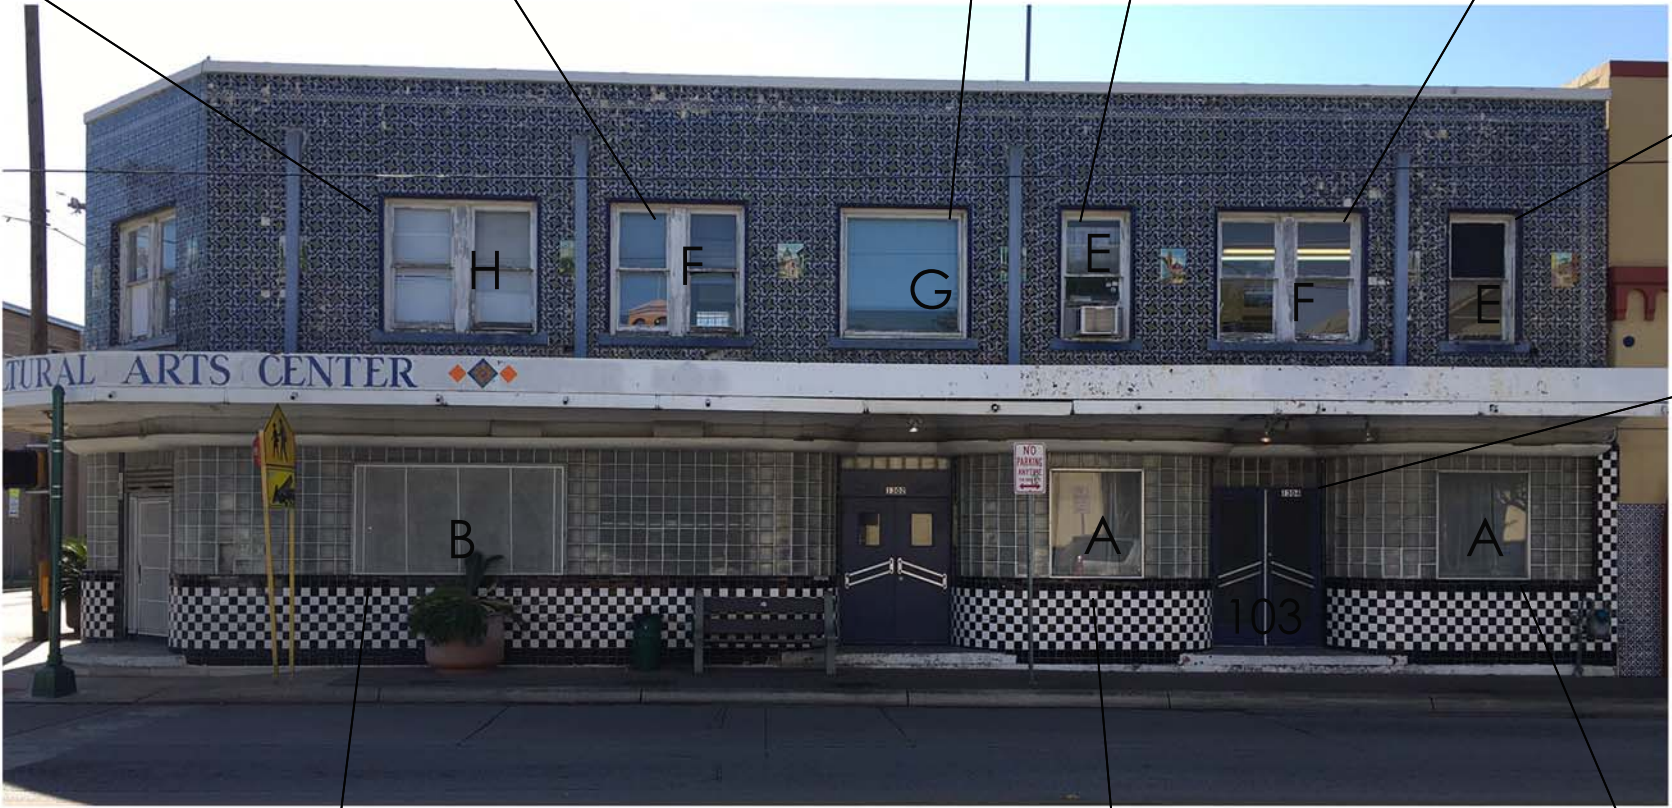
DOOR 103 IS AN ALUMINUM AND GLASS DOOR. THIS DOOR HAS A 2'-4" CLEAR OPENING AND DOES NOT MEET EMERGENCY EGRESS OR ADA. IT IS PROPOSED TO REPLACE THE DOOR WITH A SINGLE 3'-0" WIDE DOOR AND SIDELIGHT, BUT IN SAME MATERIAL AND DOOR CONFIGURATION AS EXISTING.

103 - DOOR IS UNDERSIZED FOR EMERGENCY EGRESS

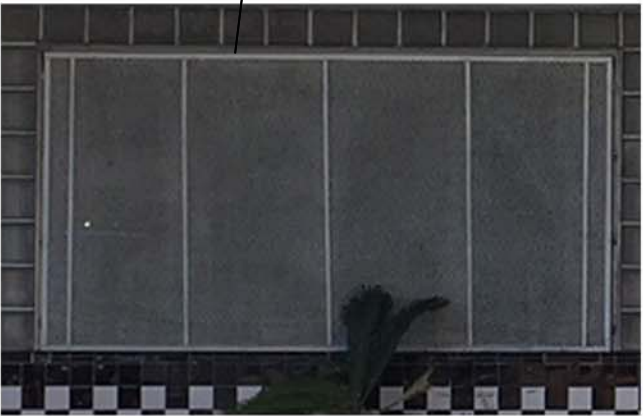
B - WINDOW HAS BEEN REPLACED WITH PLEXIGLAS

ALL WINDOWS ON THE FIRST FLOOR NORTH ELEVATION ARE ALUMINUM. SEVERAL OF THESE WINDOWS HAVE BEEN REPLAED WITH PLEXIGLAS. THE GLASS OR PLEXIGLASS DOES NOT MEET THE ENERGY CODE FOR AN AIR CONDITIONED SPACE.IT IS PROPOSED TO REPLACE THE WINDOWS WITH ALUMINUM AND GLASS TO MATCH THE EXISTING/ HISTORIC PROFILE CONDITION.

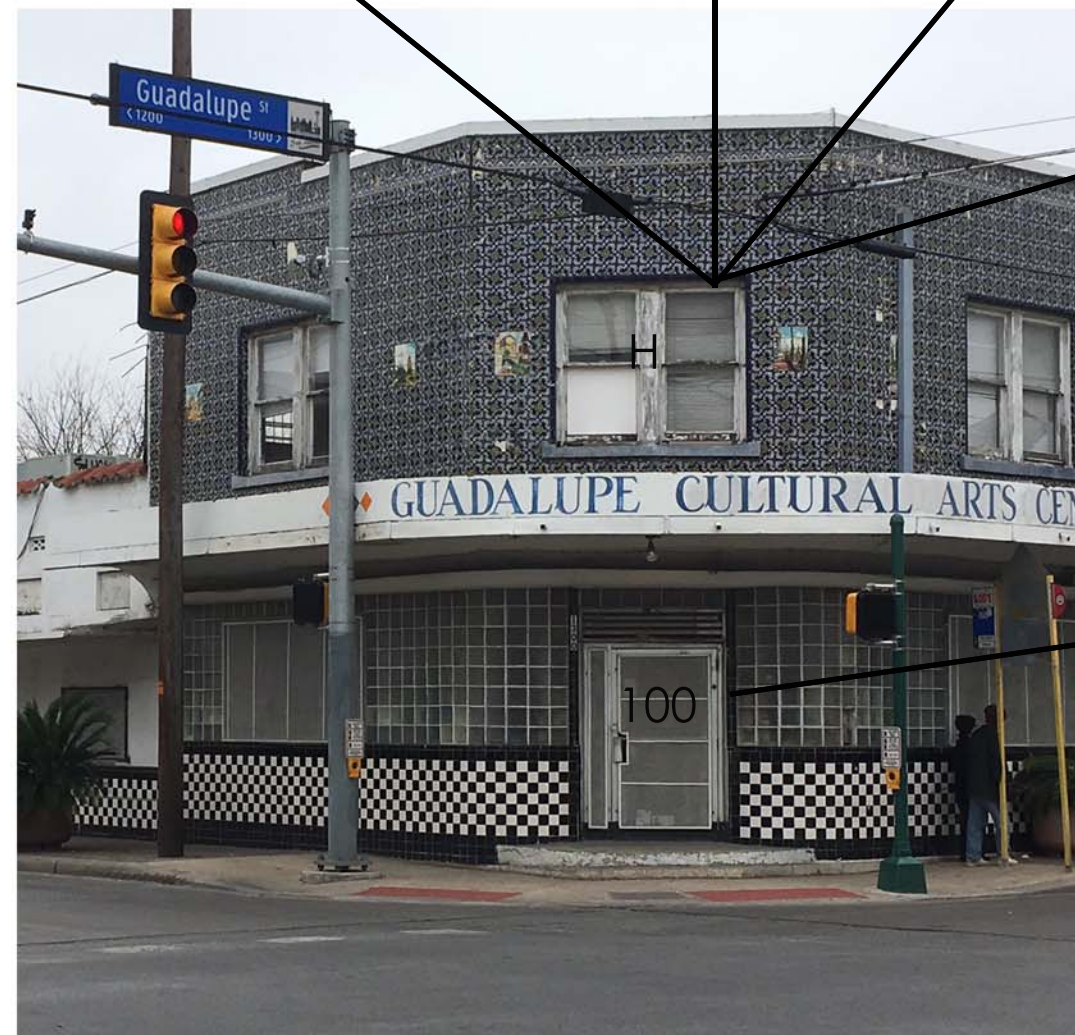
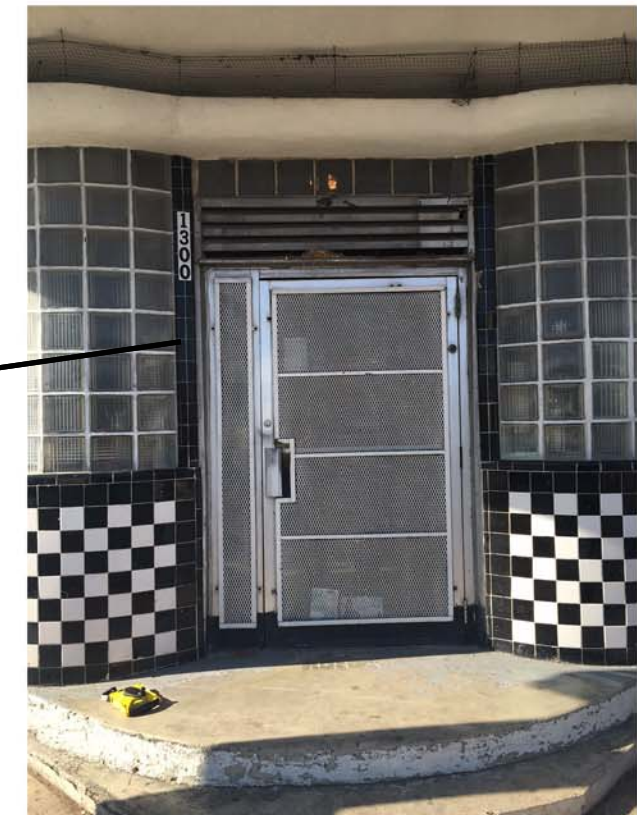
WINDOW ON THE SECOND FLOOR NORTH-EAST ELEVATION IS CONSTRUCTED OF WOOD. THE WINDOW HAS WOOD ROT, AND IS LEAKING WATER WHEN IT RAINS. ONE OF THE GLASS PANES IS MISSING AND IS BOARDED WITH PLYWOOD. THE GLASS DOES NOT MEET THE ENERGY CODE FOR AN AIR CONDITIONED SPACE. IT IS PROPOSED TO REPLACE THE WINDOW WITH WOOD TO MATCH THE EXISTING/ HISTORIC PROFILE CONDITION.

DOOR 100 DOES NOT APPEAR TO BE ORIGINAL. THE TRANSOM HAS BEEN REPLACED WITH A GRILL THAT IS BOARDED WITH PLYWOOD ON THE INTERIOR. THE GLASS DOES NOT MEET THE ENERGY CODE FOR CONDITIONED SPACES. IT IS PROPOSED TO REPLACE THE DOOR WITH AN ALUMINUM STOREFRONT DOOR TO MATCH THE EXISTING PROFILE CONDITIONS.

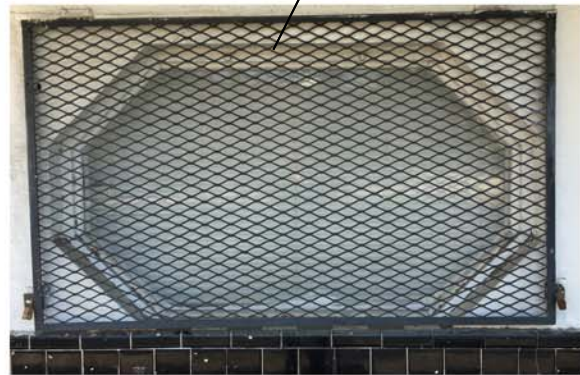
WINDOWS C ARE WOOD. ONE WINDOW HAS BEEN BOARDED WITH PLYWOOD, ONE WINDOW HAS BEEN REMOVED AND PLASTERED OVER. ALL THREE WINDOWS HAVE BEEN COVERED WITH STEEL GUARDS. IT IS PROPOSED TO REMOVED THE STEEL GUARDS, AND REPLACE THE WINDOWS WITH WOOD AND GLASS TO MATCH THE HISTORIC CONDITION

C- WINDOW IS BOARDED WITH PLYWOOD

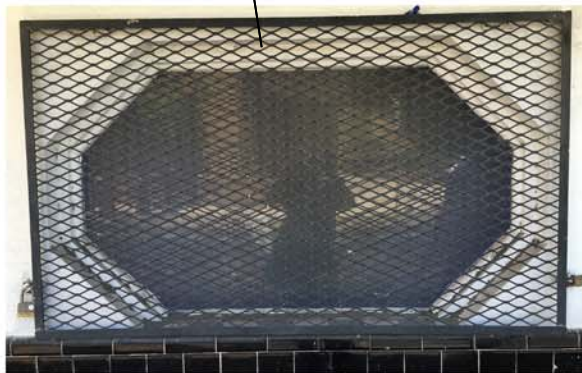
C- WINDOW HAS BEEN REPLACED WITH PELXIGLASS

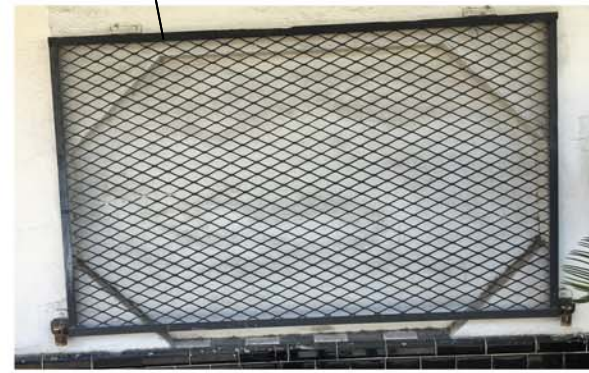
C- WINDOW HAS BEEN REMOVED AND FILLED IN WITH PLYWOOD AND PLASTER

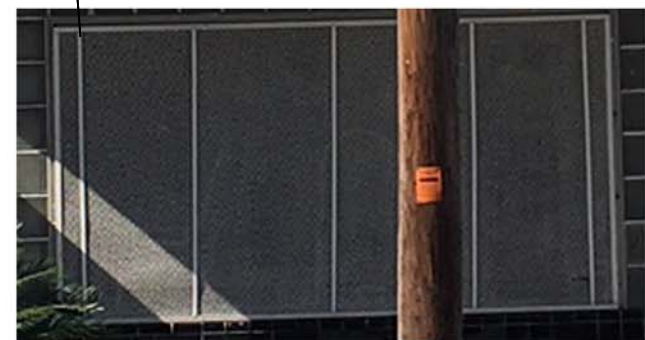
WINDOW B ON THE FIRST FLOOR IS ALUMINUM AND HAS BEEN REPLAED WITH PLEXIGLAS. THE PLEXIGLASS DOES NOT MEET THE ENERGY CODE FOR AN AIR CONDITIONED SPACE. THIS WINDOW HAS A STEEL GUARD COVERING THE WINDOW. IT IS PROPOSED TO REMOVED THE STEEL GUARD AND REPLACE THE WINDOW WITH ALUMINUM TO MATCH THE EXISINTG/ HISTORIC PROFILE CONDITION.

B- WINDOW HAS BEEN REPLACED WITH PLEXIGLASS

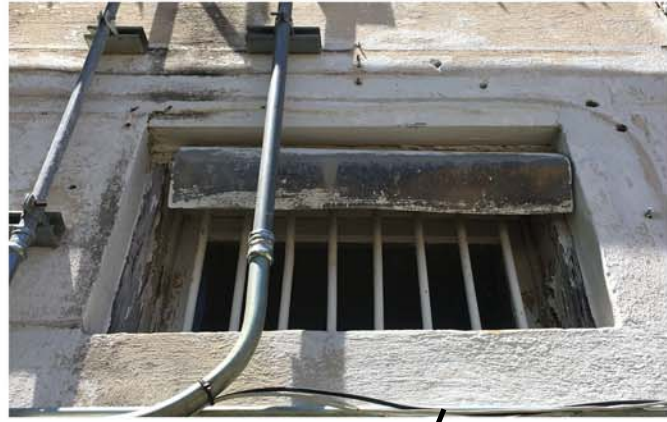
ALL D WINDOWS ARE WOOD AWNING WINDOW. THERE IS WOOD ROT ON BOTH OF THESE WINDOWS. STEEL BARS HAVE BEEN PLACE TO KEEP VANDALS OUT. IT IS PRPOSED TO REPLACE THESE WINDOWS WITH WOOD WINDOWS, AND REMOVE THE STEEL BARS.

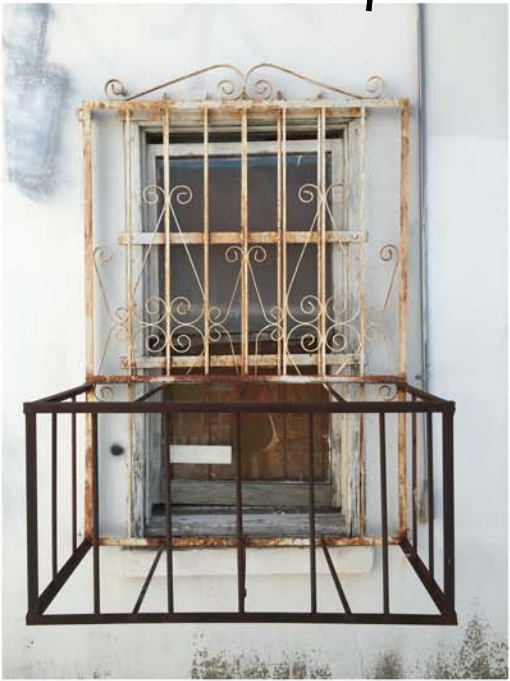
WINDOWS K ARE WOOD FRAMED WINDOWS WHERE THE GLASS HAS BEEN BROKEN AND MUCH OF THE WOOD IS ROTTED OR BROKEN. THE OPENING HAS BEEN BOARDED WITH PLYWOOD AN STEEL GUARDS HAVE BEEN PLACED TO KEEP VANDALS OUT. IT IS PROPOSED TO REPLACE THE WINDOW WITH WOOD FRAMED WINDOWS TO MATCH EXISTING/ HISTORIC CONDITIONS AND TO REMOVE THE STEEL GUARDS.

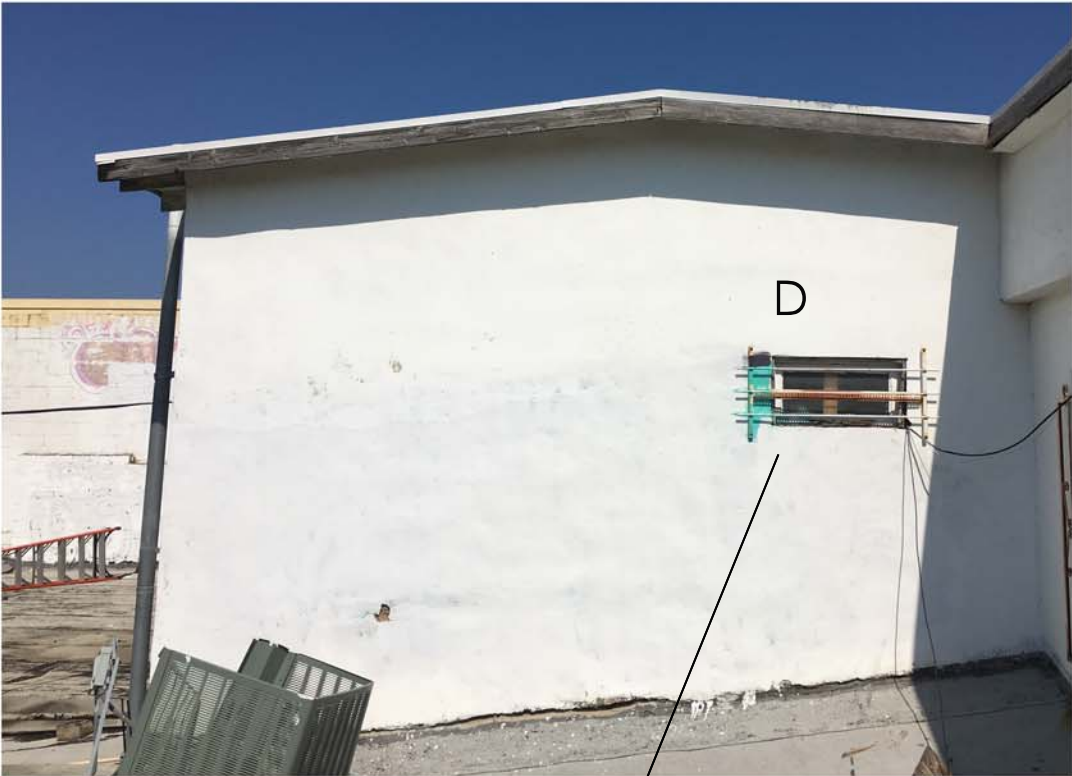
WINDOW D IS A WOOD AWNING WINDOW. THERE IS WOOD ROT AND THE WINDOW LEAKS WHEN IT RAINS. IT IS PROPOSED TO REPLACE THIS WINDOW WITH A FIXED WINDOW TO MATCH EXISTING/ HISTORIC PROFILE CONDITIONS.

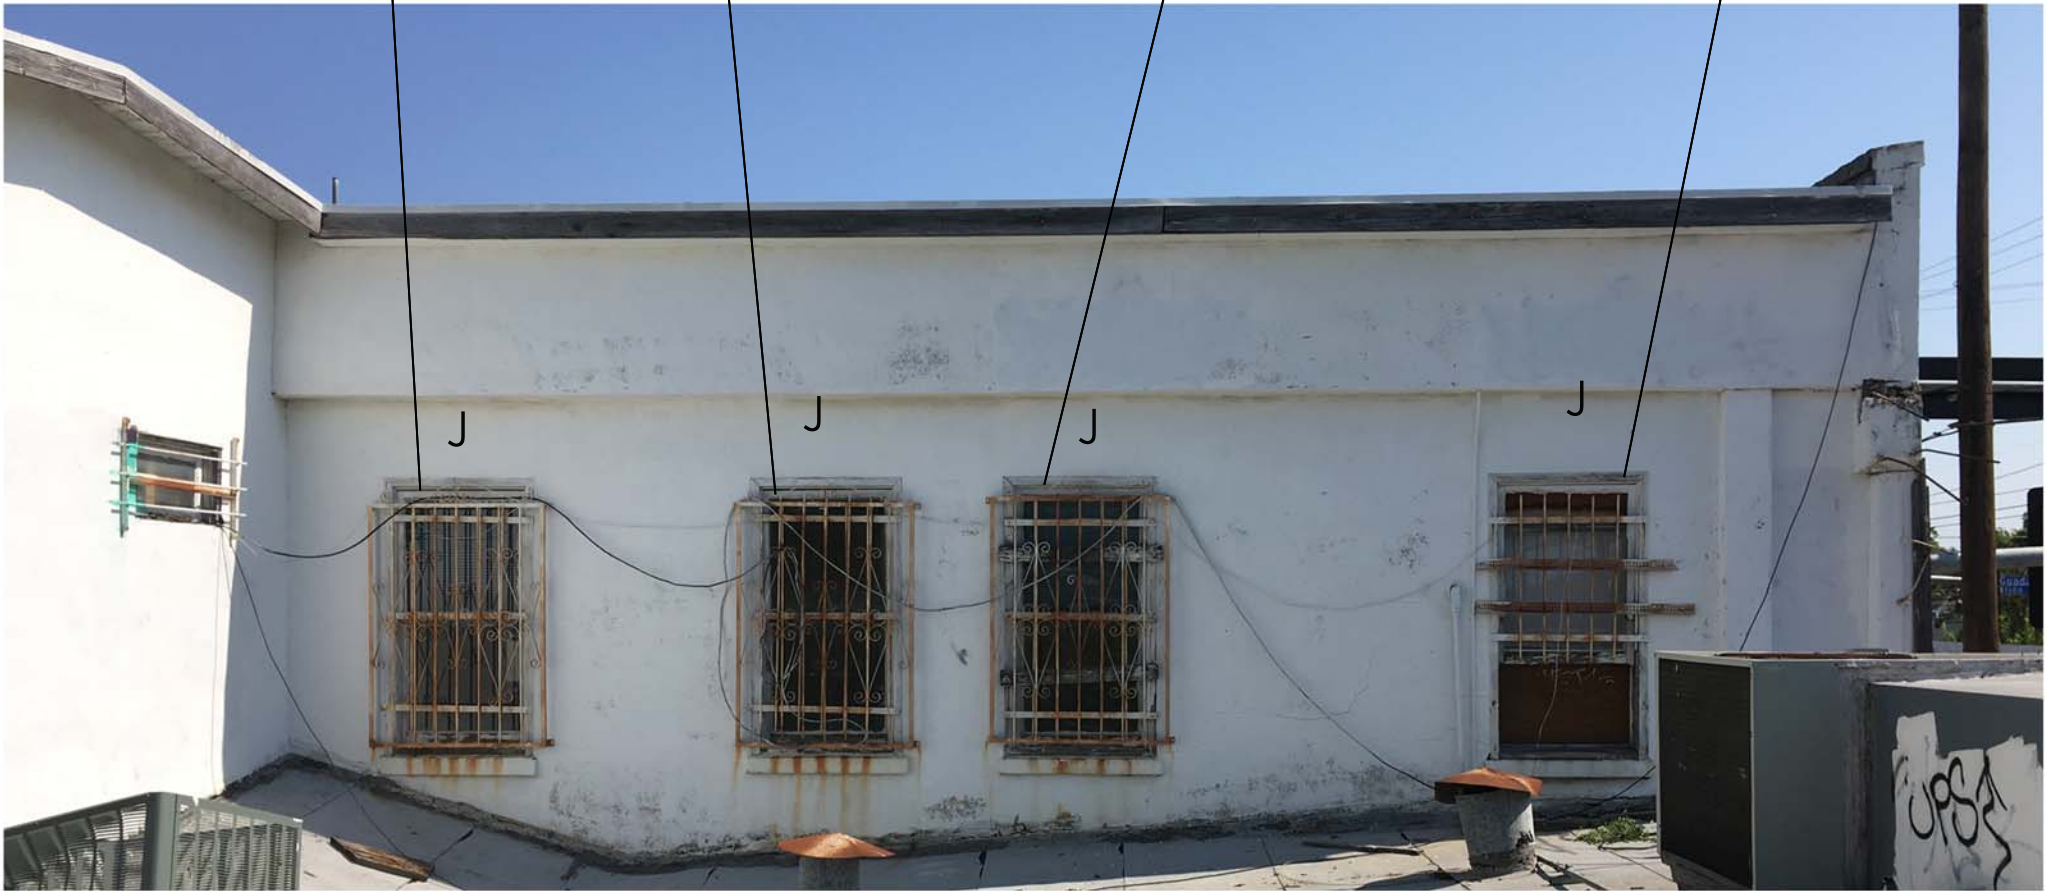
WINDOWS J ARE WOOD FRAMED WINDOWS. THERE IS WOOD ROT AND THE WINDOW LEAKS WHEN IT RAINS. THE STEEL GUARDS HAVE BEEN PLACED OVER THE WINDOWS TO KEEP VANDAL OUT. IT IS PROPOSED TO REPLACE THE WINDOW WITH WOOD FRAMED WINDOWS TO MATCH EXISTING/ HISTORIC PROFILE CONDITIONS AND TO REMOVE THE STEEL GUARDS.
