HISTORIC AND DESIGN REVIEW COMMISSION

August 17, 2016

HDRC CASE NO: 2016-254
ADDRESS: 327 W CRAIG PLACE
LEGAL DESCRIPTION: NCB 1858 BLK 1 LOT 16, E 10 FT OF 15 & W 10 FT OF 17
ZONING: O2 H
CITY COUNCIL DIST.: 1
DISTRICT: Monte Vista Historic District
APPLICANT: William Triplett/H.E.B.
OWNER: Respite Care of San Antonio
TYPE OF WORK: Rehabilitations to carriage house
REQUEST:

HDRC Application
Respite Care of San Antonio
327 W. Craig Place (Carriage House), Monte Vista
Neighborhood
San Antonio, TX

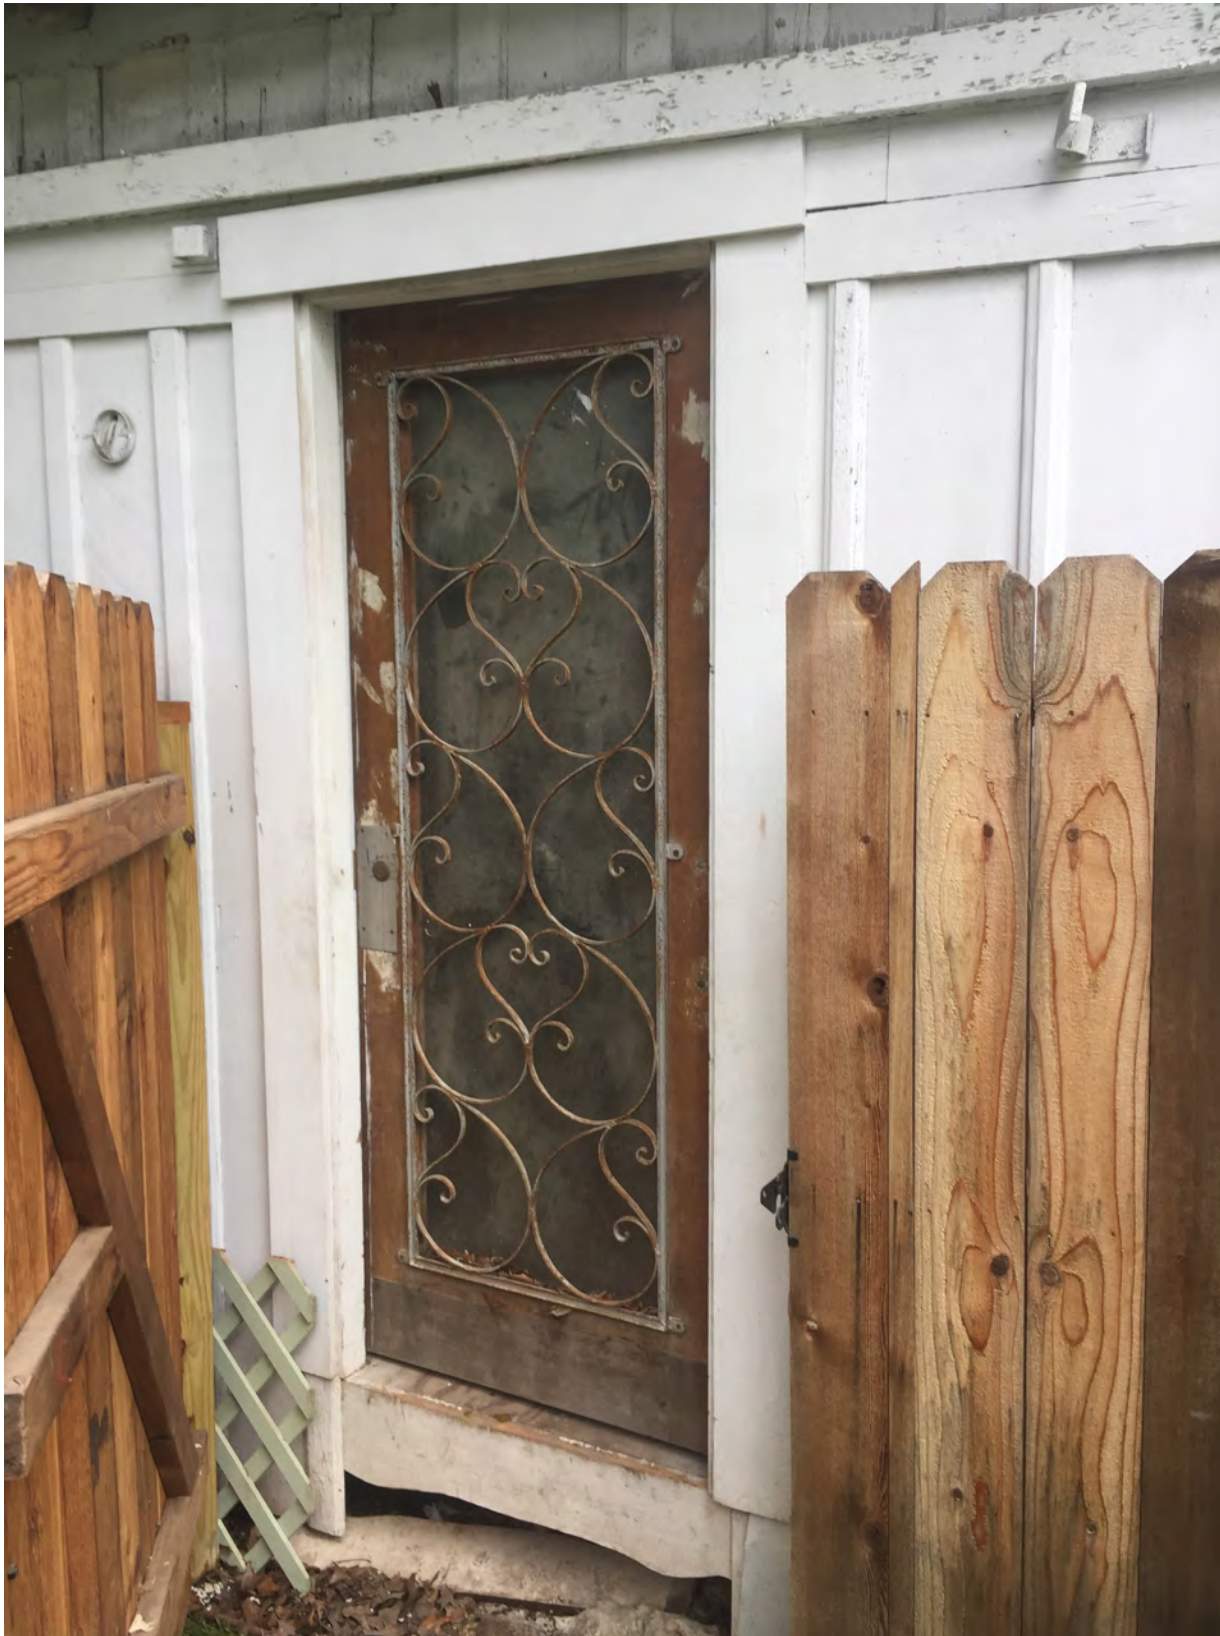
1 - Carriage House Door

-Door appears to not be original. Plan to replace with door similar the front door of the Main House.

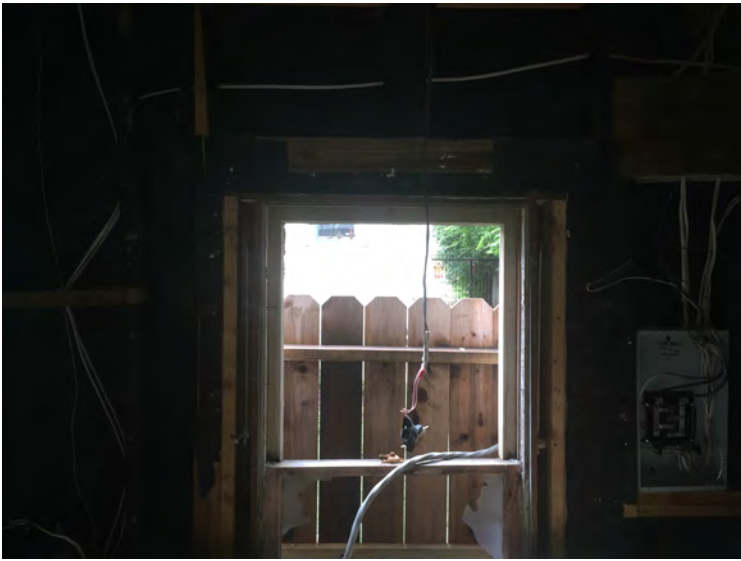
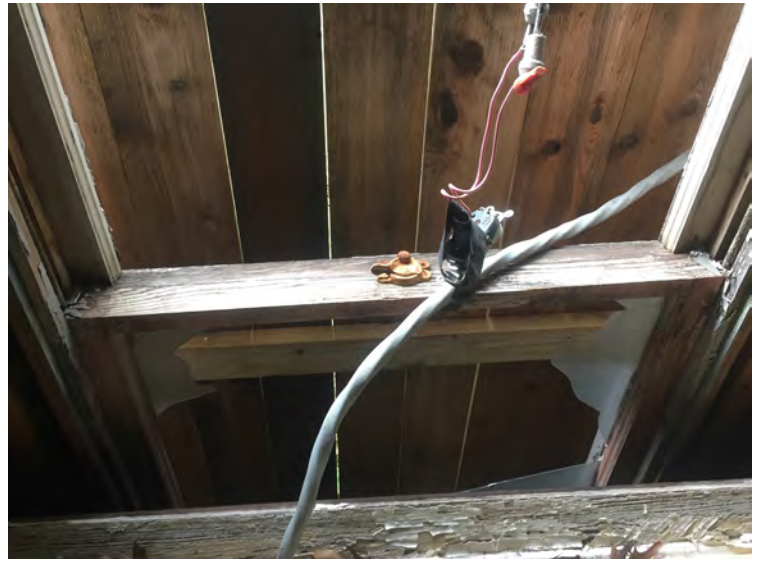
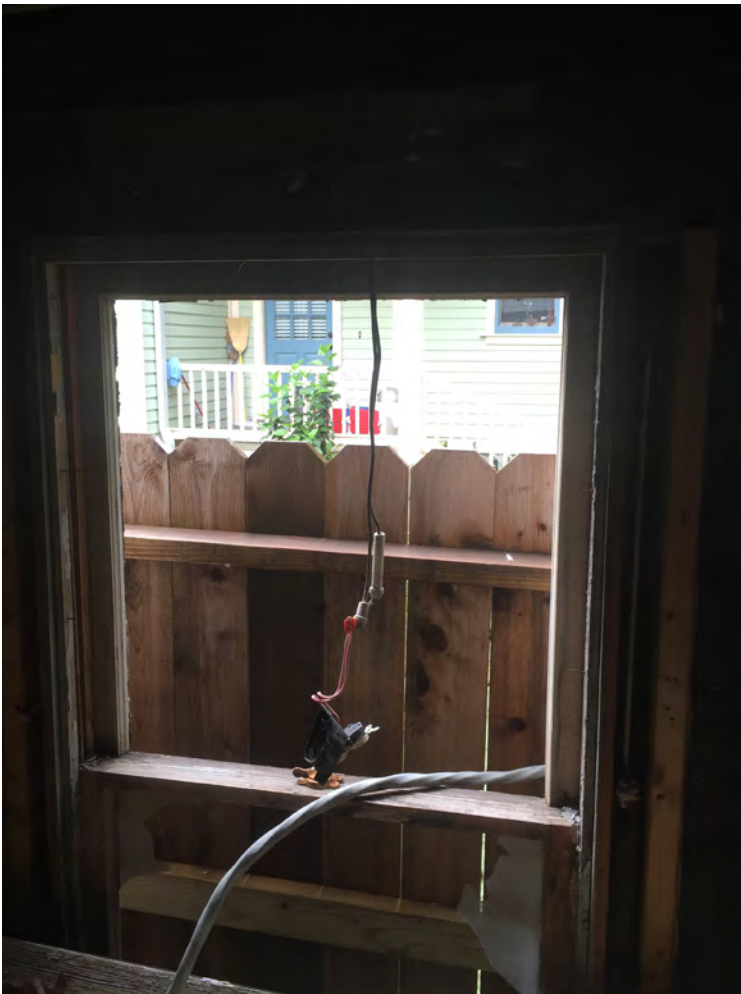
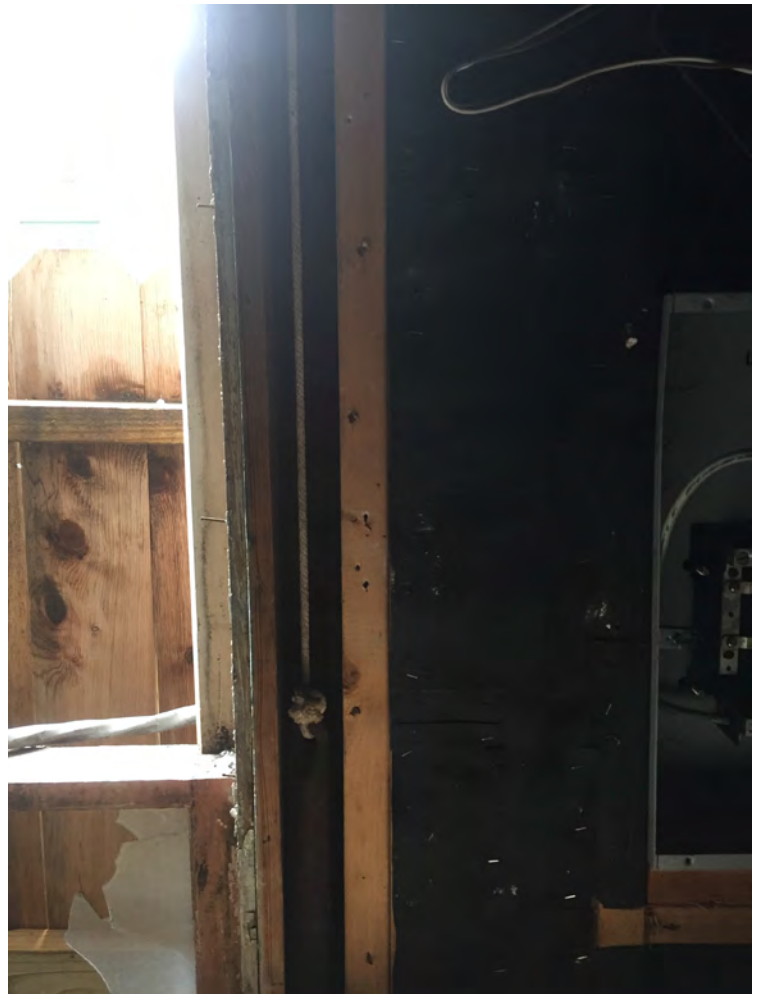
2 - Carriage House Window (South Facade)

- Window is in very poor shape. Plan to replace with window similar to the Main House (all main house windows were replaced with new wood windows).
- Window and Framing do not appear to be original.

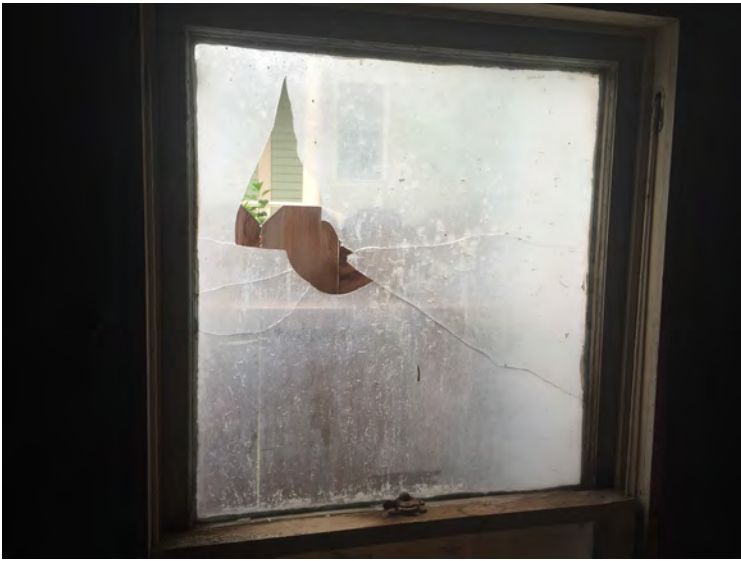
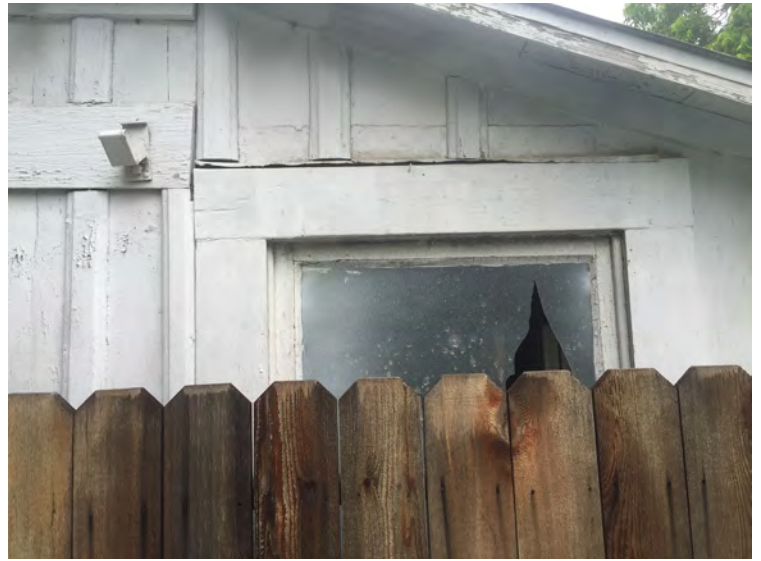
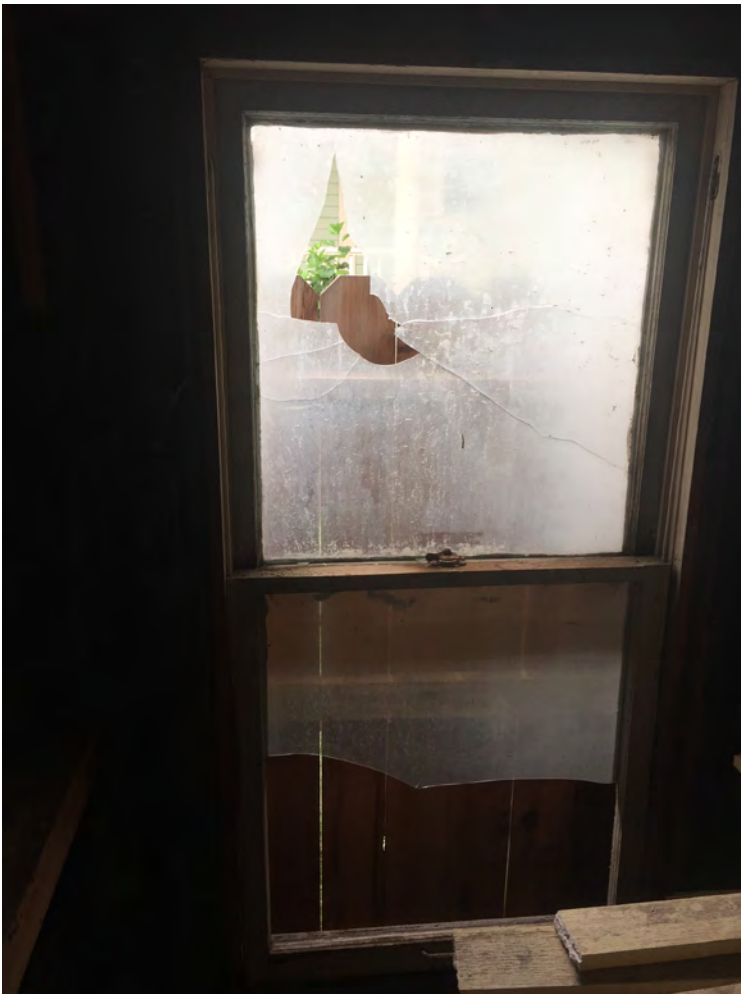
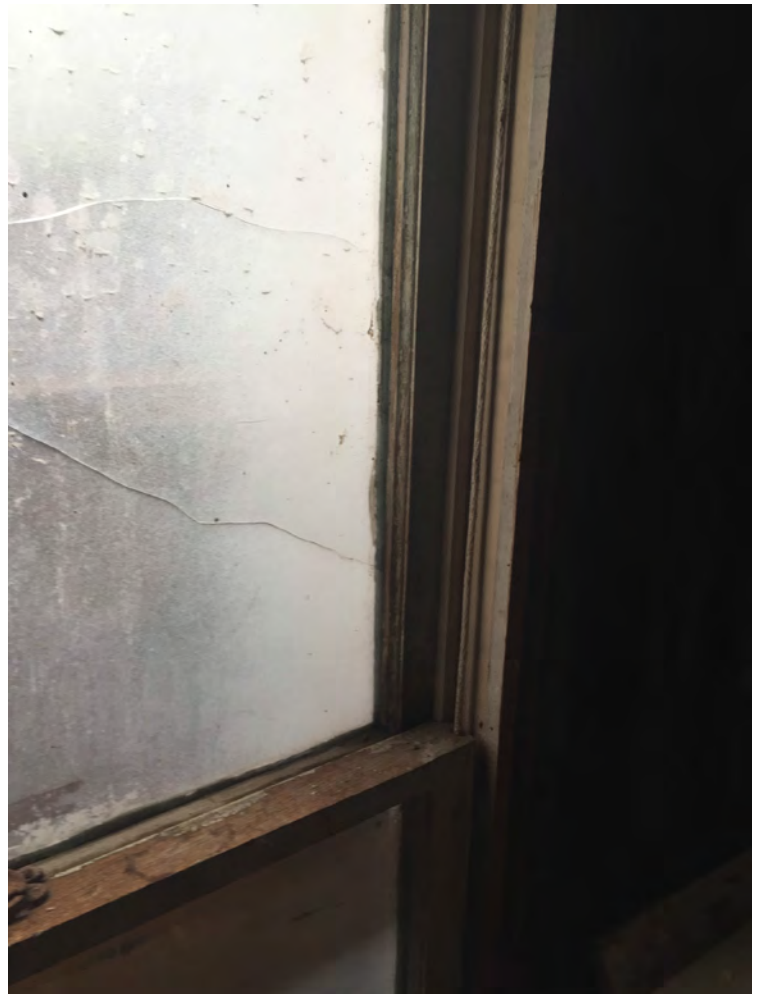
3 - Carriage House Window (South Facade)

-Window appears to not be original (part of the addition). Plan to eliminate the Window along with the addition.

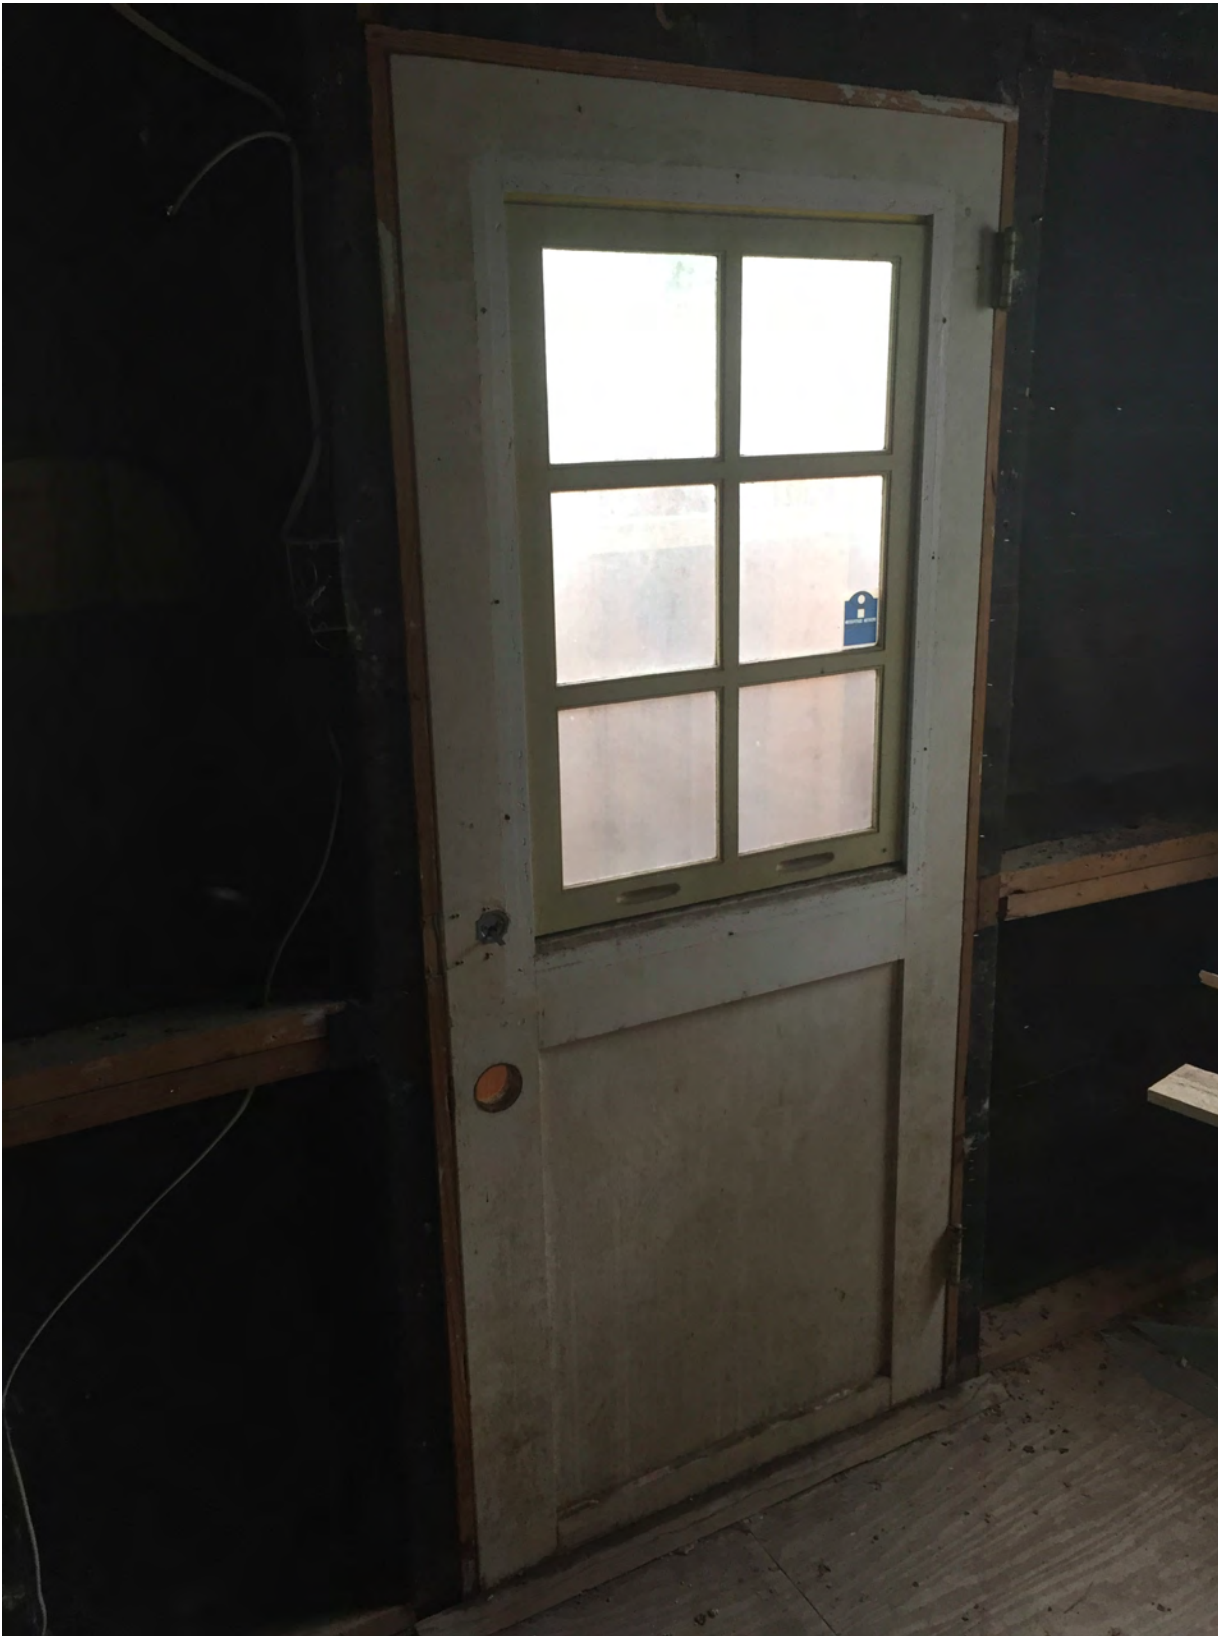
4 - Carriage House Door (East Facade)

-Door appears to not be original (part of the addition). Plan to eliminate the door along with the addition.

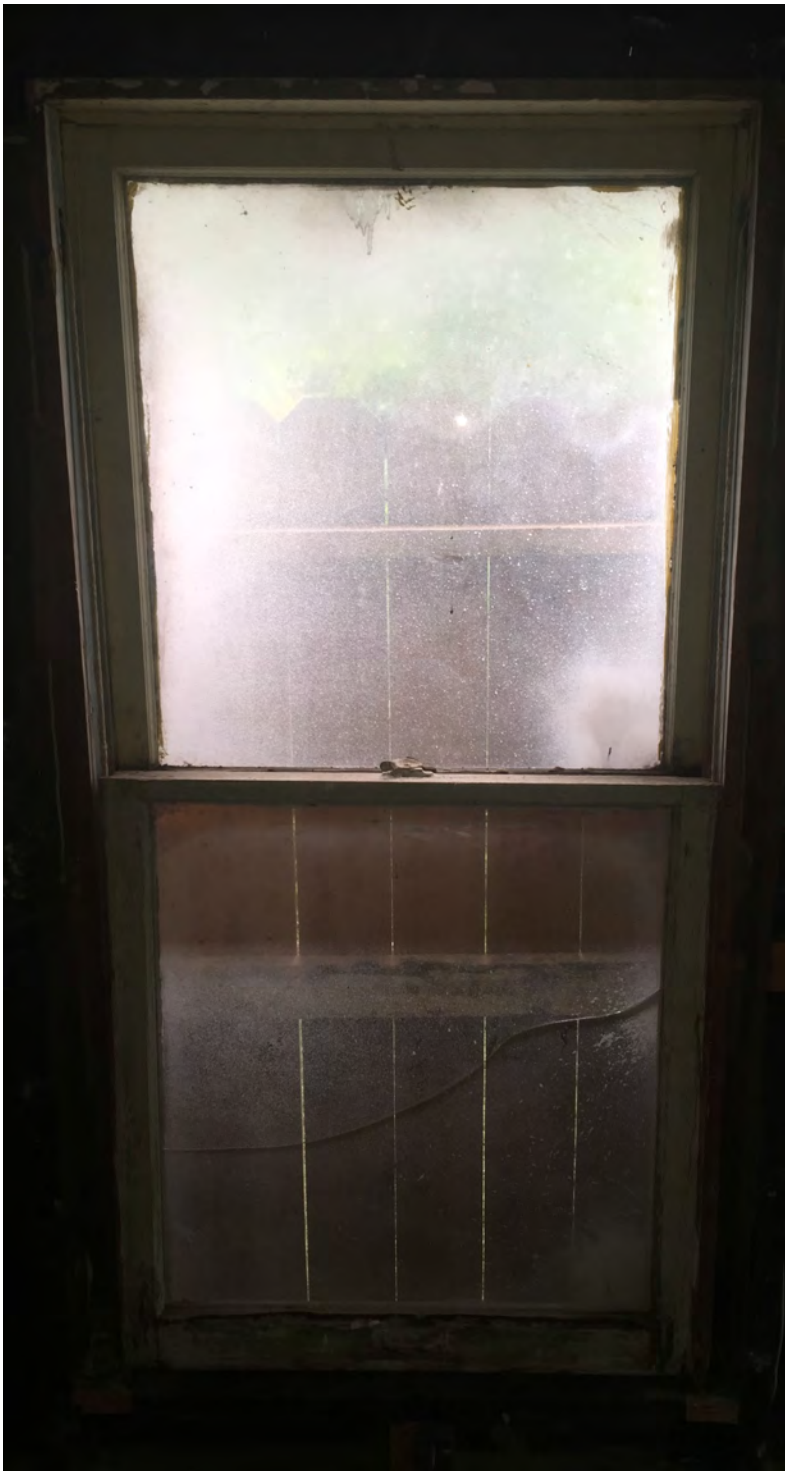
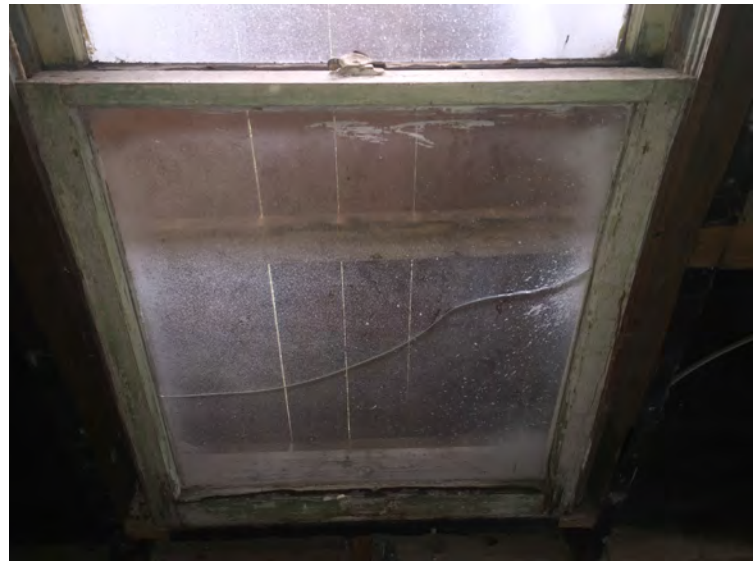
5 - Carriage House Window (East Facade)

-Window appears to not be original (part of the addition). Plan to eliminate the Window along with the addition.

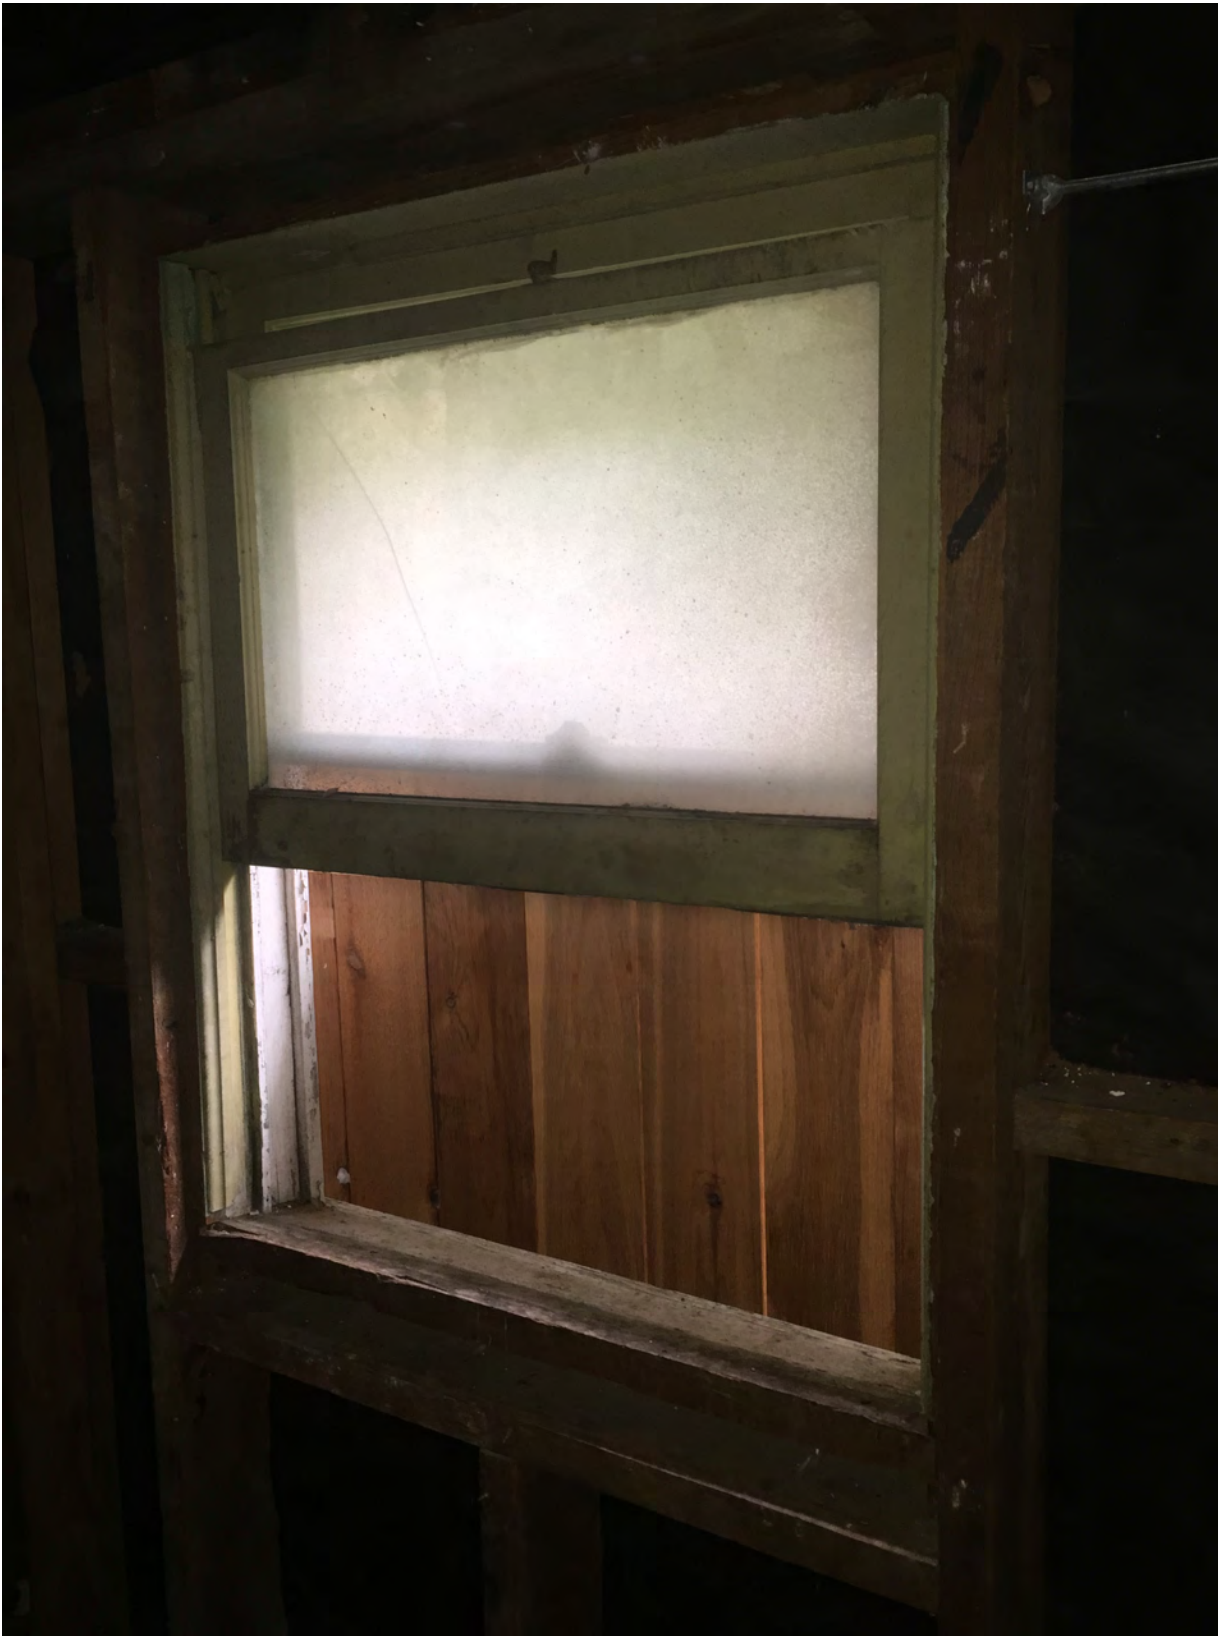
6 - Carriage House Window (East Facade)

-Window appears to not be original (part of the addition). Plan to eliminate the Window along with the addition.

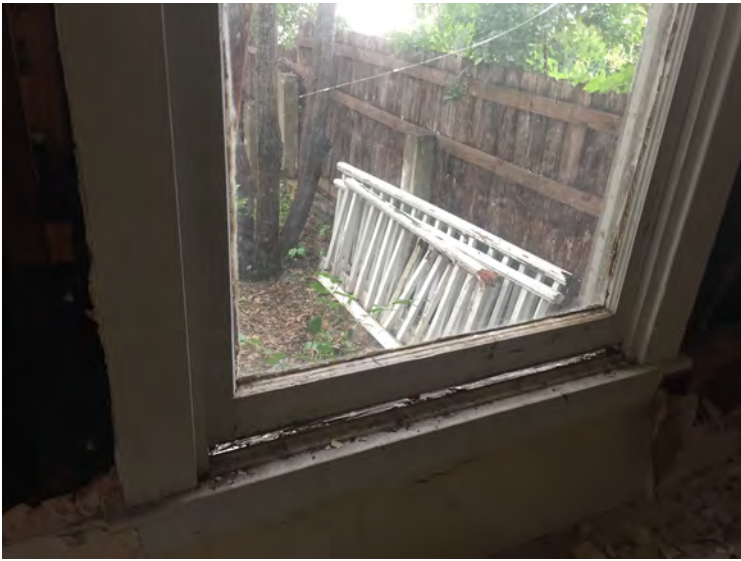
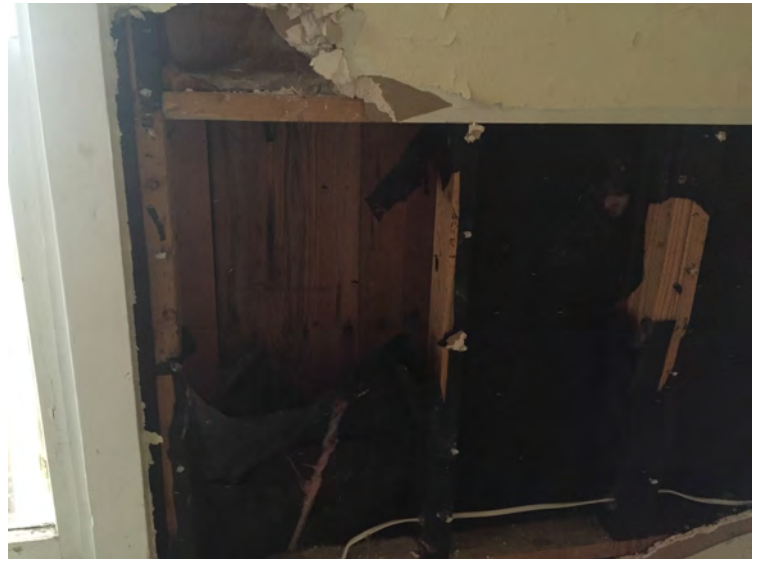
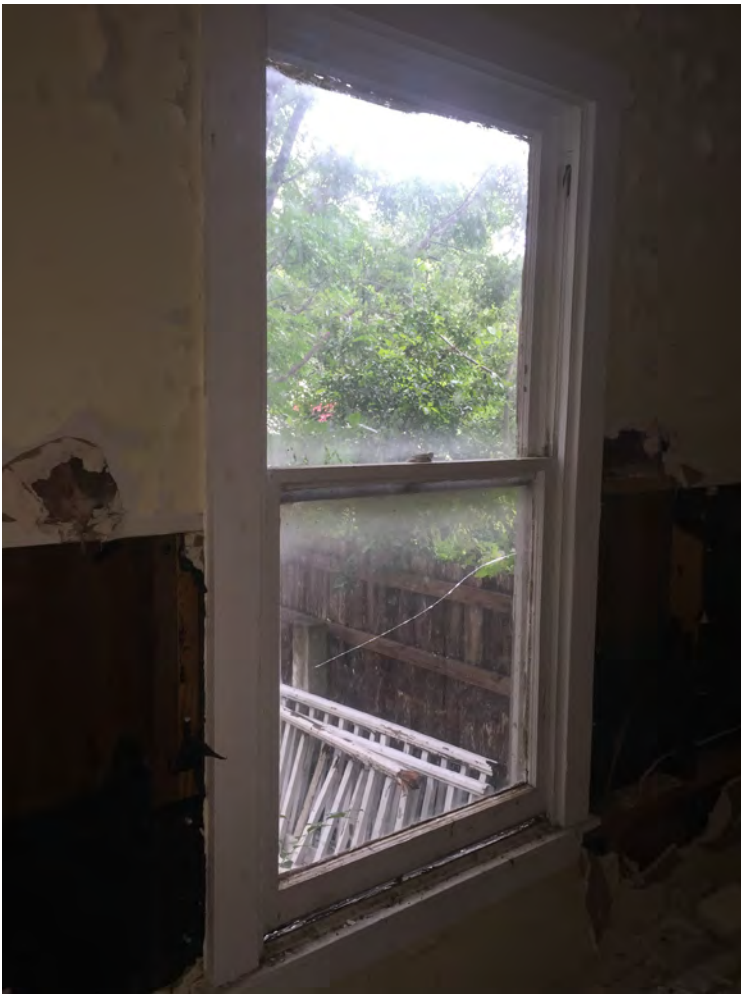
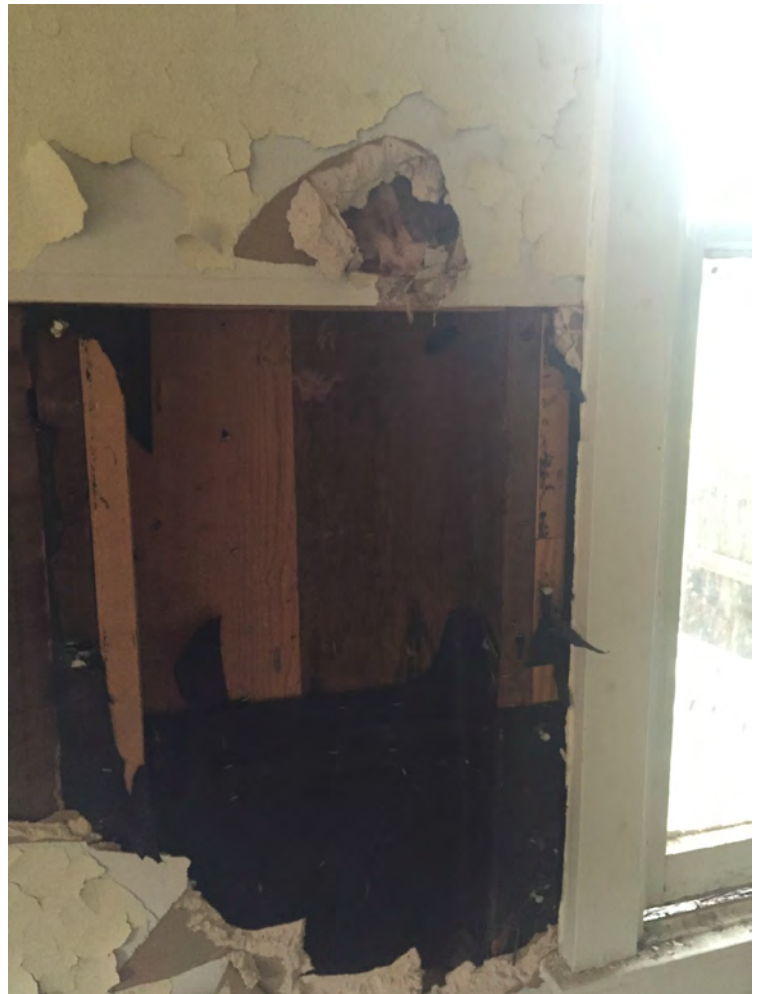
7 - Carriage House Window (West Facade)

- Window is in very poor shape.
- Window and Framing do not appear to be original.
- Due to the window having a direct view into the adjacent backyard, we plan to eliminate the window for the privacy and safety of the Respite Care Children.

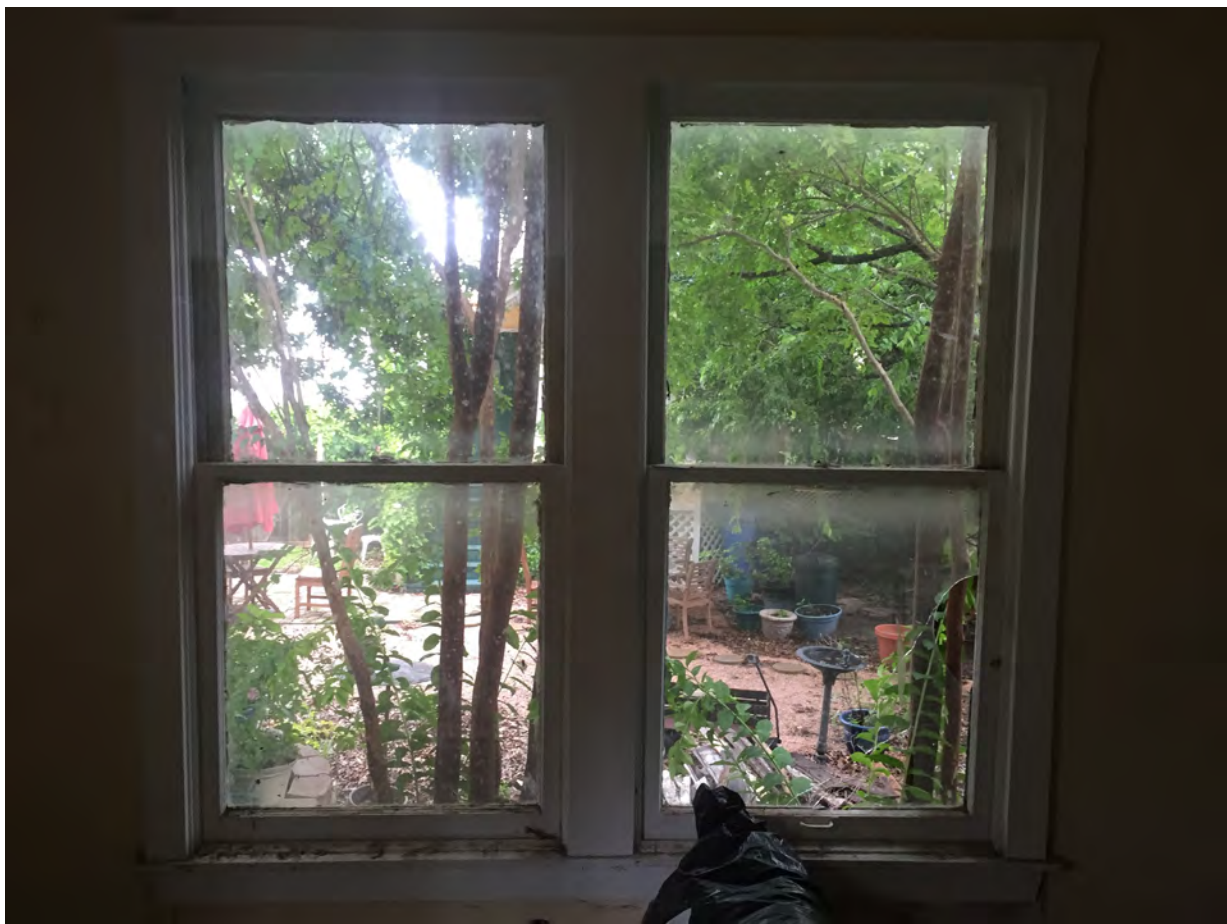
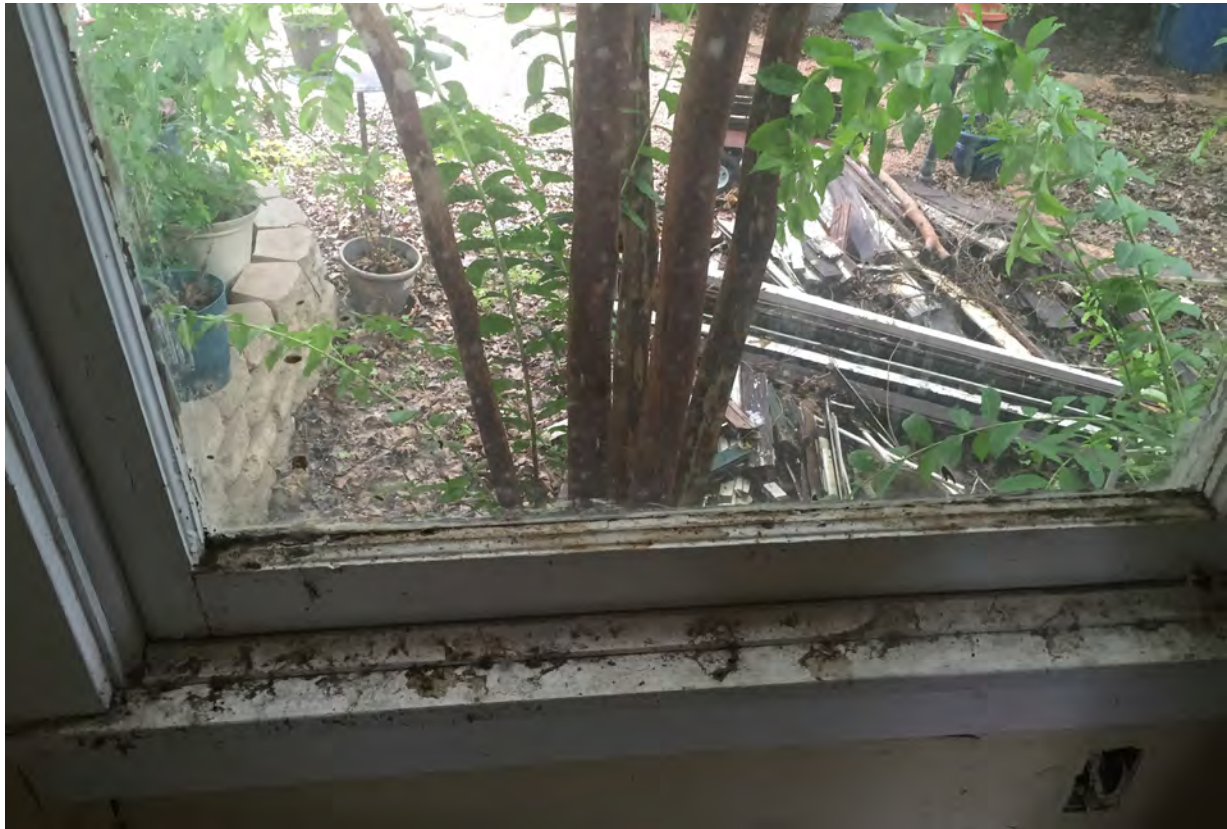
7 - Carriage House Window (West Facade)

- Window is in very poor shape.
- Window and Framing do not appear to be original.
- Due to the window having a direct view into the adjacent backyard, we plan to eliminate the window for the privacy and safety of the Respite Care Children.

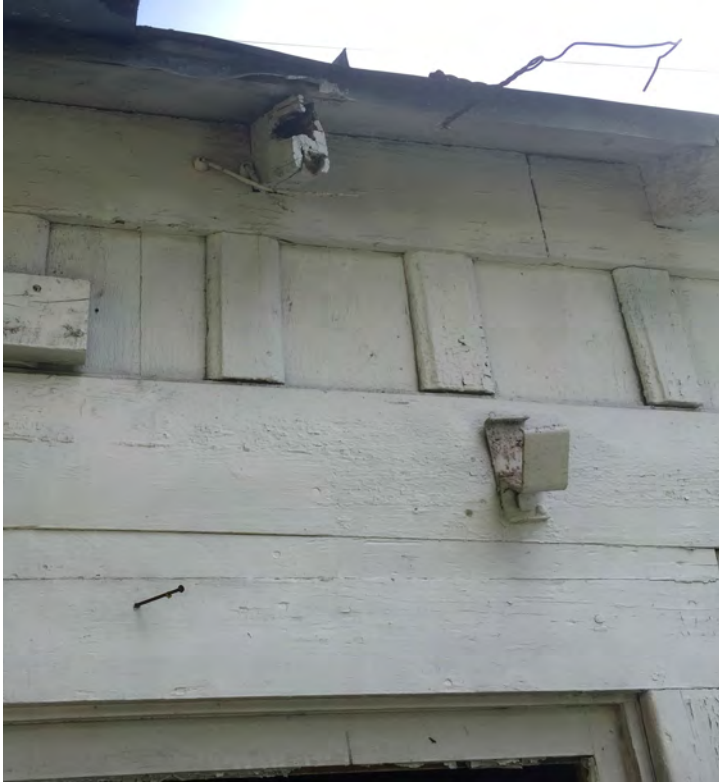
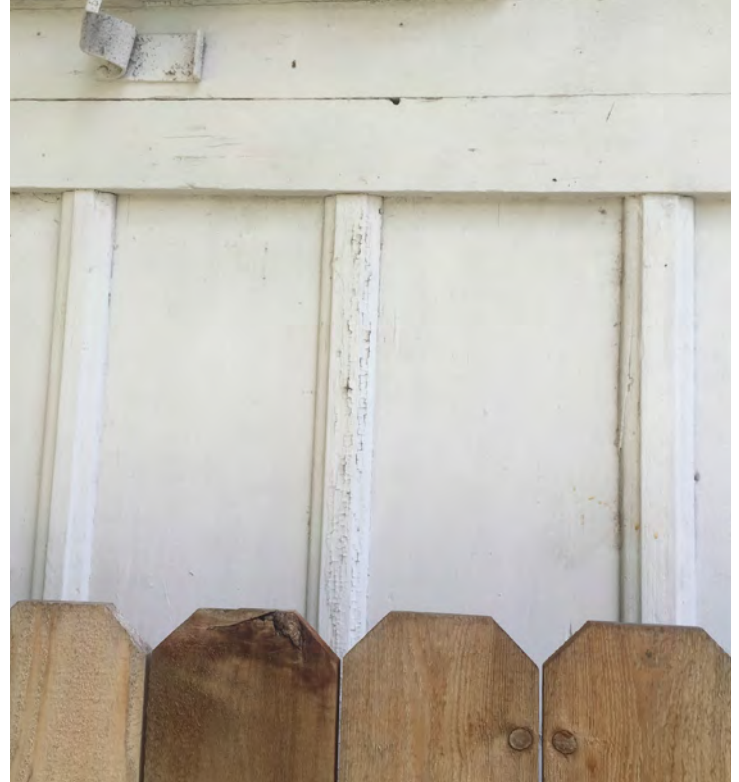
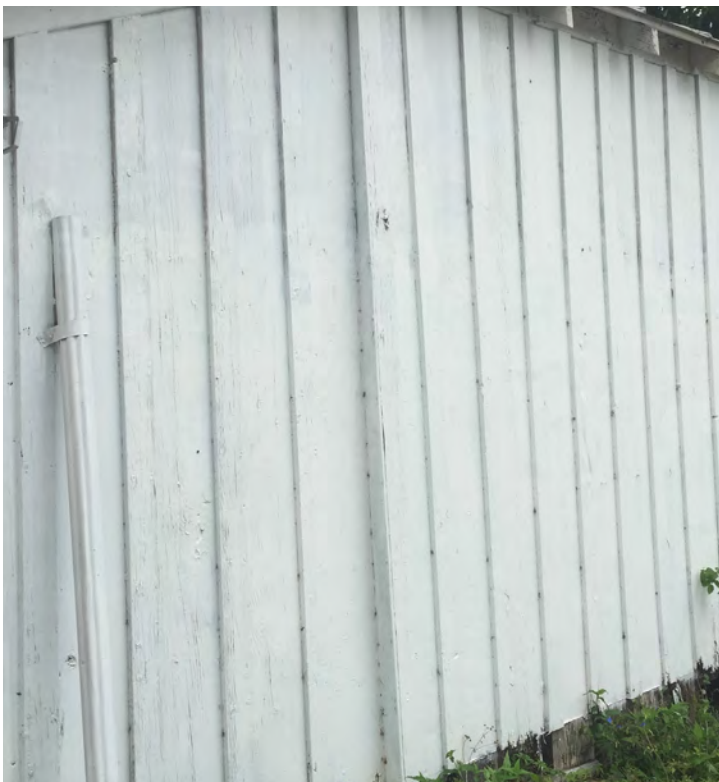
Due to the fact that there are 3 styles of Board & Batten Siding we are proposing to use the following:

-Board & Batten Siding - fiber cement board with 2" composite trim pieces every 12" on center .
