HISTORIC AND DESIGN REVIEW COMMISSION

October 19, 2016

Agenda Item No: 15

HDRC CASE NO: 2016-402
ADDRESS: 332 ADAMS ST
LEGAL DESCRIPTION: NCB 2879 BLK 4 LOT 2,N1/2 OF 4, NCB 946 BLK 2 LOT 18,SWTR 11.5 OF 16,17 EXC NETRI 16.2
ZONING: RM-4 S H HE
CITY COUNCIL DIST.: 1
DISTRICT: King William Historic District
LANDMARK: Meerscheidt, Otto - House
APPLICANT: Daniel Sexton/Buffalo Contracting
OWNER: Beverly Bunn
TYPE OF WORK: Replacement of the first and second level porch decking and front porch steps with a composite decking material
REQUEST:

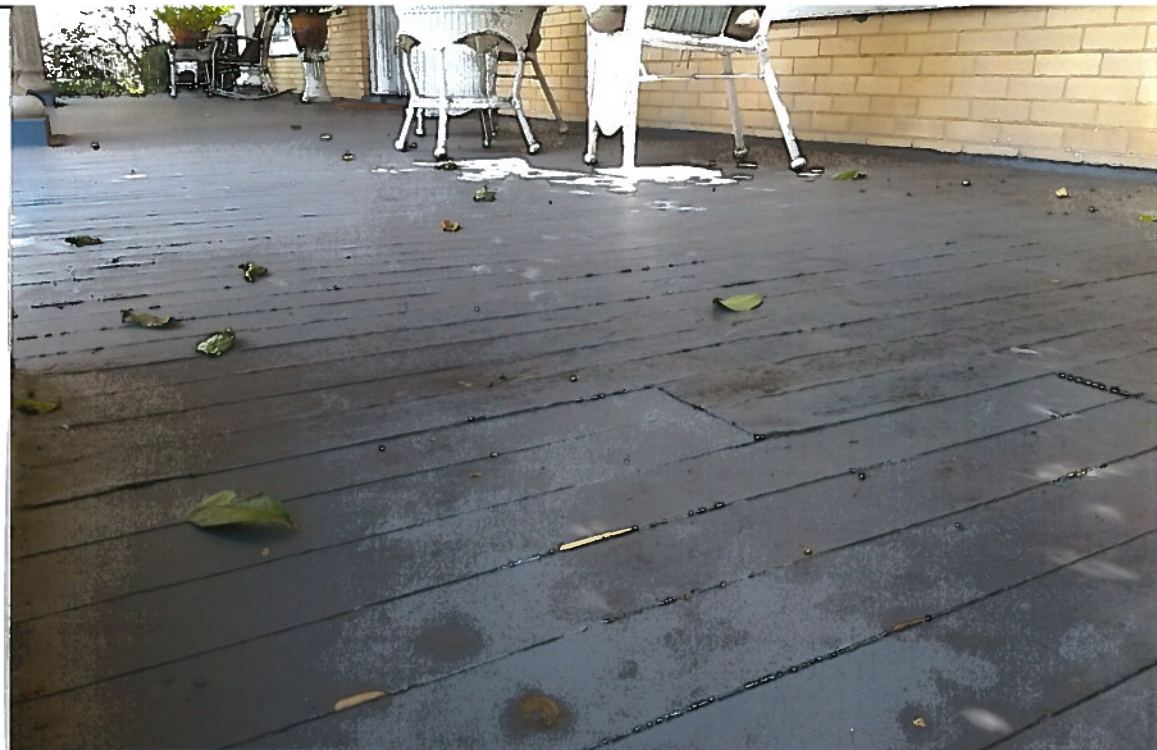
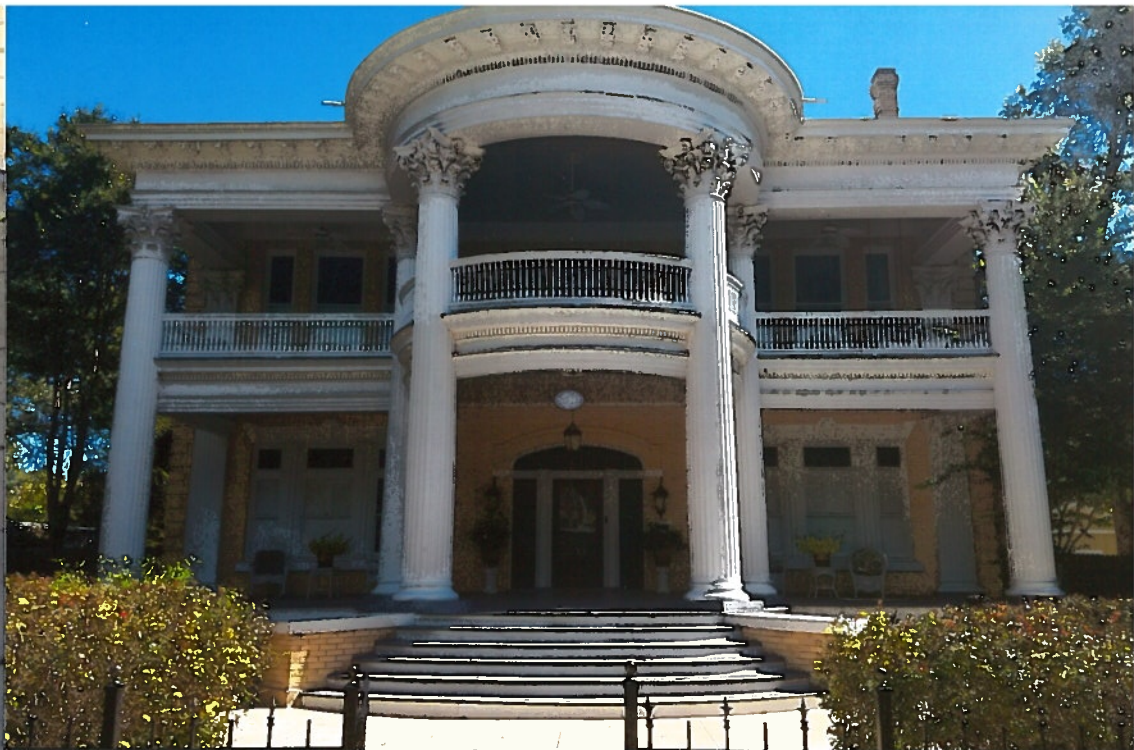
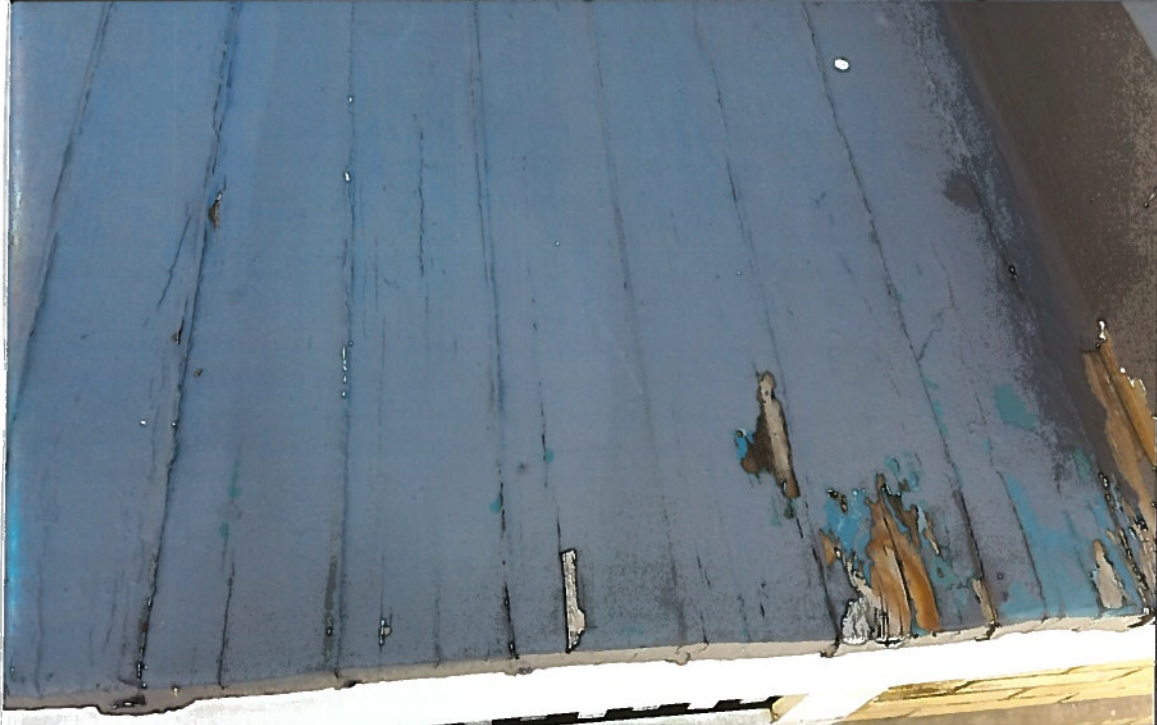
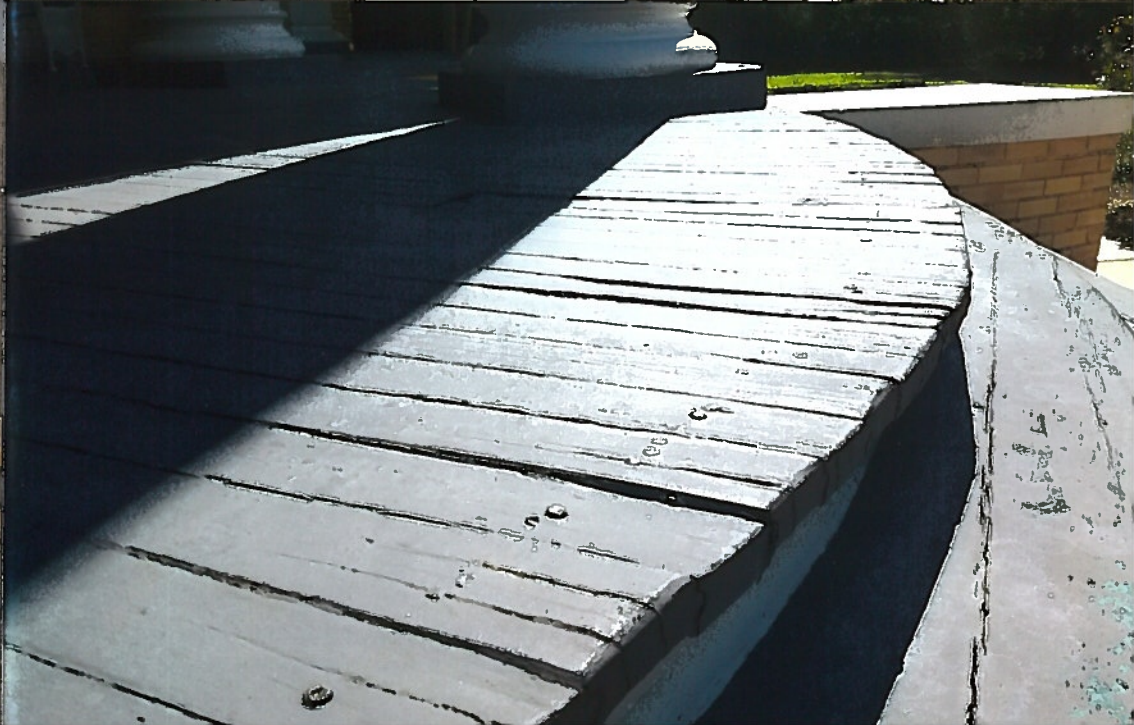
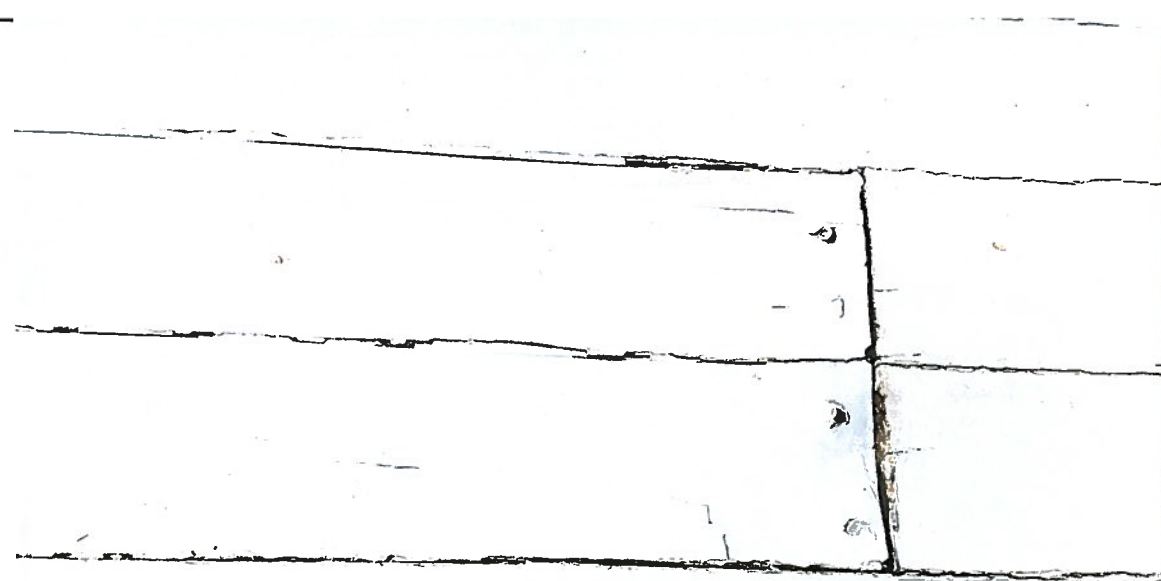
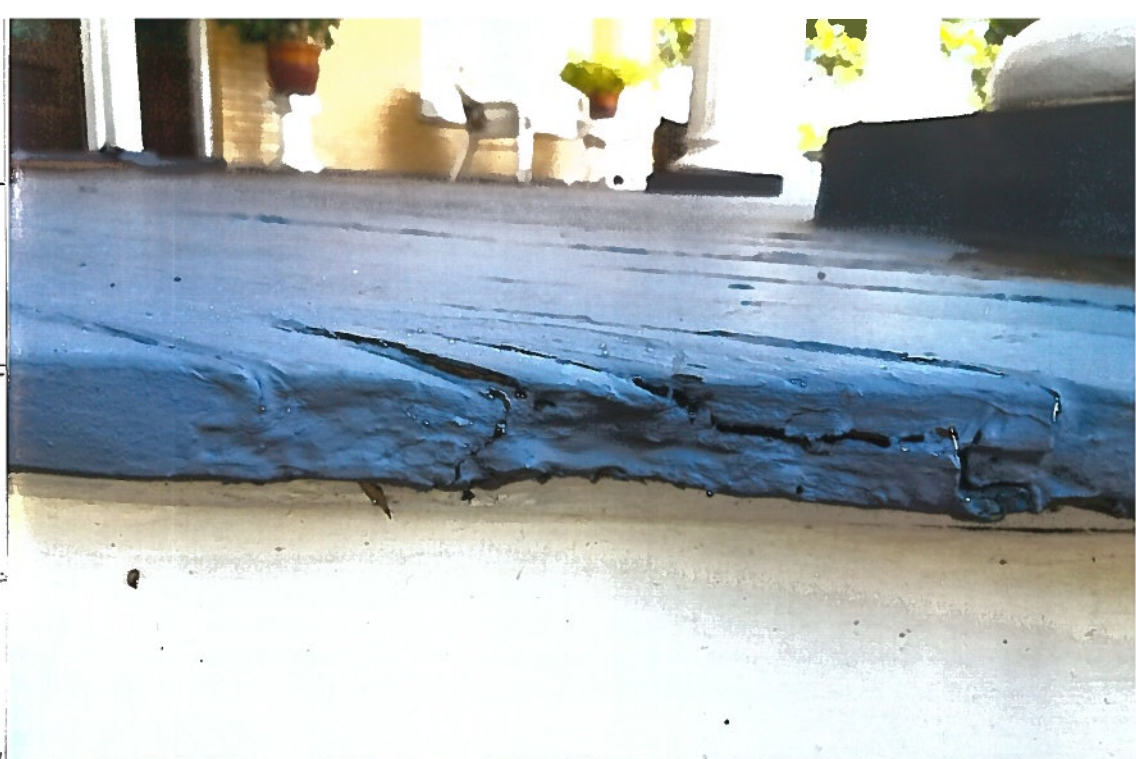
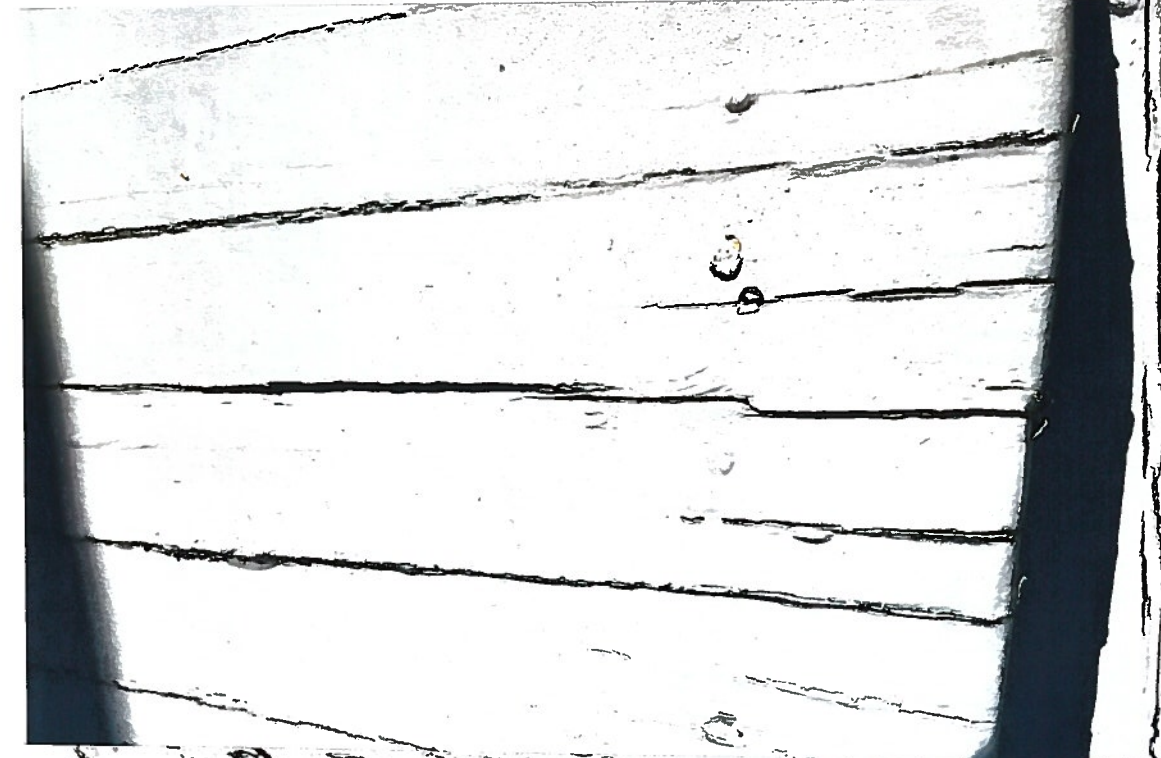
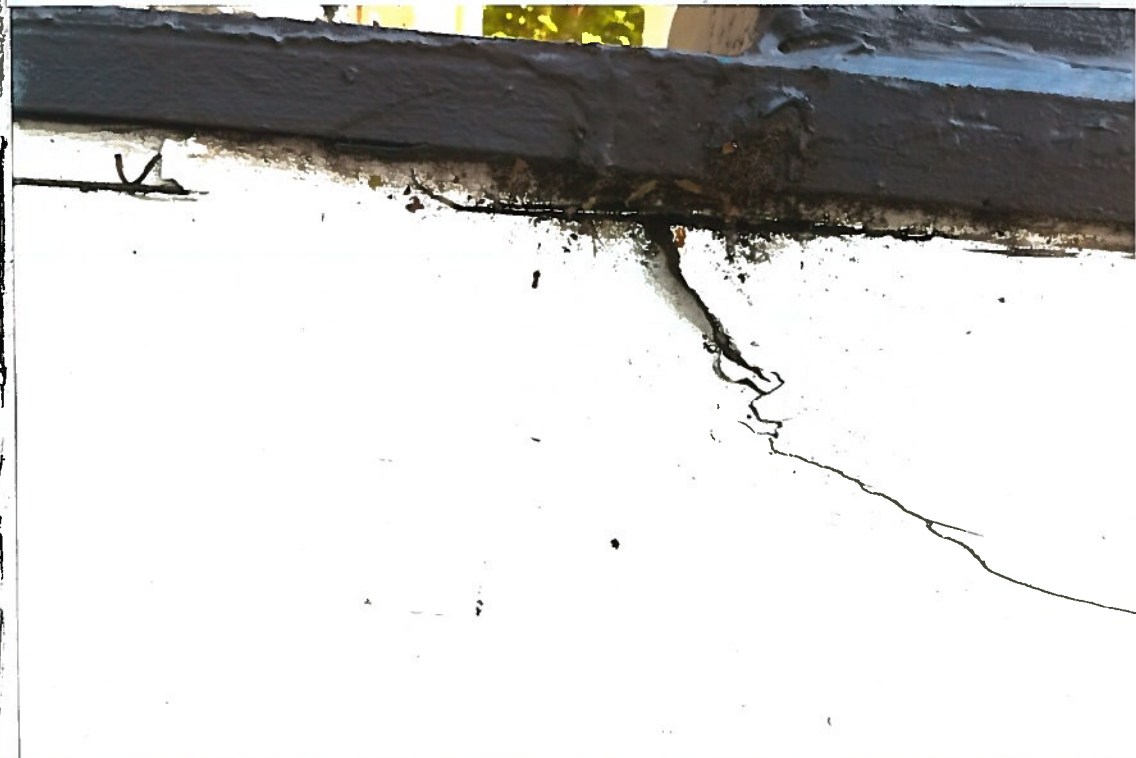
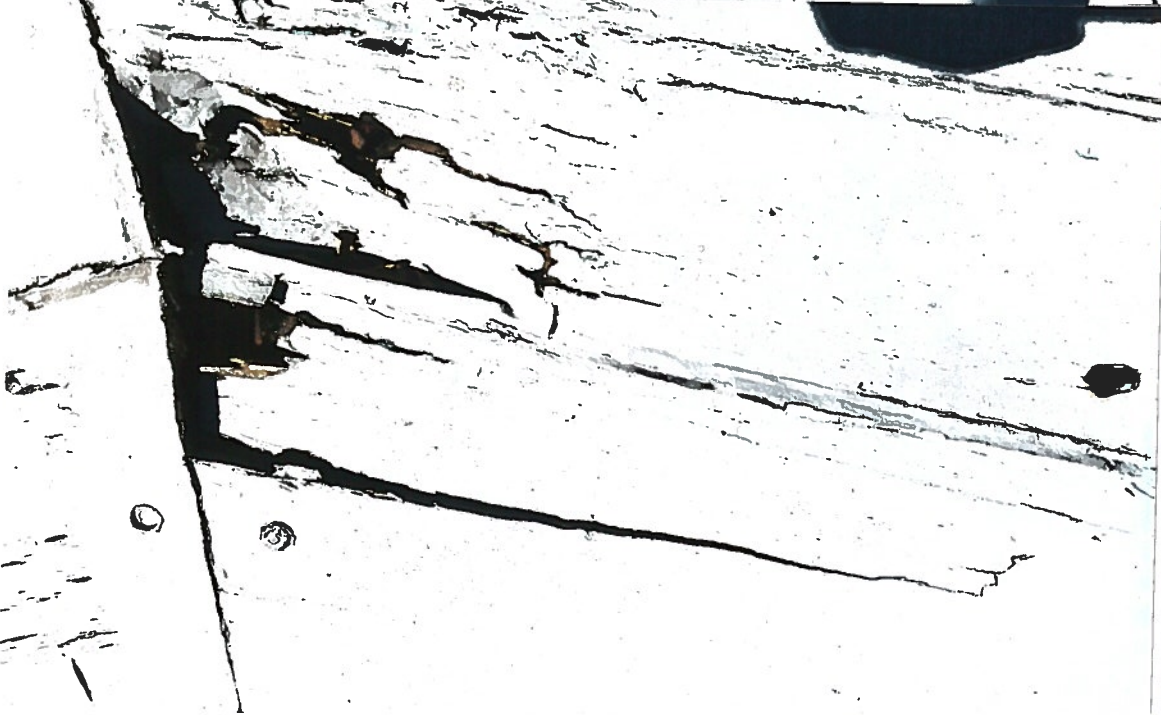
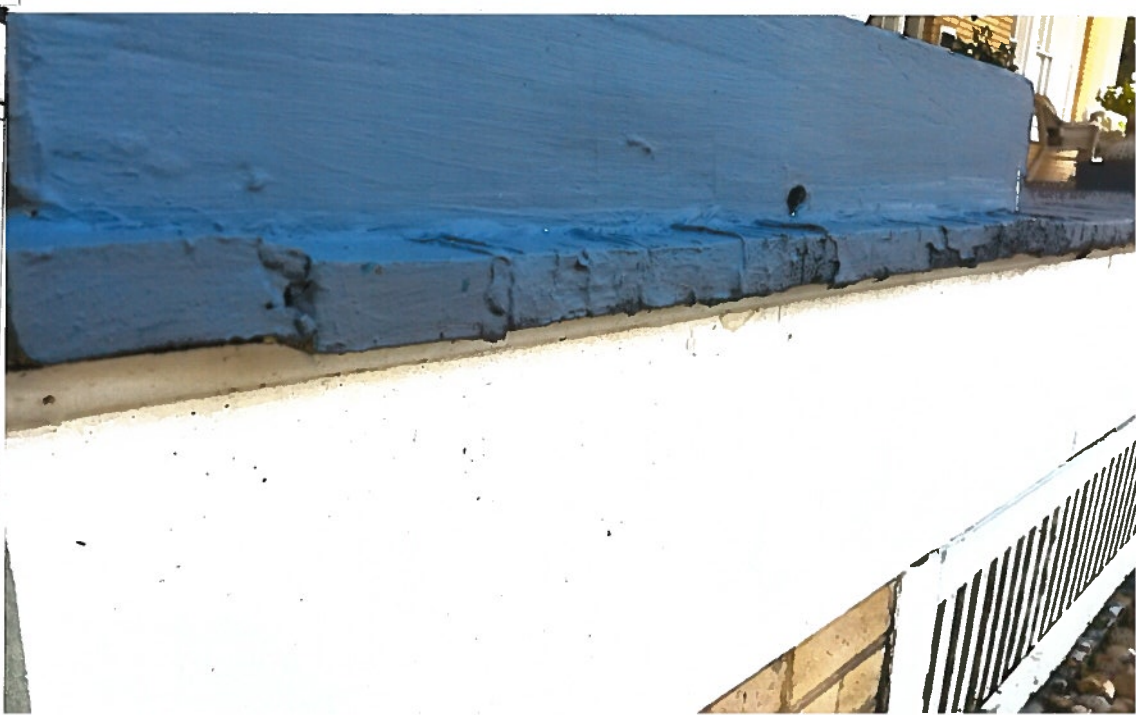
Porch- Noted items are in regards to providing evidence that the existing porch flooring is not original

- Not enough paint layers in multiple places tested to of been from the original home over 120 years
- We found different types of screws as fasteners in multiple places to indicate replacement of porch flooring

- We found no less than 3 types of tongue & groove profiles on existing porch to indicate replacement at multiple points in its life span with different materials non original to the home

- We found different types of nails not typical to the original home
- We found caulk and putty in multiple places with 2 or more layers of paint to indicate patch work

- We found 2 different thickness of wood on the porch flooring to indicate replacement at some point
- We found in multiple places different species of wood or newer pine type wood not original to the time period

- We found obvious “seams” in boards in multiple locations to indicate replacement/patch work
- To summarize we can find no evidence (without tearing up or removing boards) to indicate this is the original porch material, but has been replaced/repared at multiple places over multiple time frames spanning back no more than 50 years, some as recent as 2 years ago

Front stairs- Noted items are in regards to providing evidence that the existing stairs are not original

- Treads, risers and assumably the stringers are made form treated materials
- Tread thickness is 1 1/4” typical of newer treated boards designed for decking material

- Not enough coats of paint in sample areas to have been more than approximately 15 years
- Found screw fasteners in multiple locations, not typical to time period to be original
