HISTORIC AND DESIGN REVIEW COMMISSION

March 01, 2017

HDRC CASE NO: 2017-085
ADDRESS: 325 W MISTLETOE
LEGAL DESCRIPTION: NCB 1834 BLK 9 LOT 16
ZONING: R-4
CITY COUNCIL DIST.: 1
DISTRICT: Monte Vista Historic District
APPLICANT: Bob King/Alamo Construction
OWNER: Tyler Sibley
TYPE OF WORK: Chimney removal and window replacement

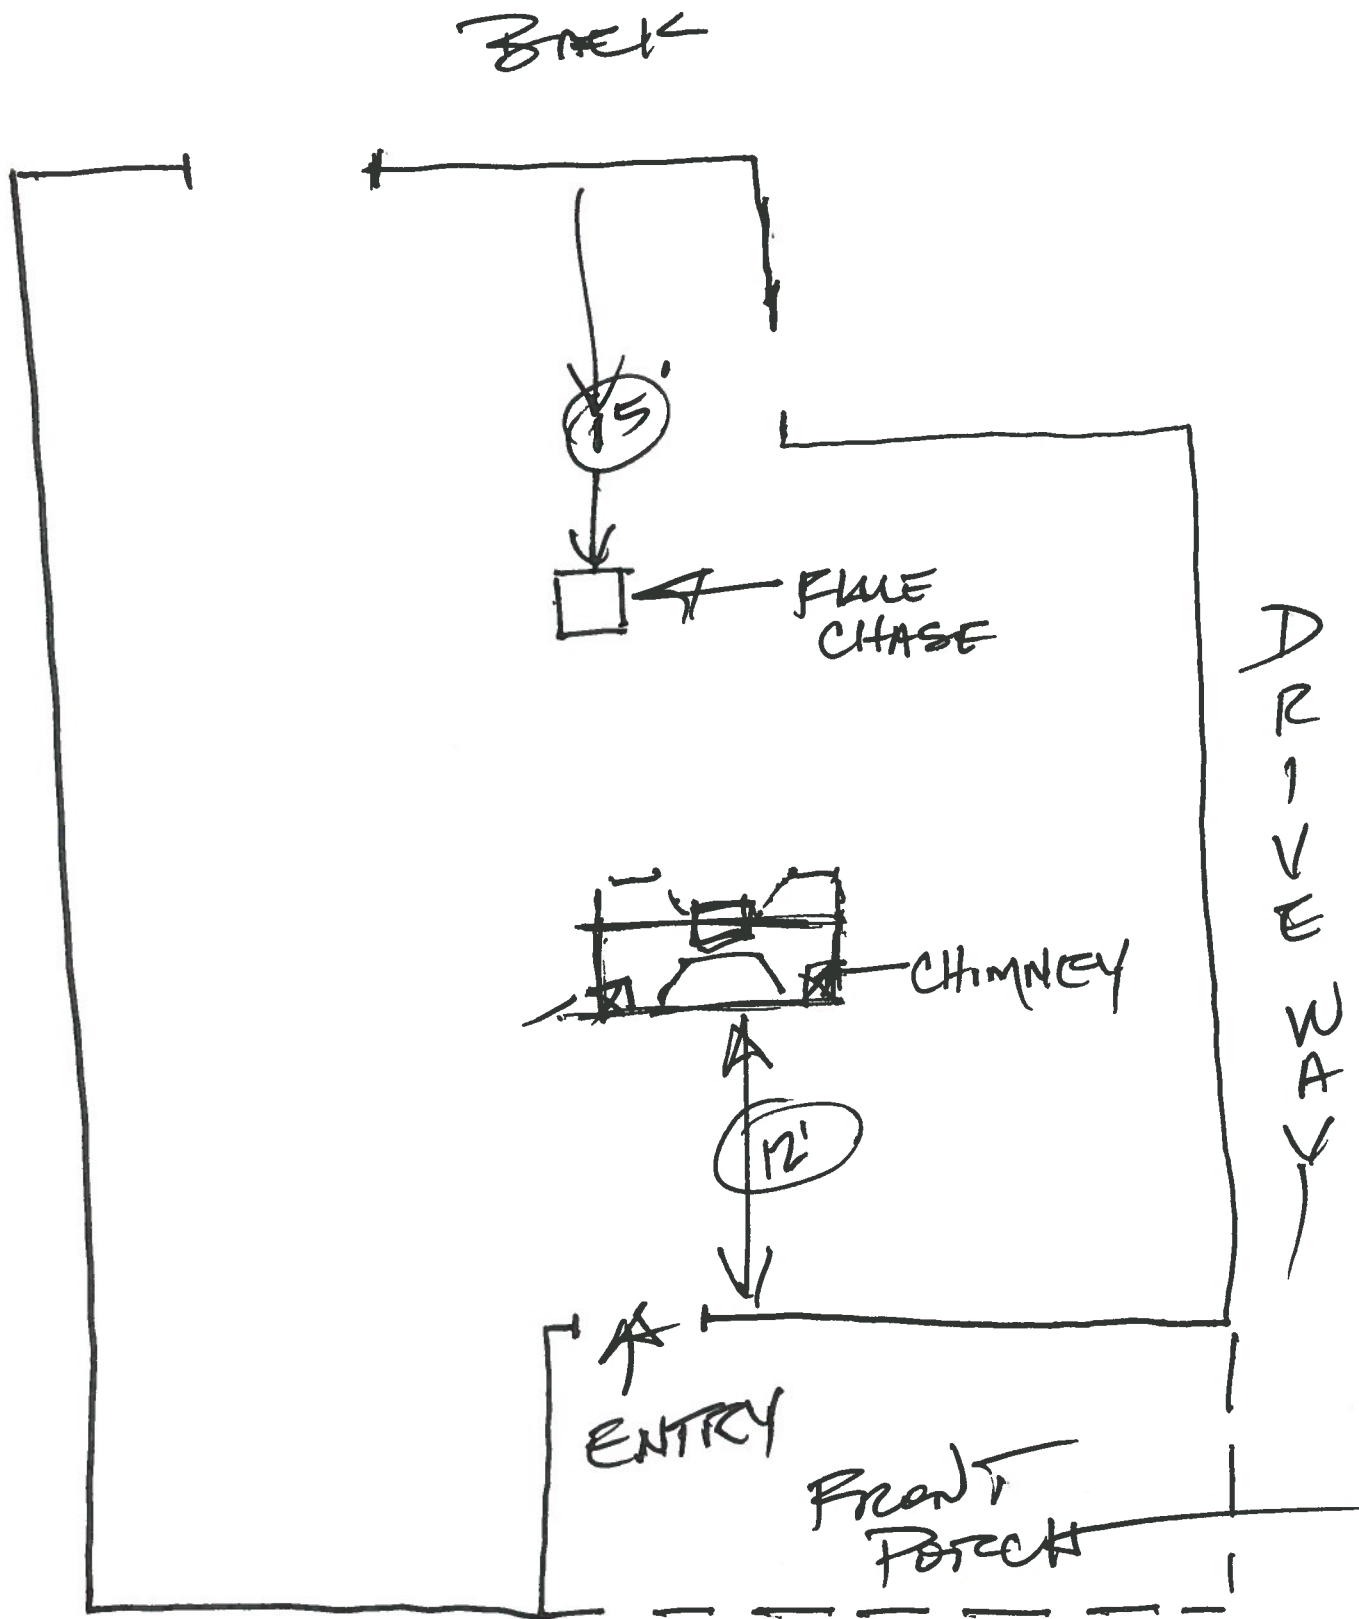
325 Mistletoe W

- a. The existing structure is designed in the Craftsman Bungalow style and is estimated to be constructed between 1930 and 1935. The property appears on a Sanborn map in 1935. The chimney, constructed of brick masonry, is located on center with the primary front-facing façade of the home and is a character defining feature. The flue vent is located in the rear of the structure and cannot be seen from the public right-of-way.

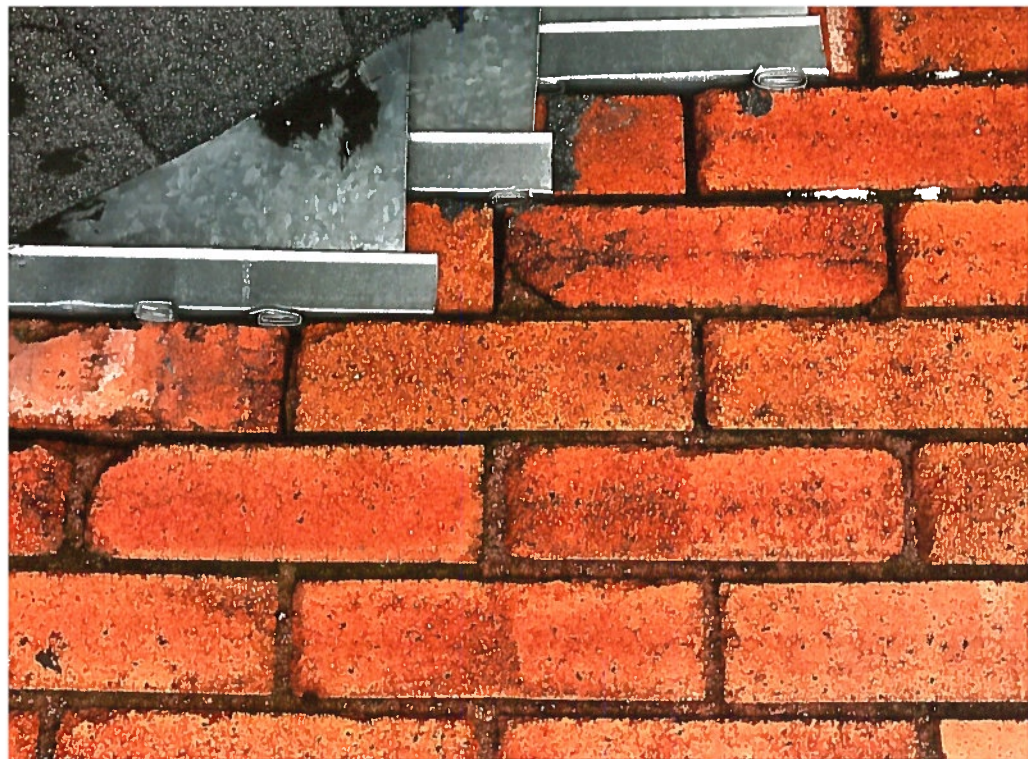
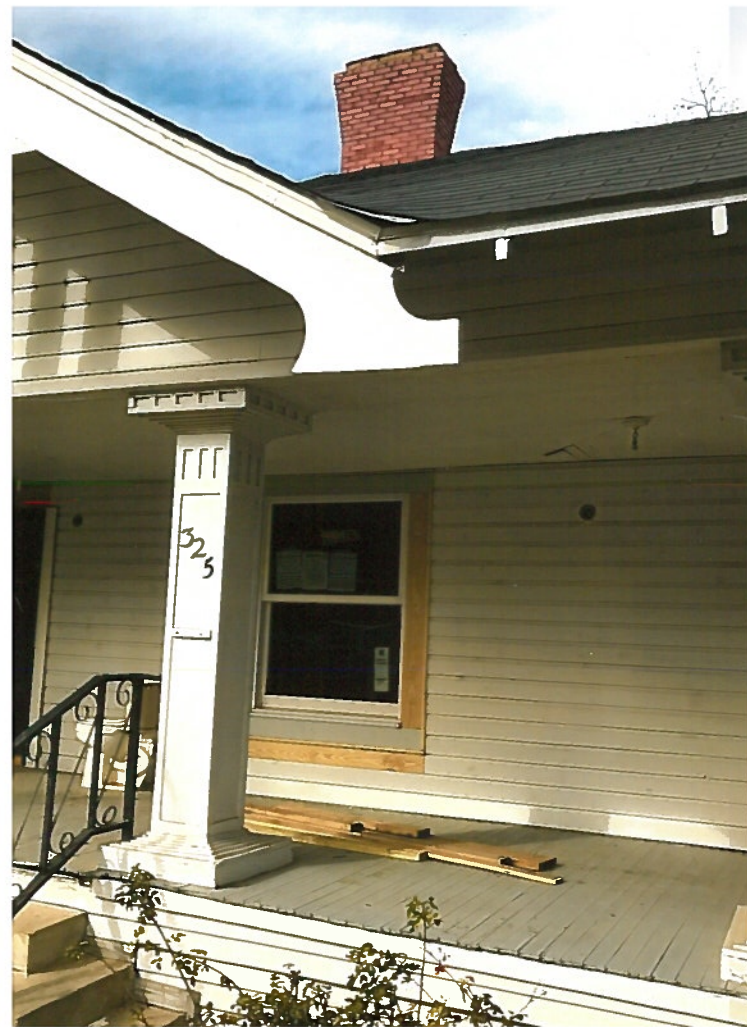
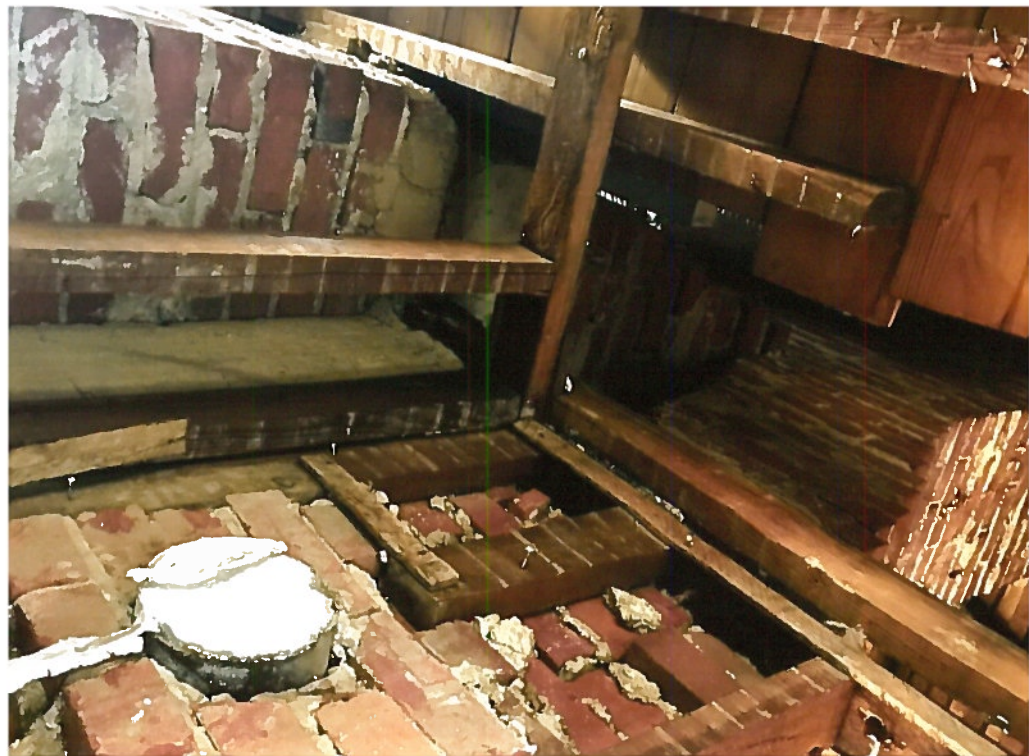
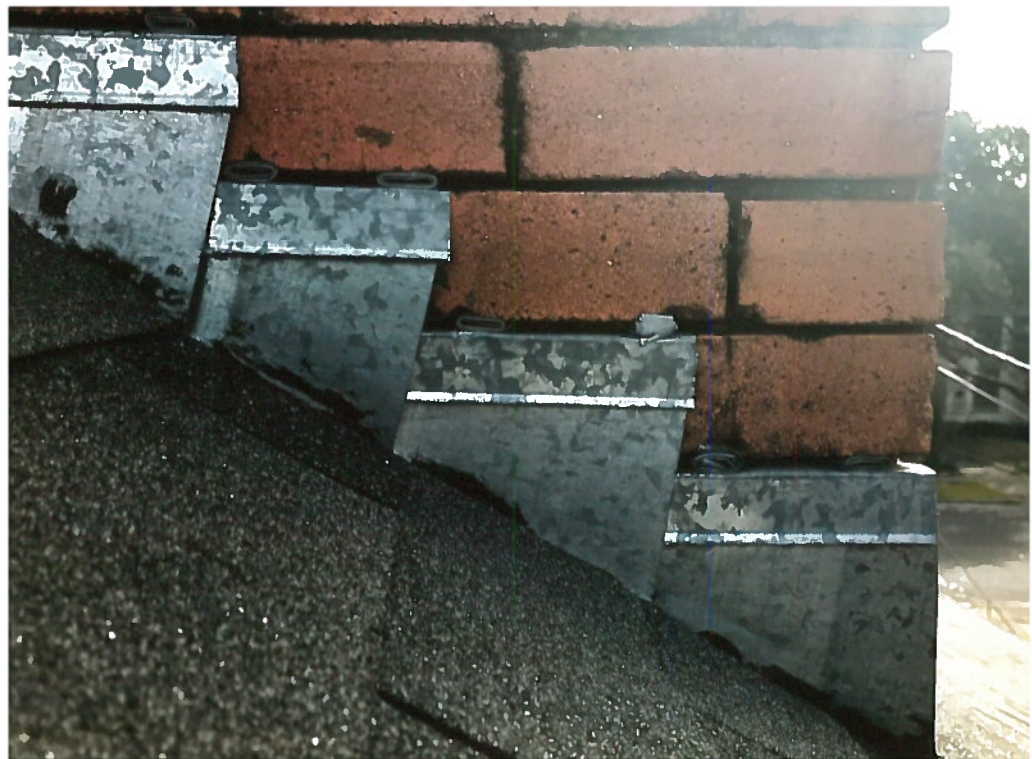
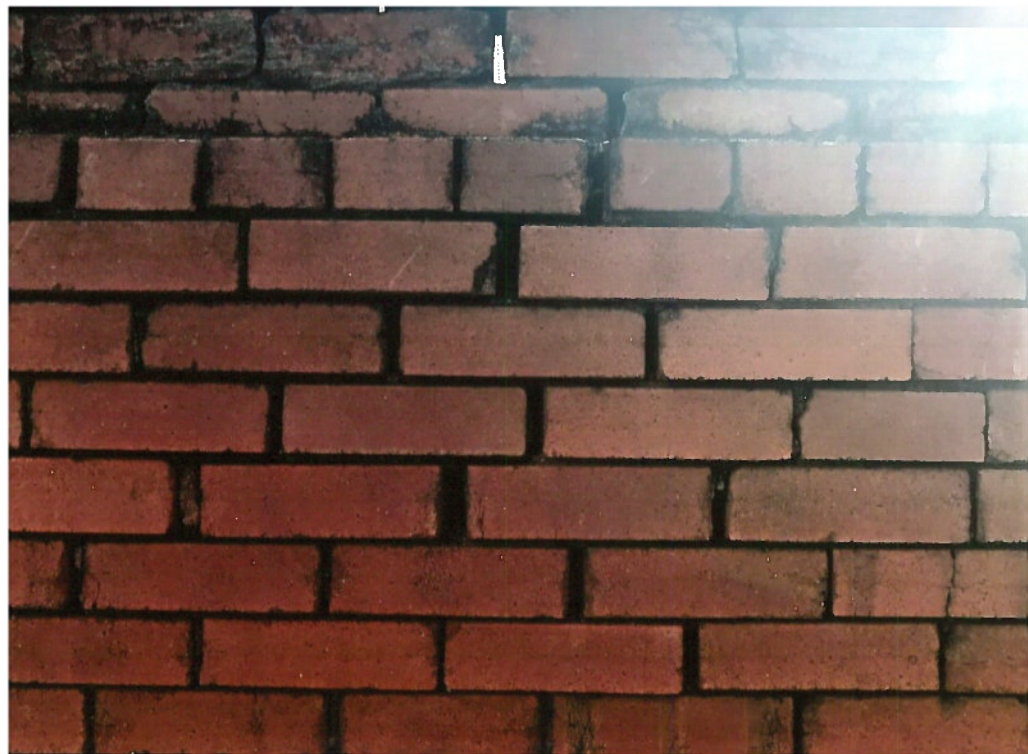
Pursuant to your request I have reviewed the chimney and mechanical vent at the above referenced address. The house appears to be constructed about 90 years ago. The chimney is a brick masonry chimney extending through the center of the house. There was evidence of cracking within the chimney and the mortar that is on the exterior is deteriorated.

It is my opinion that the chimney has deteriorated to the point where the only possible correction would be to tear down and replace.

The mechanical flue in the rear does not appear to be properly constructed and should be replaced.
