HISTORIC AND DESIGN REVIEW COMMISSION

March 01, 2017

HDRC CASE NO: 2017-080
ADDRESS: 507 KINGS COURT
LEGAL DESCRIPTION: NCB 3094 BLK 10 LOT 24
ZONING: R-4
CITY COUNCIL DIST.: 1
DISTRICT: Monte Vista Historic District
APPLICANT: Arthur Gonzalez
OWNER: Arthur Gonzalez
TYPE OF WORK: Construct rear accessory structure
REQUEST:

The applicant is requesting a Certificate of Appropriateness for approval to construct a two-story 20' by 20' rear accessory structure.

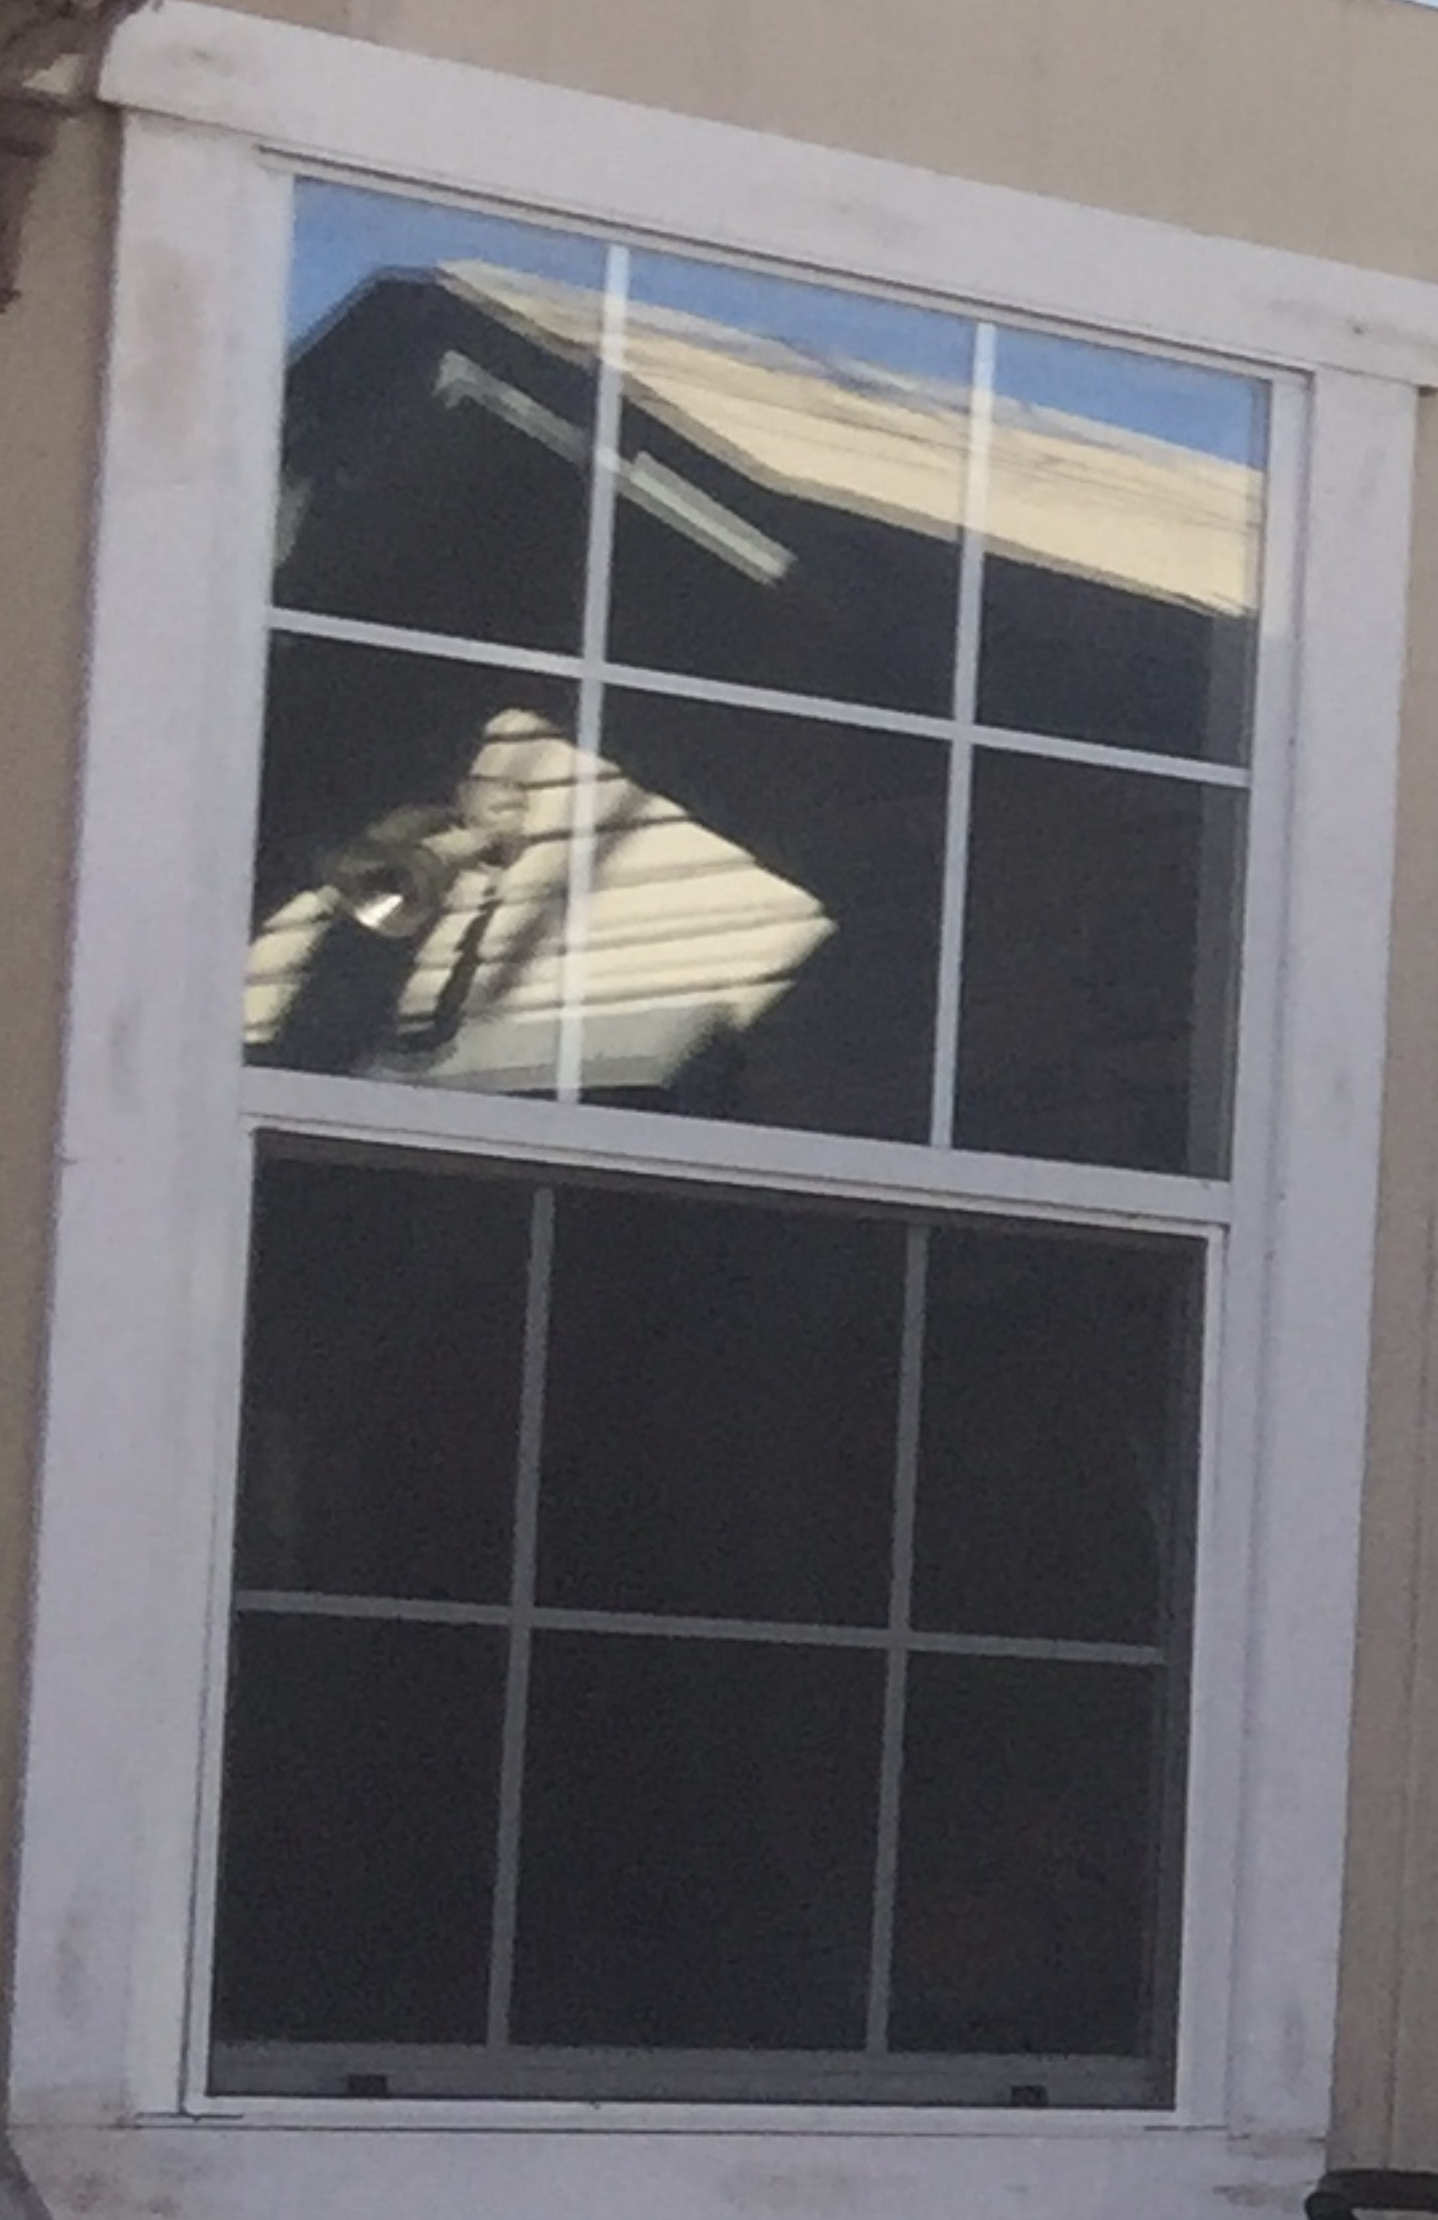
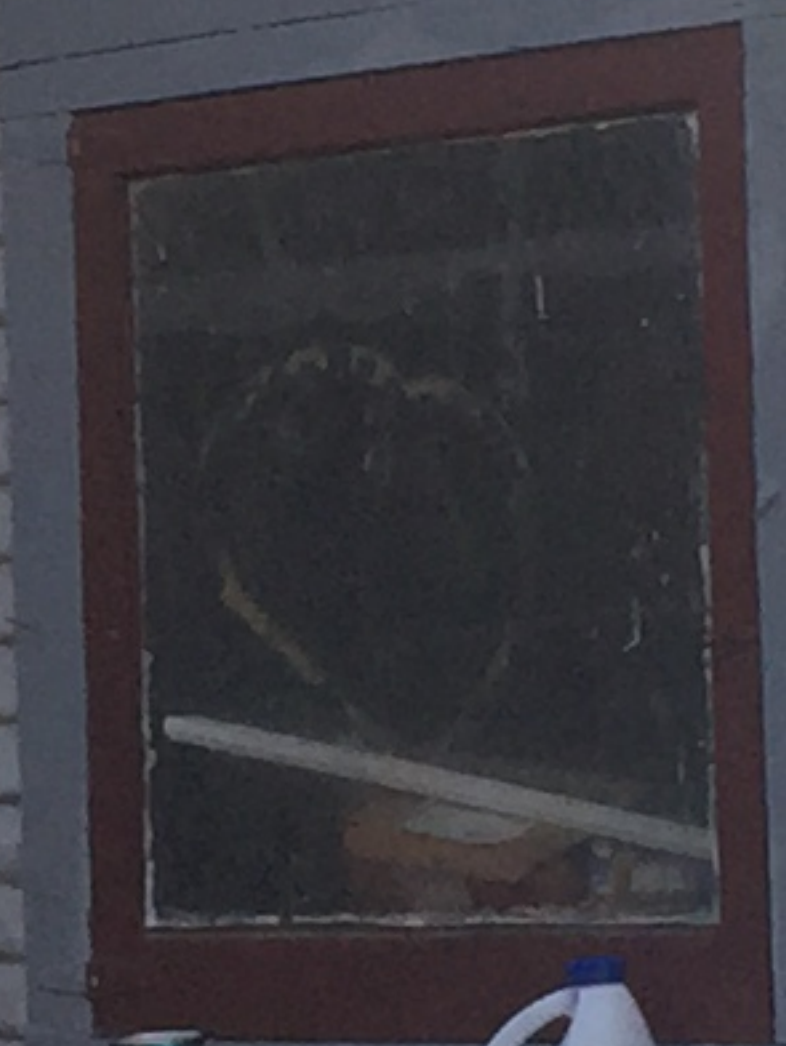
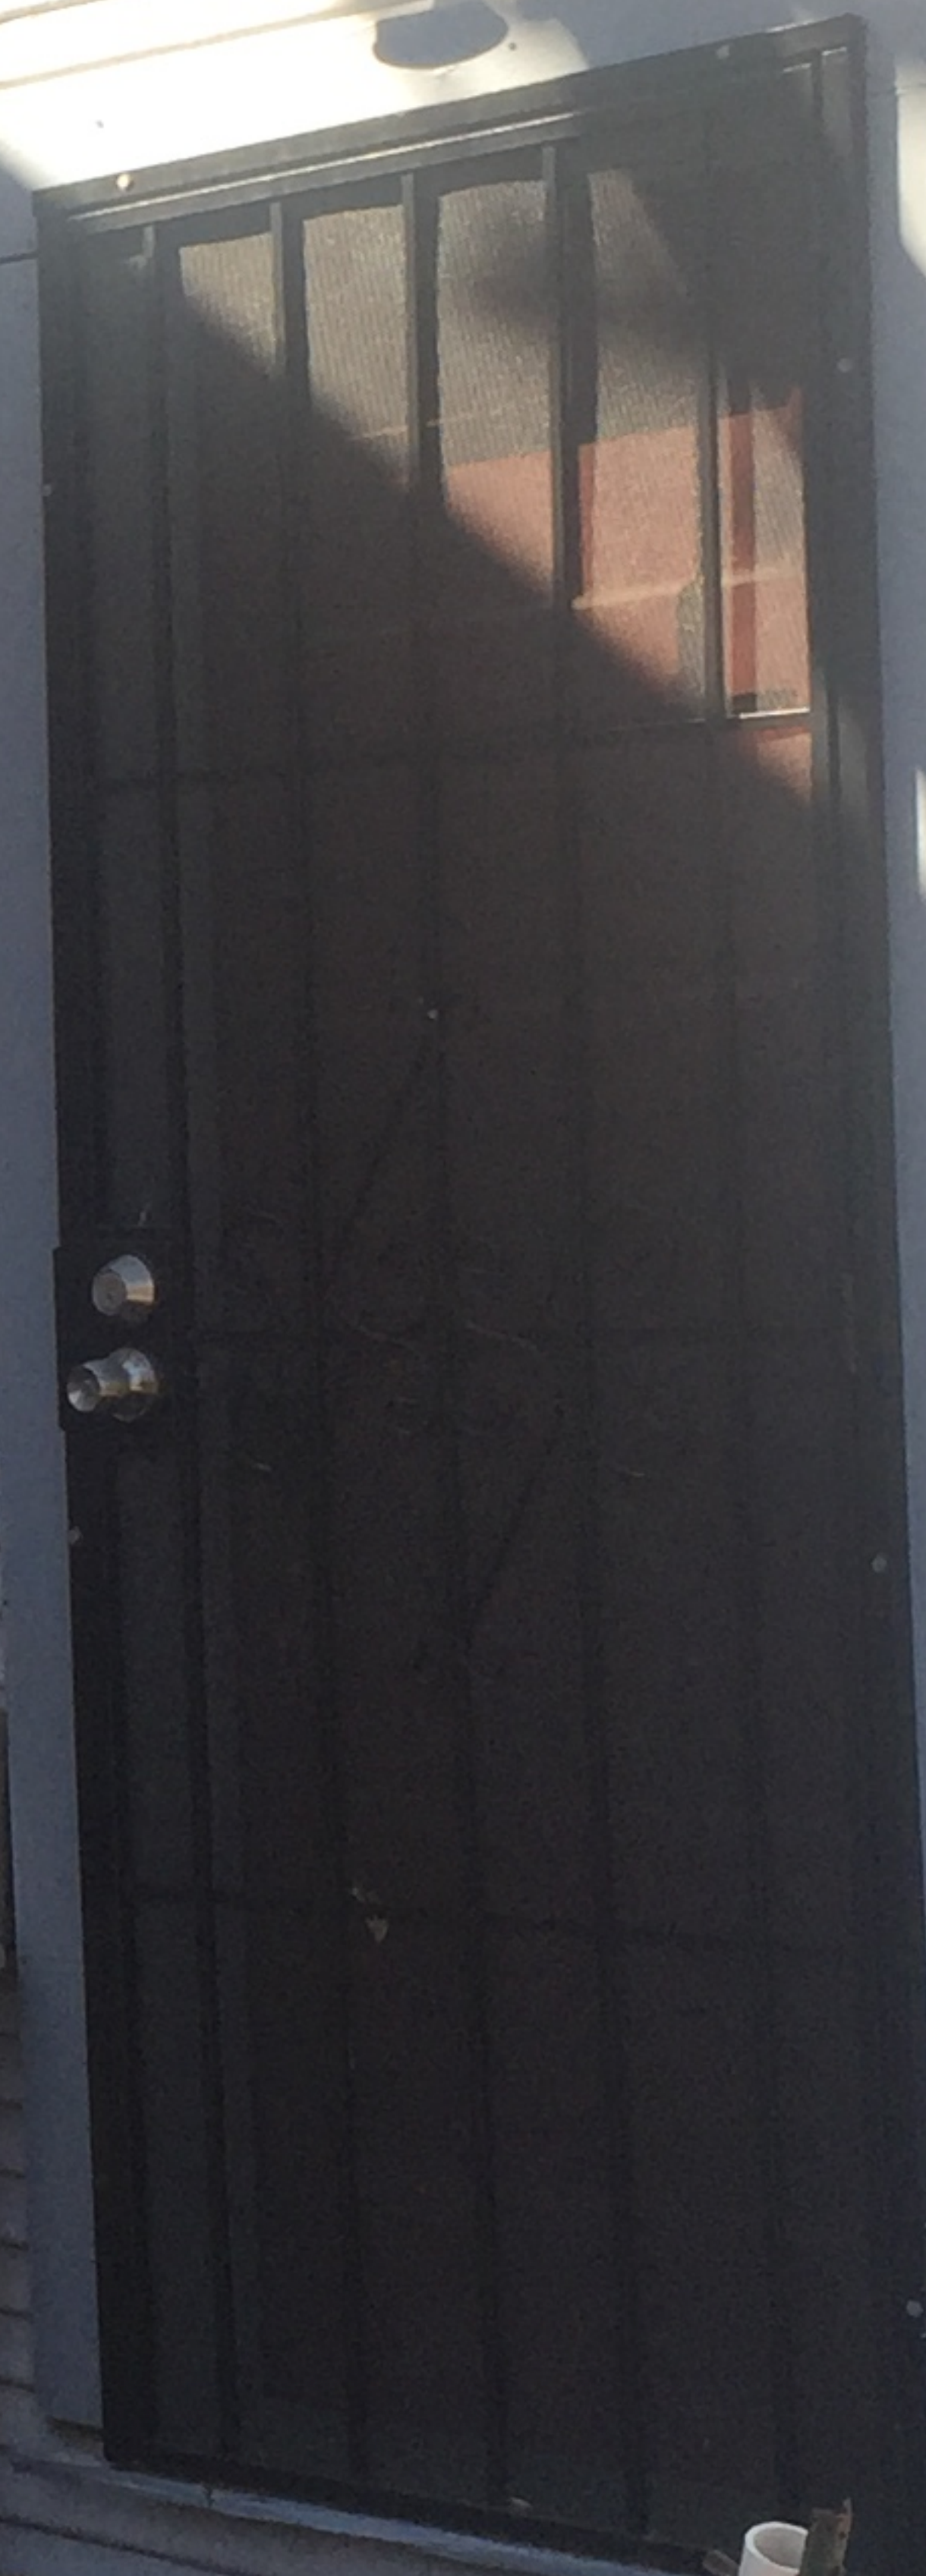
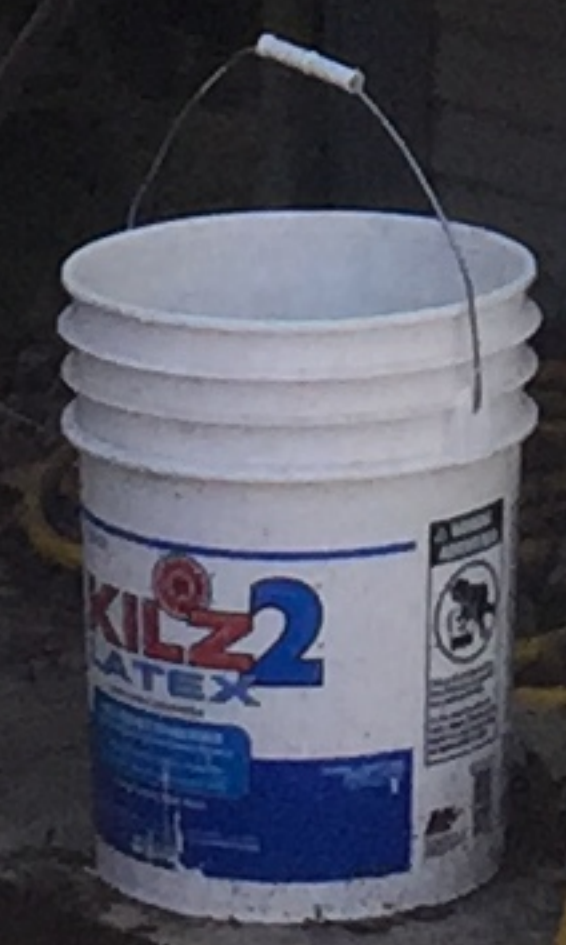
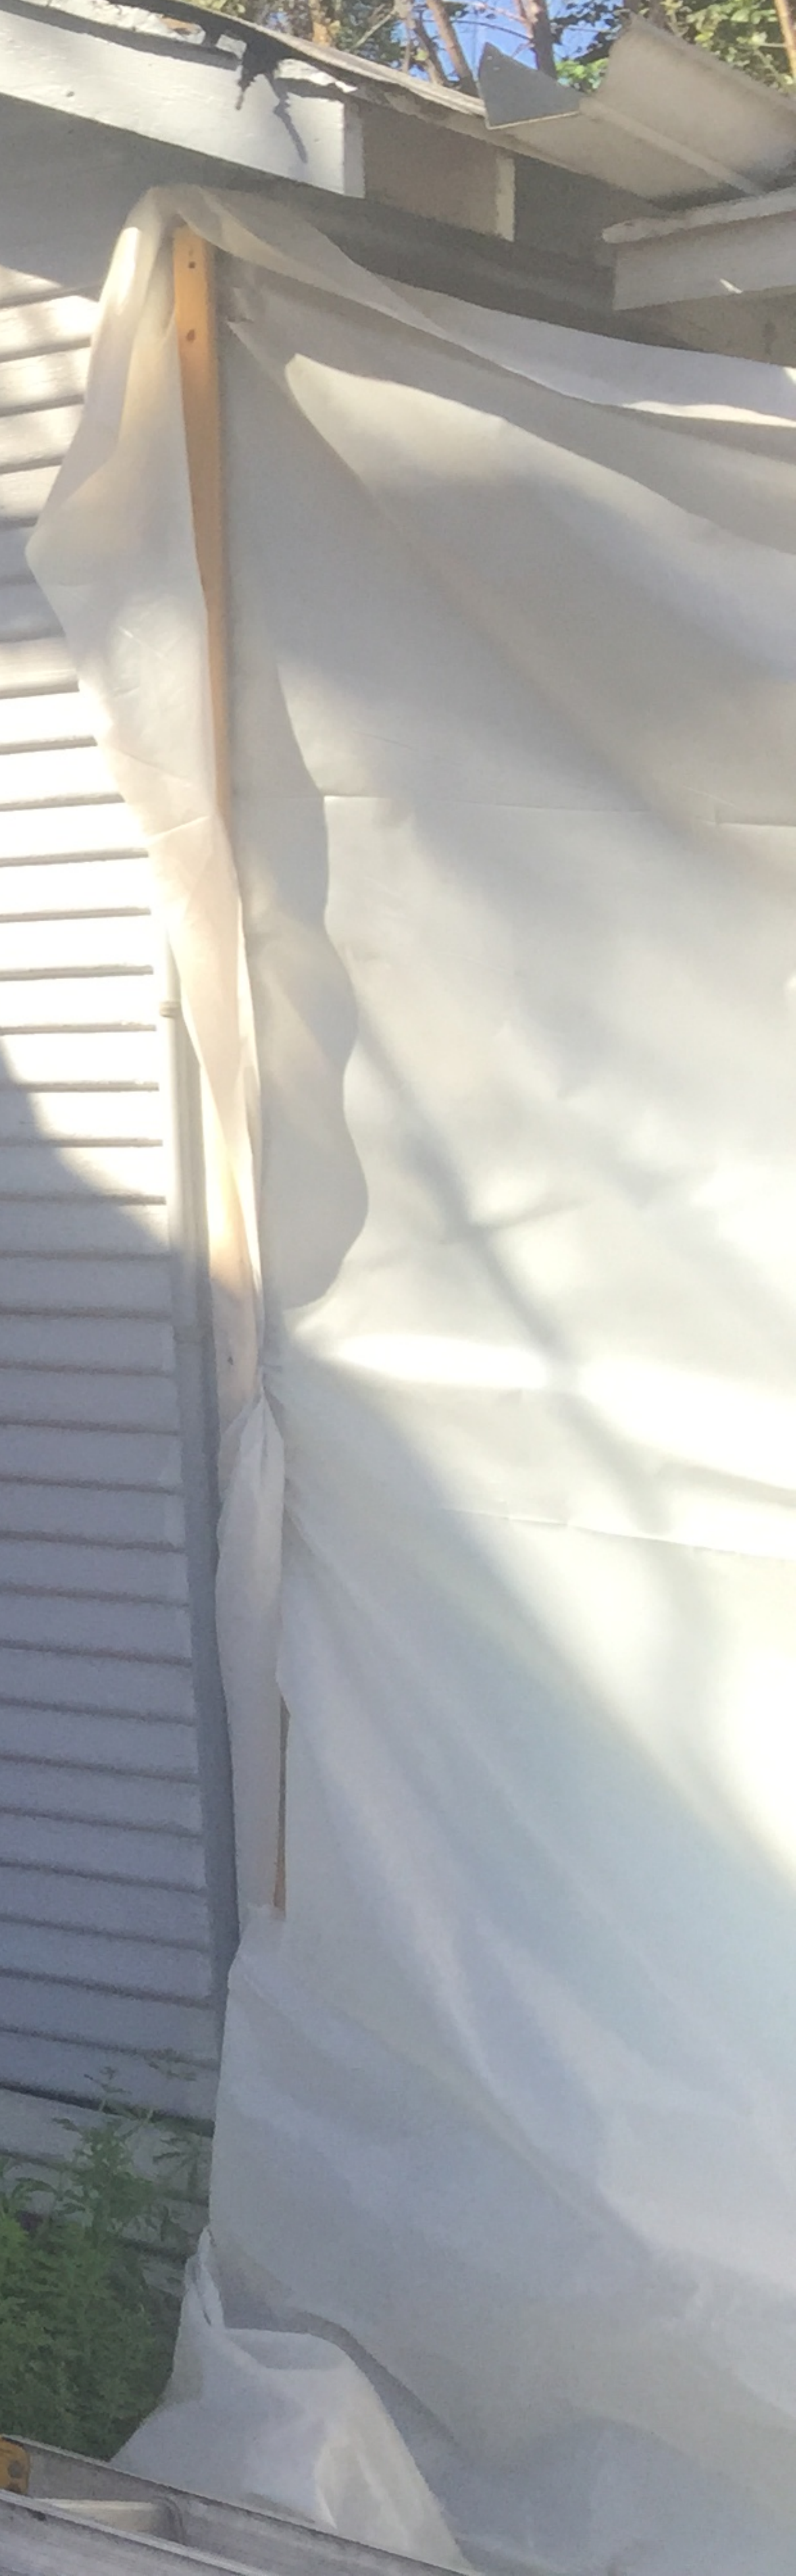
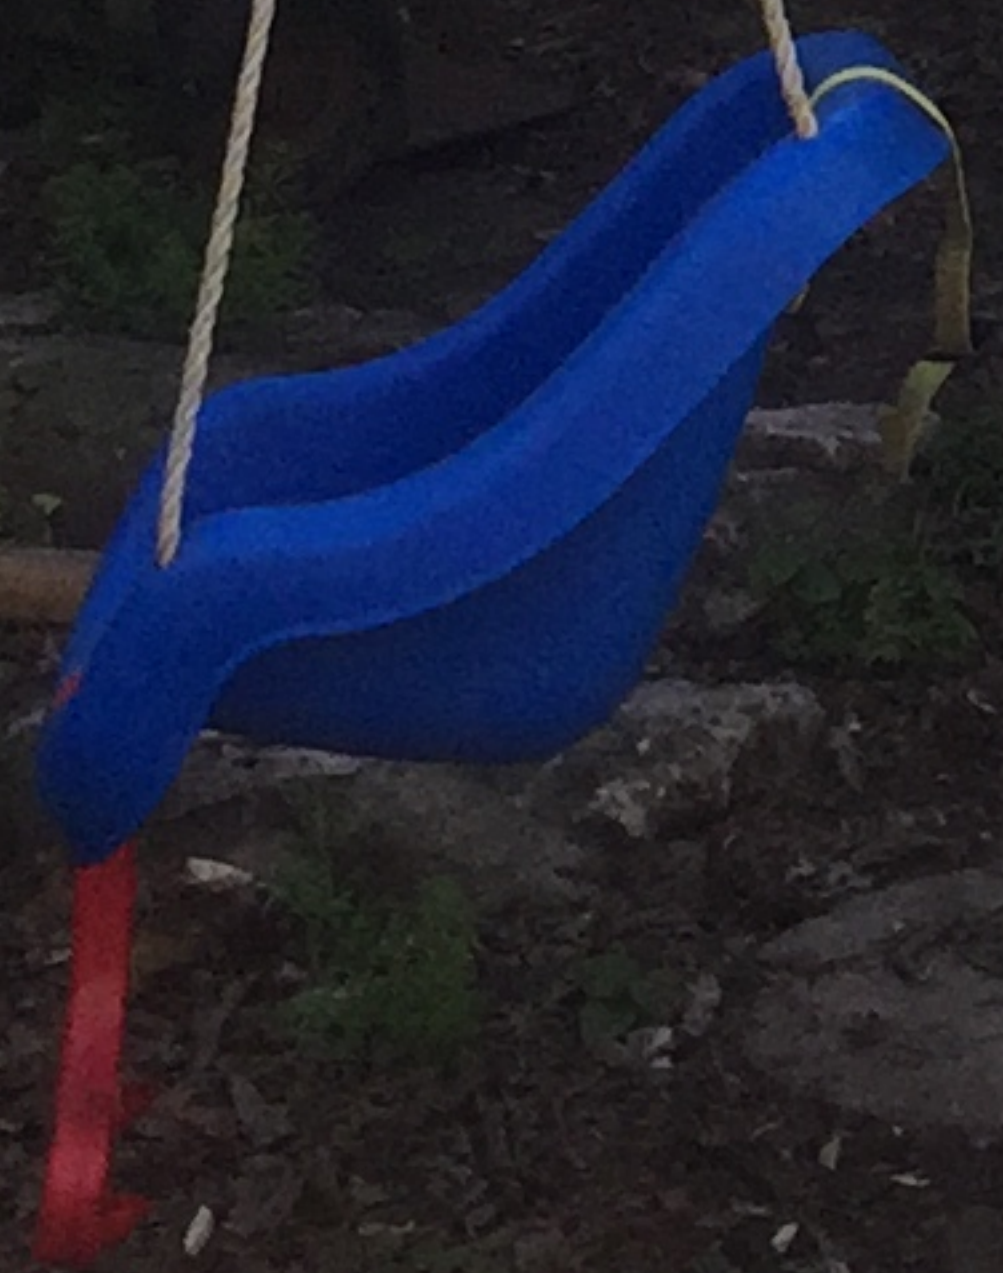
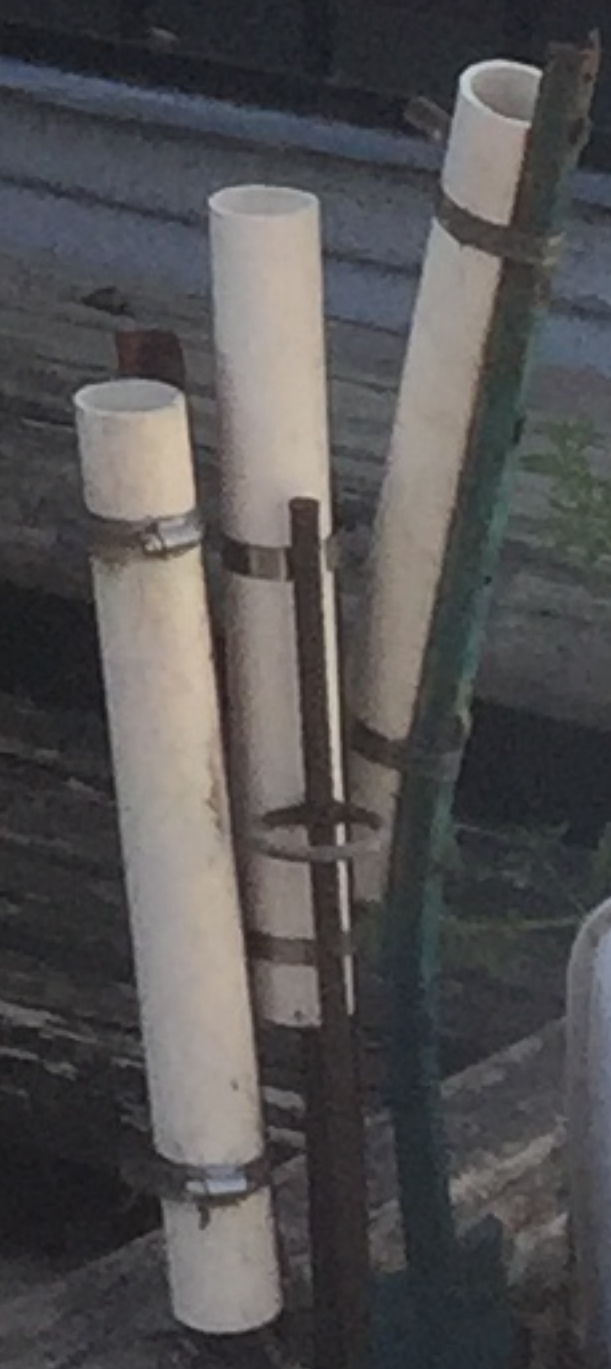
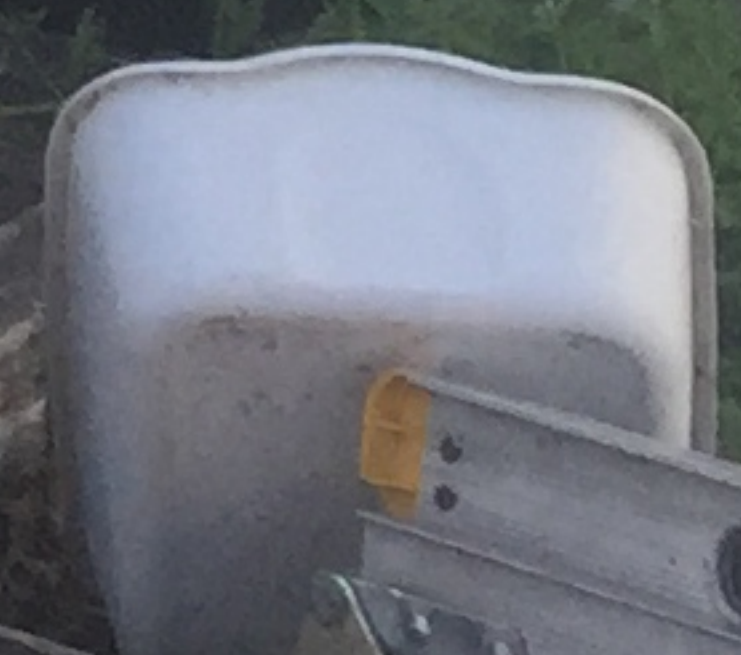
- d. **CHARACTER** – The main structure is a craftsman style house of modest size featuring asbestos siding, a front gabled roof with composition shingles, and a front chimney. The proposed rear accessory structure has a front gable roof, vertical plywood panel, a composition shingle roof, is two-stories, and 400 square feet. The building lacks architectural ornamentation and compatible design elements such as trim, eave, and siding details. According to the Guidelines for New Construction 5.A.iii., new outbuildings should relate to the period of construction of the principal building. The overall design and selected materials are not compatible with the character of the primary structure on the property and are not appropriate.

- f. **WINDOWS/DOORS** – The proposed accessory structure has seven vinyl windows with false dividing lights. According to the Guidelines for New Construction 5.A.v., doors and windows should be similar in proportion and materials as those traditional found in the district. Staff finds the proposed windows are not consistent with the Guidelines. Staff finds wood one over one windows would be appropriate. Additional fenestrations on blank walls would also be more appropriate.

Siding - vertical plywood siding
 Windows - vinyl, false dividing lights, 6 over 6

Staff recommends does not recommend approval based on findings a through f. Staff recommends that the overall design be modified to include architectural features, materials, and fenestrations that are compatible within the historic district.
