HISTORIC AND DESIGN REVIEW COMMISSION

April 05, 2017

HDRC CASE NO: 2017-133
ADDRESS: 222 WICKES
LEGAL DESCRIPTION: NCB 942 BLK 1 LOT W 67.3 FT OF 6 AT 222 WICKES
ZONING: RM-4,HS
CITY COUNCIL DIST.: 1
DISTRICT: King William Historic District
LANDMARK: Rutledge / Ingram House
APPLICANT: Delia Bora
OWNER: Delia Bora
TYPE OF WORK: Replacement of four front windows, front door installation
REQUEST:

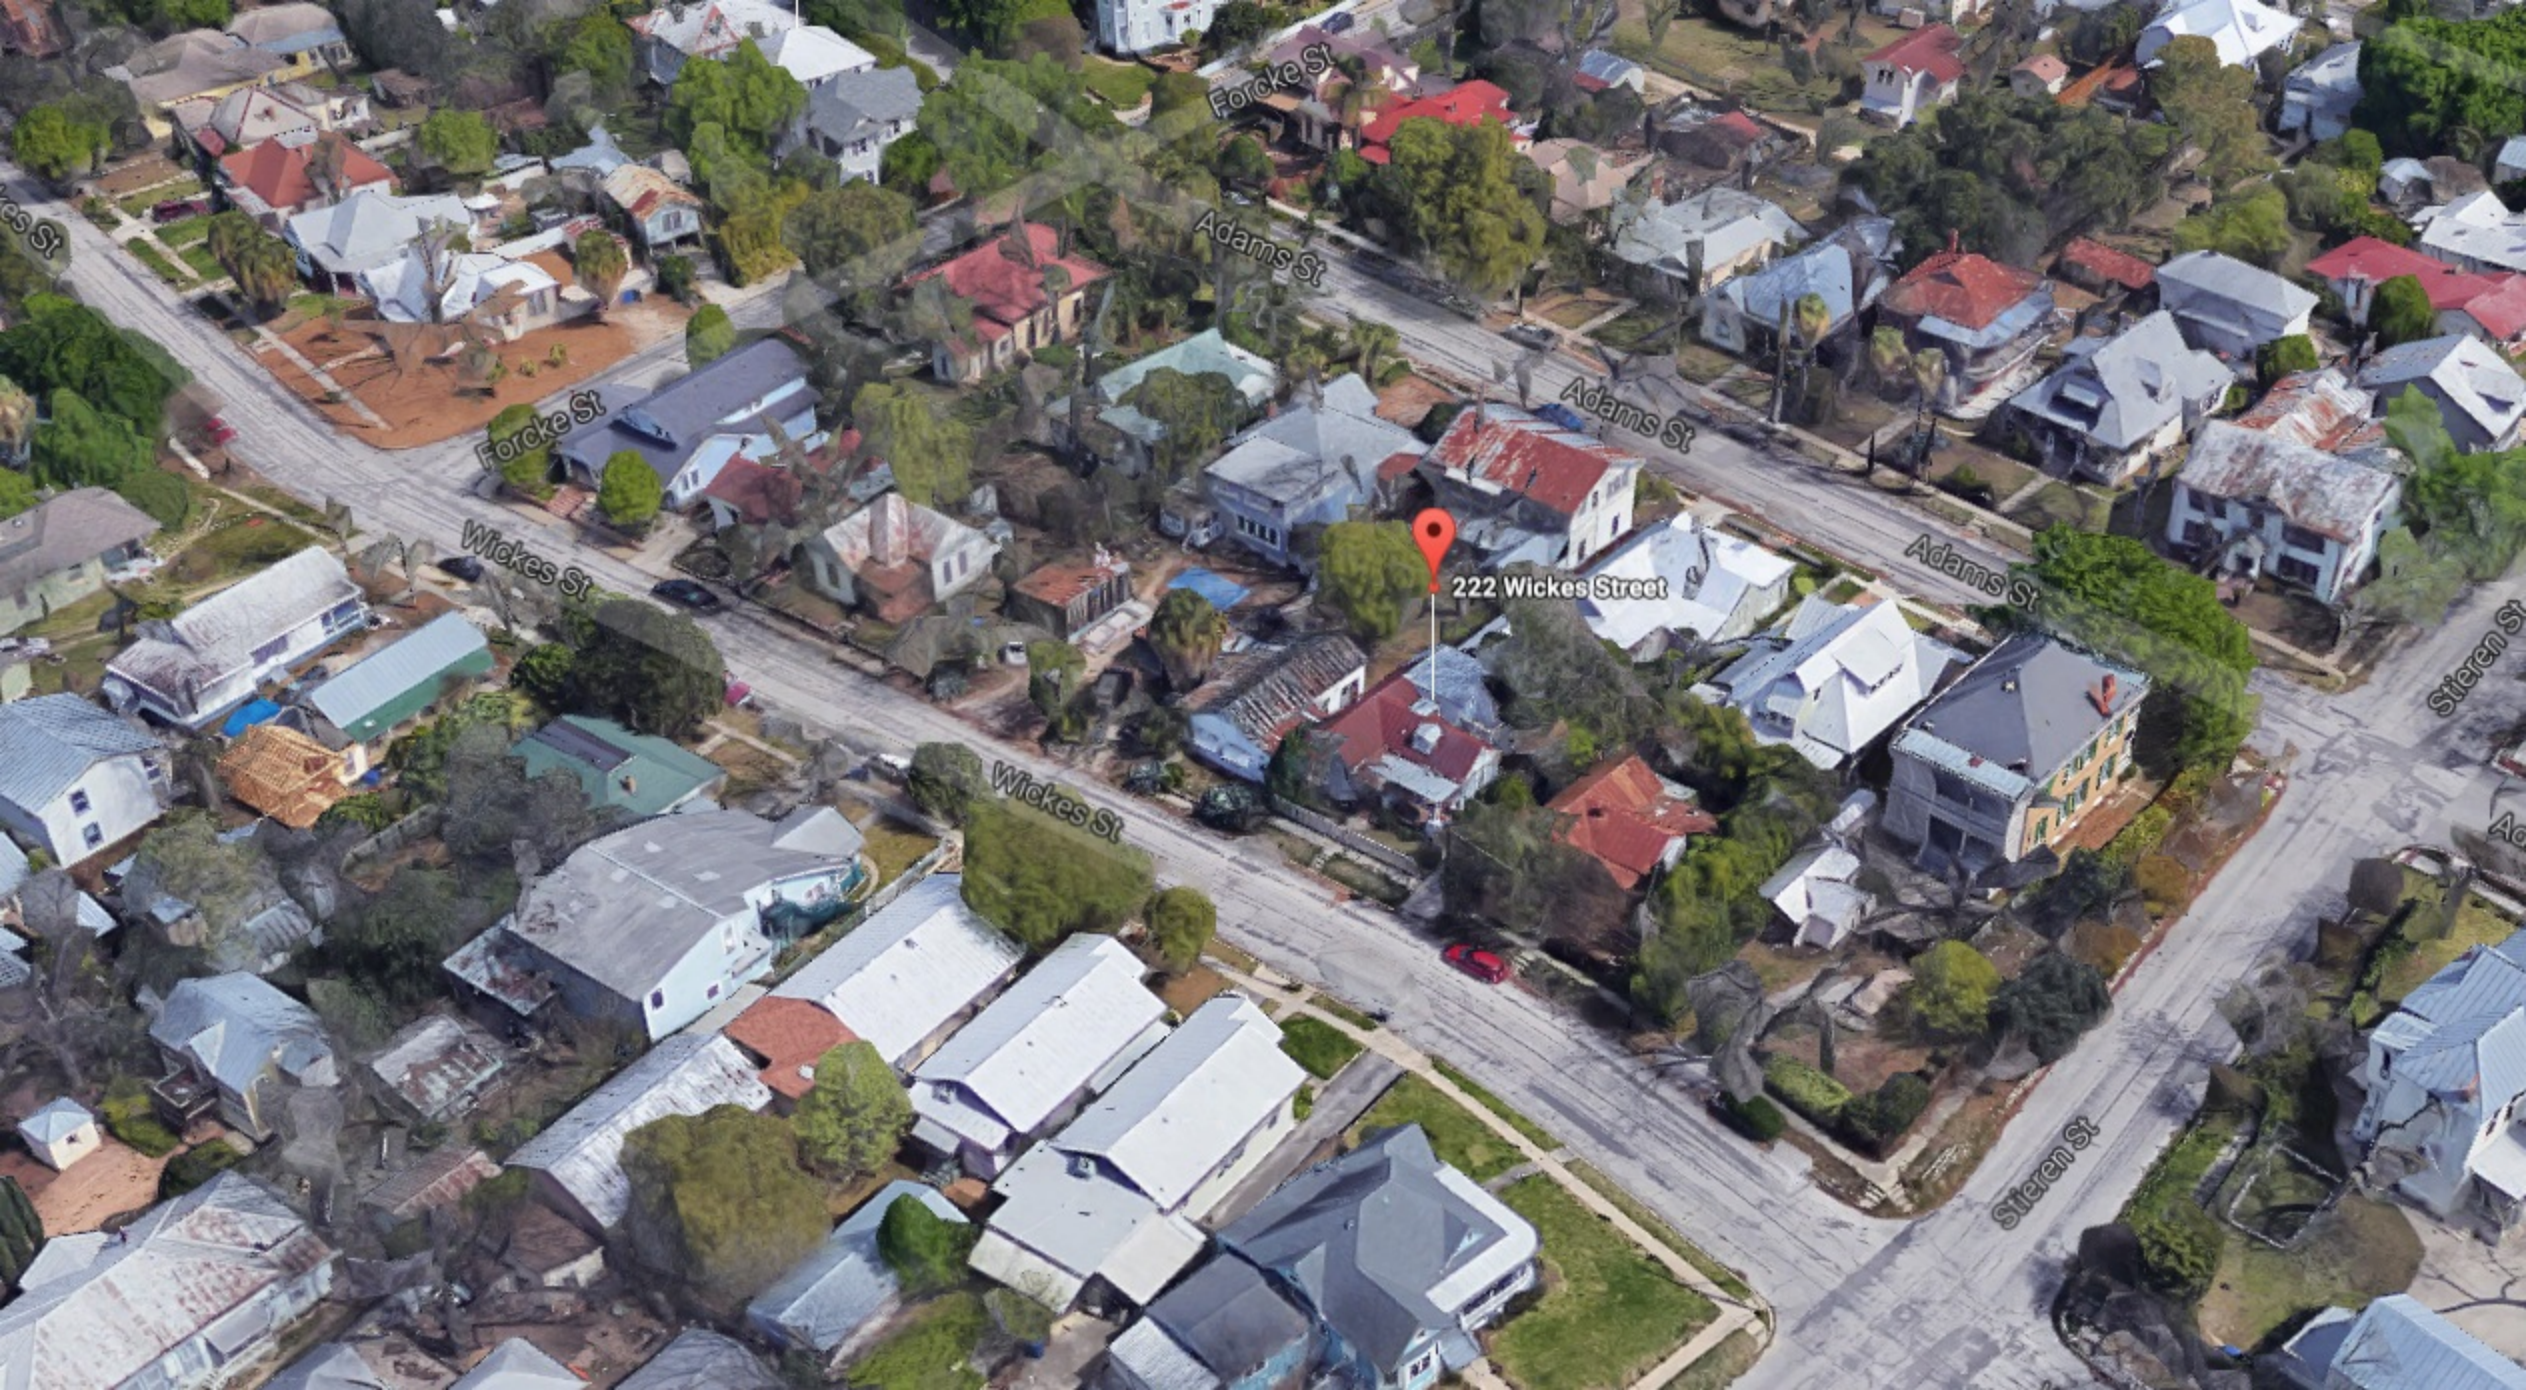
MARCH 2016

- d. PORCH OPENING – Many Folk Victorian houses in San Antonio feature a vernacular design element that includes two front porch door openings, one facing the side yard and the other facing the street. Per a March 2016, photo, a window was located in the side porch opening, which was probably an original door opening. At this time, this opening has been enclosed. The Guidelines for Exterior Maintenance 6.A.i., notes that historic window and door opening should be enclosed. Additionally, the sizes of original window and door openings should be preserved. Staff finds that the existing opening should be restored to a window opening that match those that are on the front facing window bay.
- e. FRONT DOOR – A new front has been installed. Staff finds the new front door to be architecturally appropriate for the historic structure. The door should be painted to match the colors of the house.

Staff does not recommend approval of item #2 based on finding c. Staff recommends that the opening be restored to its previous size and a window be installed that matches the 4 front window in regards to size, material and profile.

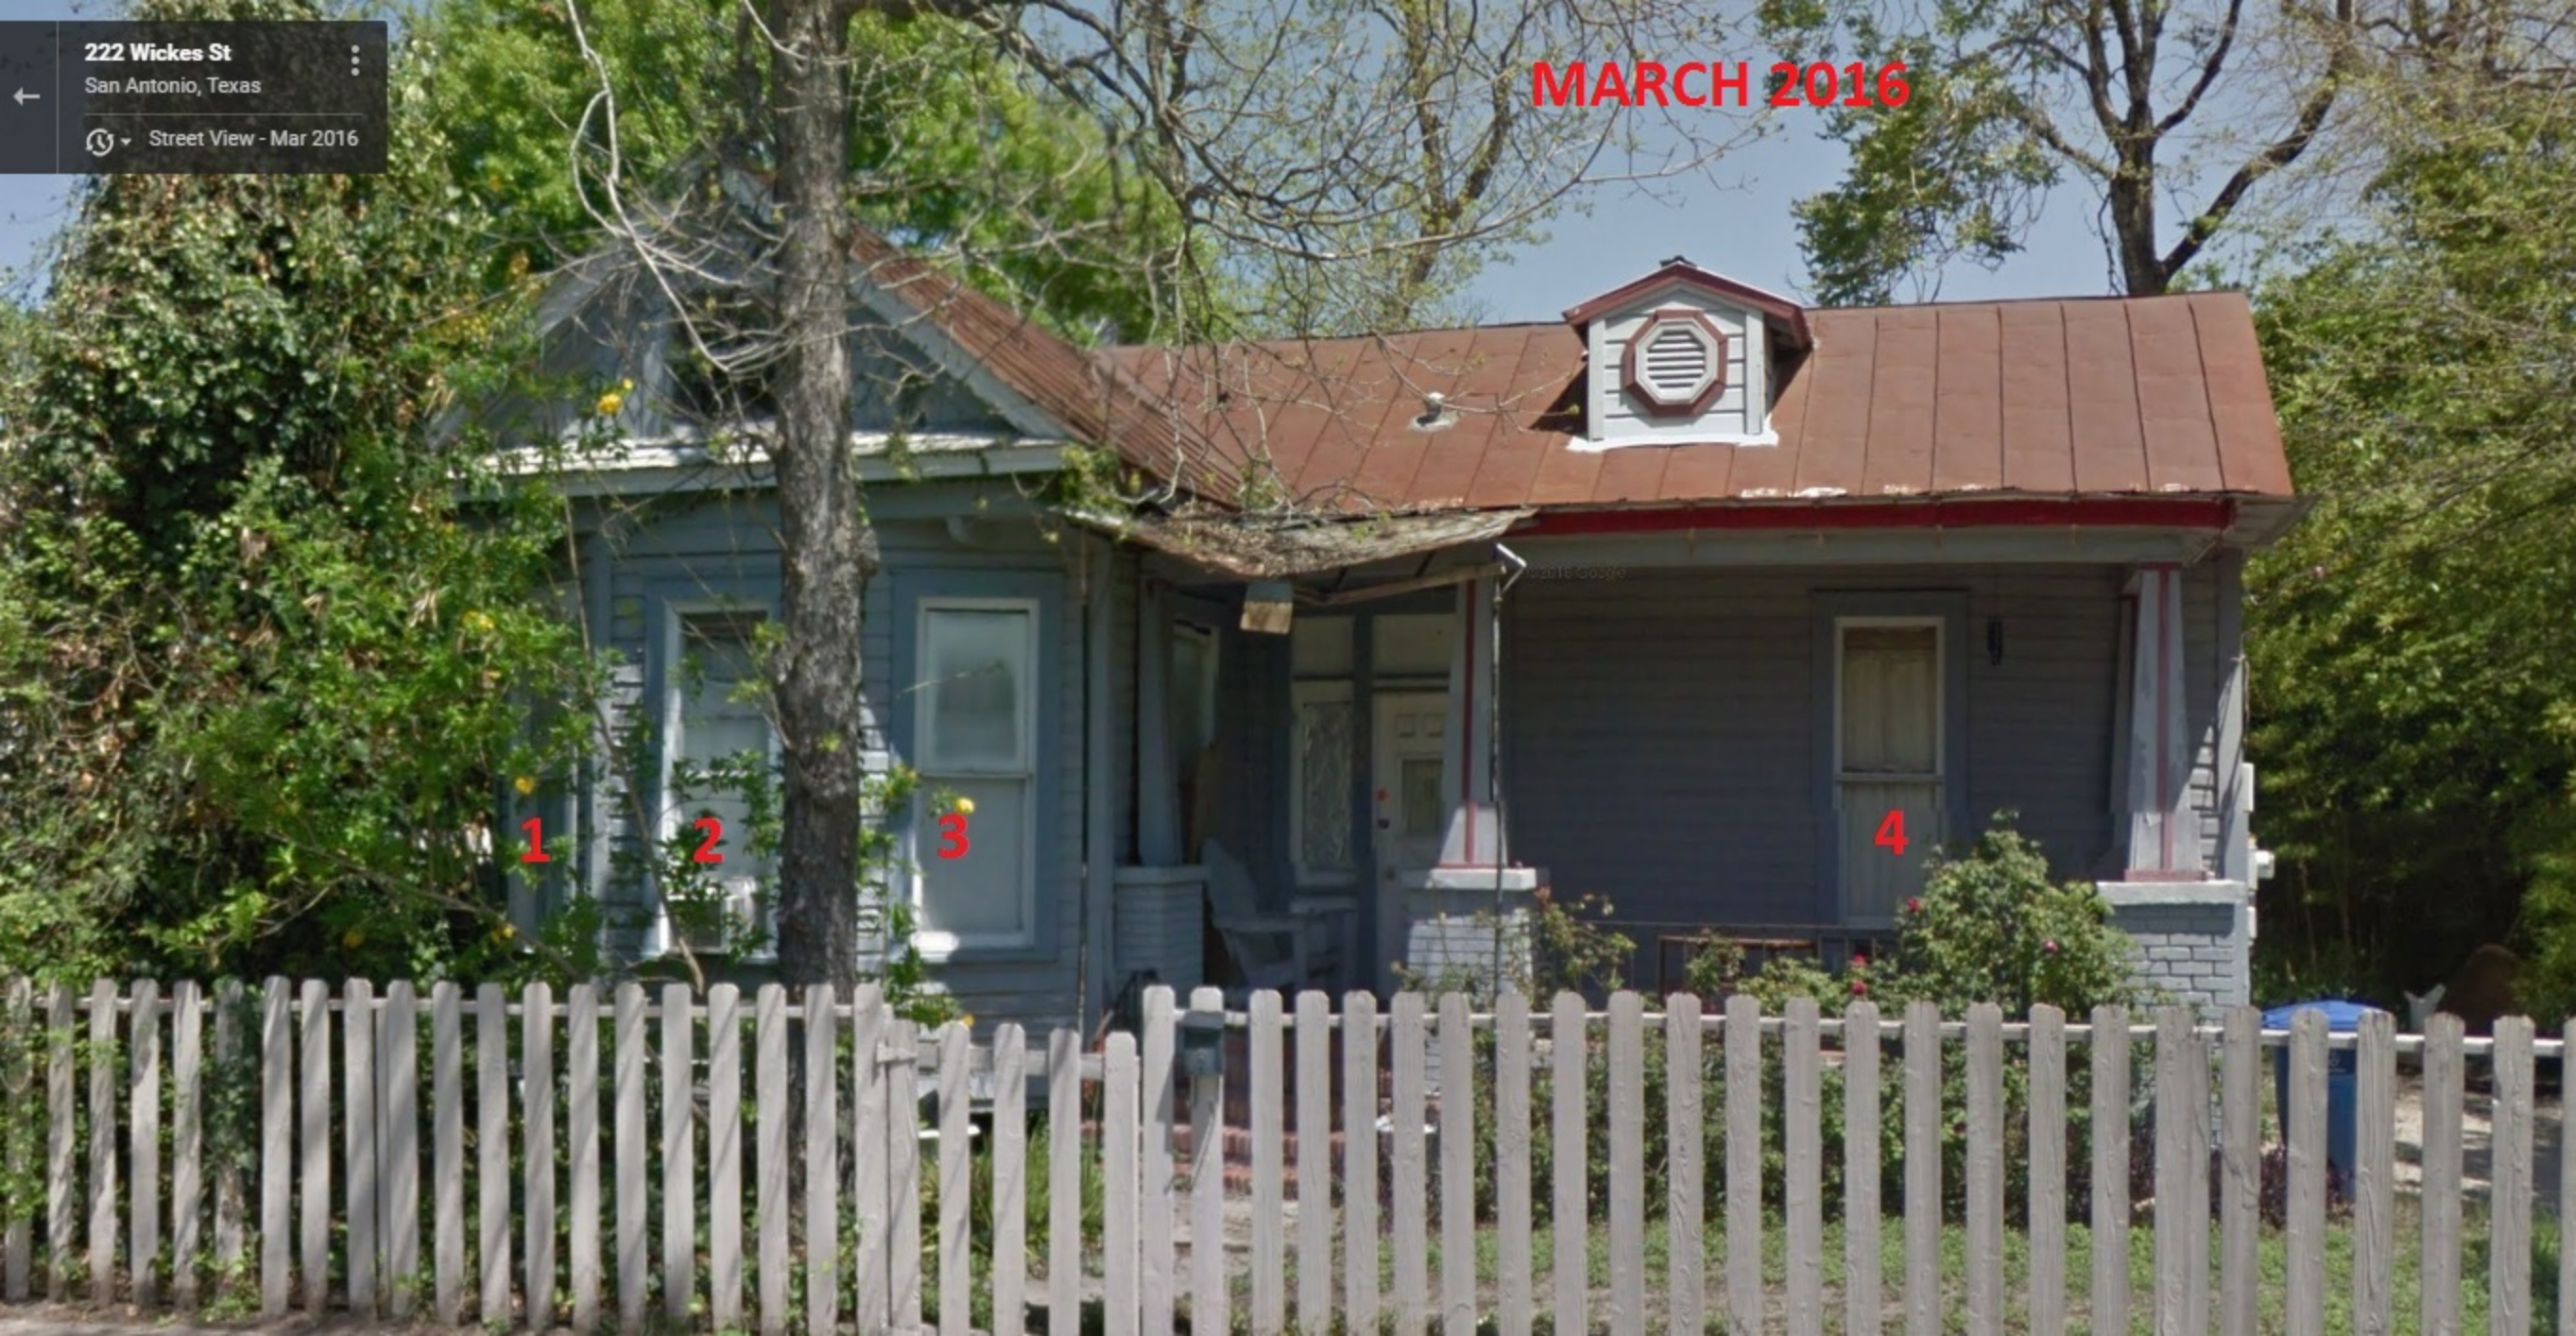
MARCH 2016

ENCLOSED WINDOW OPENING

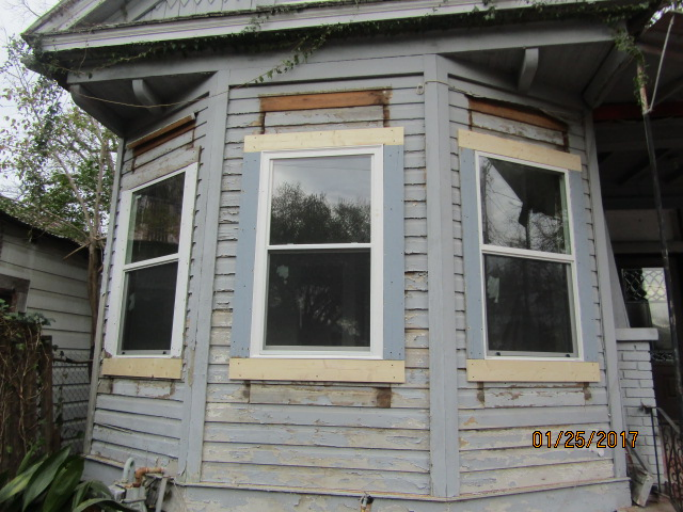
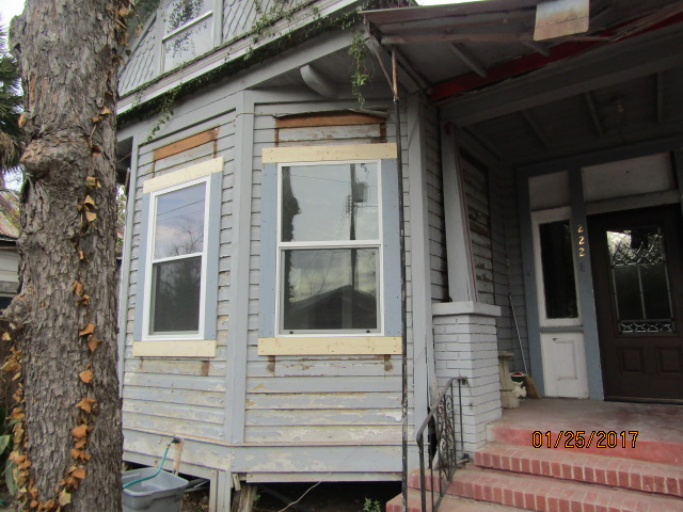
01/25/2017

- b. At the January 25, 2017, site visit, staff informed the applicant that the original windows that had been removed were to be maintained on site, repaired and reinstalled into the historic structure.

Staff recommends approval of item #1 based on finding b with the stipulation that the historic window openings should not be modified to accommodate a contemporary window size. Additionally, the proposed replacement windows are to include traditional dimensions and profiles, be recessed within the window frame, feature traditional materials or appearance and feature traditional trim and sill details.

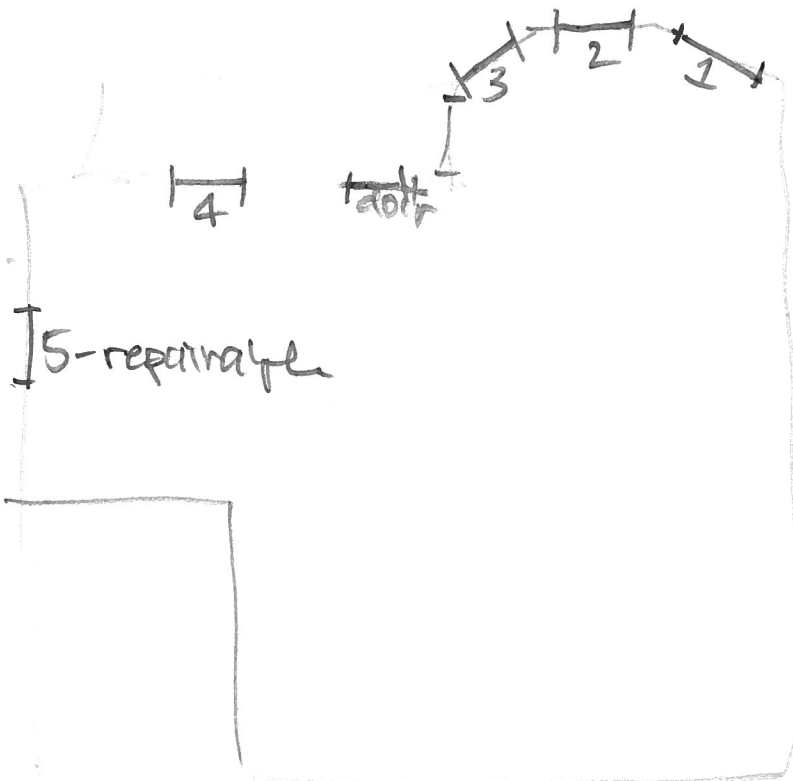
7 through 4 to
be replaced
