HISTORIC AND DESIGN REVIEW COMMISSION May 03, 2017

HDRC CASE NO: 2017-192 1025 DAWSON ST **ADDRESS:** NCB 2872 BLK N LOT 6 **LEGAL DESCRIPTION: ZONING:** R-6 H **CITY COUNCIL DIST.:** 2 **Dignowity Hill Historic District DISTRICT: Richard Gross APPLICANT: OWNER: Enrlour** Investments Fenestration modifications, wood window replacement **TYPE OF WORK:**

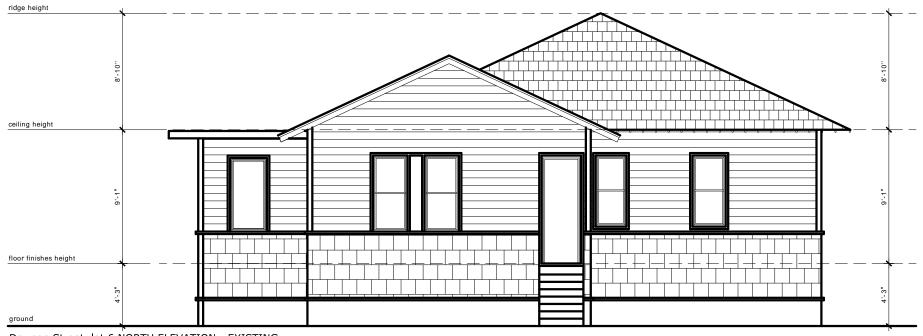
Dawson Street, lot 6 NORTH ELEVATION - EXISTING

- b. REAR FAÇADE MODIFICATIONS– On the rear façade, the applicant has proposed to modify an existing door and window opening. The proposed modification is to occur on the rear façade of the original structure. Per the Guidelines for Exterior Maintenance and Alterations 6.A.1., historic window and door openings are to be preserved and should not be enlarged or diminished. The proposed modifications are not consistent with the Guidelines.

Staff does not recommend approval of items #1 and #2 based on findings b and e. Staff recommends the applicant maintain the rear façade arrangement and repair the existing windows.
