# HISTORIC AND DESIGN REVIEW COMMISSION

May 17, 2017

**HDRC CASE NO:** 2017-207  
**ADDRESS:** 325 W MISTLETOE  
**LEGAL DESCRIPTION:** NCB 1834 BLK 9 LOT 16  
**ZONING:** R-4 H  
**CITY COUNCIL DIST.:** 1  
**DISTRICT:** Monte Vista Historic District  
**APPLICANT:** Tyler Sibley/Pursuant Ventures  
**OWNER:** Tyler Sibley/Pursuant Ventures  
**TYPE OF WORK:** Fenestration modifications  
**REQUEST:**

The applicant is requesting a Certificate of Appropriateness for approval to remove and replace an original 6 over 1 window on the primary façade with a new 1 over 1 window.

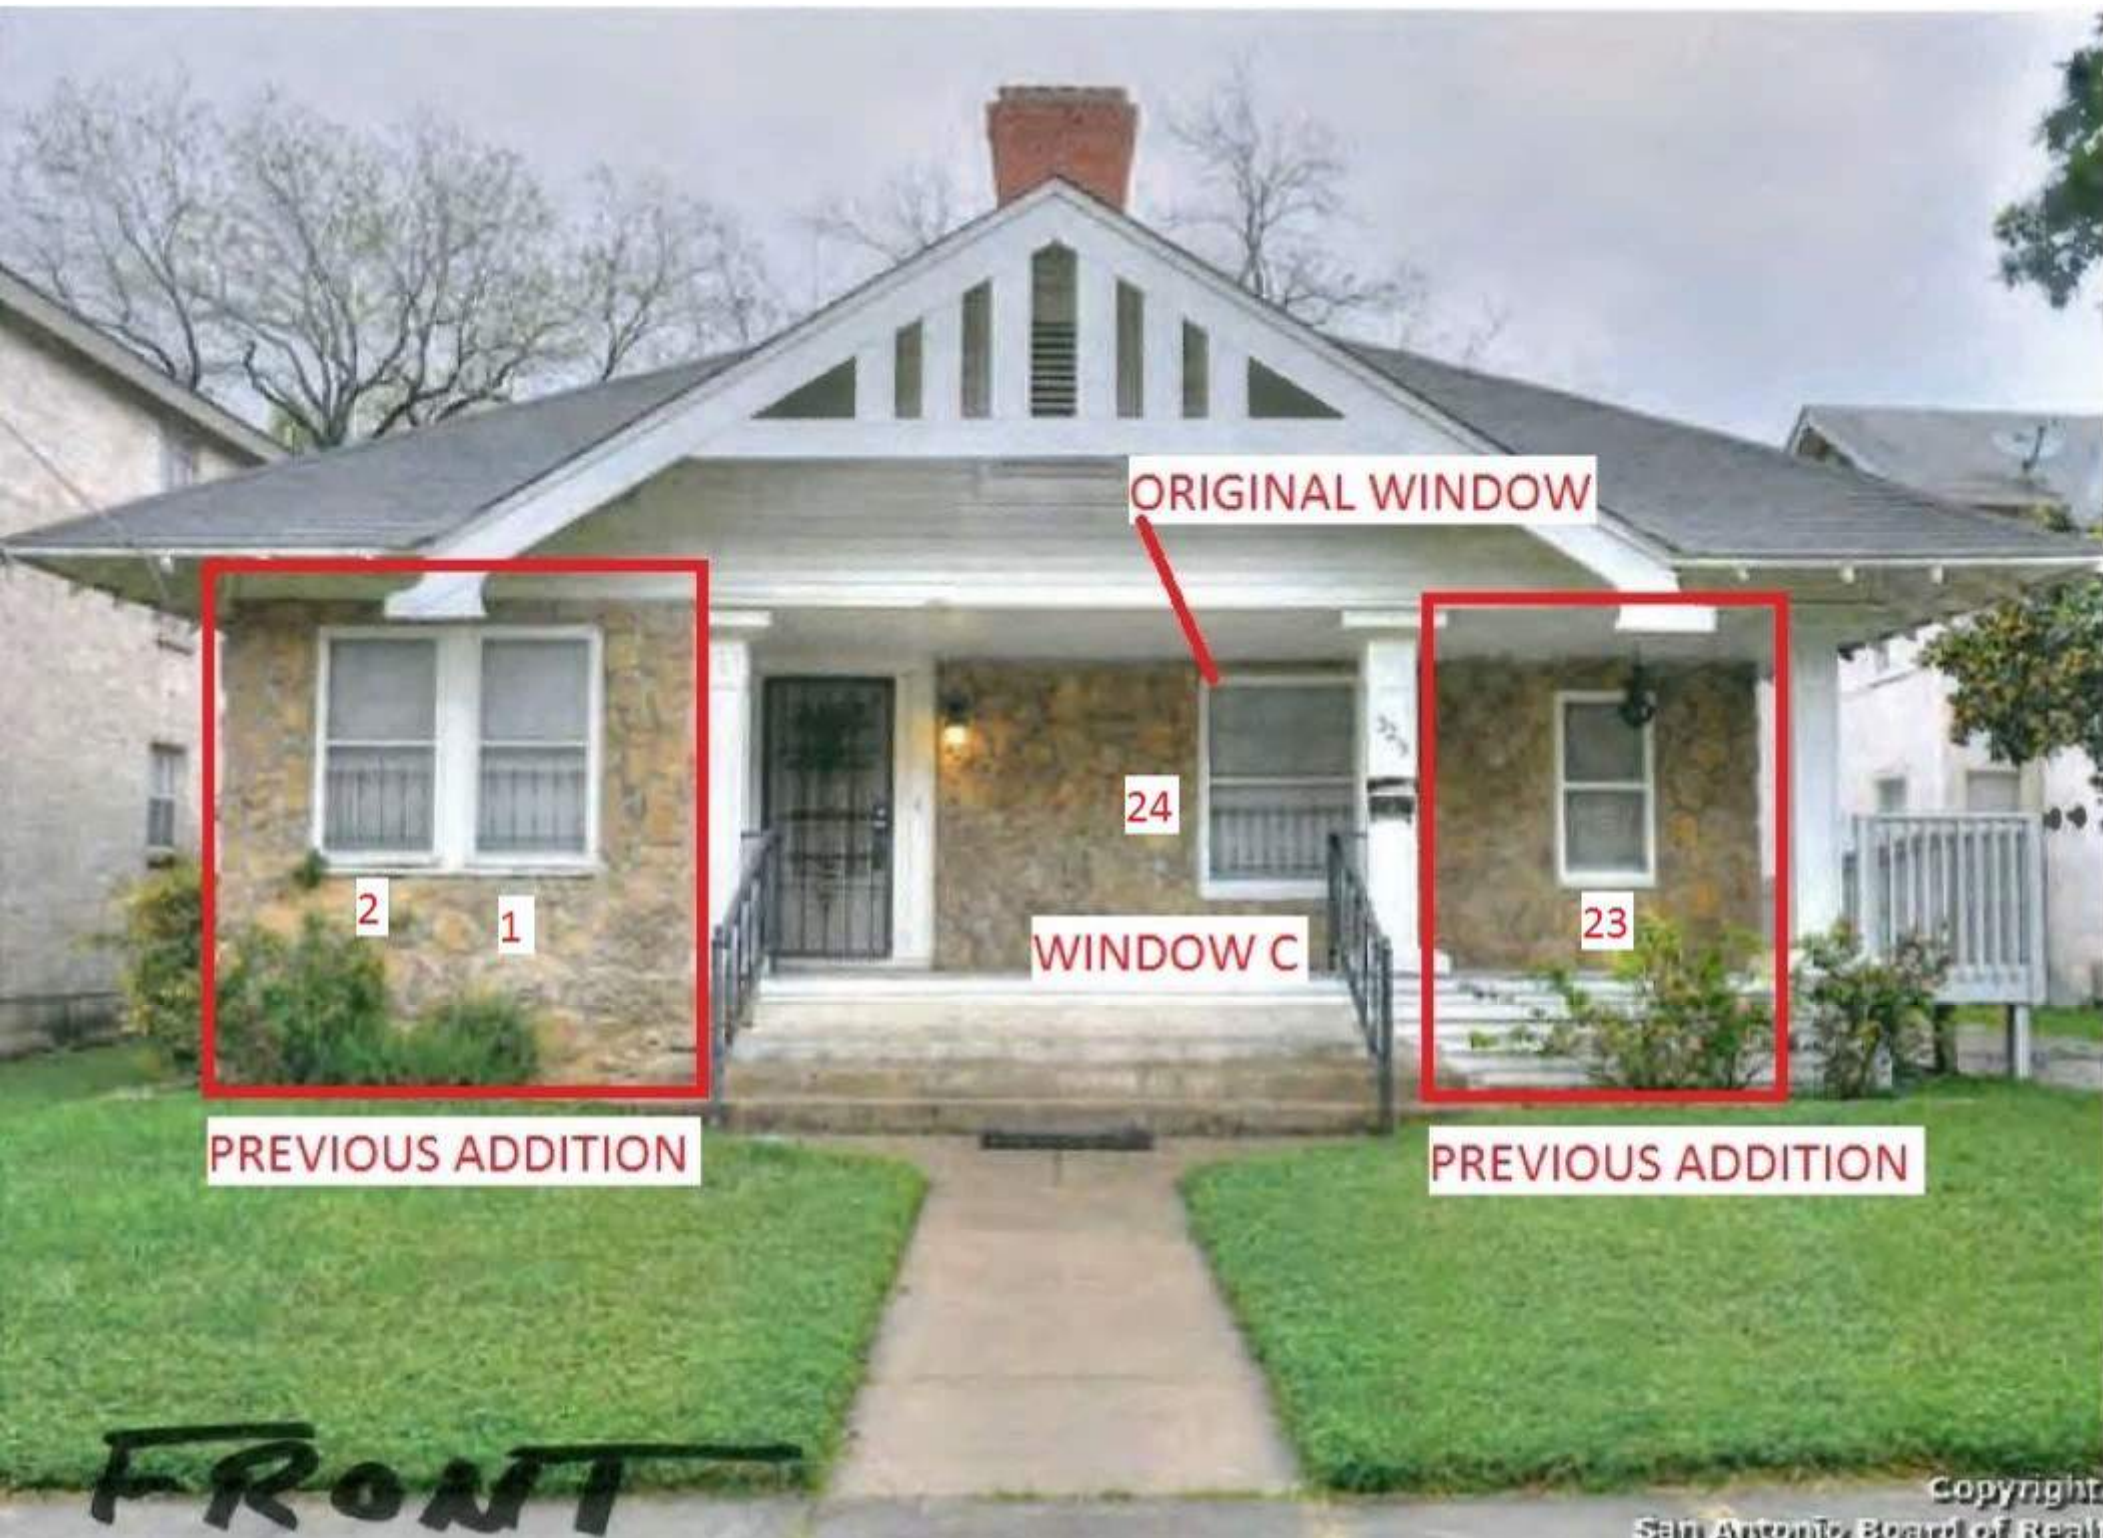
ORIGINAL WINDOW

- b. WINDOW REMOVAL – The original 6 over 1 window, located directly to the right of the property's main entrance, has been removed and replaced without approval. Administrative approval was granted to repair the original window on August 12, 2016. According to the Guidelines for Exterior Maintenance and Alterations, historic windows should be preserved unless deteriorated beyond repair. The proposed removal and reuse of the 6 over 1 window is not appropriate.

- Staff conducted a site visit on February 18, 2017, and noted that the window had already been removed and replaced without approval.
- The applicant requested Historic Tax Certification (case no. 2016-483) and was heard by the HDRC on December 7, 2017. The requirements for Historic Tax Certification outlined in UDC Section 35-618 were met and the application was approved as submitted. Approval of Historic Tax Verification is contingent on consistency with all approvals and permits. Currently, the property is in violation and is not eligible to receive the incentive.

Staff does not recommend approval of the window removal based on findings a through c.

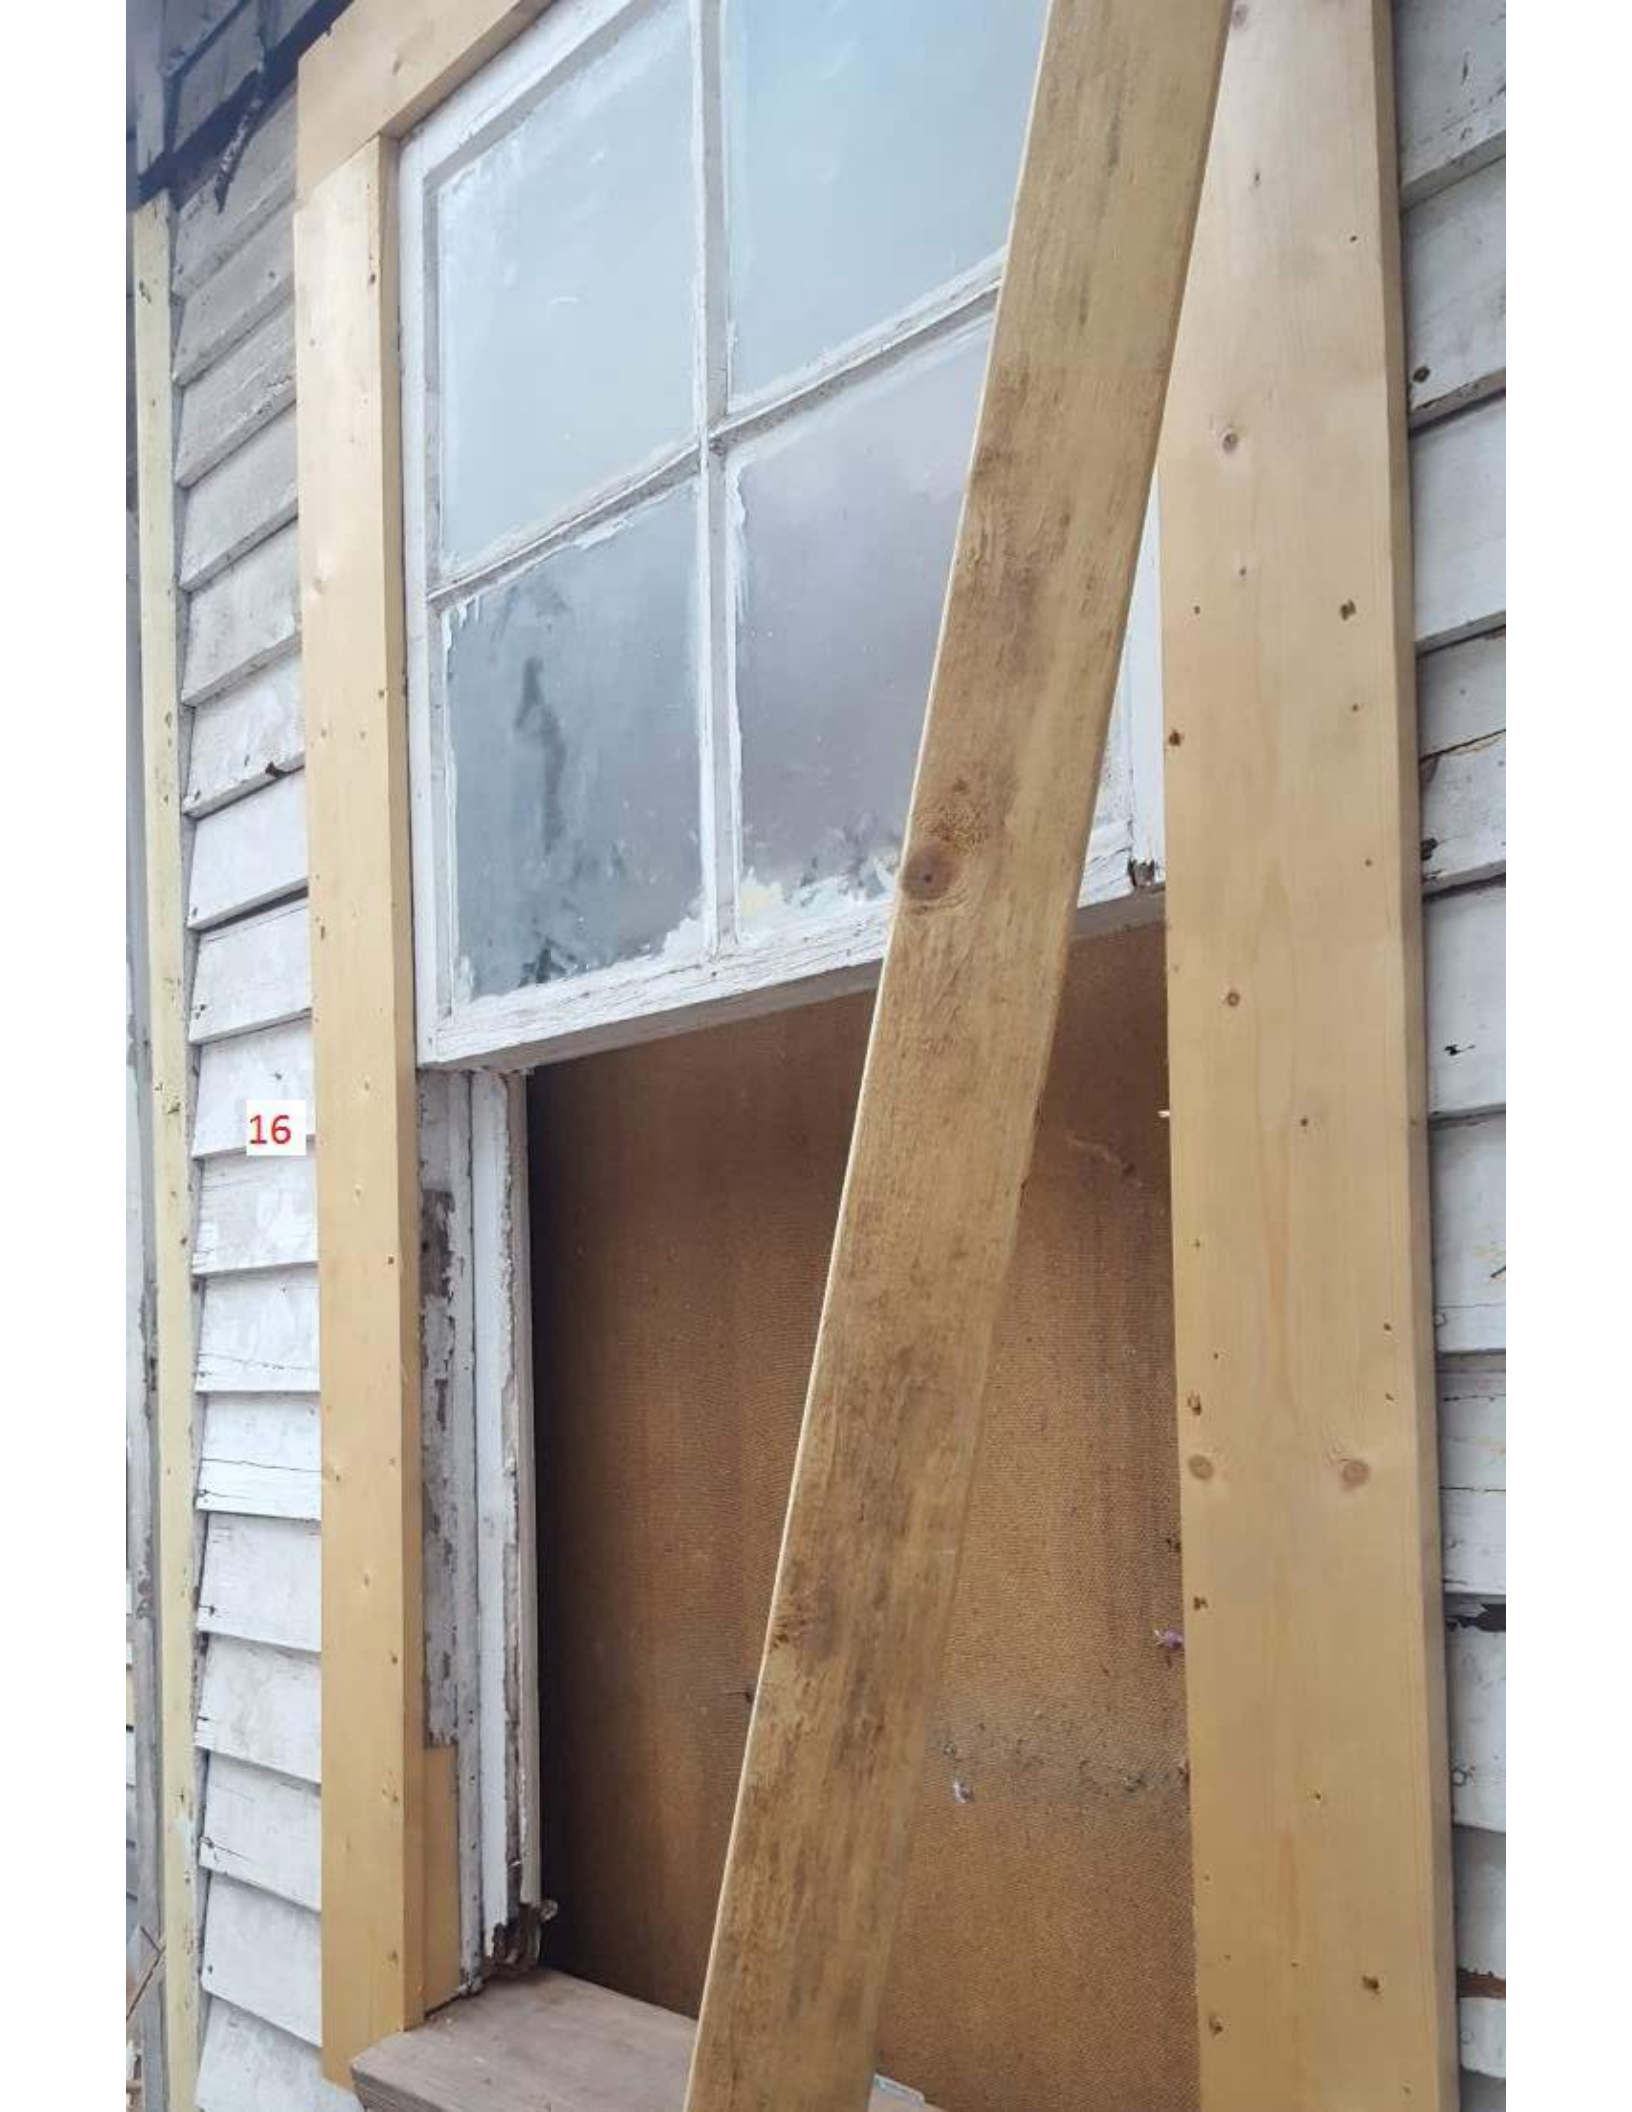
| window | existing condition | proposed |
|---|---|---|
| 16 | original 4 over 1 | To remain and repair - approved administratively |
