HISTORIC AND DESIGN REVIEW COMMISSION

June 07, 2017

HDRC CASE NO: 2017-266
ADDRESS: 458 FURR DR
LEGAL DESCRIPTION: NCB 6696 BLK 5 LOT 22 W 25 FT OF 23 E 25 FT OF 21
ZONING: R-6 H
CITY COUNCIL DIST.: 7
DISTRICT: Monticello Park Historic District
APPLICANT: David and Lydia Lerma
OWNER: David and Lydia Lerma
TYPE OF WORK: Window replacement
REQUEST:

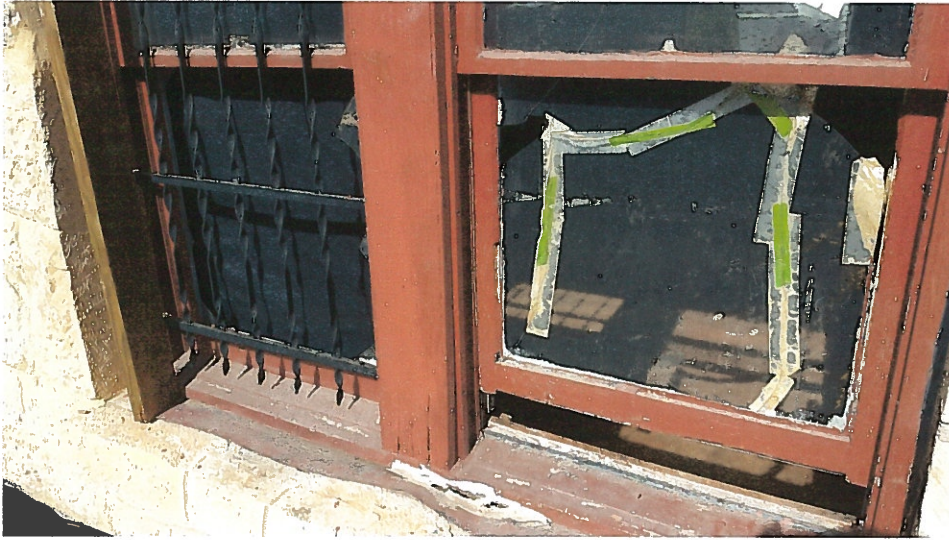
South - 2d FLOOR

2. Four (4) windows in bedroom #1 (child's room) located on the second floor: They are missing counter balance weights and wood bottom rails, all are double hung windows. They are a hazard and in unsafe condition, if you were to raise anyone of these windows, they could fall injuring our child or worse.

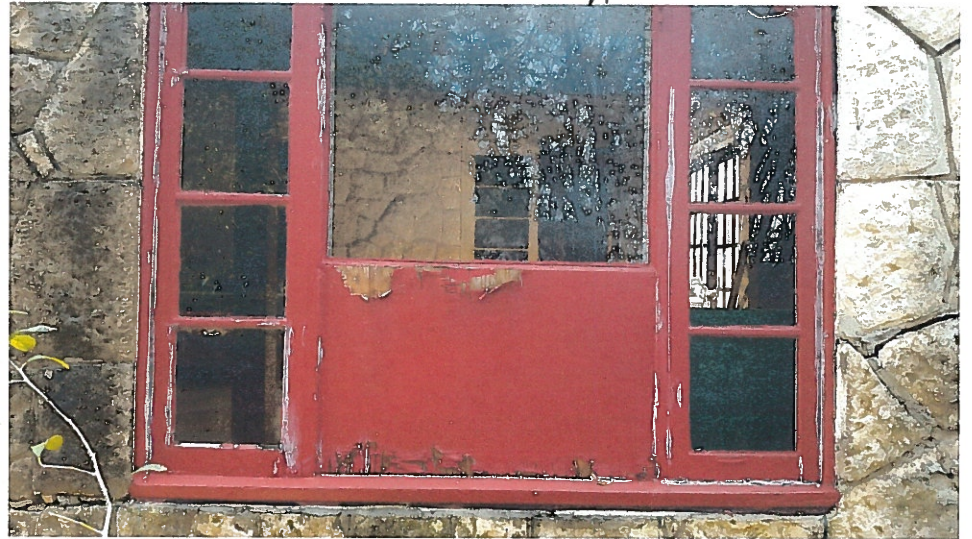
WEST - GAME/POOL ROOM

1. Three (3) windows located on the first level of the home in the game/pool room: are so dilapidated that the wood has deteriorated to the point that they are falling apart, and there is no way of salvaging them as they are unsound.
