# HISTORIC AND DESIGN REVIEW COMMISSION

July 19, 2017

**HDRC CASE NO:** 2017-207  
**ADDRESS:** 325 W MISTLETOE  
**LEGAL DESCRIPTION:** NCB 1834 BLK 9 LOT 16 R-4  
**ZONING:** R-4 H  
**CITY COUNCIL DIST.:** Monte Vista Historic District  
**DISTRICT:** Tyler Sibley/Pursuant Ventures  
**APPLICANT:** Tyler Sibley/Pursuant Ventures  
**OWNER:** Window modifications  
**TYPE OF WORK:**  
**REQUEST:**

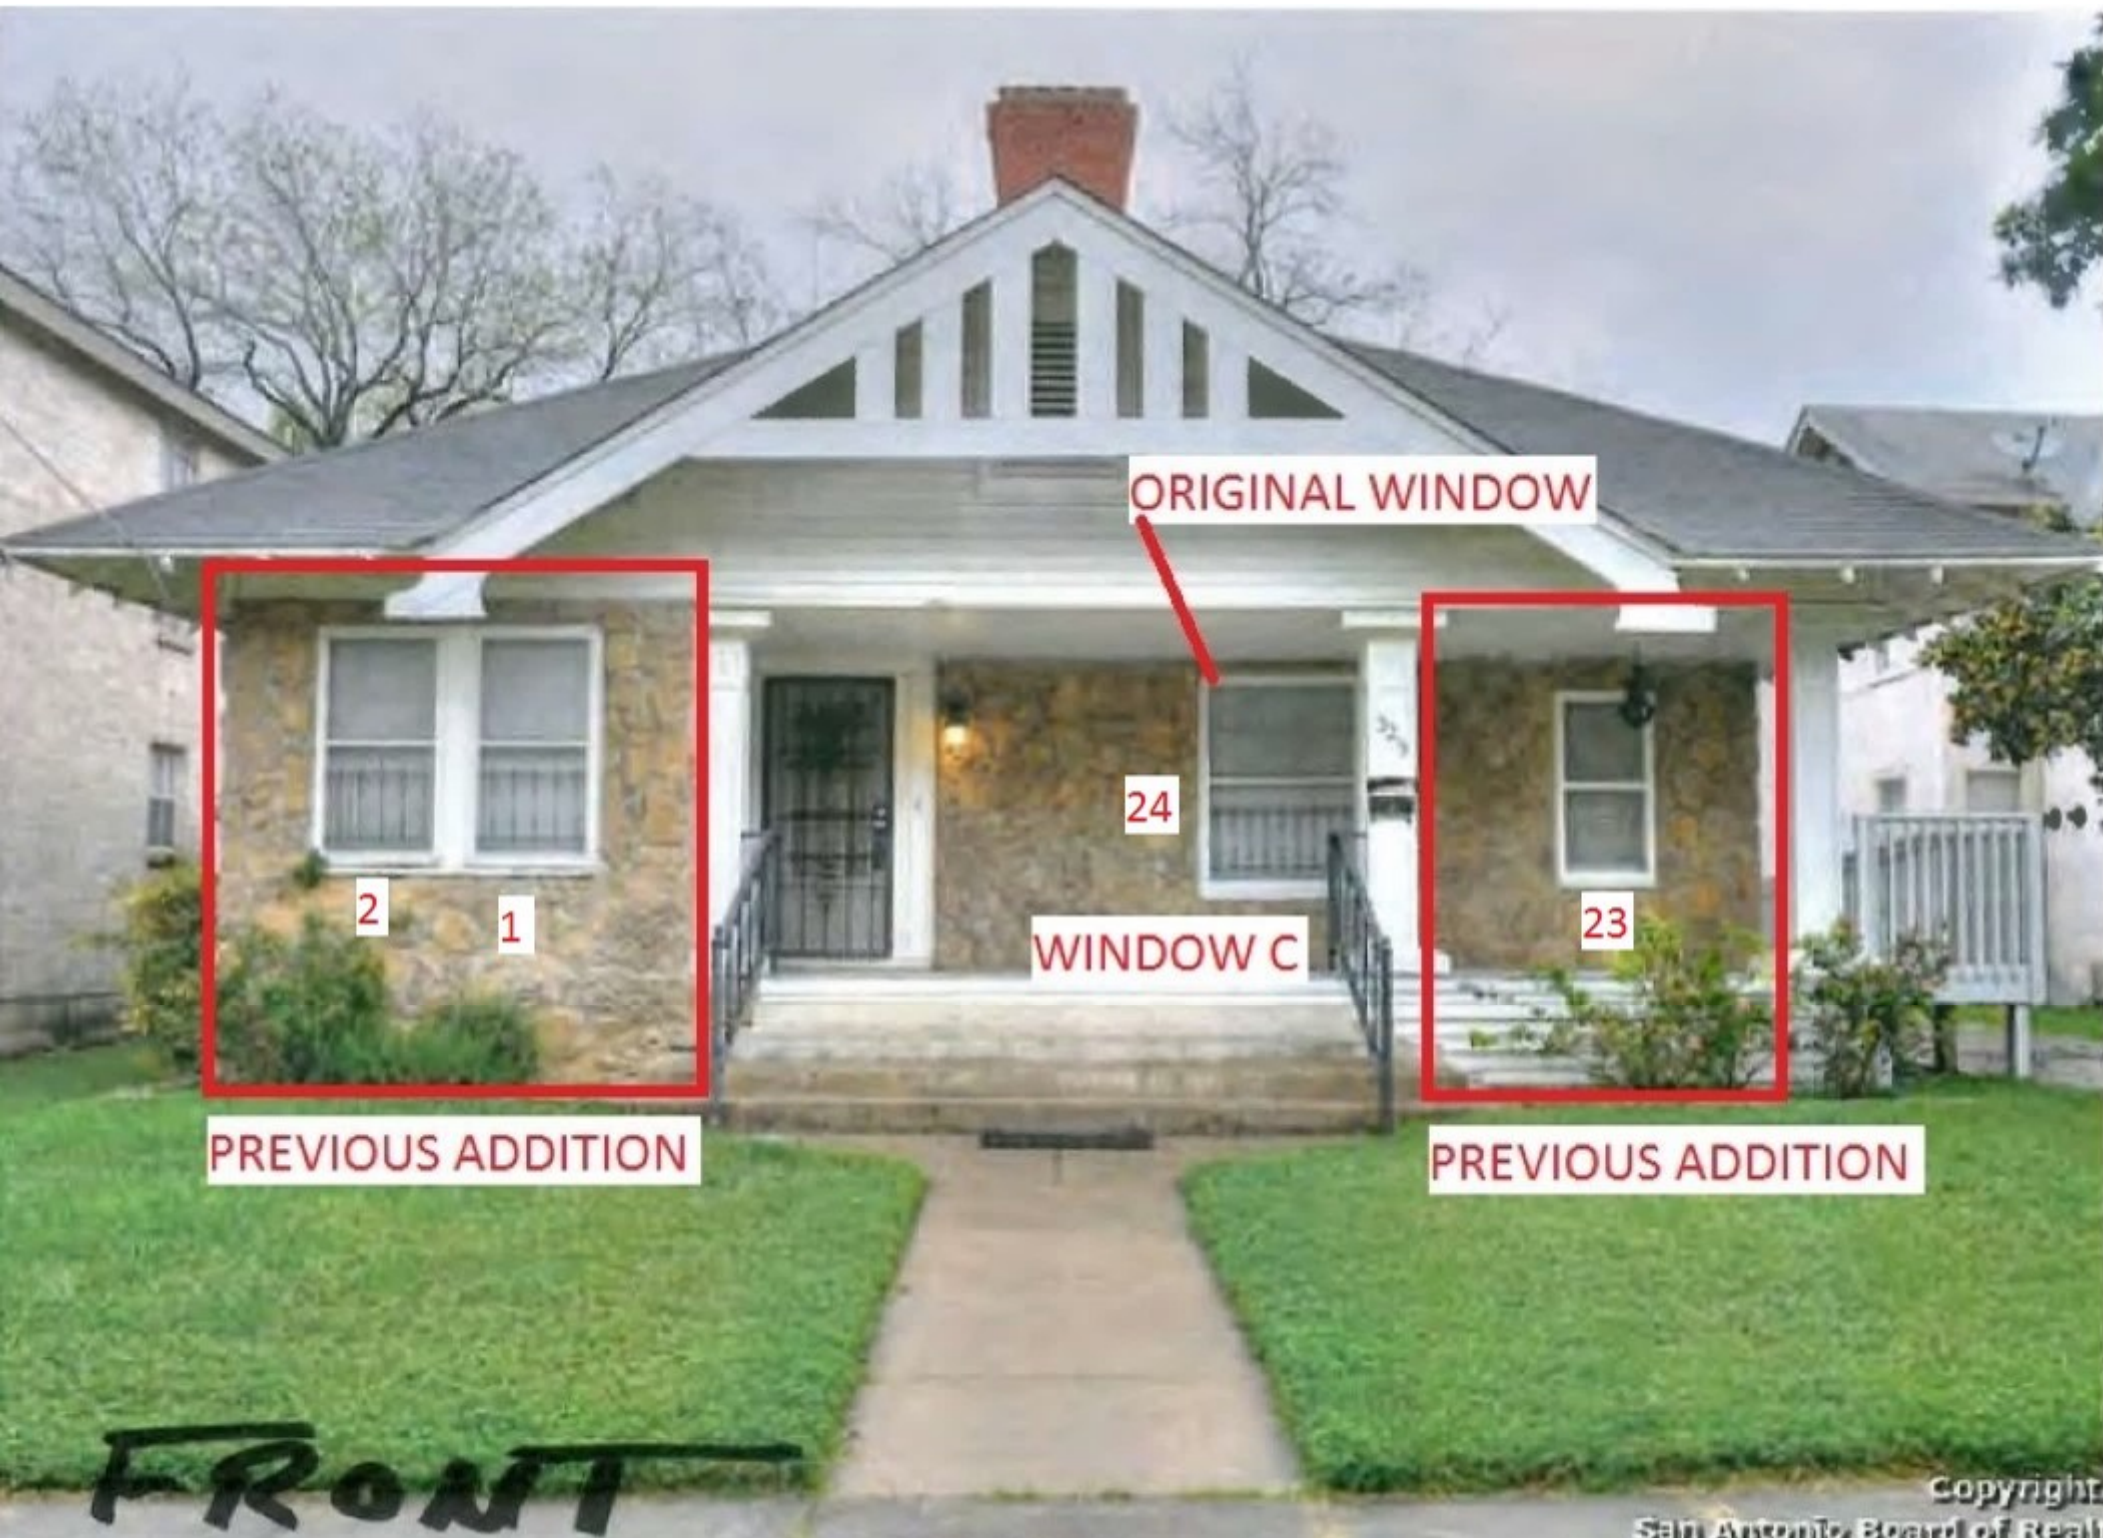
FRONT

- b. WINDOW REMOVAL – The original 6 over 1 window, located directly to the right of the property's main entrance, has been removed and replaced without approval. Administrative approval was granted to repair the original window on August 12, 2016. According to the Guidelines for Exterior Maintenance and Alterations, historic windows should be preserved unless deteriorated beyond repair. The proposed removal and reuse of the 6 over 1 window is not appropriate.

ORIGINAL WINDOW

Staff does not recommend approval of the window replacement based on findings a through c.

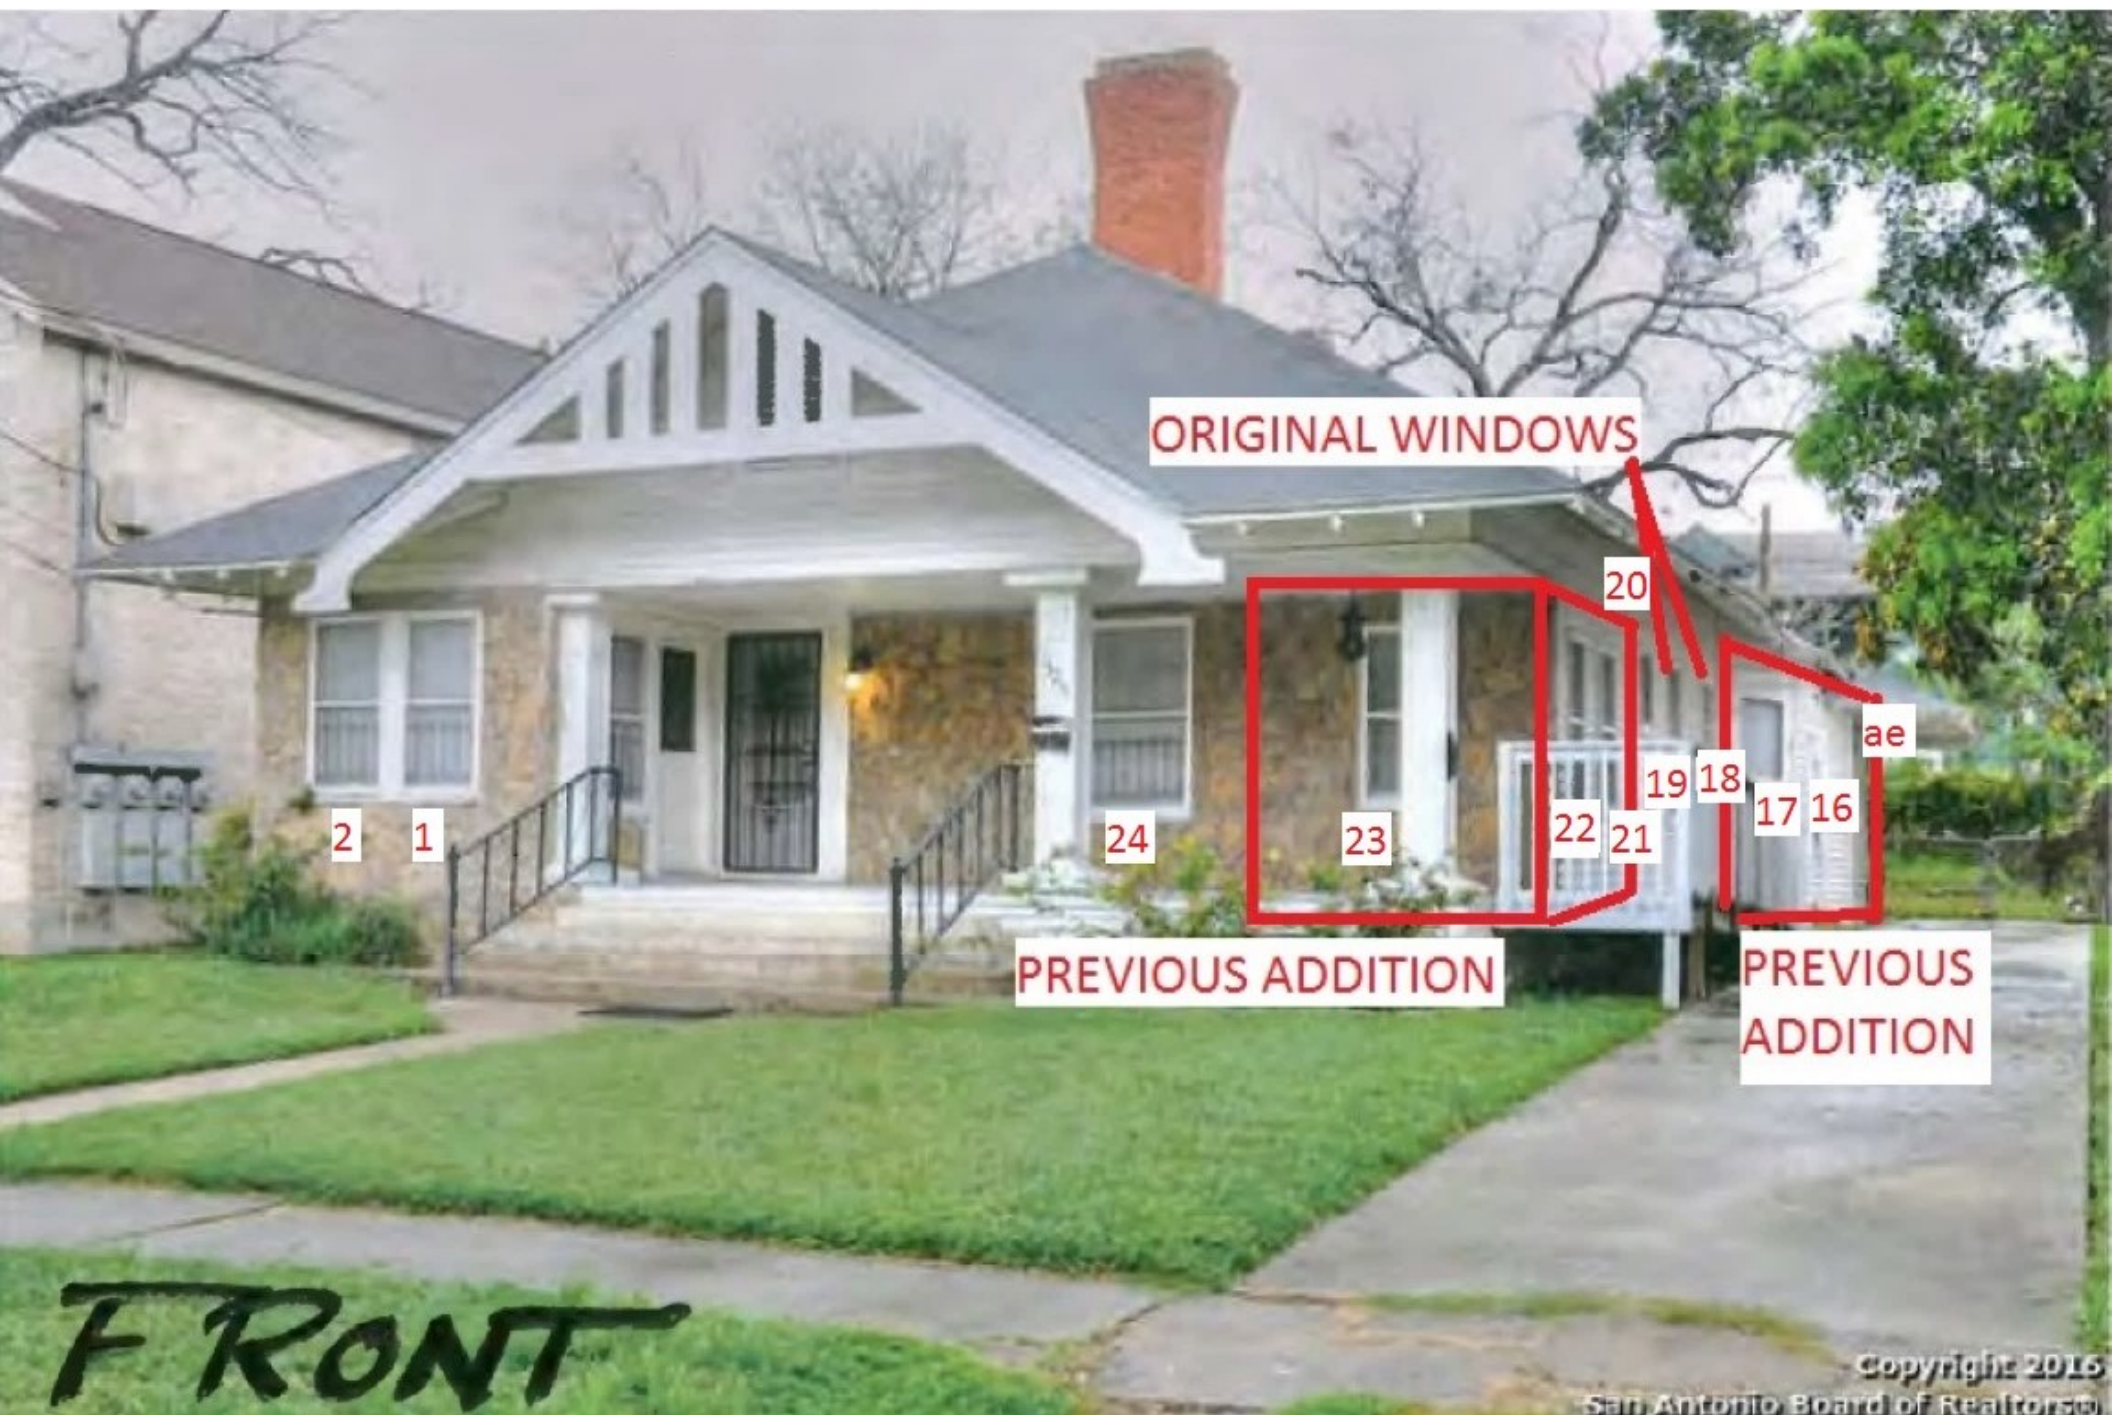
FRONT

ORIGINAL WINDOWS
