HISTORIC AND DESIGN REVIEW COMMISSION

HDRC CASE NO: 2017-420
ADDRESS: 2136 W SUMMIT
LEGAL DESCRIPTION: NCB 6826 BLK 0 LOT 9&10
ZONING: R-6 H
CITY COUNCIL DIST.: 7
DISTRICT: Monticello Park Historic District
APPLICANT: Gary Perkins
OWNER: Gary Perkins
TYPE OF WORK: Reconstruct porte-cochere
REQUEST:

HDRC Application for 2136 W Summit Av, 78201

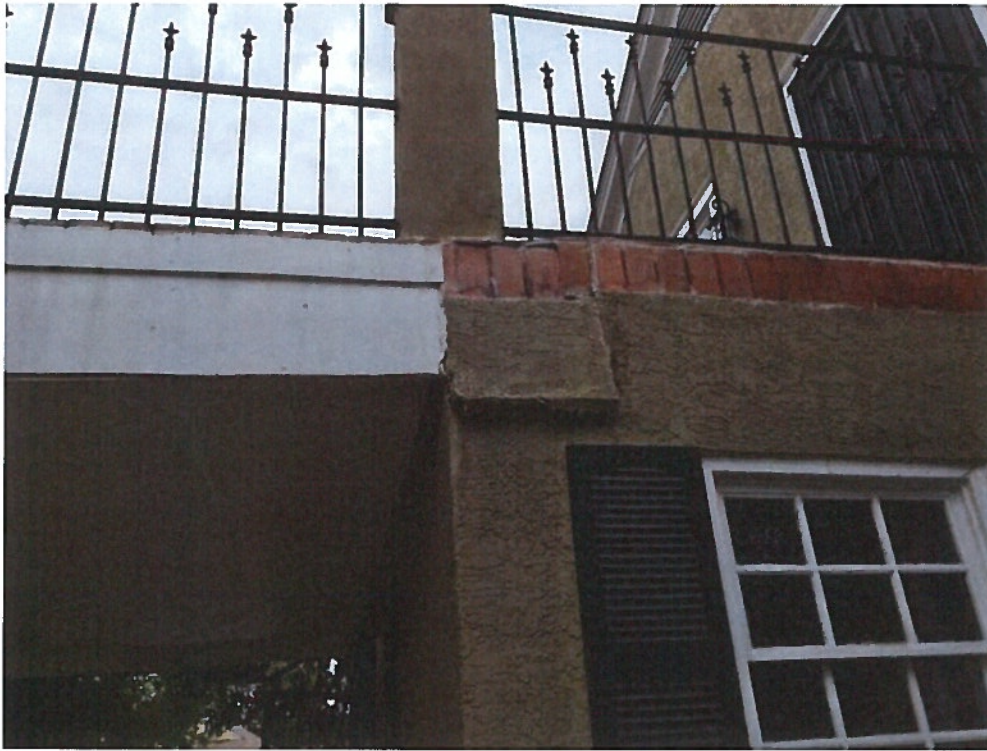
Laundry Wall – Replace framing and wall inside

Rebuild wall inside and outside of laundry room that has suffered severe water damage.

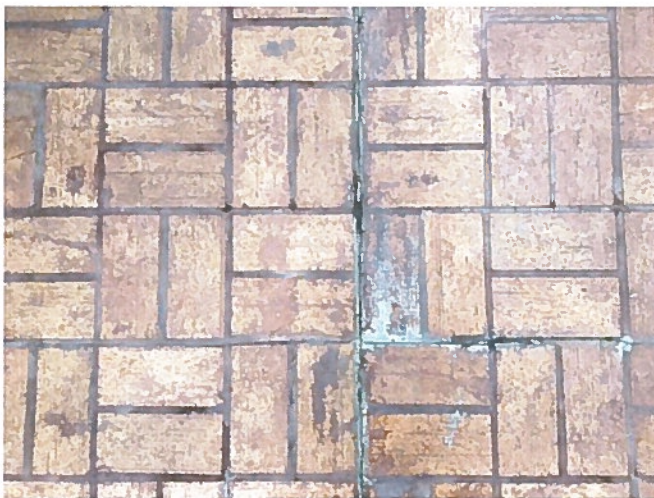
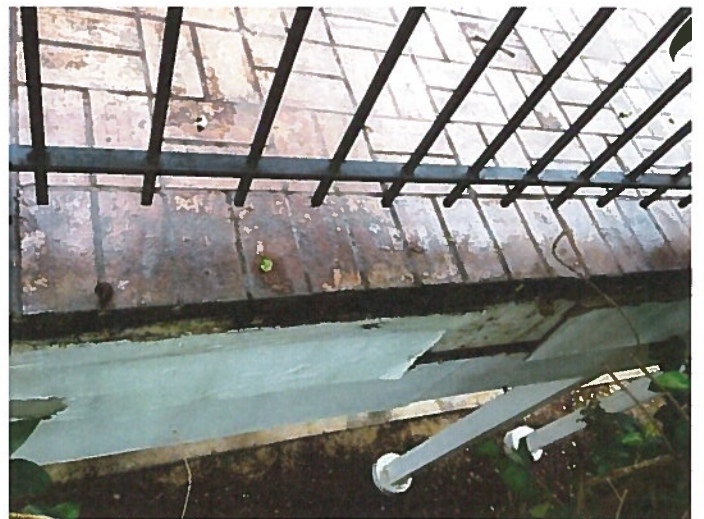
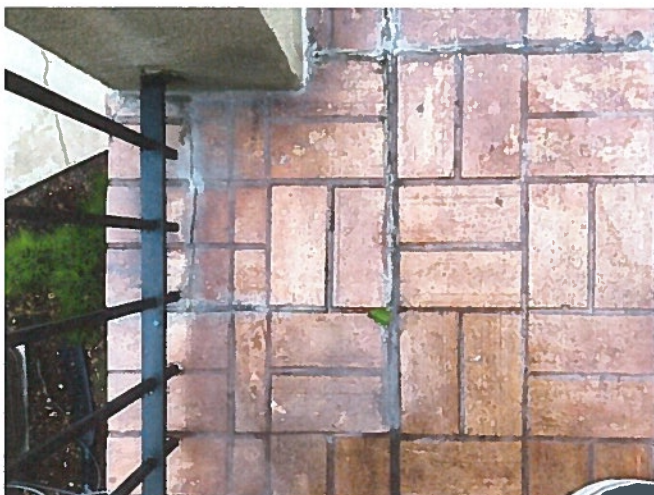
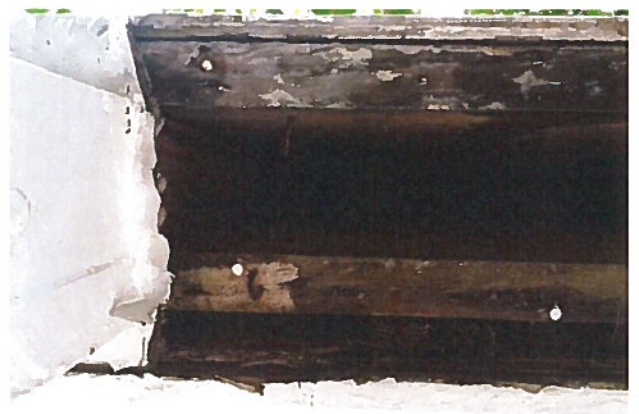
After 6 months, we discovered that water is leaking through the cracks of the tile and damaging the cross beams. Every 6 months we have sealed the tile. The terrace gets 8-9 hours of full sun every day and the sealer doesn't hold on to the clay tile.

It has come to a point where the cross beam has suffered rot and is now bending and cracks in the tile are becoming bigger.

Cracks in tiles and water rot:

Install under deck drainage system (RainEscape from Trex) and gutter to make sure water is not reaching the cross beams.

Replace upper floor decking with pressure treated cedar

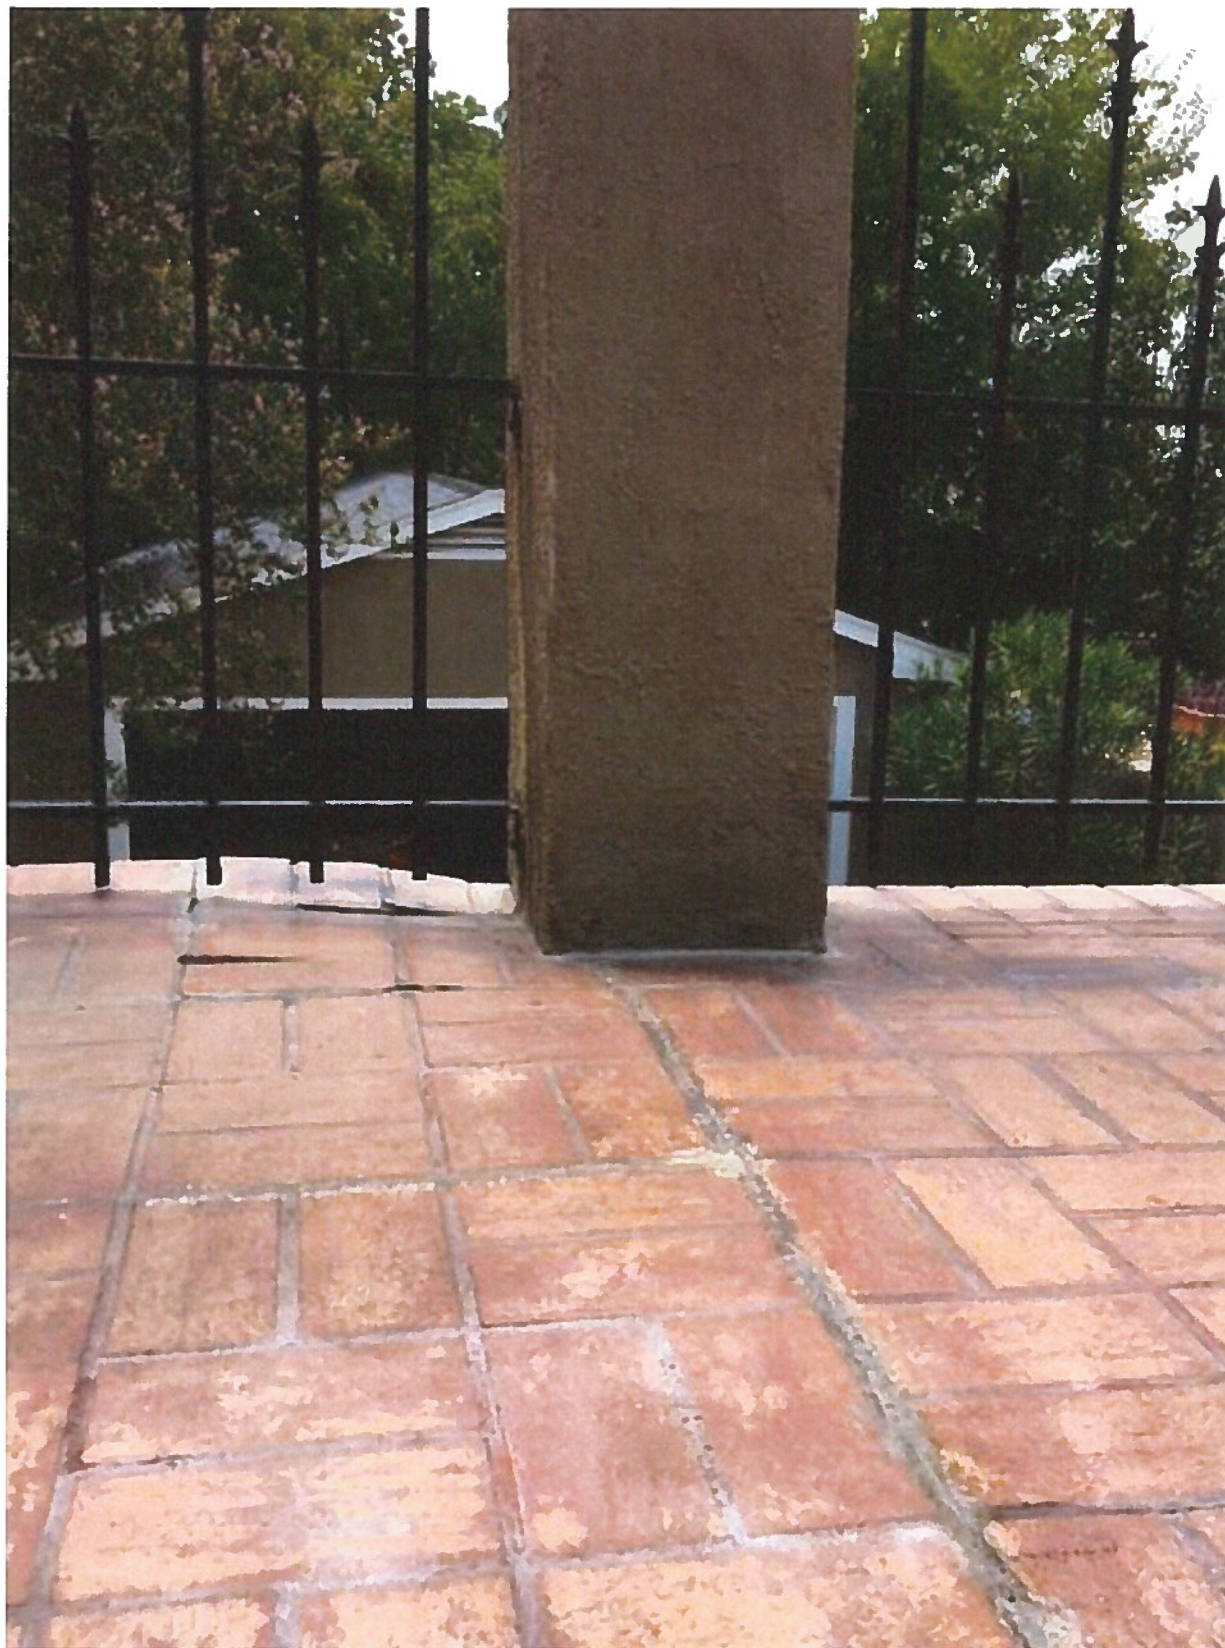
Pillars sinking (view from top)

Rebuild pillars as is.

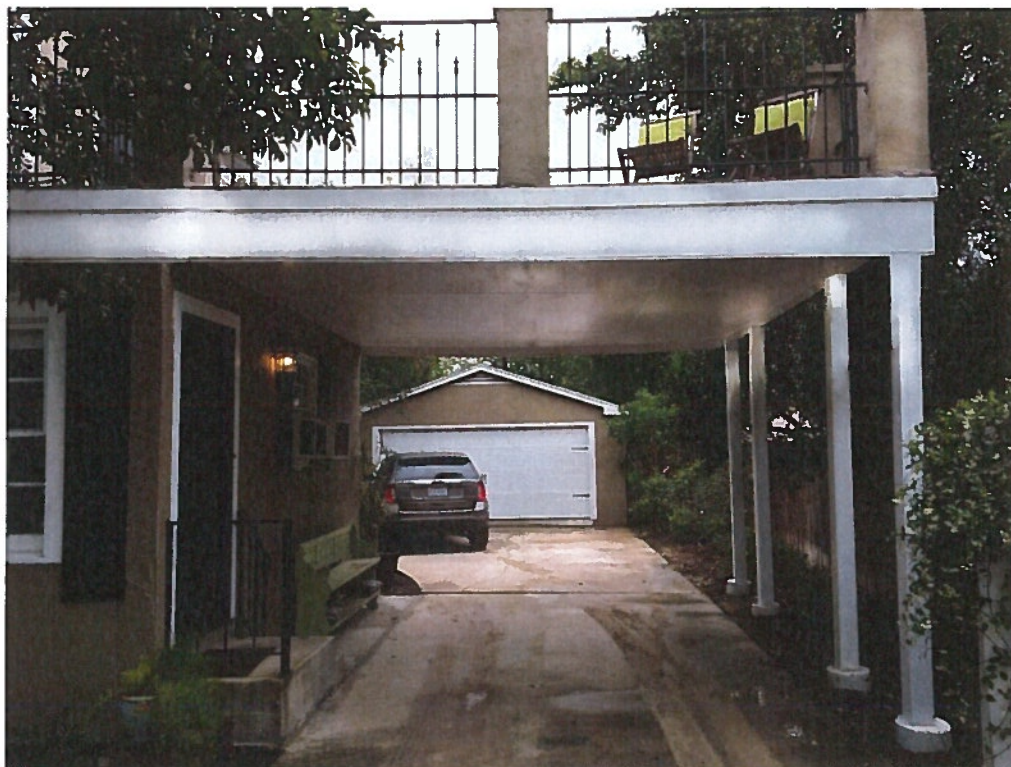
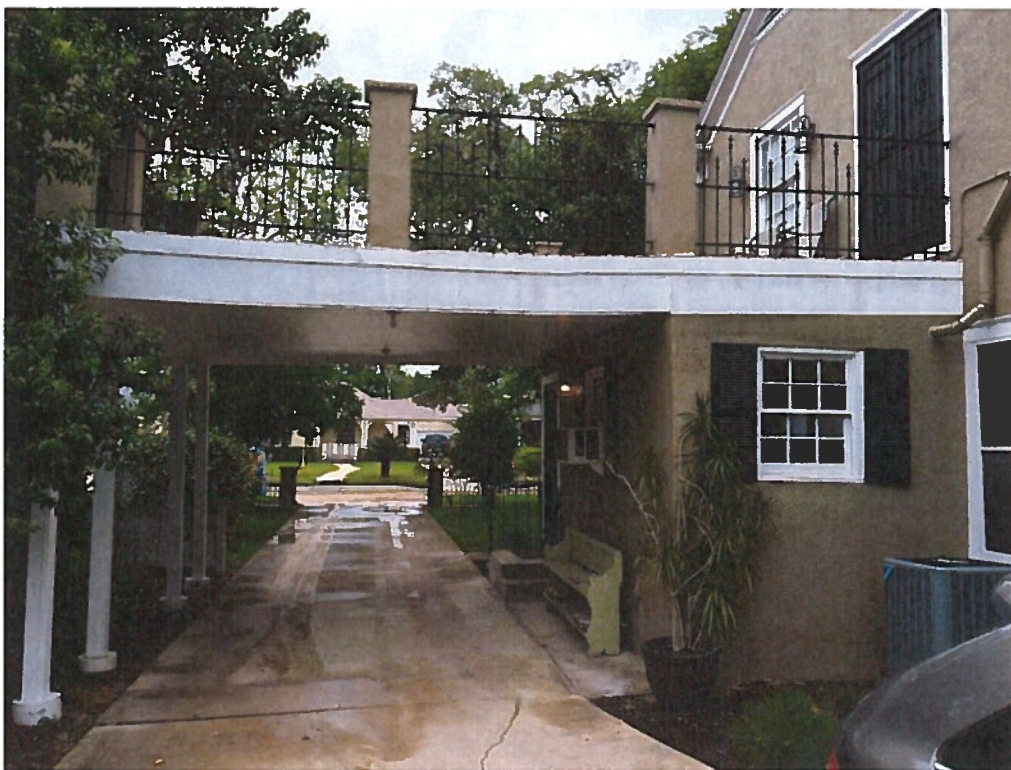
New Cross Beam from supporting beams to house:

Replace cross beam above laundry room with LVL (going from original house to supporting beams - XX ft). Paint white.

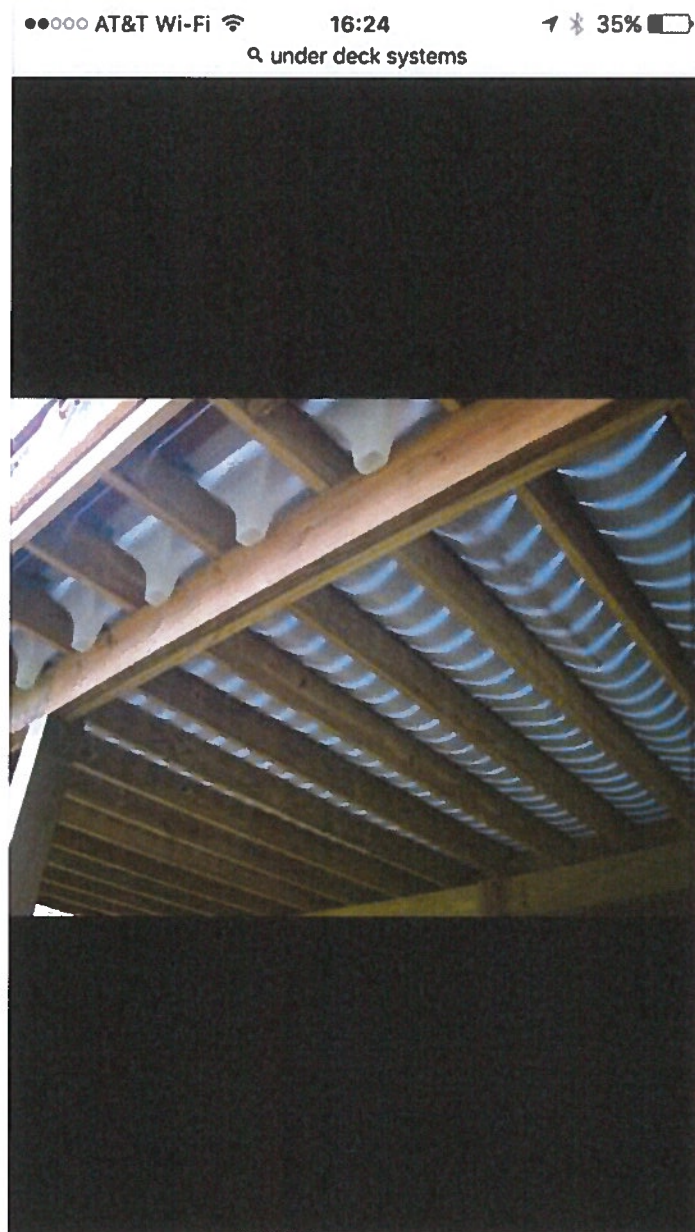
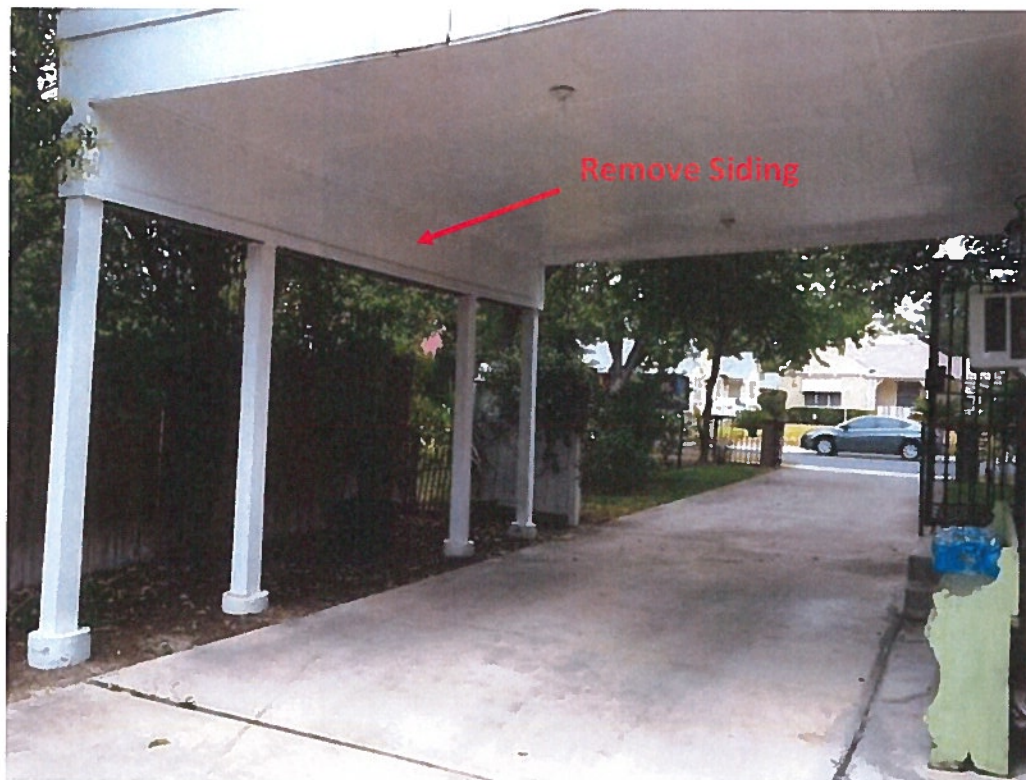
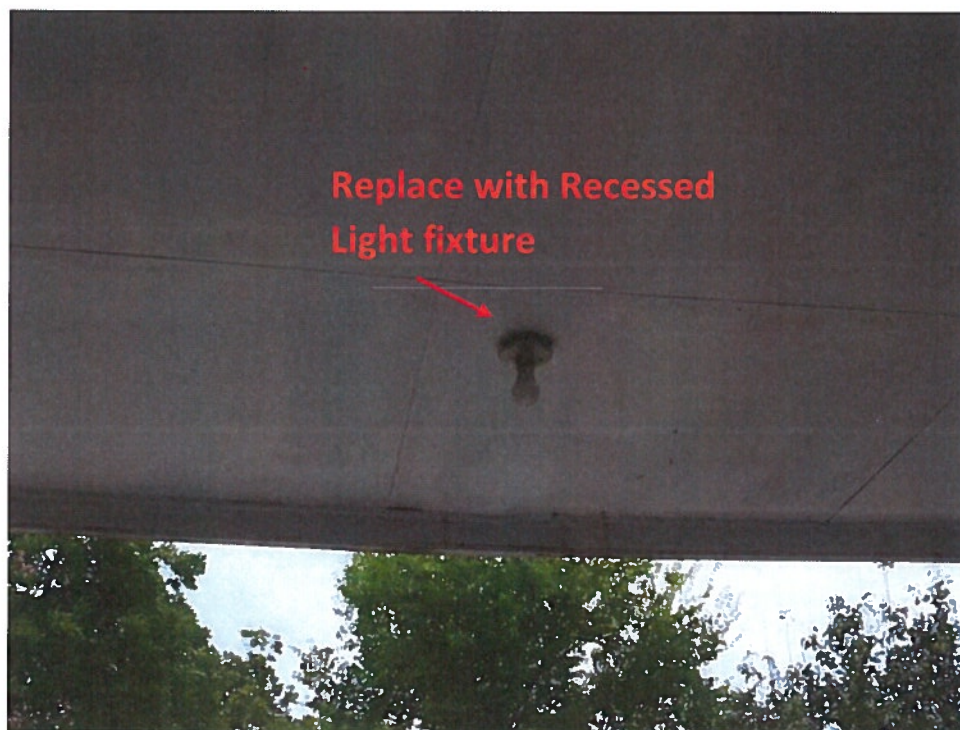
Under deck drainage system:

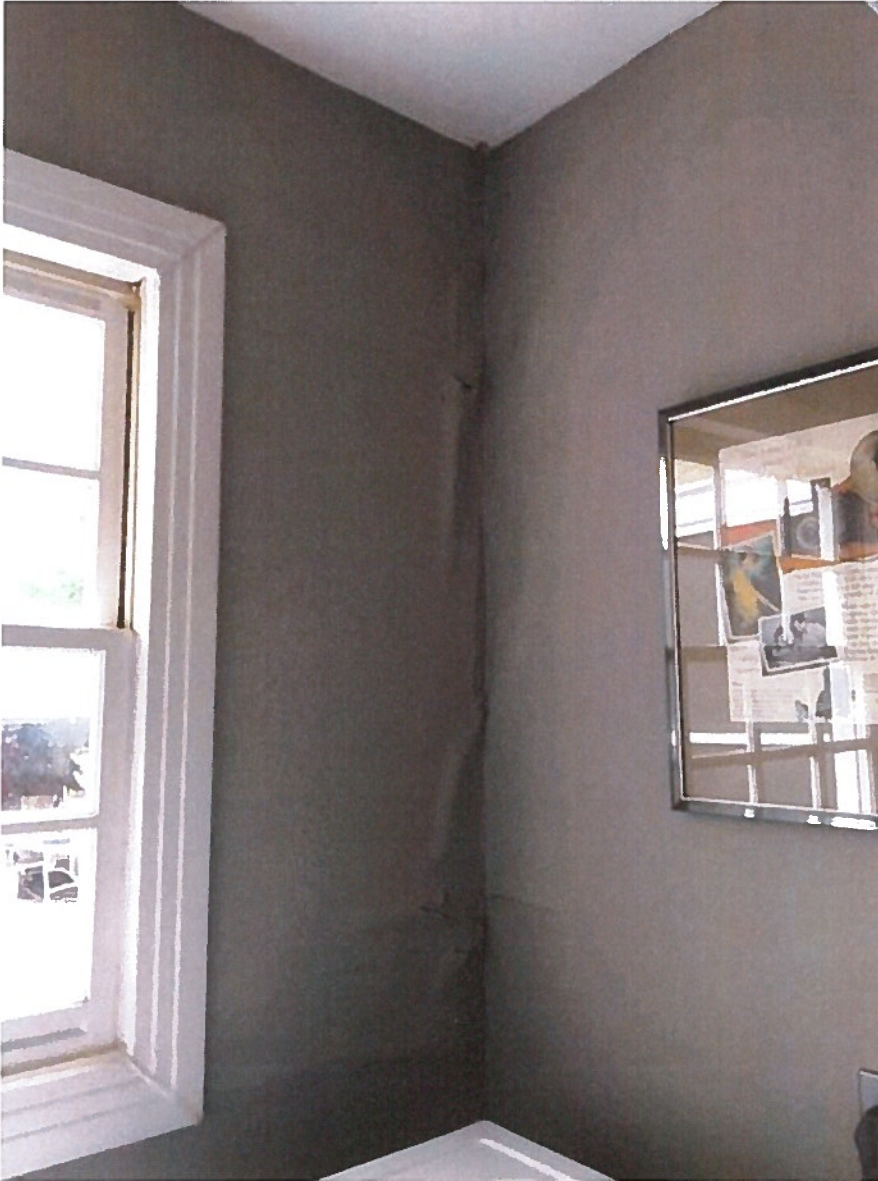
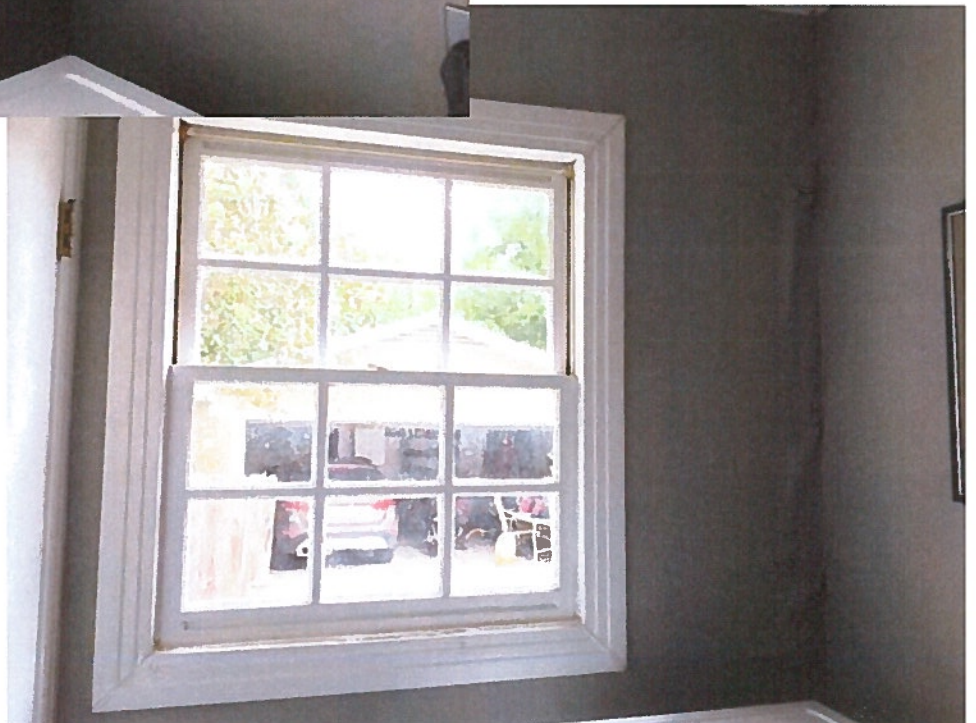
Water Damage inside Laundry Room
