HISTORIC AND DESIGN REVIEW COMMISSION

October 18, 2017

HDRC CASE NO: 2017-524
ADDRESS: 302 CEDAR ST
LEGAL DESCRIPTION: NCB 2963 LOT A12 & W IRR 97 FT OF S IRR 9 FT OF A-11, N 8 FT OF E 89 FT OF A13
ZONING: RM-4, H
CITY COUNCIL DIST.: 1
DISTRICT: King William Historic District
APPLICANT: P. Chance Kinnison
OWNER: Stephen Mason
TYPE OF WORK: Replace concrete walkway with crushed limestone
REQUEST:

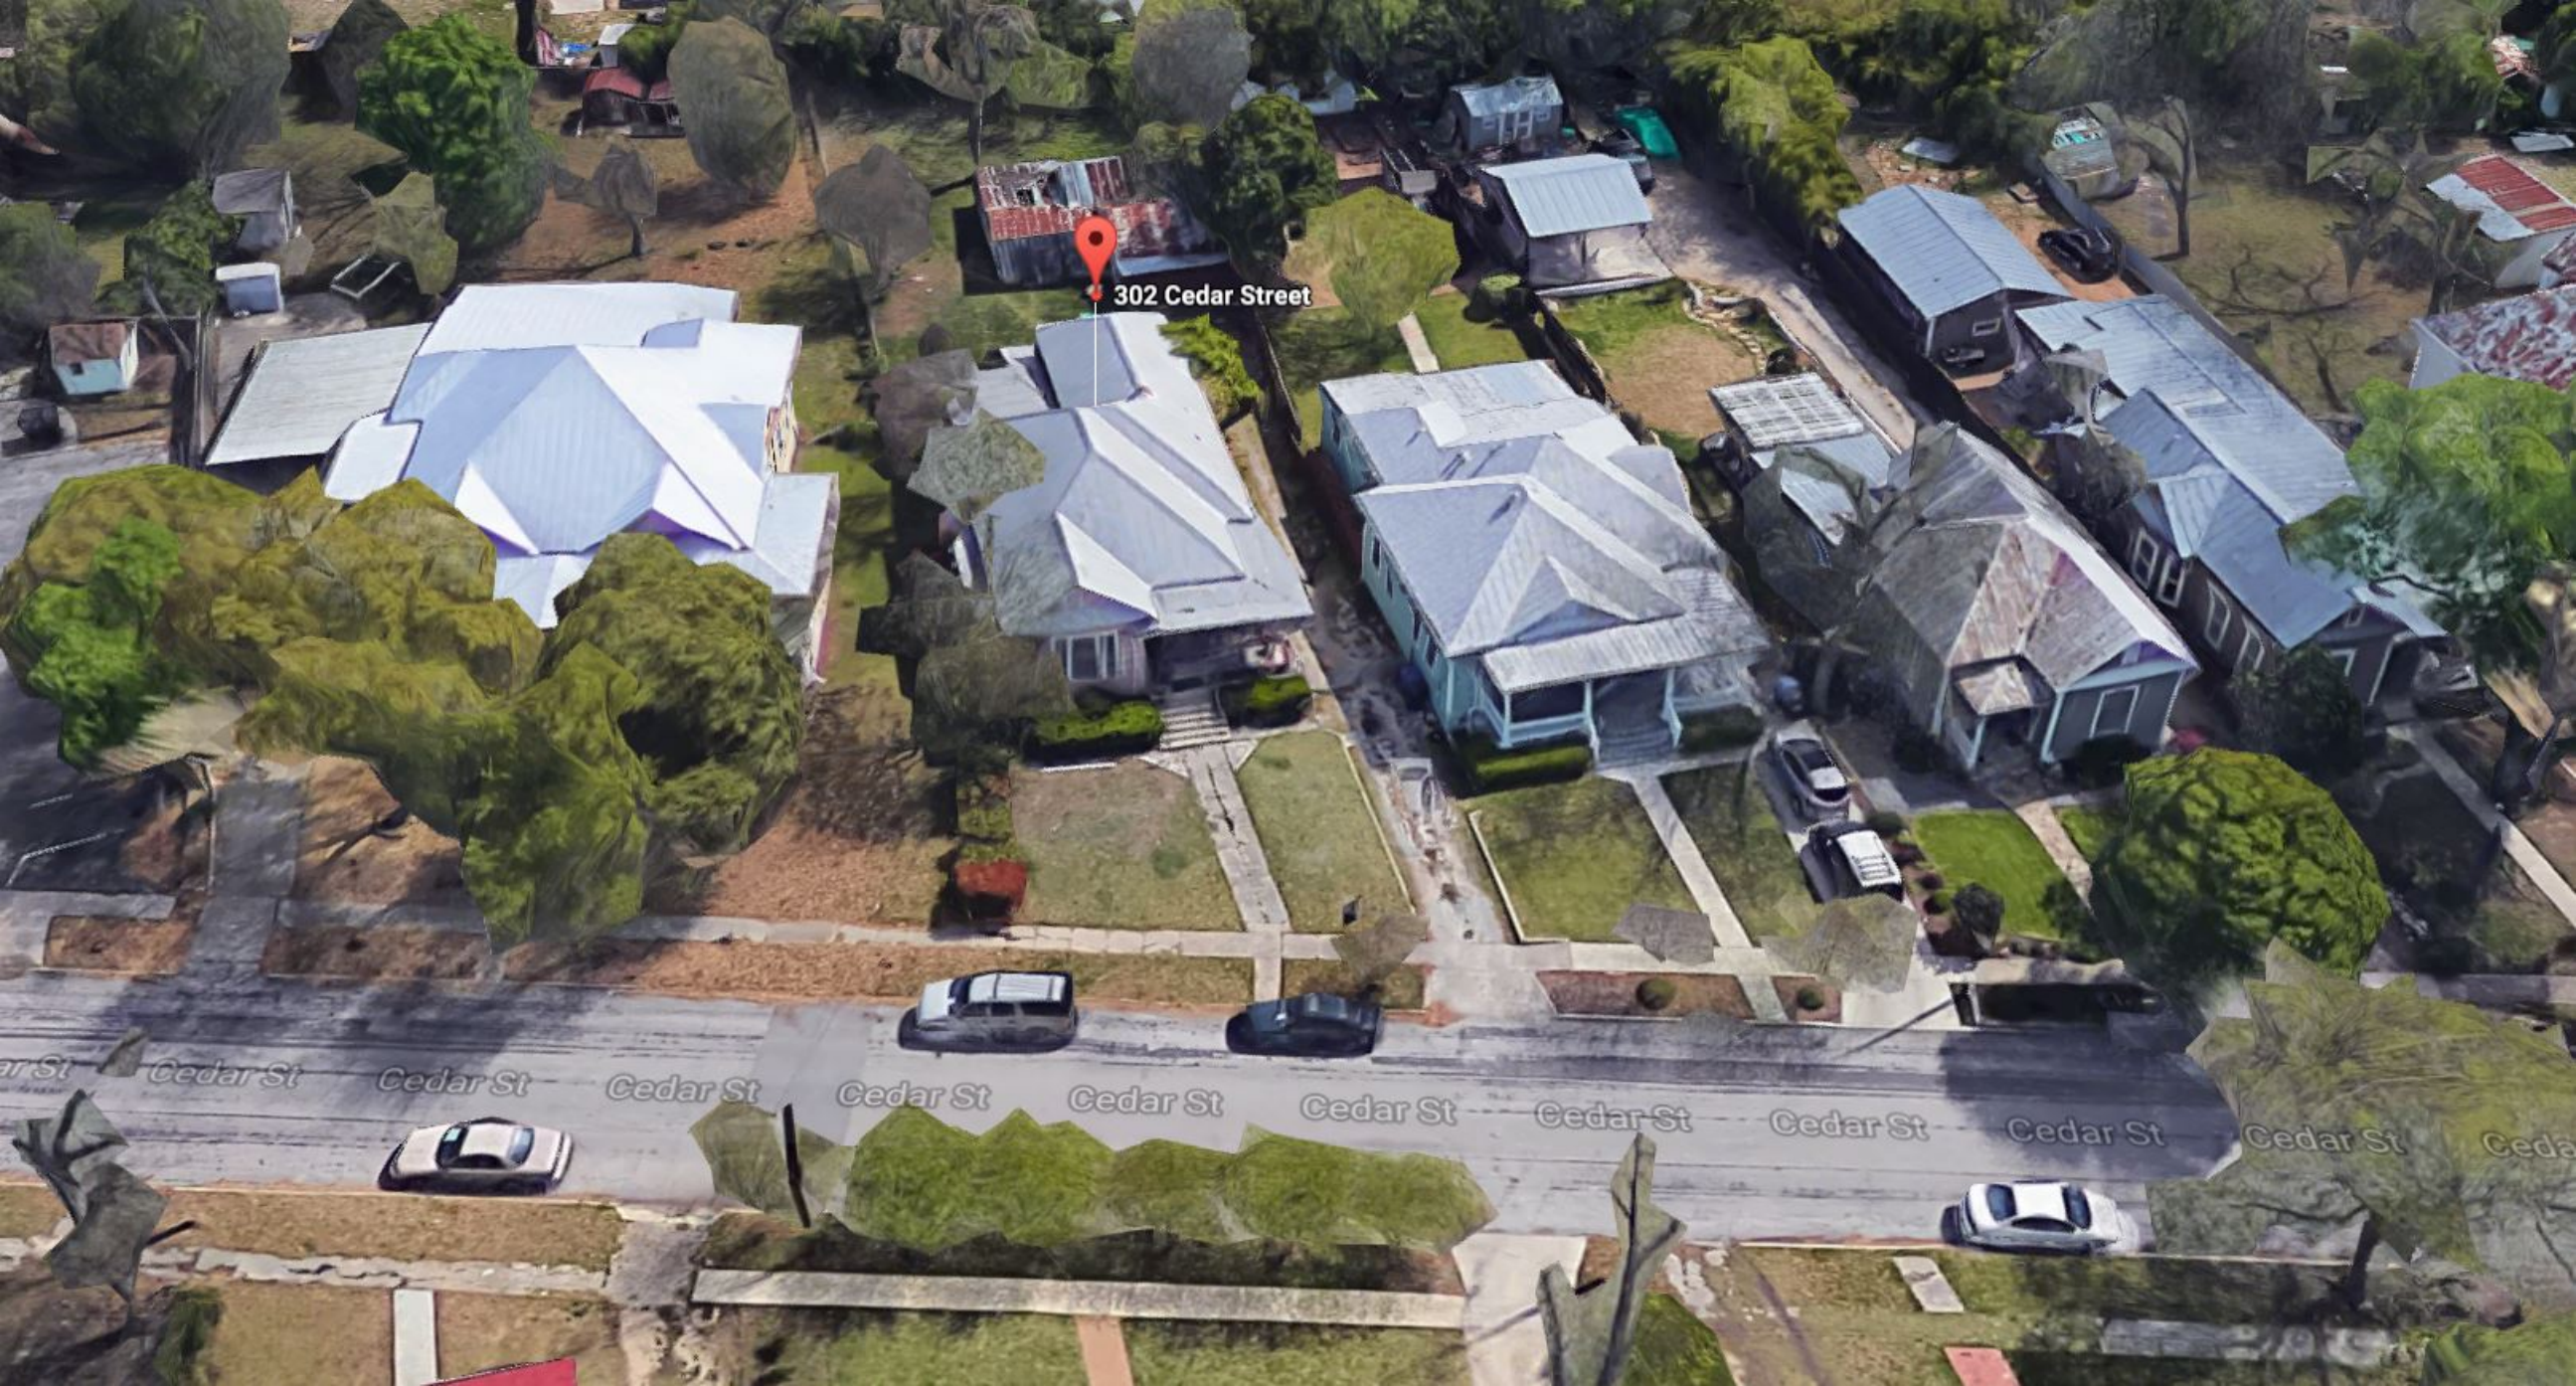
302 Cedar Street

CASE COMMENT: During a site visit conducted on October 11, 2017, staff finds that concrete walkway has been removed prior to issuance of a Certificate of Appropriateness. Staff recommends the reinstallation of a concrete walkway that matches the one prior to removal.

Staff recommends final approval of both requests based on findings b and c with the stipulation that the existing walkway remains concrete.
