## HISTORIC AND DESIGN REVIEW COMMISSION

December 20, 2017

**HDRC CASE NO:** 2017-647  
**ADDRESS:** 114 CAMARGO  
**LEGAL DESCRIPTION:** NCB 923 BLK 4 LOT W 5.6 FT OF 3 & E 28 FT OF 2  
**ZONING:** RM-4 H  
**CITY COUNCIL DIST.:** 1  
**DISTRICT:** Lavaca Historic District  
**APPLICANT:** Grace Boudewyns  
**OWNER:** Elizabeth Longoria  
**TYPE OF WORK:** Rehabilitation including fenestration changes  
**APPLICATION RECEIVED:** December 01, 2017  
**60-DAY REVIEW:** February 01, 2018

## **HDRC APPLICATION**

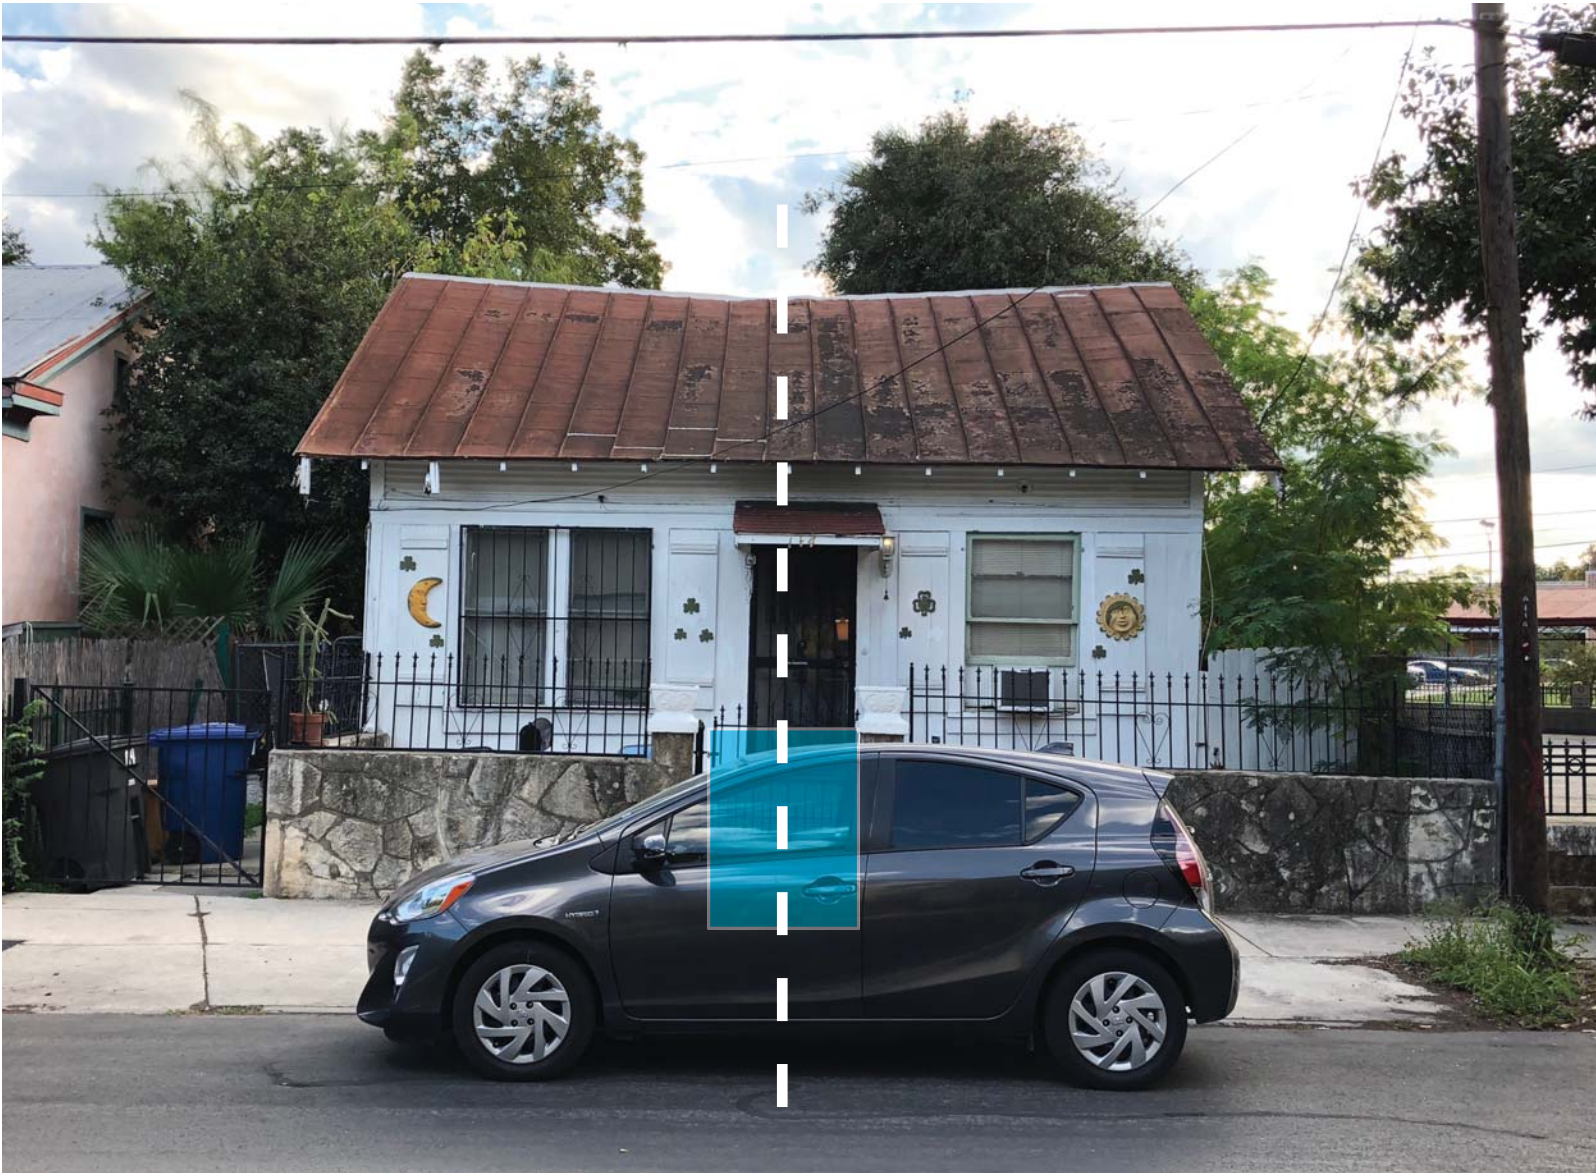
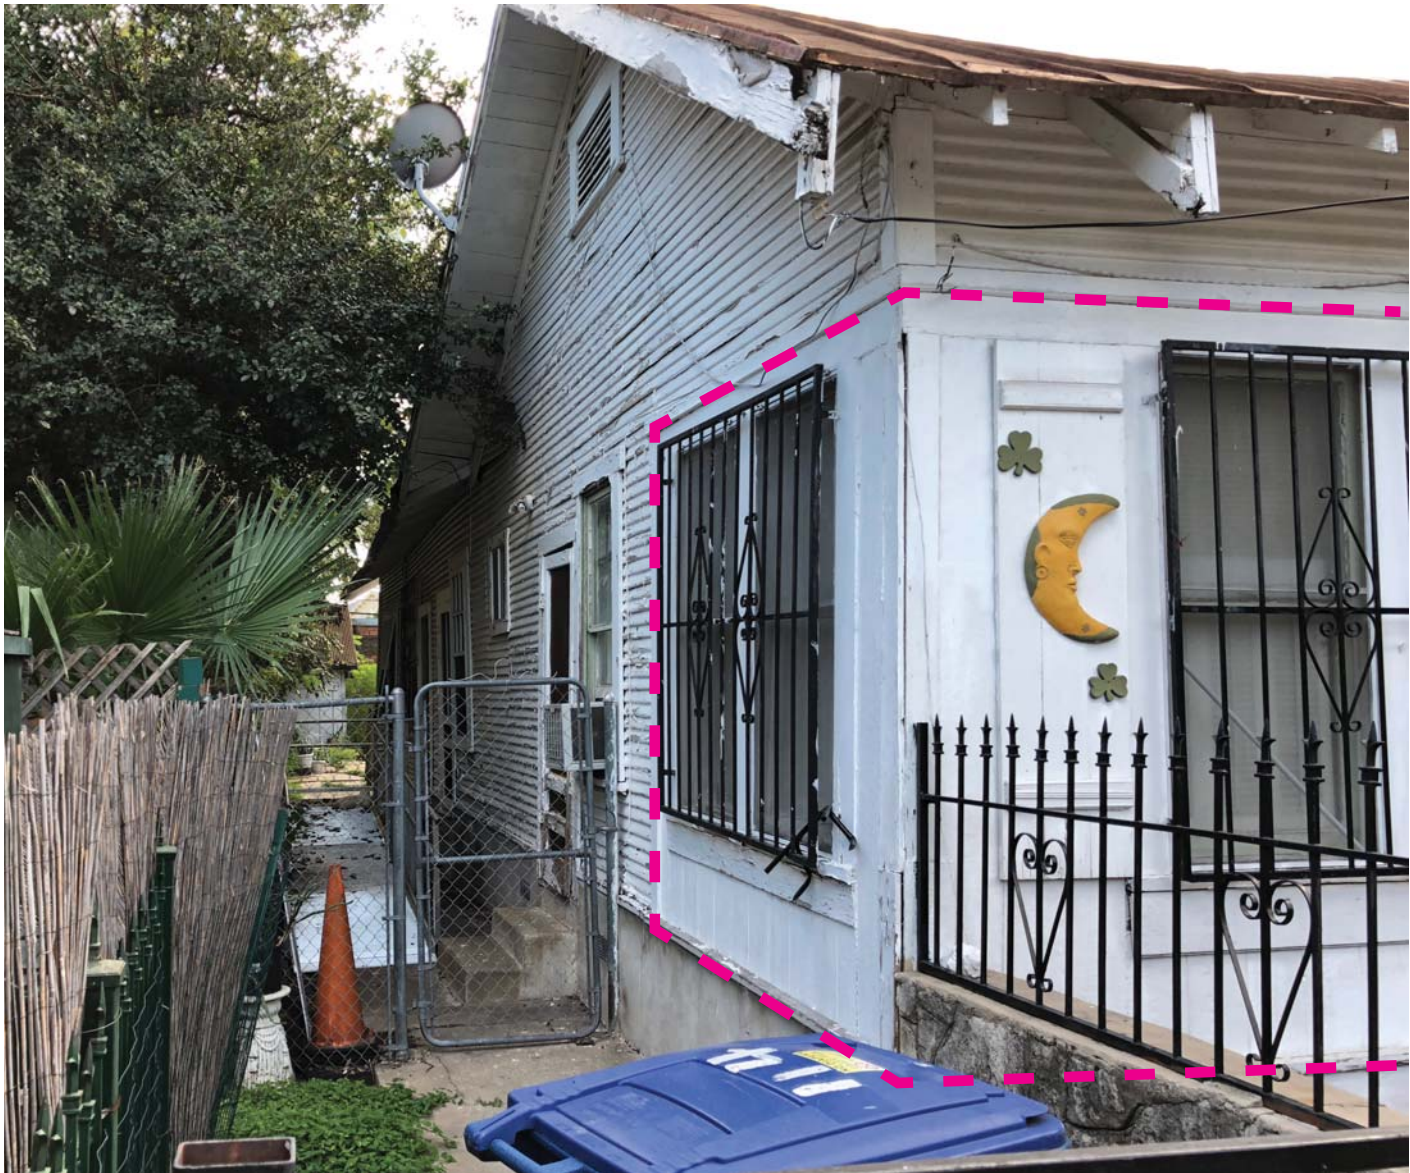
CLOSED IN PORCH:

The misalignment of the front door and gate leads me to believe that the existing facade was not original to the building. The gate is centered on the facade, which in turn leads me to believe that the original front door was also centered in the facade. As illustrated the current front door is offset from the center of the facade, indicating that it may have been when the porch was enclosed or reconfigured.

In addition, there is significant evidence that the front facade is not original due to the changes in siding material and the interior slope of the floor.

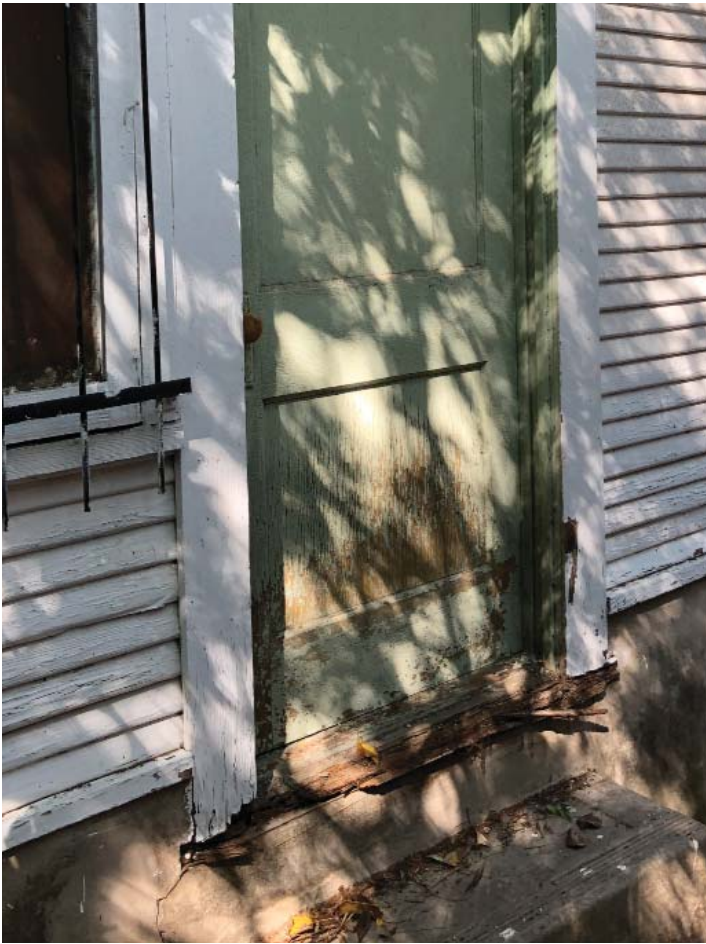
Door rot at an east elevation exterior door. Door and concrete steps are proposed to be removed given they were not part of the original design intent.

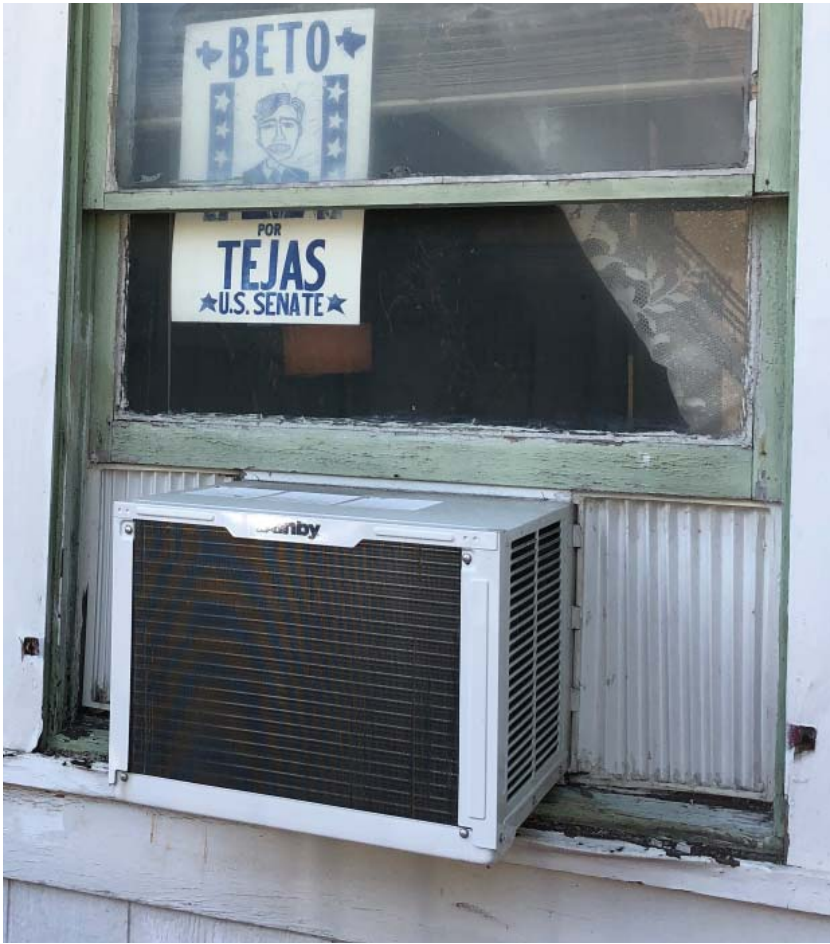
Window sill rot at existing window. Window is proposed to be replaced.

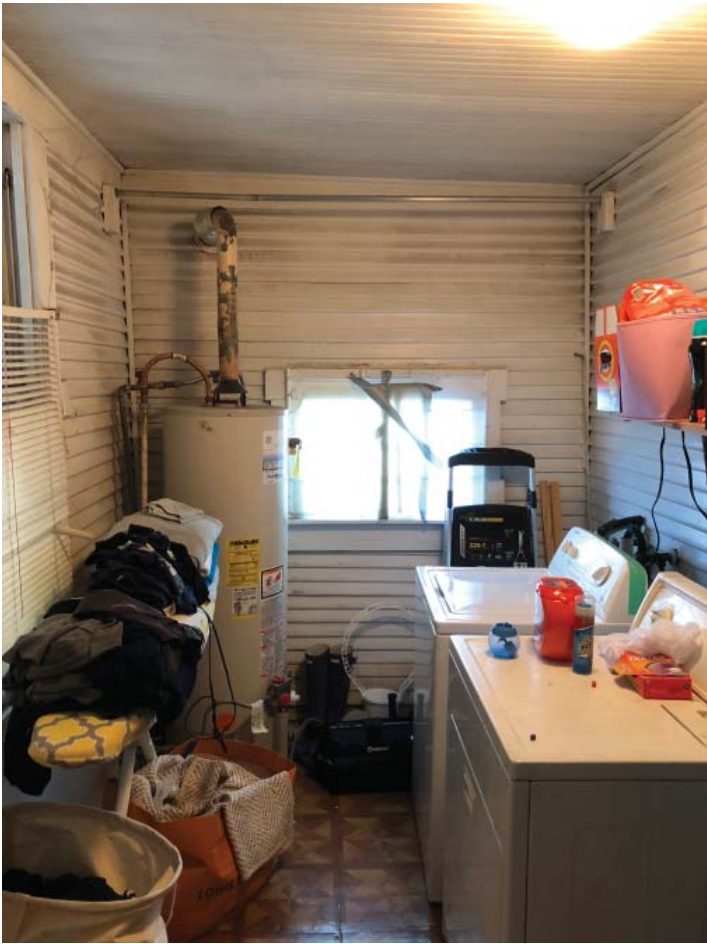
Atypical existing window in a non-historic back addition. Window is proposed to be removed.

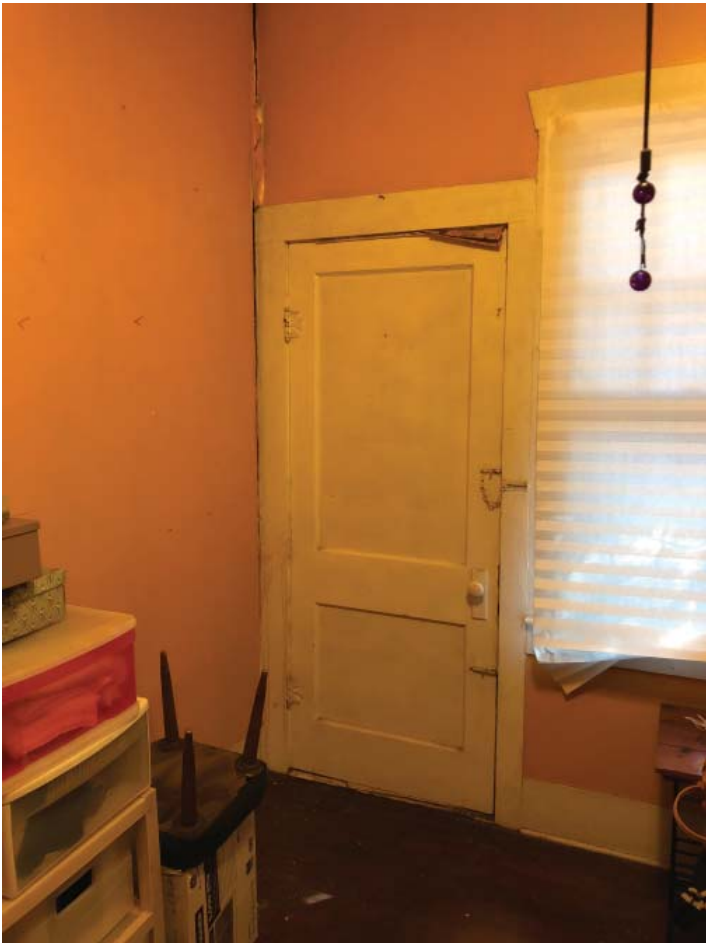
Existing exterior door to be removed. Door is meant for interior use, and is not in keeping with the original character of the house.

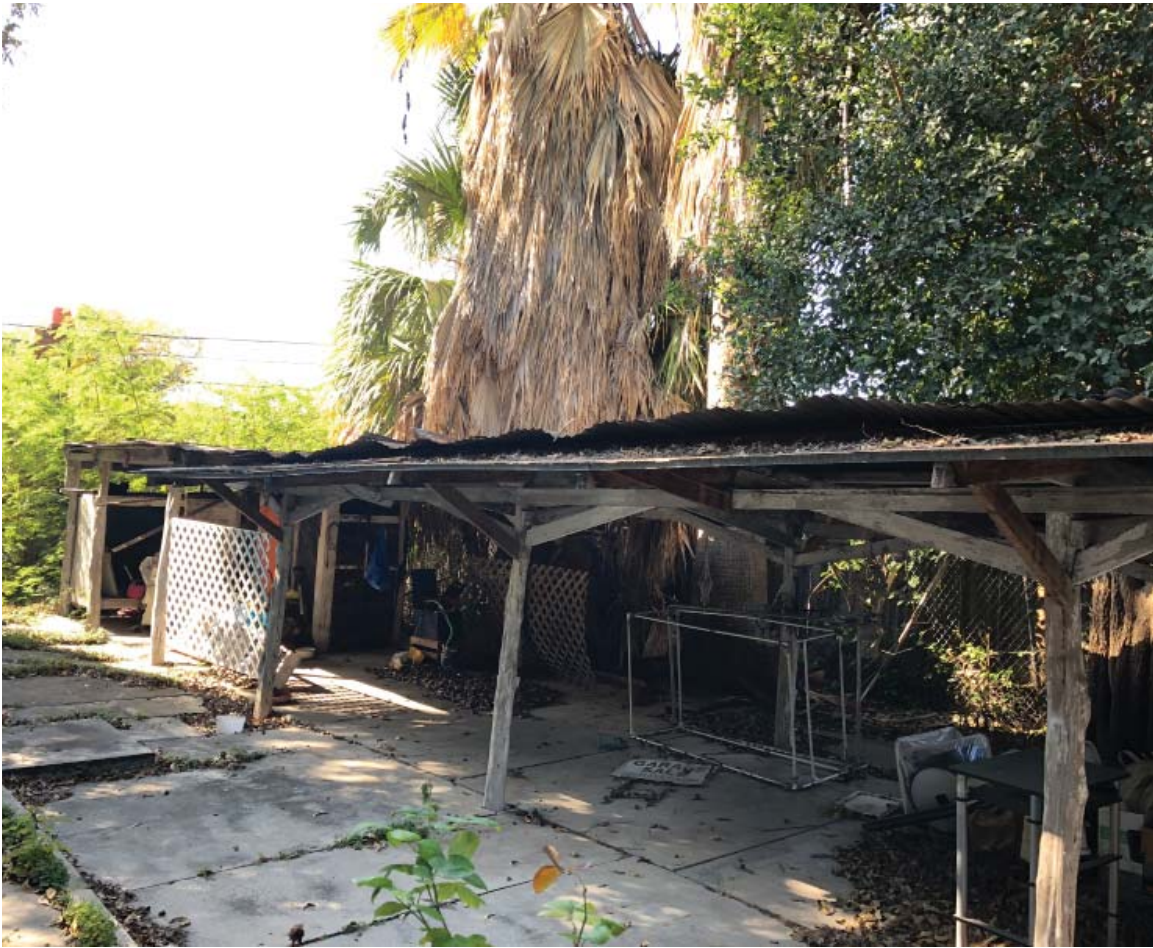
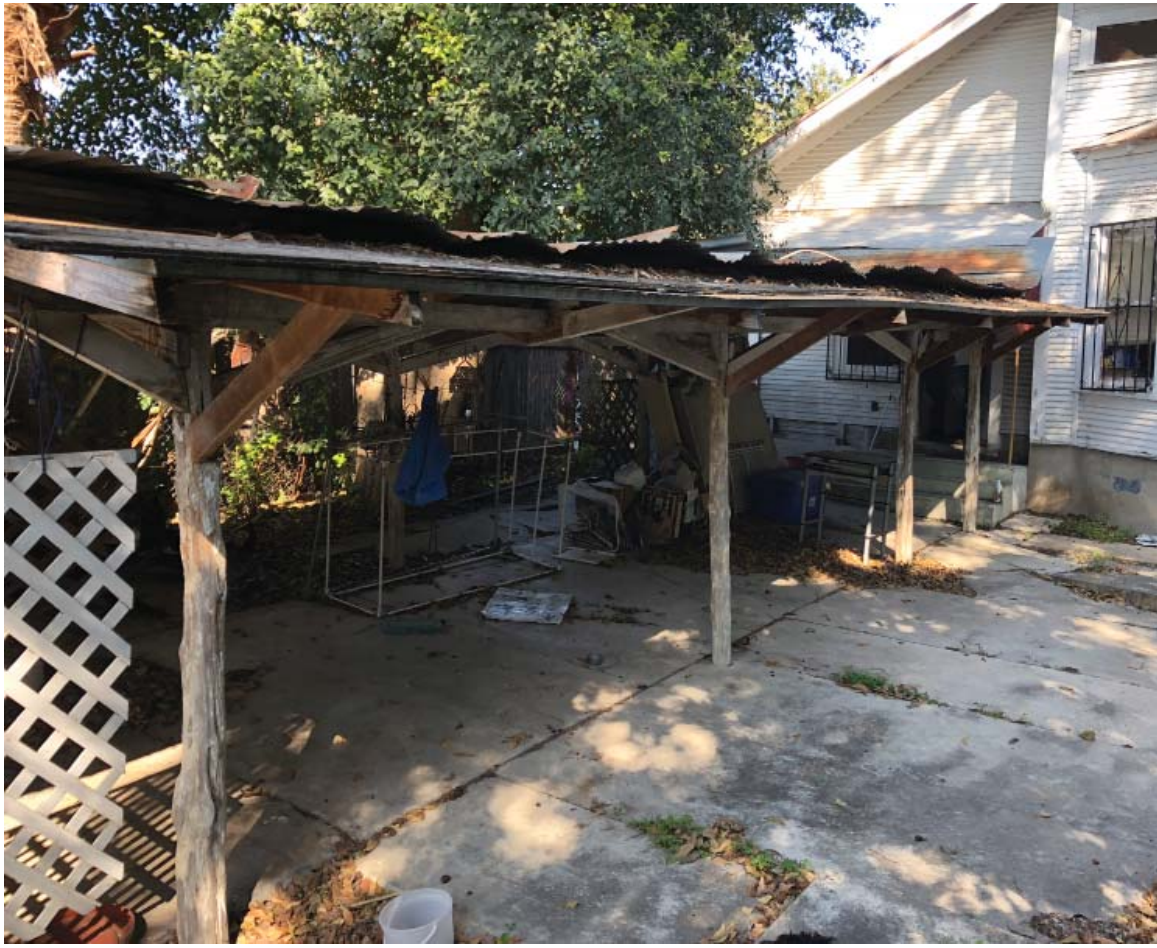
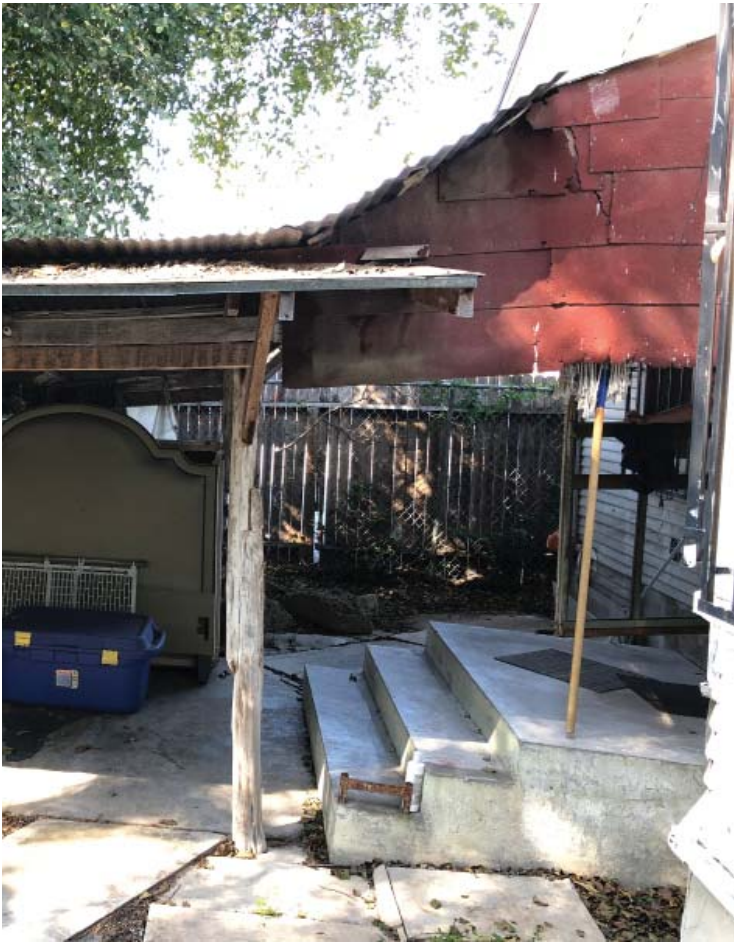
Photos of backyard lean-to to and concrete slabs that are proposed to be demolished. Lean-to is not structurally sound, and not original to the primary structure.

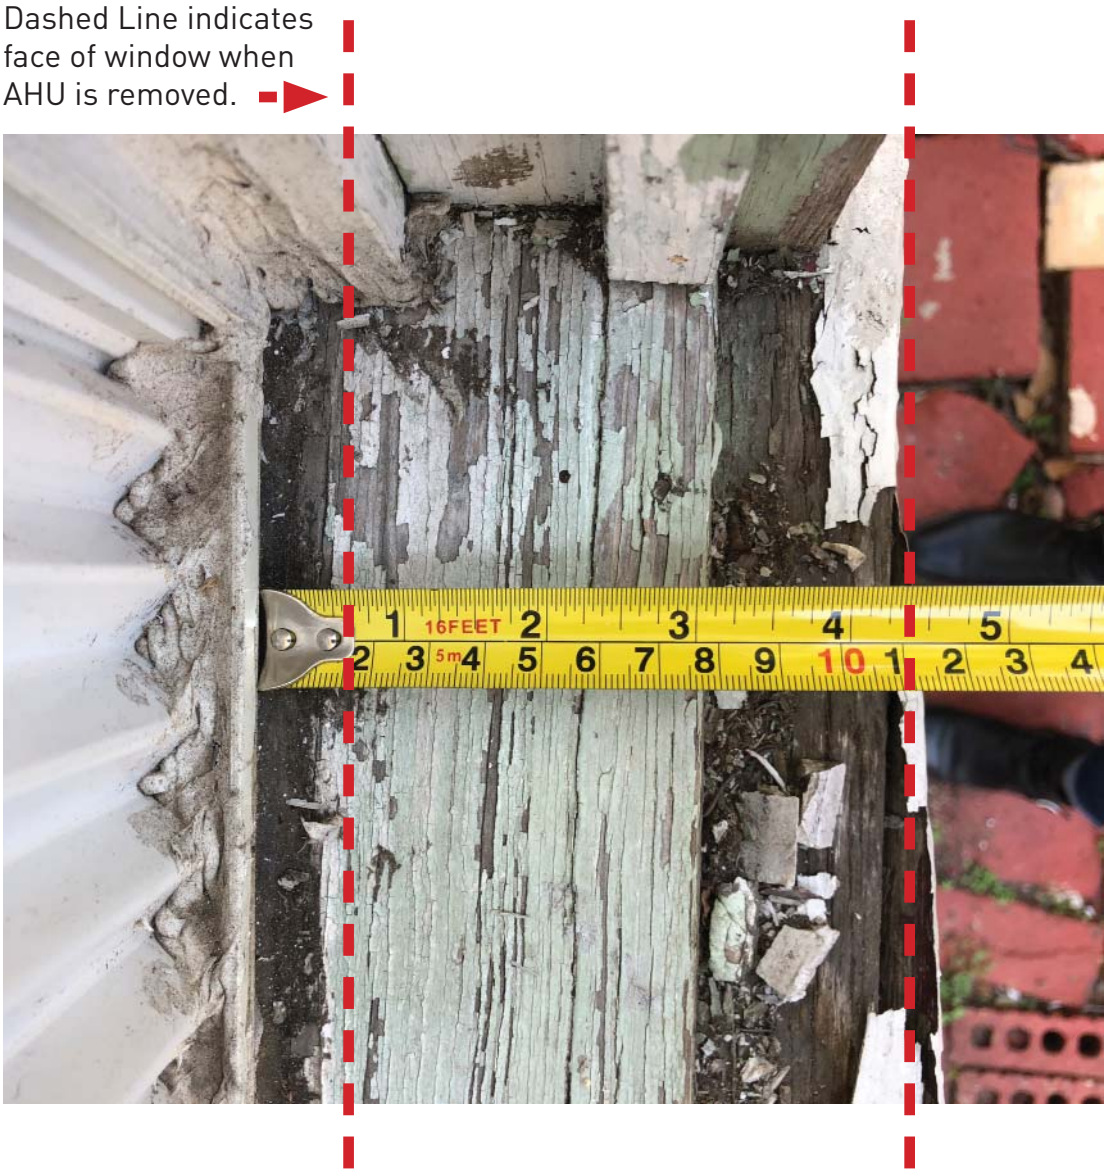
PLAN VIEW OF EXISTING WINDOW SILL:

Sill depth from face of window to exterior face of sill is approximately 0' - 4"

New windows are proposed to match the original character of the house with a 0' - 4" sill depth.
