HISTORIC AND DESIGN REVIEW COMMISSION

HDRC CASE NO: 2017-644
ADDRESS: 1125 N OLIVE ST
LEGAL DESCRIPTION: NCB 514 BLK 18 LOT 14
ZONING: R-6 H
CITY COUNCIL DIST.: 2
DISTRICT: Dignowity Hill Historic District
APPLICANT: Kelly Johnson
OWNER: Kelly Johnson
TYPE OF WORK: window replacement, window screens, porch column replacement
APPLICATION RECEIVED: December 01, 2017
60-DAY REVIEW: February 01, 2018

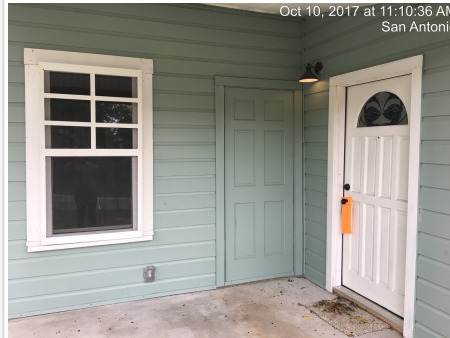
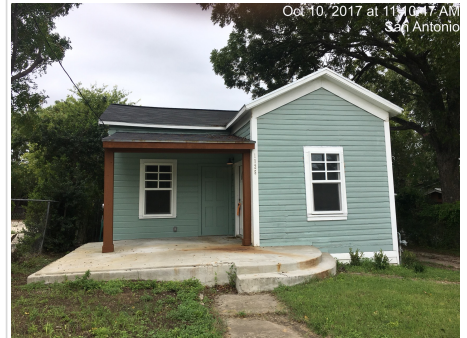
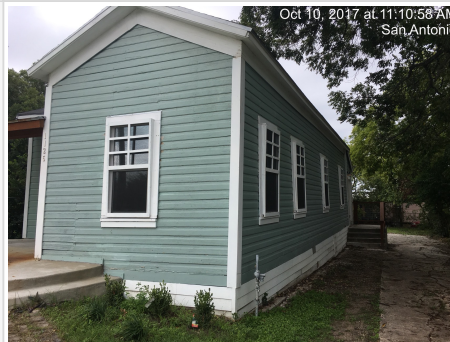
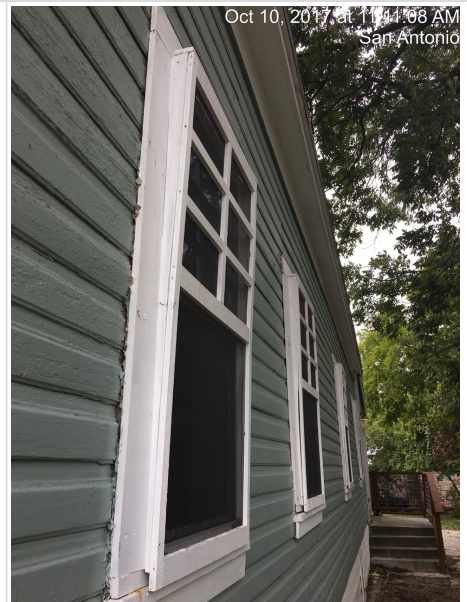
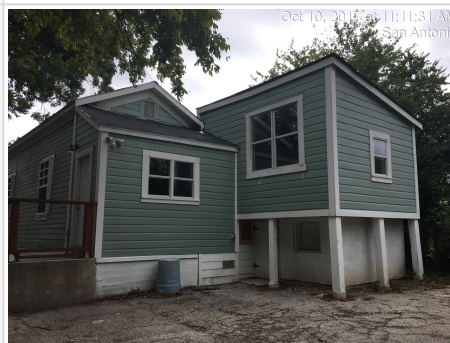
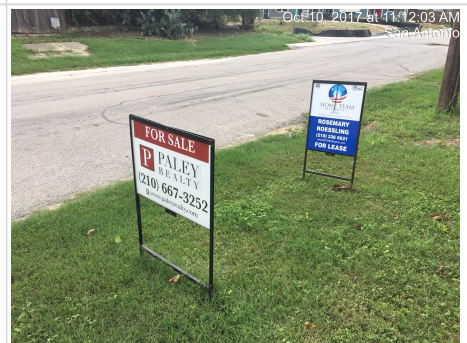
Photographs

- b. VIOLATION - According to an investigation report and site visit conducted by staff on October 10, 2017, non-original window replacement, window screen installation, and column replacement have occurred prior to receiving a Certificate of Appropriateness.

- d. WINDOW SCREENS – The applicant has proposed to install seven (7) wood window screens onto the two front-façade windows, the four driveway-side windows, and one on the opposite side elevation. The screens are framed in an unconventional way that causes them to protrude beyond the window frames. The design also features a 6-over-1 configuration that is disproportionate to traditional window lights. The Guidelines for window screens notes that replacement or installation of new screens should match in profile, design, and size to those historic found on the structure or structures with similar architecture styles. While staff finds the installation of window screens appropriate and a good solution to obscure the proposed non-original windows, the proposed protruding configuration and proportions are not consistent with the Guidelines.

- ii. Staff recommends the approval to install window screens with the stipulation that the new screens are mounted appropriately with traditional window screen hardware, inset within the window frame, and redesigned to feature a configuration that is more similar to the proportions of a traditional divided light window.
