## HISTORIC AND DESIGN REVIEW COMMISSION

**HDRC CASE NO:** 2017-646  
**ADDRESS:** 524 E EVERGREEN  
**LEGAL DESCRIPTION:** NCB 398 BLK 18 LOT 7 & E 10 FT OF 6  
**ZONING:** RM-4 H  
**CITY COUNCIL DIST.:** 1  
**DISTRICT:** Tobin Hill Historic District  
**APPLICANT:** Frank Velez/Ability Construction & Iron Works  
**OWNER:** Pedro Rodriguez  
**TYPE OF WORK:** wrought iron front yard fence  
**APPLICATION RECEIVED:** December 06, 2017  
**60-DAY REVIEW:** February 05, 2018  
**REQUEST:**

The applicant is requesting a Certificate of Appropriateness for approval to install front yard wrought iron fence at 5 feet in height.

## Investigation Report

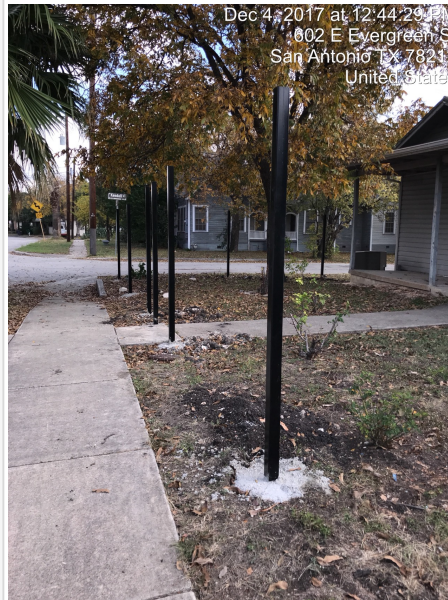
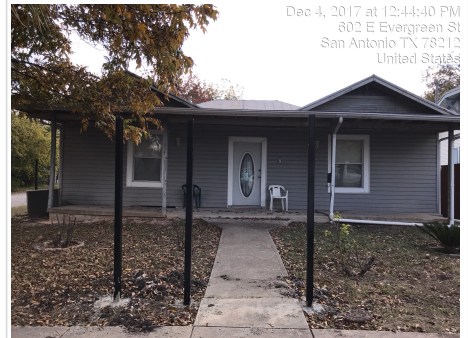
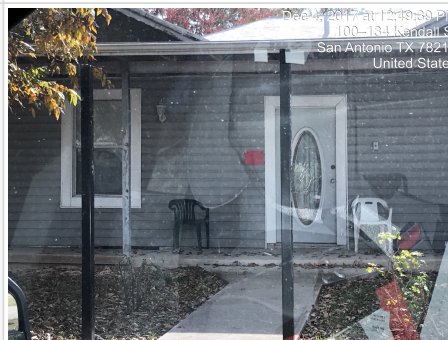
12/04/2017 12:55 PM

Date	12/04/2017
Time	12:54 PM (-6 GMT)
Present Staff	Huy Pham
Present Individuals	None
Types of Work Observed	Site Elements
Amount of Work Completed	75%
Description of work	6ft tall metal fence posts with concrete footing have been installed in front yard of home.

Violation Type	No Certificate of Appropriateness (Code 35-451a)
OHP Action	posted "Notice of Investigation"
Deadline to contact office	12/04/2017
