HISTORIC AND DESIGN REVIEW COMMISSION

HDRC CASE NO: 2017-633
ADDRESS: 413 N PINE ST
LEGAL DESCRIPTION: NCB 578 (120 BOSTON ST), BLOCK C LOT 10
ZONING: RM-4, H
CITY COUNCIL DIST.: 2
DISTRICT: Dignowity Hill Historic District
APPLICANT: Rick Archer
OWNER: Benjamin Bowman
TYPE OF WORK: Amendment to a previously approved design to include partial demolition, porch replacement and construction of a side addition
APPLICATION RECEIVED: December 01, 2017
60-DAY REVIEW: January 30, 2018
REQUEST:

RE: General Condition Inspection for purchase of residential building for issues of concern regarding: safety, function, durability habitability, structural integrity.

HDRC Application - 413 N. Pine

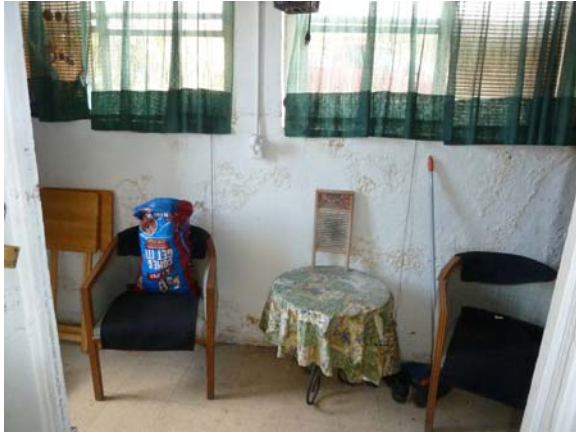
- There is a general moisture intrusion condition on the walls that are below ground. This condition is predominantly on the front and right sides where the stem walls extend below the existing exterior ground level of the first floor. There are signs of exterior moisture penetrating to the first floor living areas. On the first floor front wall, efflorescence of dissolved minerals on the surface of the front masonry wall (photo below) is evident along the entire length. There is moisture on the wall to the touch and a general high humidity condition throughout along with a detectable mildew odor.

Efflorescence from exterior moisture, front wall.

runoff water collecting around and under the foundation. The moisture condition is detrimental to the durability of the foundation and should be mitigated with a French drain or other methods to eliminate the intrusion of moisture to the habitable areas. Structure of the original house (not including the “Addition” along the left side) is in good condition. There are some areas where the rafters have been affected by moisture intrusion at the soffit areas; however these do not appear to be extensive throughout the roof structure.

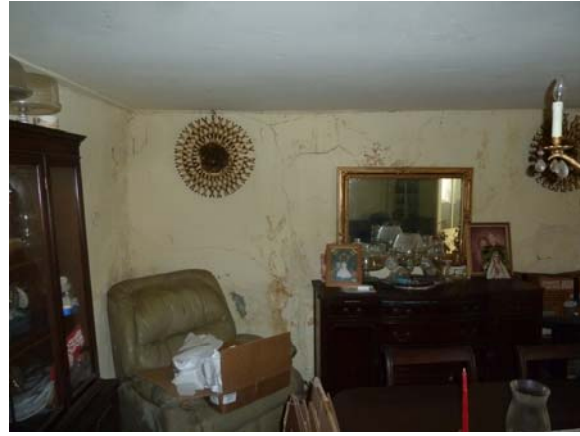
- All other interior walls, away from the exterior walls, on the first floor, show signs of moisture intrusion. It appears that the moisture is coming from the below and rising up in the walls through capillary action. This is the general condition throughout the first floor.

Interior first floor wall showing moisture.

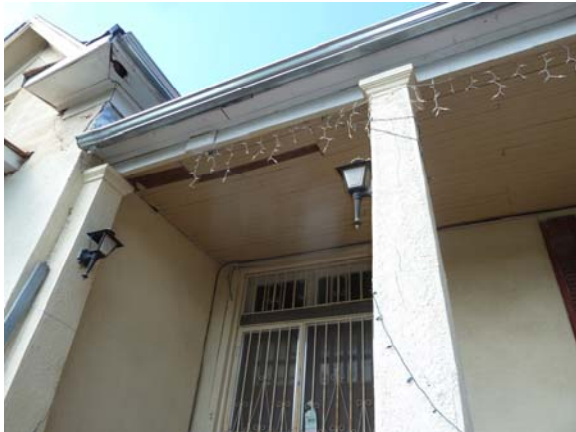
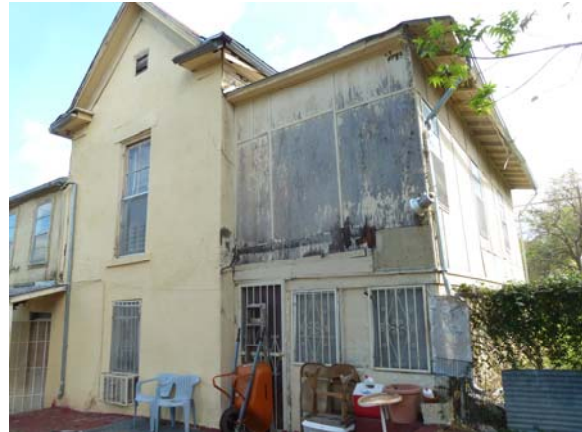
- Original wood porch covers, soffits, fascia, and other exposed wood have been degraded over the years from exposure to natural environmental factors. It is estimated that there may be as much as 70% or more of the exterior trim materials that need to be replaced. Much of the wet and dry rot is un-observable without additional destructive testing.
- The “Addition” on the left side, shows signs of significant degradation of wood materials from the exterior. This part of the house appears to have been added at a later date and was not built with the same materials or methods as the original part.

Wood rot of trim materials and possible rot of underlying structural members especially on the “Addition”.

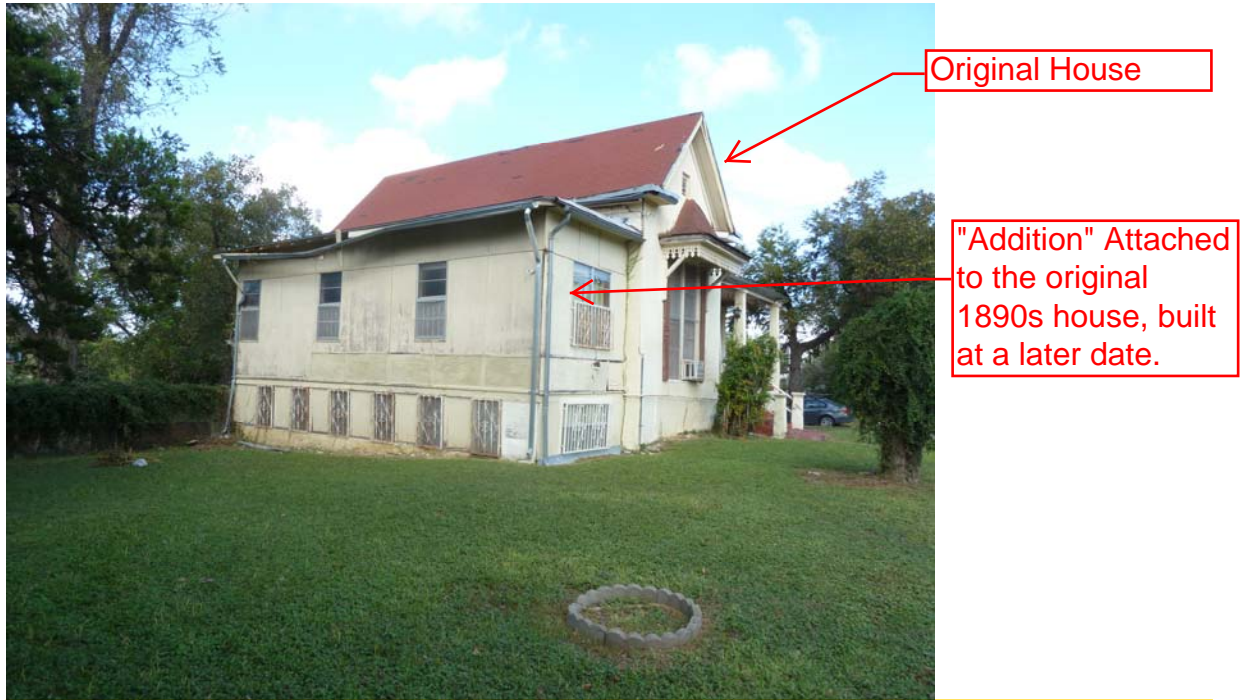
- Roof structure of the “Addition” was not observable due to the shed type roof construction. There were significant sagging areas of the Addition ceiling indicating that there may be significant degrading of the wood rafters above and to the connection point to the original structure.

Addition and attachment to original house showing low sloped roof and sources of leaks at attachment point. There are many areas on the exterior that are showing signs of degradation from the plywood construction. Interior wood framing and floor structures may be affected from the intrusion of moisture through the degrading and rotting plywood sheathing.

“Addition”: The “Addition” part of the house is substantially different from the original house construction. The low sloped roof is leaking at the attachment point to the original house and there are many sources of moisture intrusion from degrading sheathing materials. Sagging ceilings and soft rotting areas of the floors are indicative of significant rotting of underlying structural members. These conditions are in a large way inherent in the way the “Addition” was constructed. Roof areas of the “Addition” are nearly flat and there is a significant possibility that the roof structure will have to be substantially altered or removed in order to repair damage to the underlying rafters and connection to the main house.

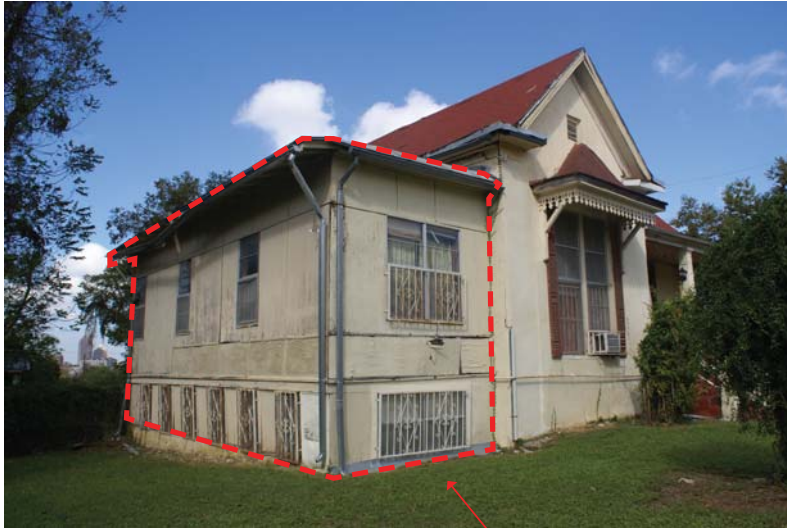
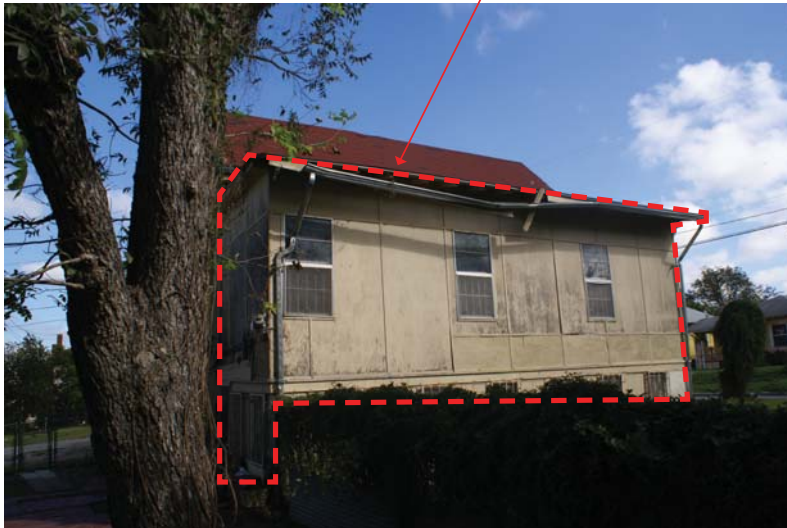
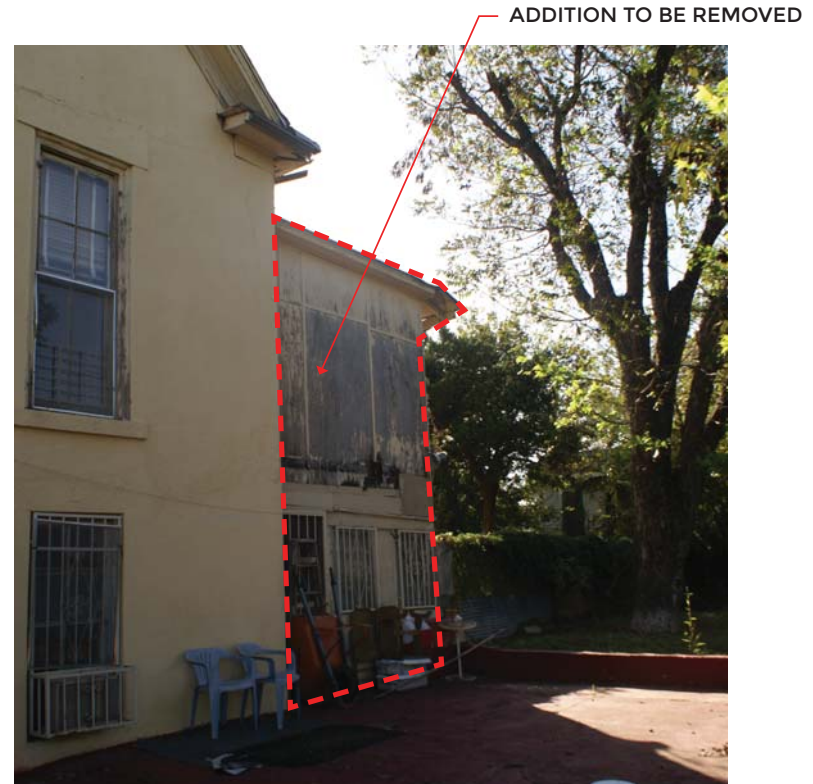
ADDITION TO BE REMOVED

“ On the “Addition” there is a low level of functional structural integrity. Repair of rotting and degrading wood members is imperative for the functional performance of the “Addition”. Due to moisture intrusion, it is possible that there are areas or the “Addition” roof structure that are significantly compromised in strength at the attachment point with the main house. This area should be investigated as soon as possible to verify the level of structural integrity for safety concerns. ”

- REMOVE EXISTING ADDITION INCLUDING FLAT ROOF AND STRUCTURALLY COMPROMISED WOOD CONSTRUCTION. EXISTING BELOW-GRADE MASONRY (CINDER BLOCK) RETAINING WALL TO REMAIN.

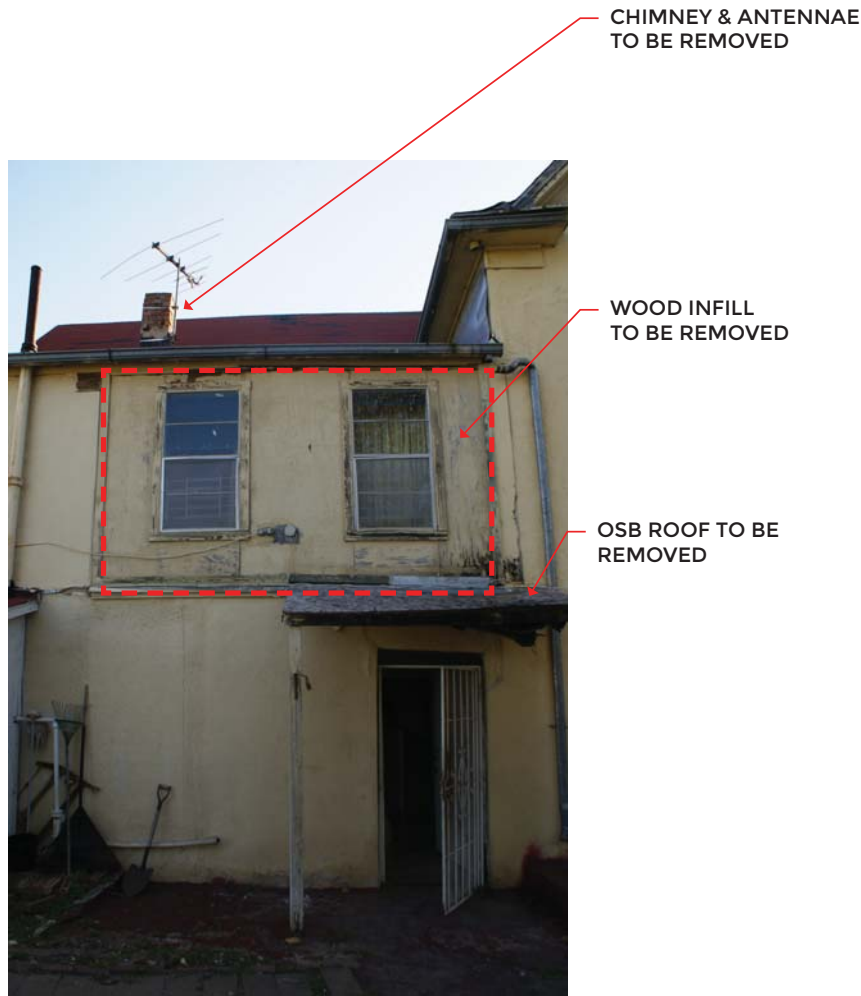
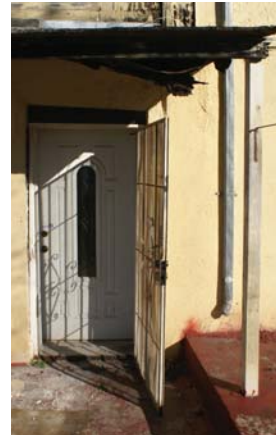
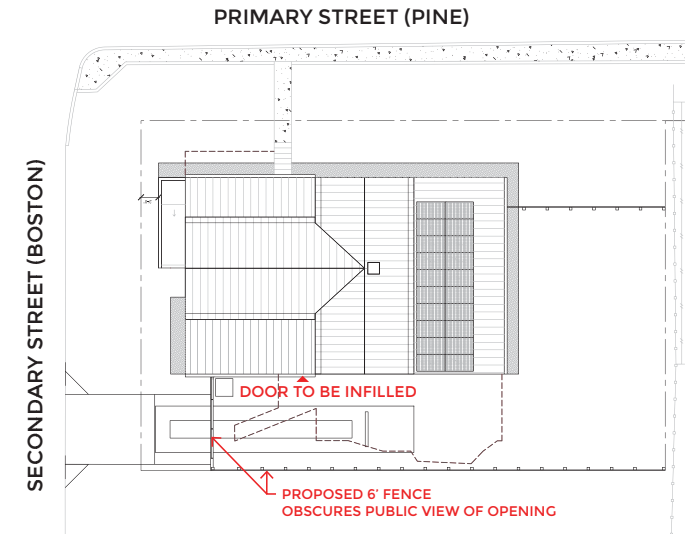
“ The back porch cover structural members are degrading from exposure to moisture. The failure of the support is could occur at any time allowing the porch roof to fall. It is imperative that this area be either temporarily reinforced or removed.

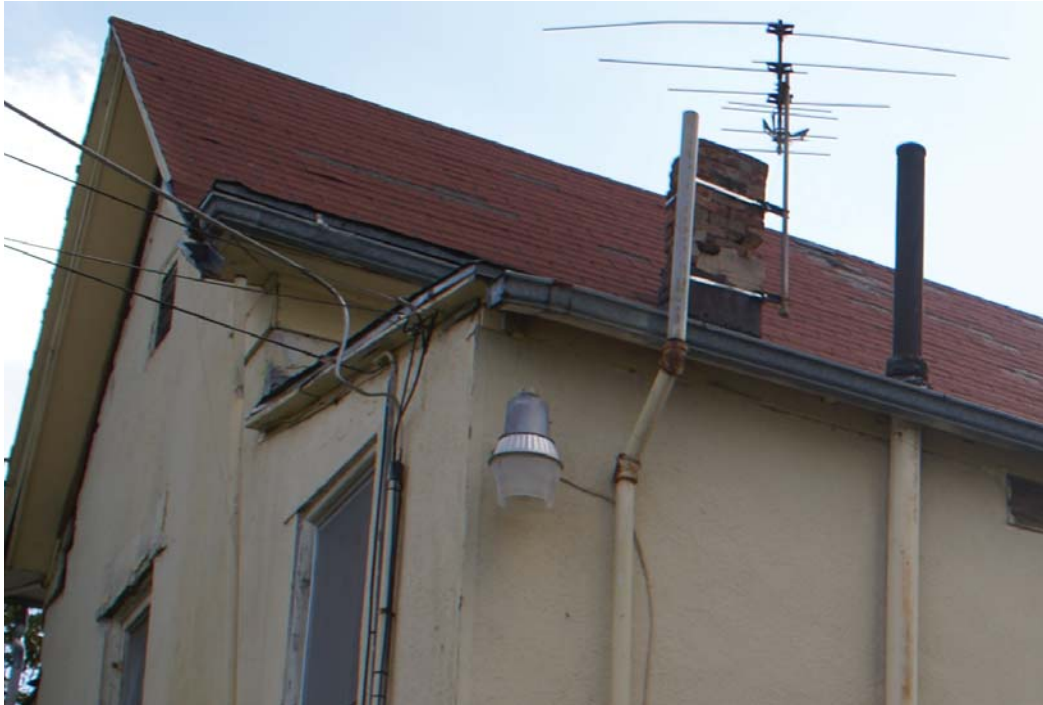
ABANDONED CHIMNEY TO BE DISASSEMBLED AND ENCAPSULATED BELOW ROOFLINE
