HISTORIC AND DESIGN REVIEW COMMISSION

February 07, 2018

HDRC CASE NO: 2018-043
ADDRESS: 722 MASON ST
LEGAL DESCRIPTION: NCB 1276 BLK 8 LOT 6
ZONING: R-5, H
CITY COUNCIL DIST.: 2
DISTRICT: Government Hill Historic District
APPLICANT: Jesse Amado
OWNER: Jesse Amado
TYPE OF WORK: Install window in existing dormer
APPLICATION RECEIVED: January 18, 2018
60-DAY REVIEW: March 17, 2018

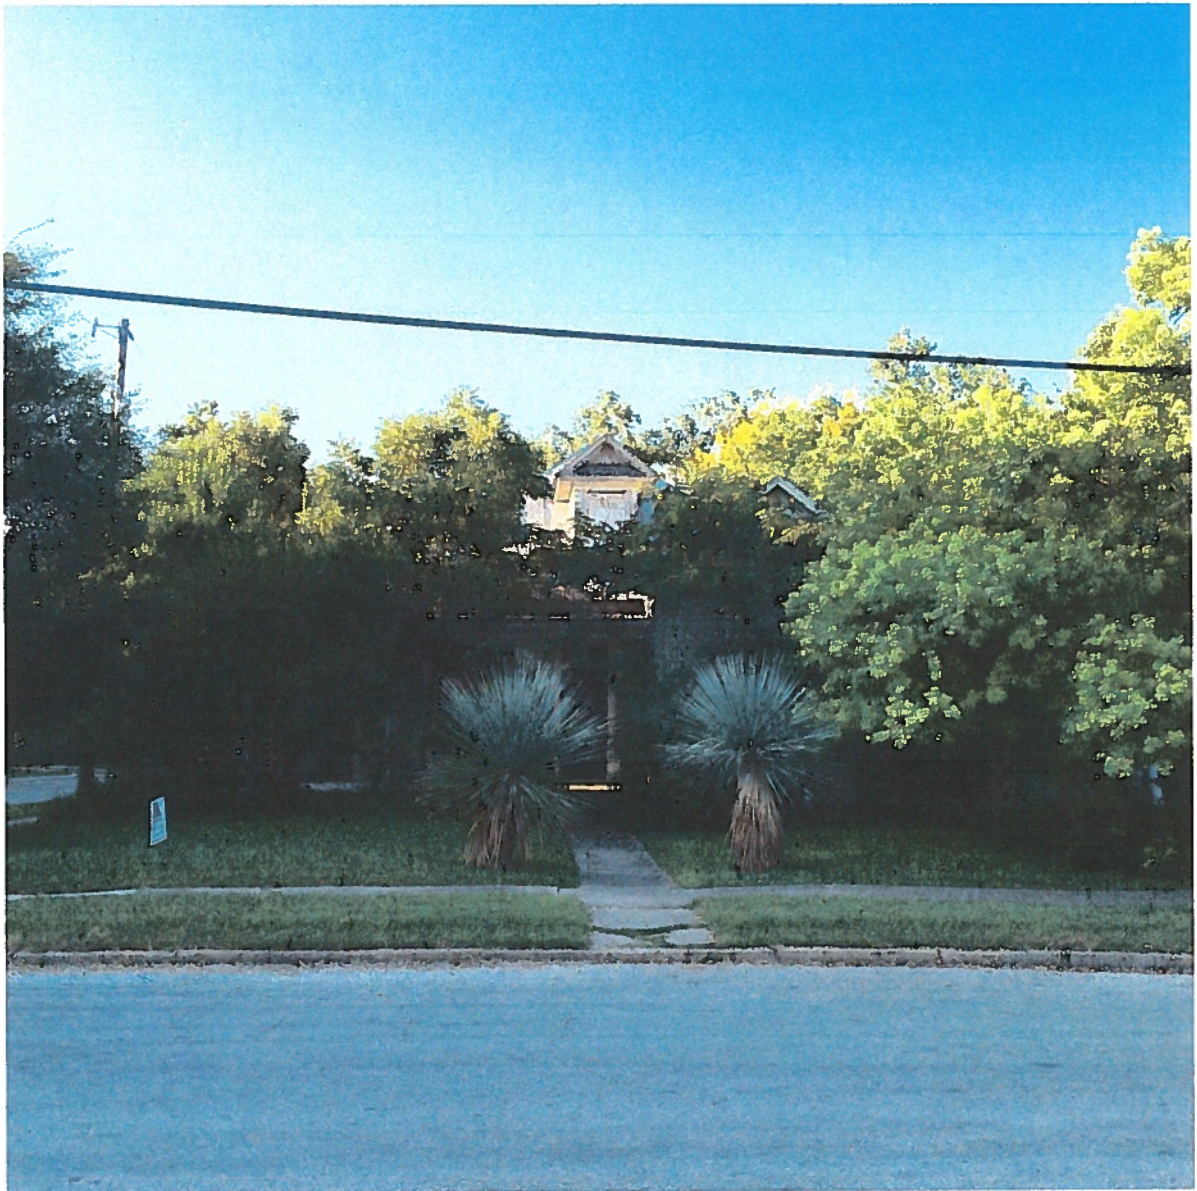
722 MASON ST
ORIGINAL CONDITION

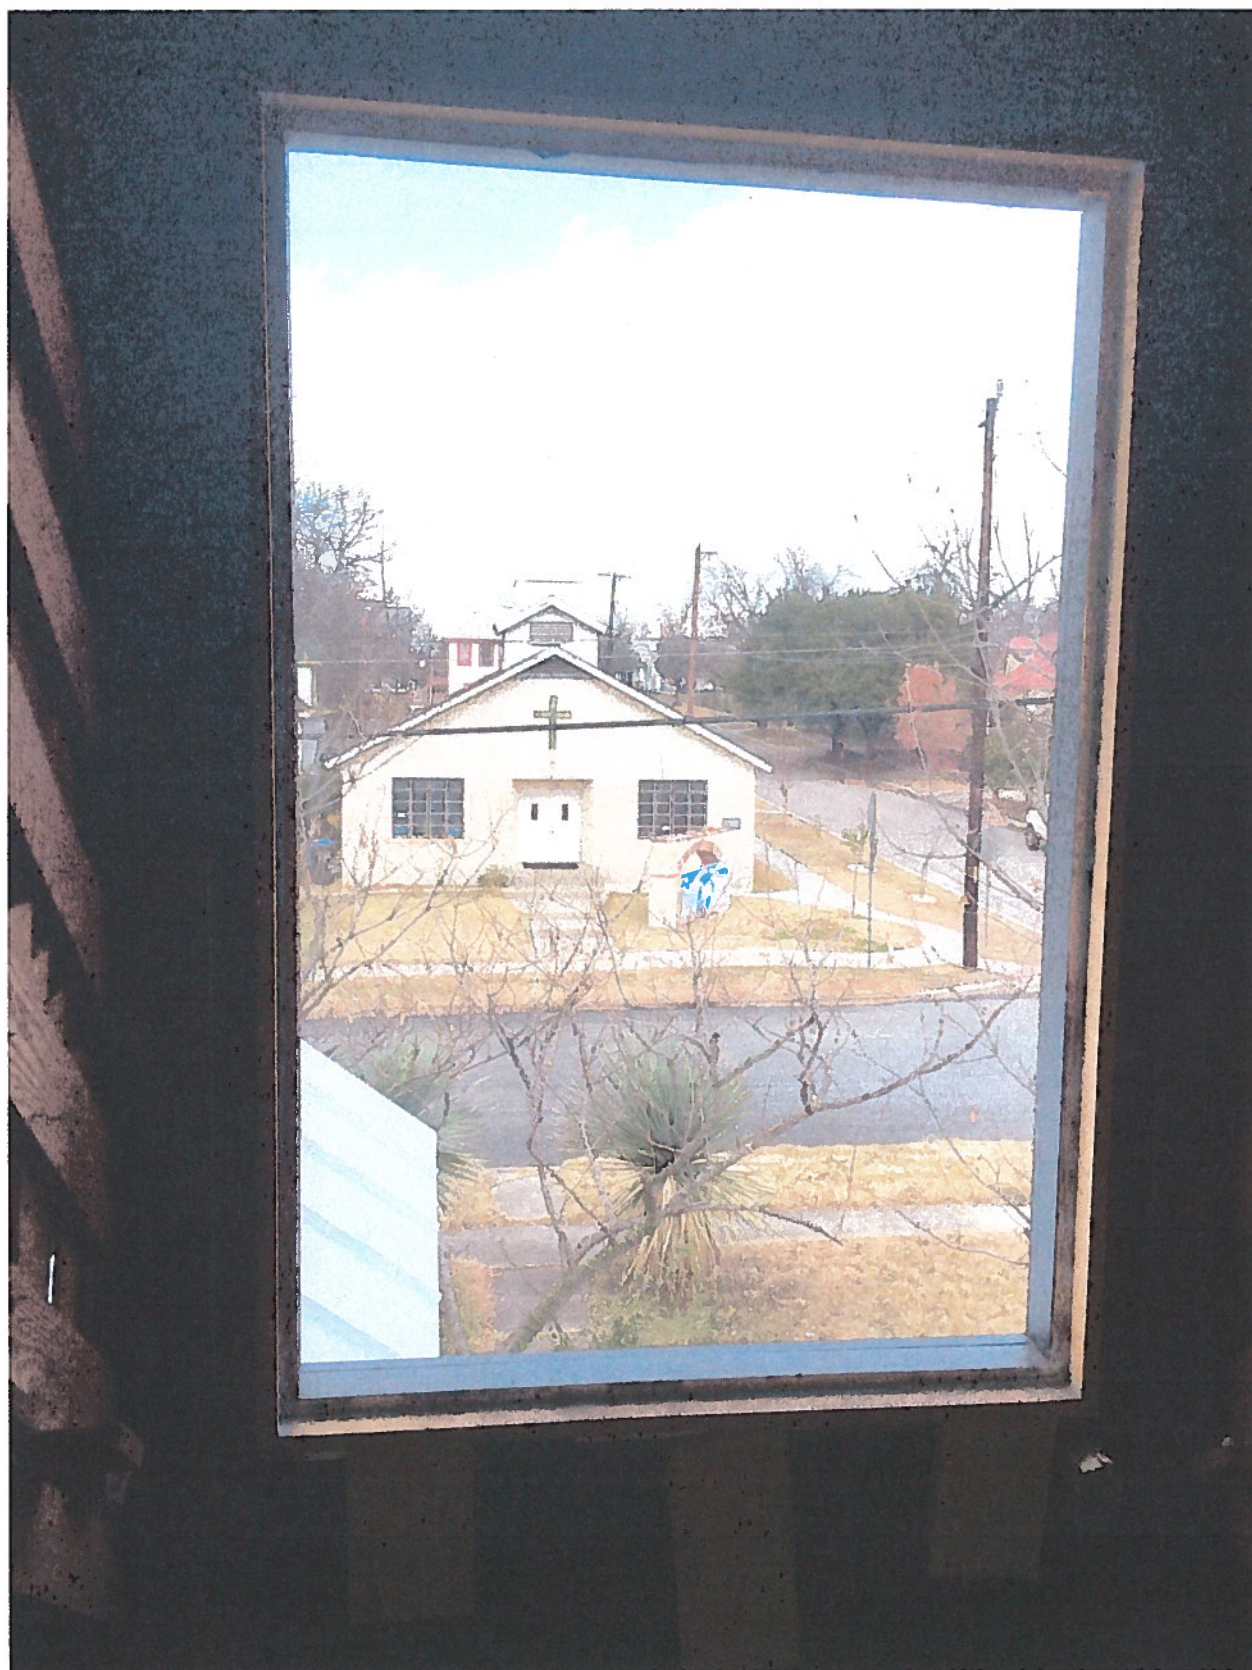
INTERIOR OF WINDOW REPLACEMENT
WITH REPAIRED ~~THE~~ FRAMING.

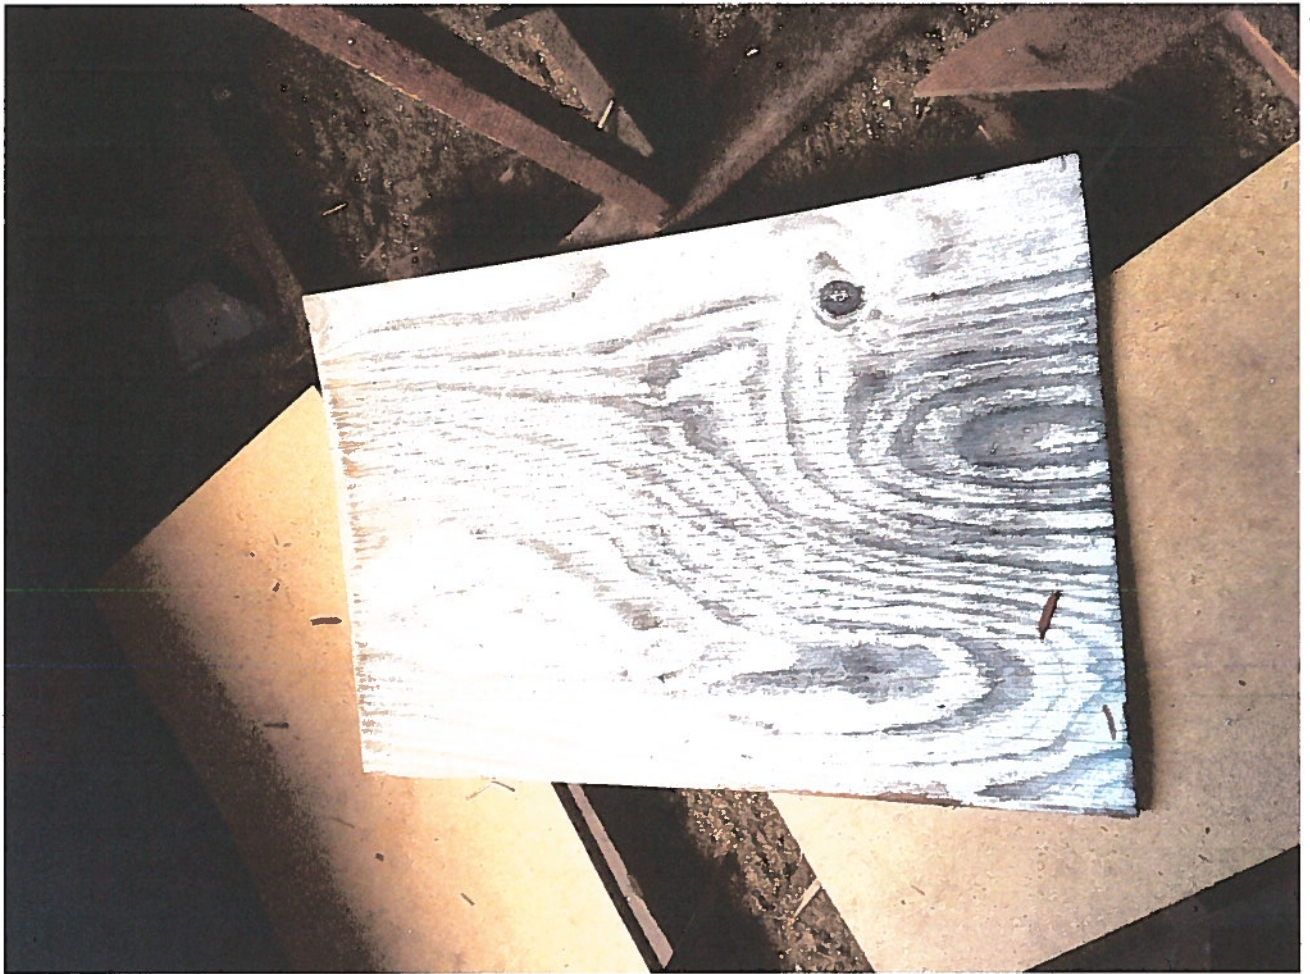
- b. **DORMER** – The applicant has installed a single-light fixed window into the dormer prior to approval. Photographs show that the window opening had been boarded with plywood since at least 2008. The Guidelines for Windows 6.B.vii notes that non-historic incompatible windows should be replaced with windows that are typical of the architectural style of the building. Given that there is evidence that a window was not installed in the dormer for a number of years, staff finds that the installed fixed window is an improvement upon the previous plywood boarding. Staff also finds that a wood window screen comparable to the configuration of a double-hung window would be an appropriate to restore the character of the historic dormer.

PLYWOOD BOARD previously covered
window.

Staff recommends the approval to install a fixed window into the dormer window opening based on finding b with the stipulation that a wood window screen of a traditional configuration also be installed to minimize the visual impact of the new window.
