## HISTORIC AND DESIGN REVIEW COMMISSION

**HDRC CASE NO:** 2018-044  
**ADDRESS:** 170 HERMINE BLVD  
**LEGAL DESCRIPTION:** NCB 9007 BLK 13 LOT 5&6  
**ZONING:** R-4, H  
**CITY COUNCIL DIST.:** 1  
**DISTRICT:** Olmos Park Terrace Historic District  
**APPLICANT:** Joseph Gamez  
**OWNER:** Joseph Gamez  
**TYPE OF WORK:** Window replacement, concrete patio and driveway installation  
**APPLICATION RECEIVED:** January 22, 2018  
**60-DAY REVIEW:** March 21, 2018

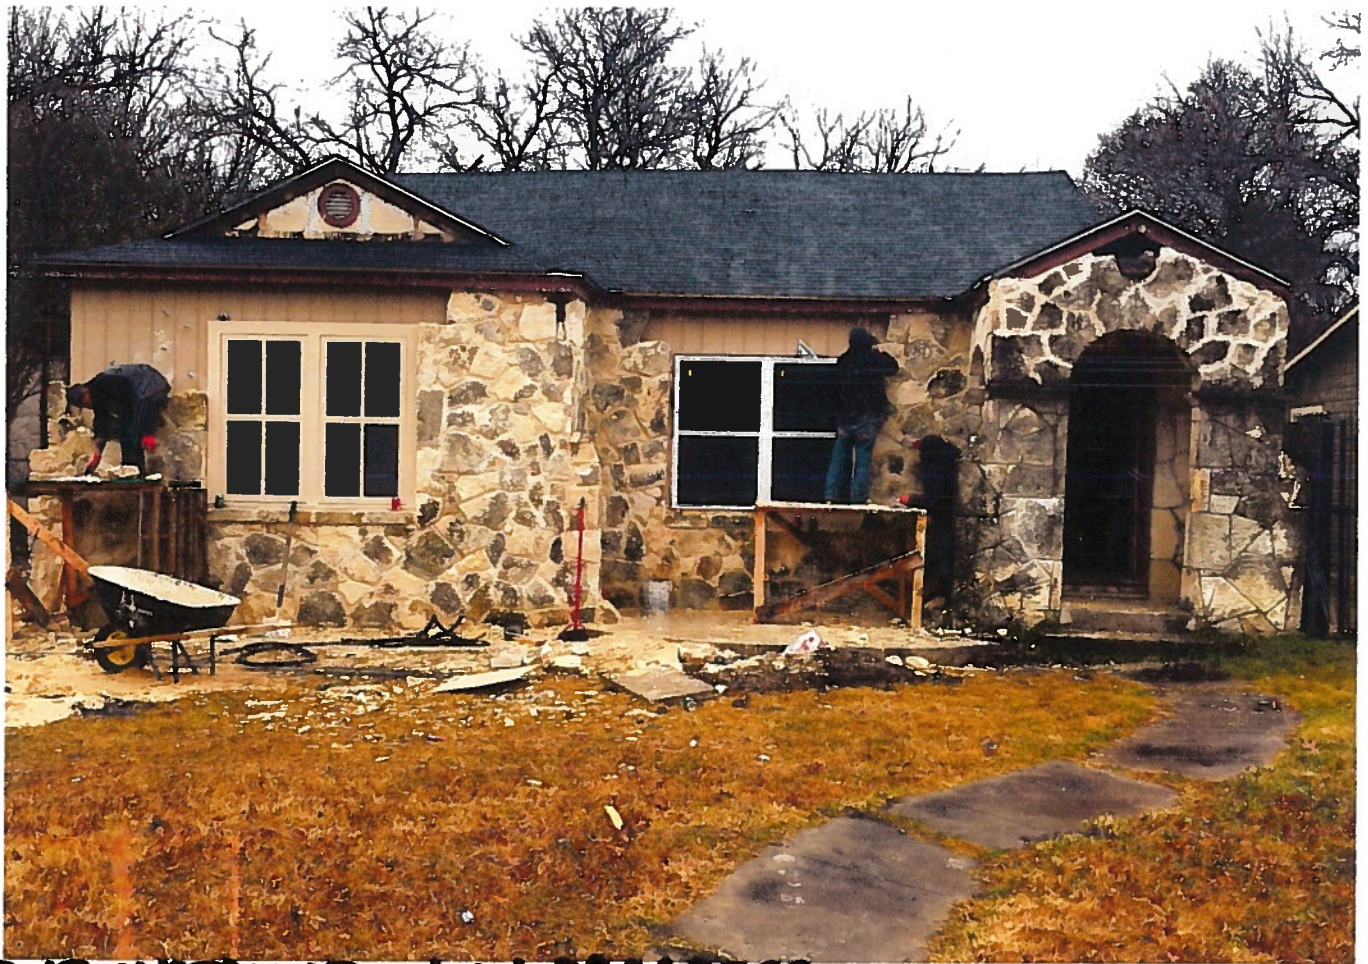
**STONE INSTALLATION IN PROGRESS**

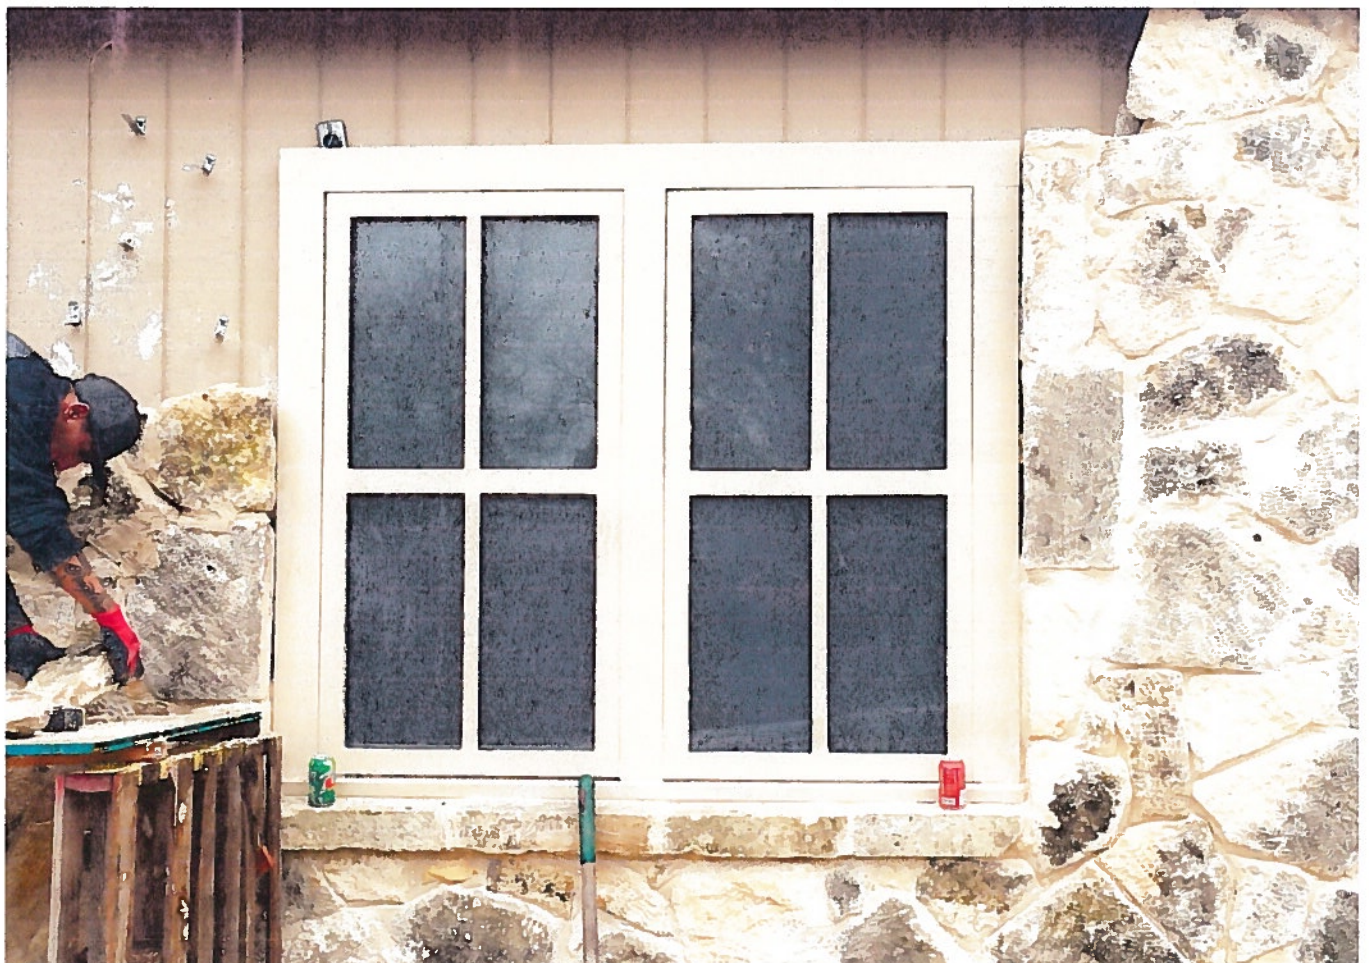
**WINDOWS PAINTED**

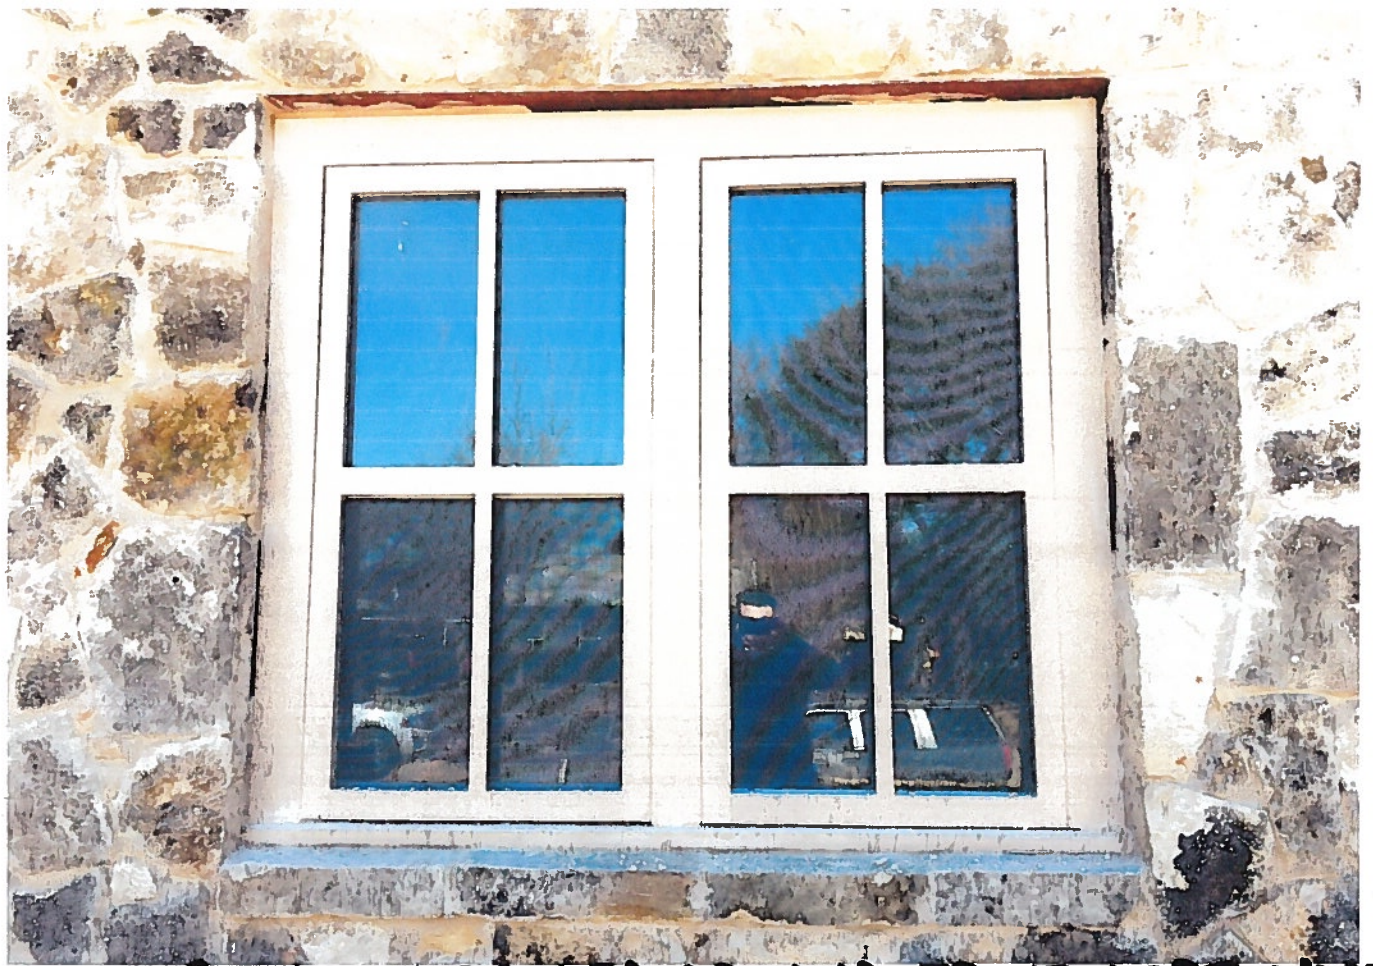
**STONE INSTALLED AROUND FRONT LEFT WINDOW**

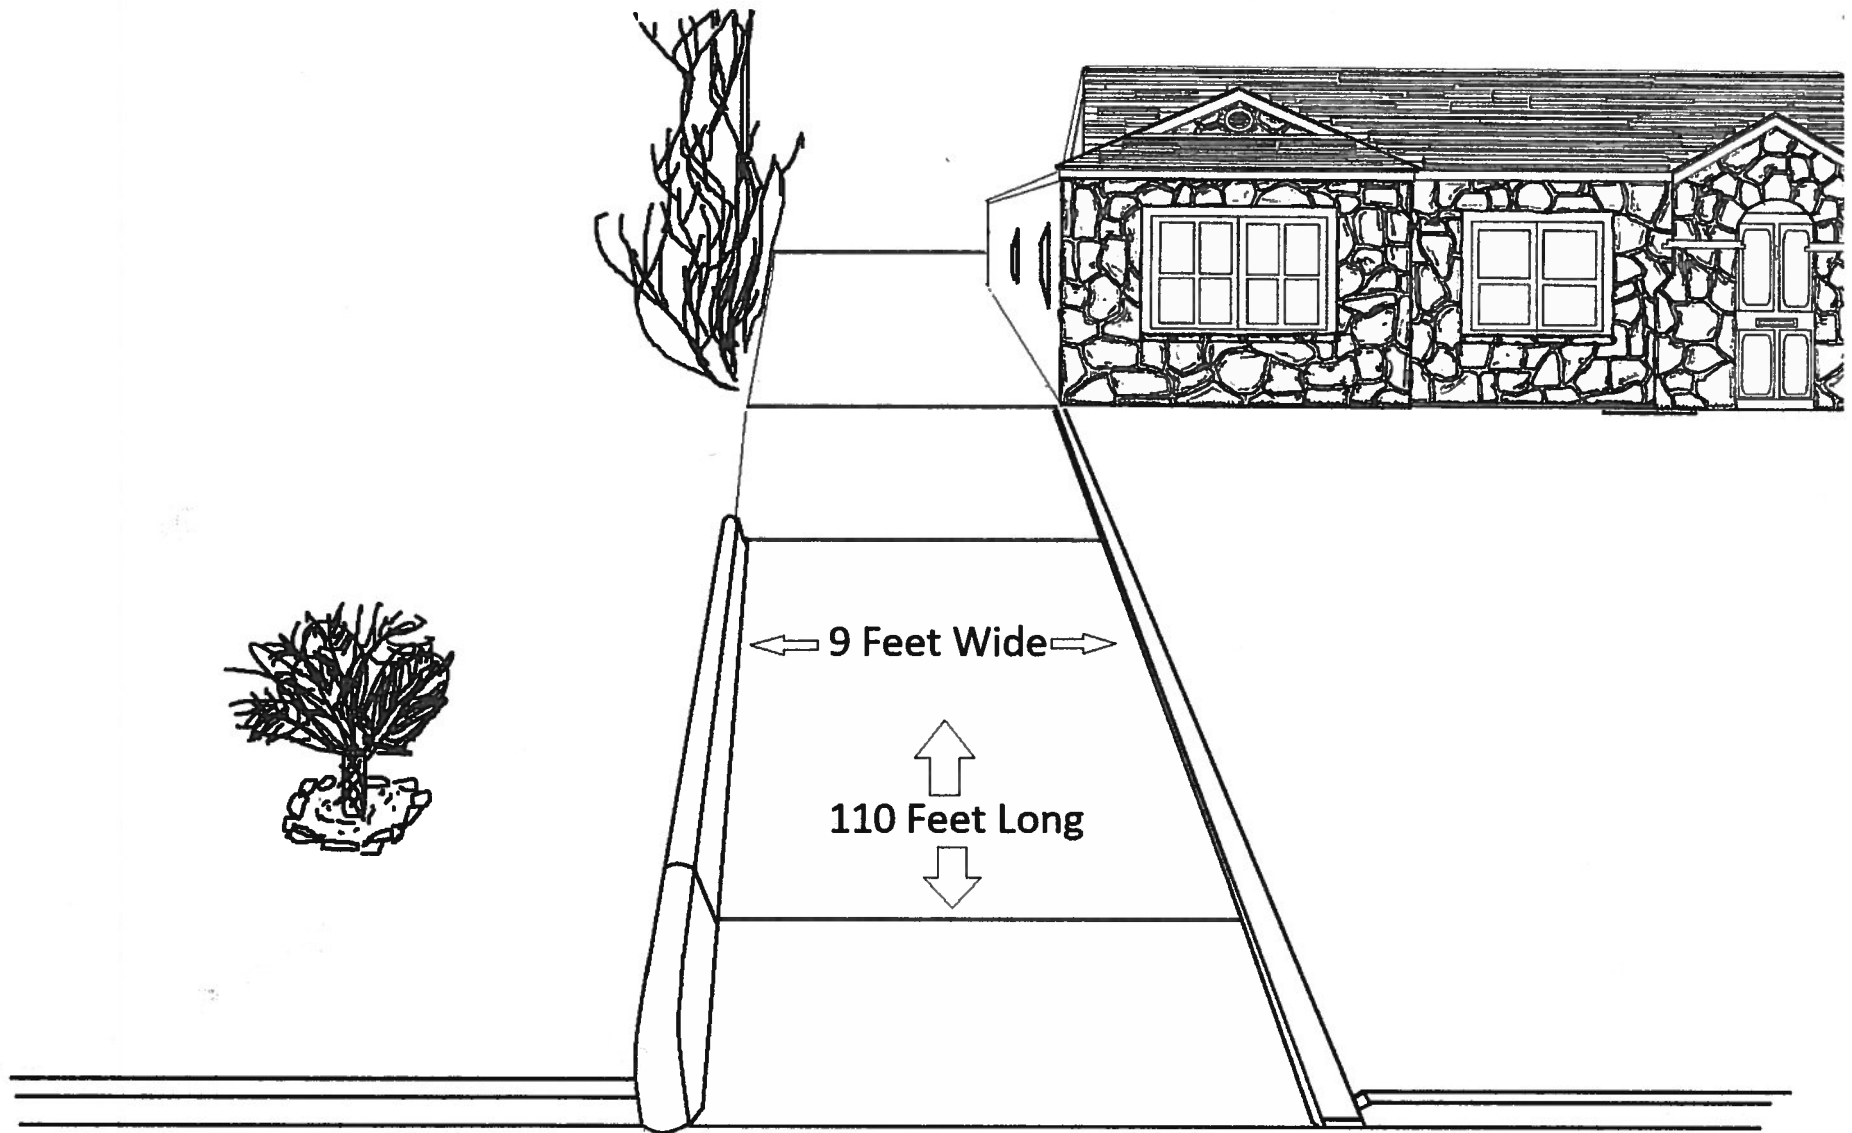
- e. **DRIVEWAY** – The applicant has proposed to install a concrete driveway to replace the existing, unpaved gravel driveway. The proposed driveway will feature 9 feet in width and 110 feet in length. Per the Guidelines for Site Elements 5.B.i, new driveway configurations should be similar in material, width, and design to that historically found on the site and that pervious paving surfaces may be considered where replacement is necessary. Given that the surrounding properties also include fully paved or concrete ribbon strip driveways, staff finds the proposed driveway appropriate.

170 HERMINE BLVD.  
SAN ANTONIO, TX 78212  
**PROPOSED CONCRETE DRIVEWAY**

2. Staff does not recommend the installation of the concrete patio based on finding d. Staff recommends the immediate removal of unapproved work.
3. Staff recommends approval of the concrete driveway as proposed based on finding e.
4. Staff does not recommend approval of the addition at this time based on finding f. The applicant can resubmit when the proper construction documents are provided.

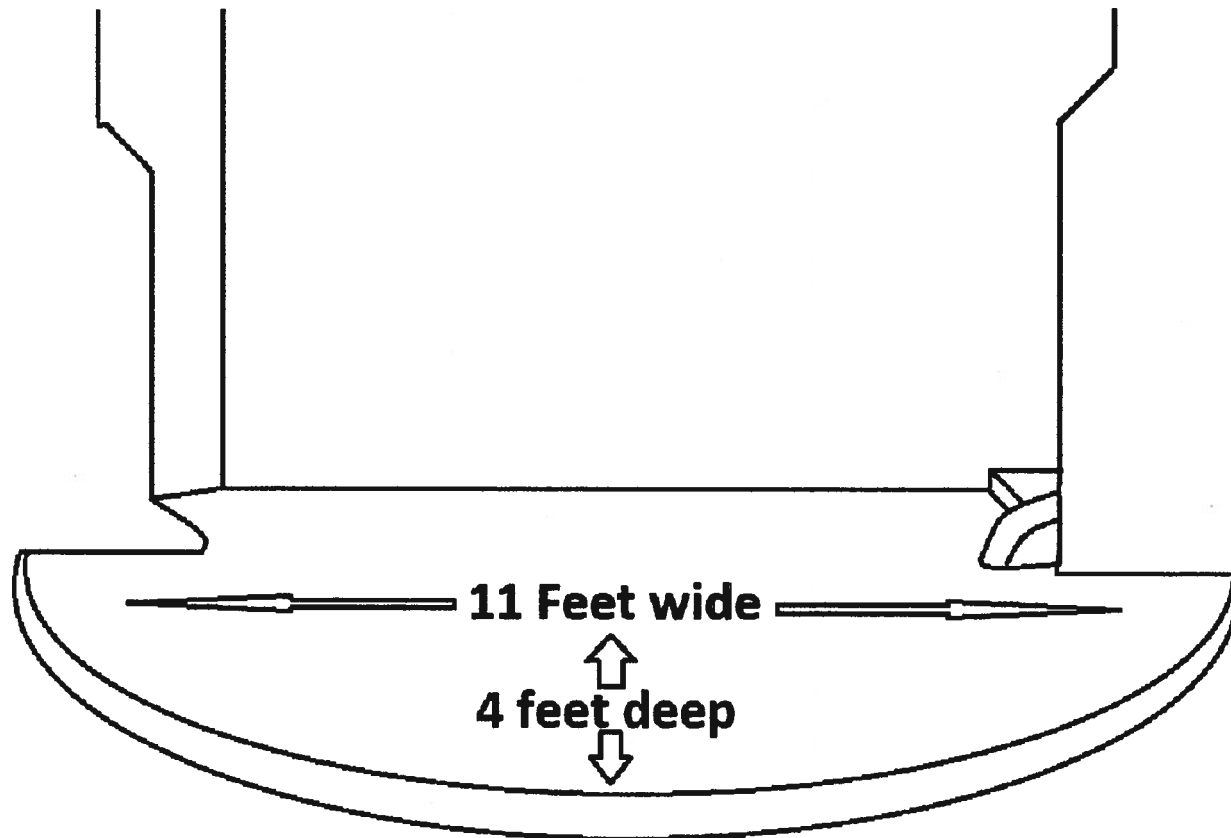
- d. **PATIO** – The applicant has partially installed a concrete rounded patio centered to the front façade.. Staff finds that there is no evidence of an existing patio in this location or configuration associated with this structure or its architectural style. Staff does not find the patio consistent with the Guidelines for Site Elements 7.B.

170 HERMINE BLVD.  
SAN ANTONIO, TEXAS 78212  
**NEWLY INSTALLED PATIO**
