HISTORIC AND DESIGN REVIEW COMMISSION

February 07, 2018

HDRC CASE NO: 2018-034
ADDRESS: 121 BUFORD
LEGAL DESCRIPTION: NCB 1369 BLK 6 LOT S 81.3 FT OF 5
ZONING: R-4, H
CITY COUNCIL DIST.: 2
DISTRICT: Dignowity Hill Historic District
APPLICANT: Ryan McWhirter/LUSH Greenscape Design
OWNER: Chris H. Williams Laura Lopez
TYPE OF WORK: Front yard site elements
APPLICATION RECEIVED: January 17, 2018
60-DAY REVIEW: March 16, 2018
REQUEST:

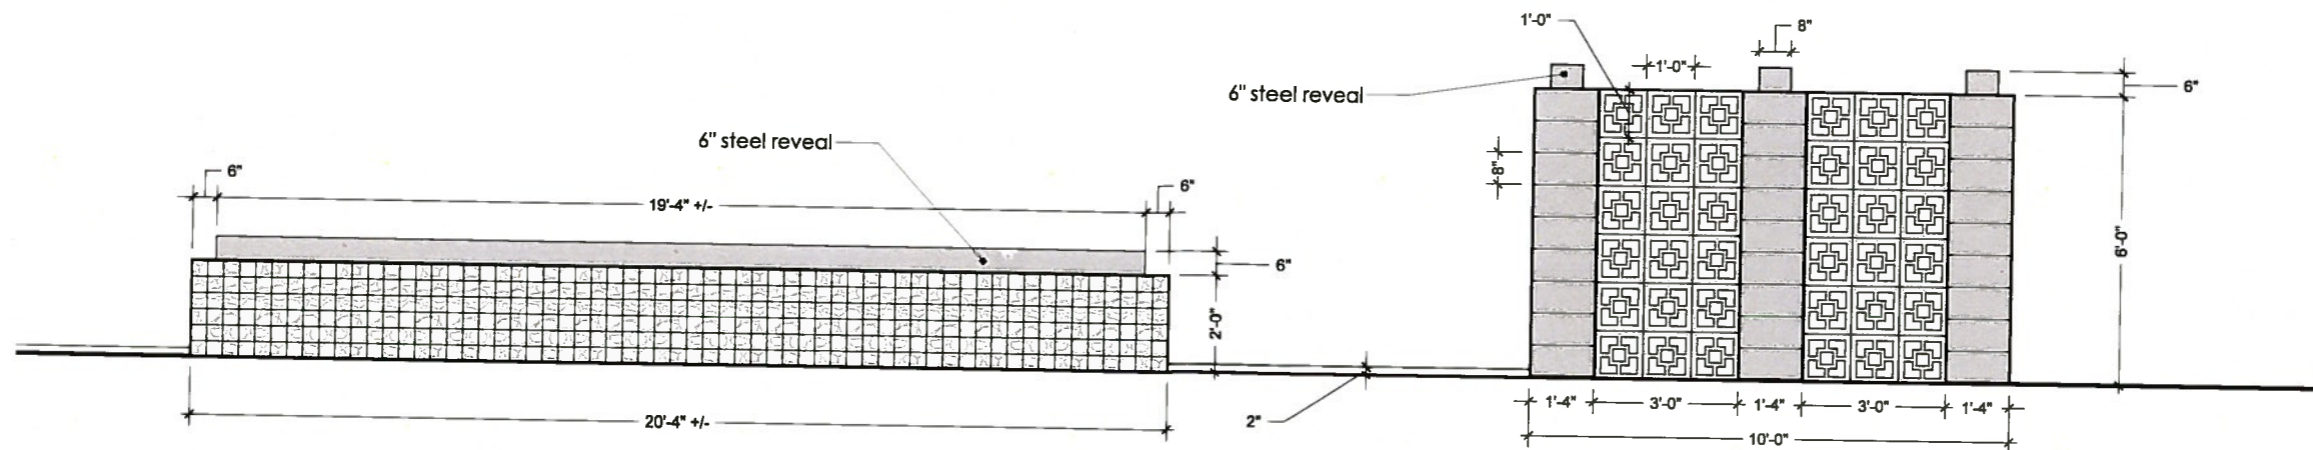
entry elevation
scale: 1/4" = 1'-0"

- i. **GABION WALL/ROCK PLANTER**– The applicant has installed a gabion wall prior to approval. The gabion wall features a steel cage filled with river rock (20’4” long, 36” deep, 24” tall) and is topped with a steel planter (19’4” long, 24” deep, 6” tall). The planter is proposed to feature black bamboo which will add up to 6 feet in height per the illustrations. Per the Guidelines for Site Elements 2.B.i, new walls should appear similar to those used historic within the district in terms of their scale, transparency, and character and that the design should respond to the design and materials of the house or main structure. Staff finds that there is absolutely no historic precedent on Buford Alley and its immediate neighboring blocks, nor the Dignowity Hill Historic District, nor the minimal traditional architecture style that calls for the installation of a gabion wall nor bamboo plantings that would screen a majority of the front façade.

- j. **MASONRY WALL/SOLAR SCREEN** – The applicant has installed a solar screen prior to approval. The solar screen (10’ wide, 6’ tall) features two perforated masonry panels between three CMU columns topped with 6” steel planters. The planters are proposed to feature giant hesperaloe which will add up to 2 feet per the illustrations. Per the Guidelines for Site Elements 2.B.i, new walls should appear similar to those used historically within the district in terms of their scale, transparency, and character and that the design should respond to the design and materials of the house or main structure, (2.B.iii) new walls are limited to four feet in height in the front yard, and (3.B.iv) concrete masonry units and concrete blocks are expressly prohibited construction materials for new fences and walls. Staff finds that there is no historic precedent on Buford Alley, within the Dignowity Hill Historic District or associated with the structure’s architecture style to support this installation.

8. Staff does not recommend the installation of a gabion wall that features bamboo plantings. Staff recommends the gabion wall be removed. The applicant may submit to staff a front yard fence design that is consistent with the Guidelines.

9. Staff does not recommend the installation of a solar screen as proposed. Staff recommends the solar screen be removed. The applicant may resubmit to staff a front yard fence design that is consistent with the Guidelines.

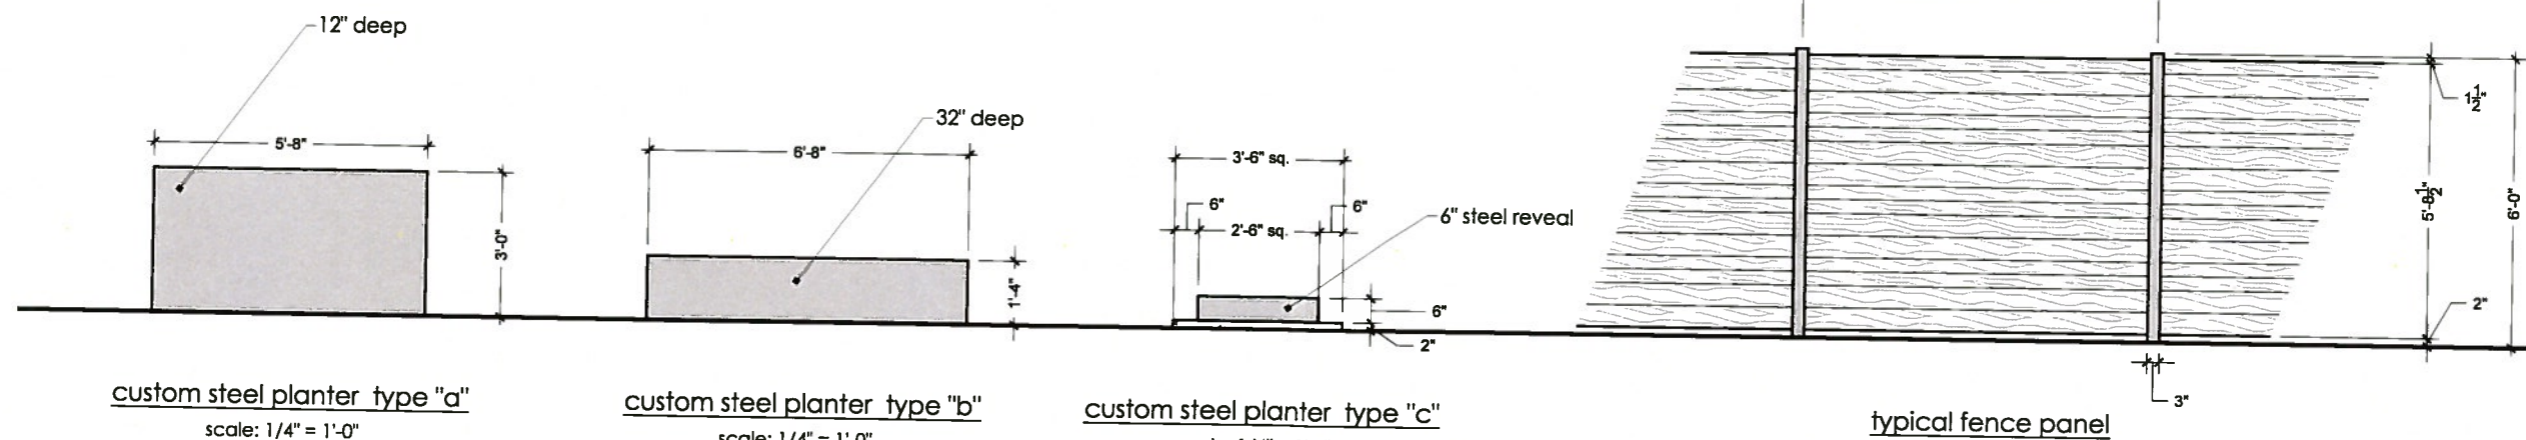
- b. FENCE – The applicant received administrative approval to install a privacy fence, featuring metal posts, and horizontal cedar planks to feature six feet in height in the rear and four feet in height past the rear plane of the front porch. The applicant has proposed a height beyond rear plane of the front porch of six feet in height to the public right of way. The applicant has failed to adhere to the administratively approved fence plan and has previously constructed a six foot tall fence in the front yard. Staff finds this request is inconsistent with Guidelines for Site Elements 2.B.iii., 2.C.i and ii.

- f. STEEL PLANTER (BELOW WINDOW) – The applicant has installed a steel planter (68” long, 12” deep, 26” tall) prior to approval. The planter is located below the front façade window. Staff finds that the proposed massing and material of the planter is inconsistent with Guidelines for Site Elements 1.A.iii. The height of this planter should feature wood construction instead of steel and be reduced to match the height of the planter requested in finding g.

- g. STEEL PLANTER (BY PORCH)- The applicant has installed a steel planter (80” long, 32” deep, 16” tall) prior to approval. The planter is located adjacent to the front porch and steps. Staff finds that the proposed material of the planter is inconsistent with Guidelines 1.A.iii. The planter should feature wood construction instead of steel.

- h. CONCRETE PLANTER – The applicant has proposed to install a low-ground concrete planter with a steel skirt (30” long, 30” deep, 6” tall). The applicant has not begun this installation as of February 2, 2018. Staff finds that

1. Staff does not recommend approval of the proposed to amend the previously issued administrative Certificate of Appropriateness to allow 6-foot tall fencing beyond the rear plane of front porch. The approved design should be adhered to.

5. Staff does not recommend the installation of the steel planter beneath the window as proposed. Staff recommends the applicant resubmit a planter design that features wood construction and a reduced height.

6. Staff does not recommend the installation of a steel planter adjacent to the porch and steps as proposed. Staff recommends the applicant resubmit a planter design that features wood construction.

7. Staff does not recommend the installation of the low-ground concrete planter with a steel skirt. Staff recommends the applicant resubmit a planter design that features wood construction.

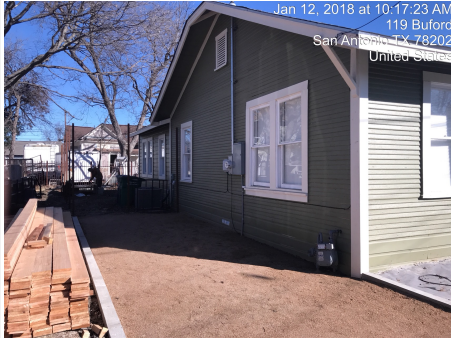
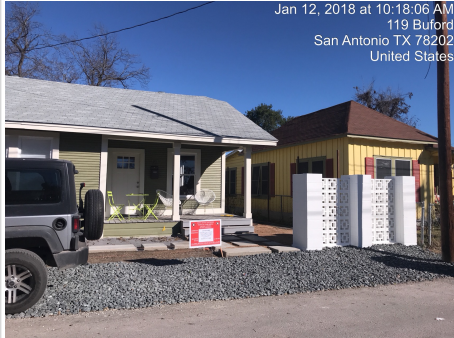
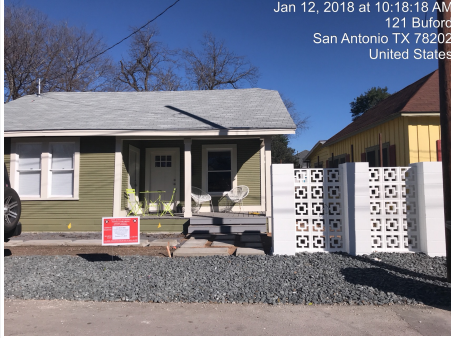
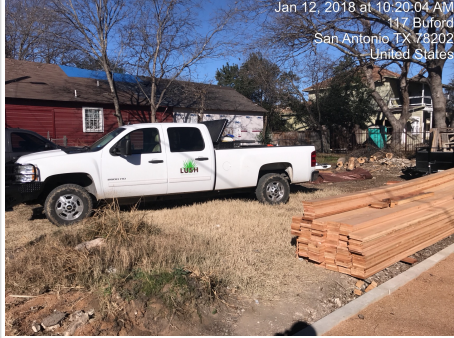
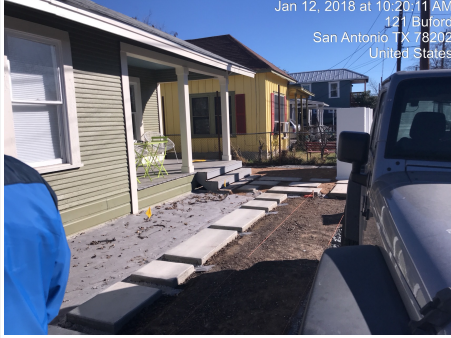
01/12/2018 10:51 AM

Date	01/12/2018
Time	10:47 AM (-6 GMT)
Present Staff	Huy Pham, Edward Hall
Present Individuals	Homeowner, Contractor(s)
Present Companies	Lush (fence)
Types of Work Observed	Site Elements
Amount of Work Completed	75%
Description of work	Initiated installation of rear and front yard fence with steel posts and wood pickets, and completed constructed of decorative CMU wall in front yard.

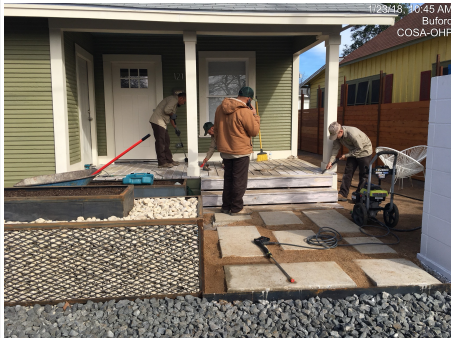
Date	01/23/2018
Time	10:46 AM (-6 GMT)
Present Staff	Huy Pham, Edward Hall
Present Individuals	Contractor(s), Crew member(s)
Present Companies	LUSH Landscaping
Types of Work Observed	Site Elements
Amount of Work Completed	75%
Description of work	Continued work without approval for front yard modifications including concrete pavers, metal planters, and site work.
