HISTORIC AND DESIGN REVIEW COMMISSION

June 20, 2018

HDRC CASE NO: 2018-291
ADDRESS: 607 PIEDMONT AVE
LEGAL DESCRIPTION: NCB 1404 BLK 2 LOT 6 & 7
ZONING: RM-4,HL
CITY COUNCIL DIST.: 2
LANDMARK: New Light Baptist Church
APPLICANT: Odie Davis/Proline Construction
OWNER: New Light Baptist Church
TYPE OF WORK: Replacement of standing seam metal roof with shingles
APPLICATION RECEIVED: June 01, 2018
60-DAY REVIEW: July 31, 2018
REQUEST:

The applicant is requesting a Certificate of Appropriateness for approval to replace the existing standing seam metal roof with a new shingle roof.

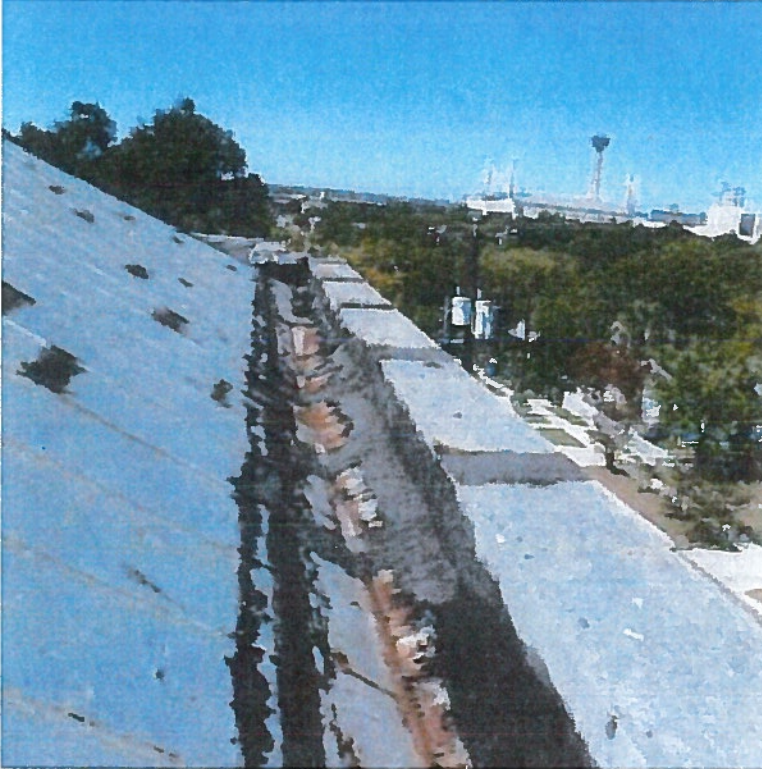
31

Overview of right slope of metal roof.

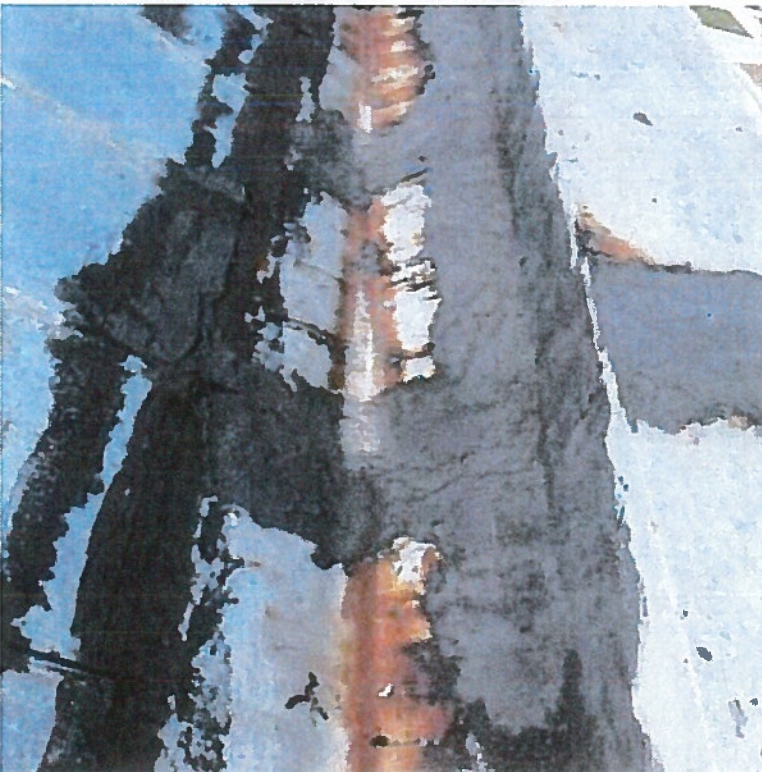
32

Close up of right slope of metal roof.

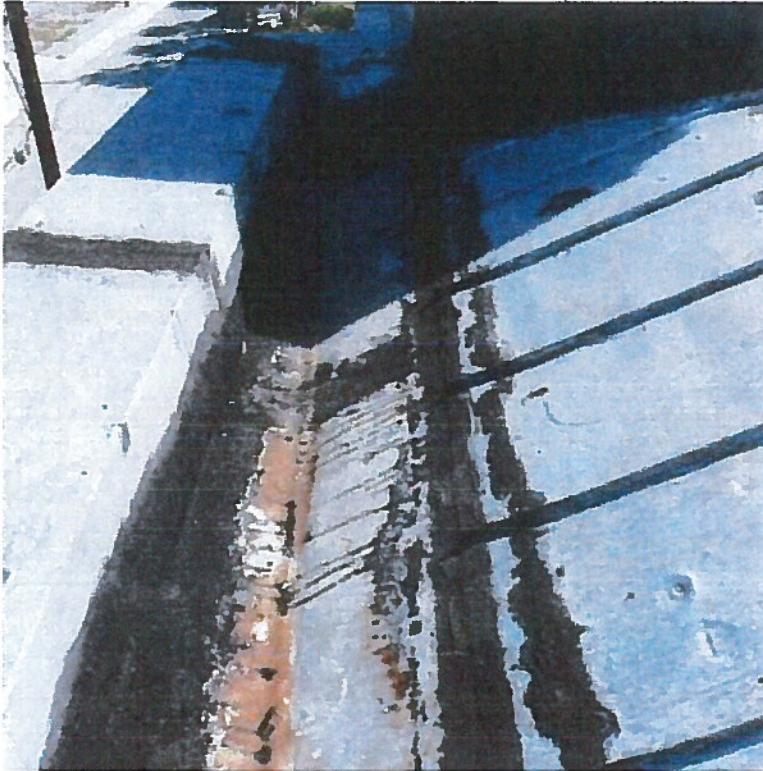
33

Close up of right slope of metal roof.

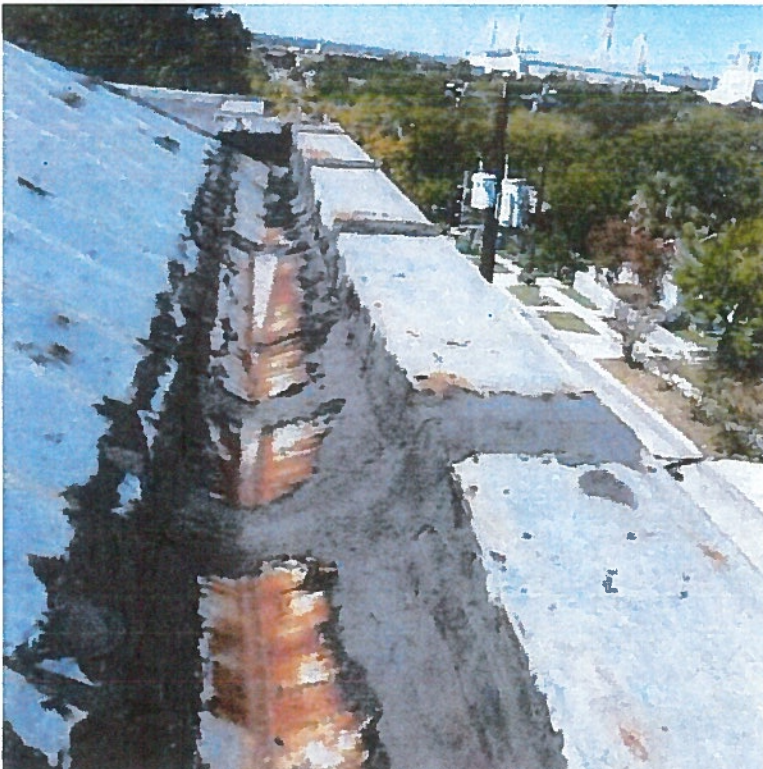
34

Close up of right slope of metal roof.

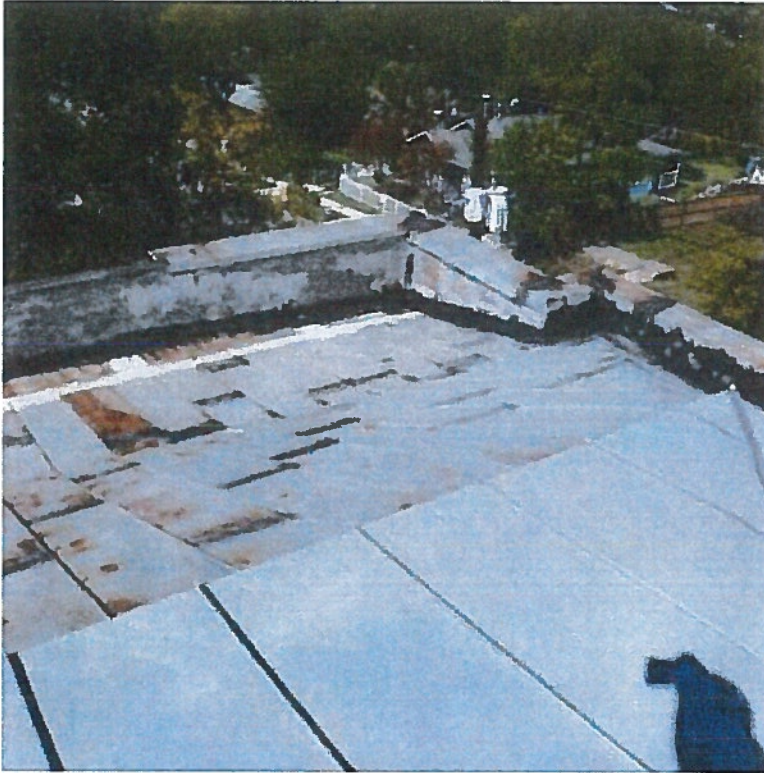
35

Overview of back slope of metal roof.

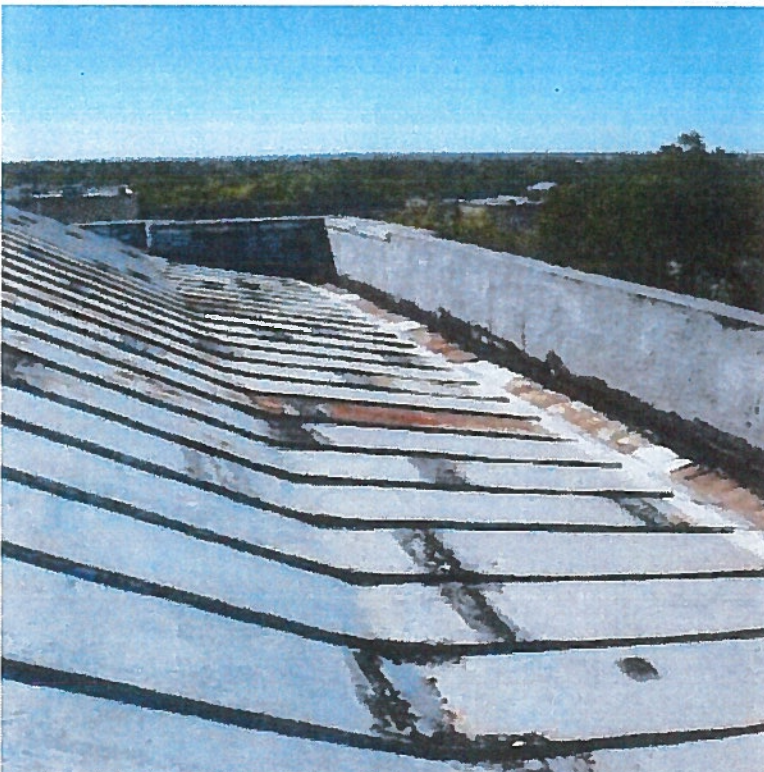
36

Overview of back slope of metal roof.
