# HISTORIC AND DESIGN REVIEW COMMISSION

July 06, 2018

**HDRC CASE NO:** 2018-254  
**ADDRESS:** 205 OSTROM  
**LEGAL DESCRIPTION:** NCB 6938 BLK LOT 1&2  
**ZONING:** R-4 CD, H, RIO-1  
**CITY COUNCIL DIST.:** 1  
**DISTRICT:** River Road Historic District  
**APPLICANT:** Tobias Stapleton  
**OWNER:** Tobias Stapleton  
**TYPE OF WORK:** Rehabilitation, construction of a rear addition and a two story accessory structure  
**APPLICATION RECEIVED:** June 15, 2018  
**60-DAY REVIEW:** August 14, 2018  
**REQUEST:**

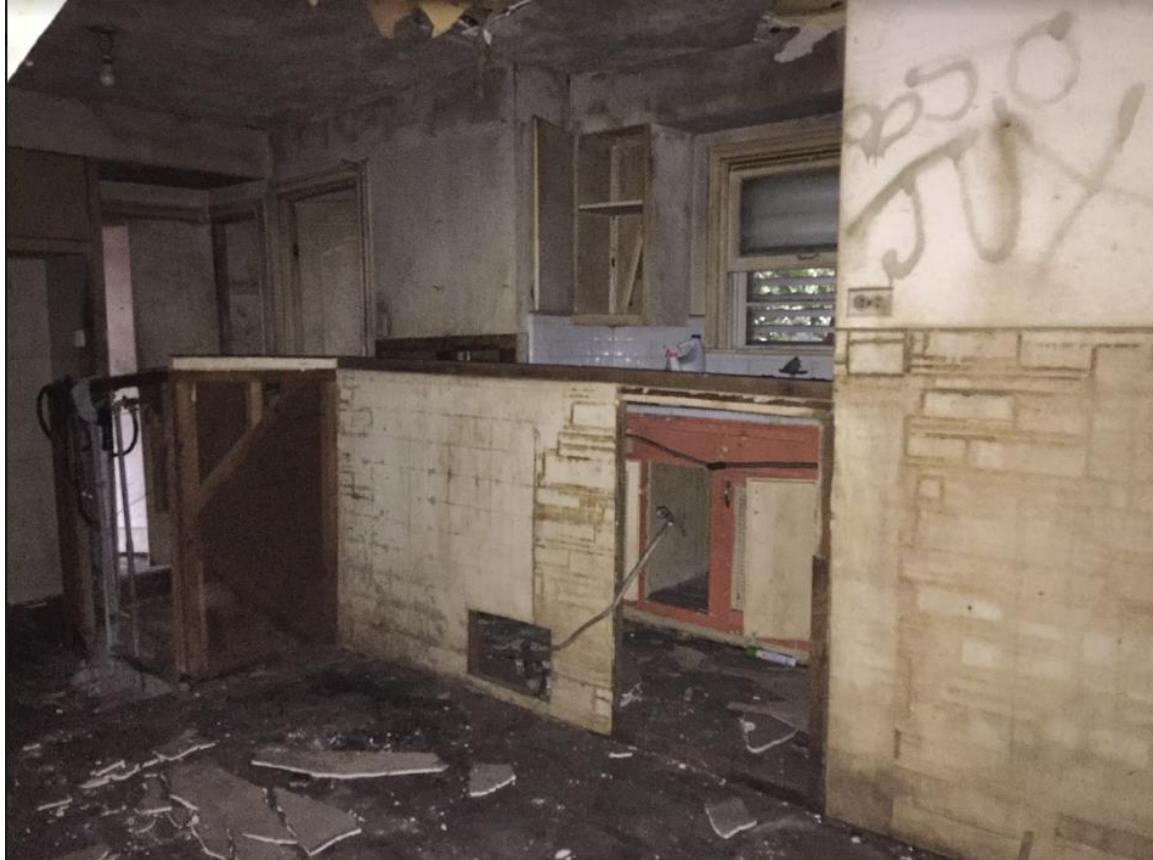
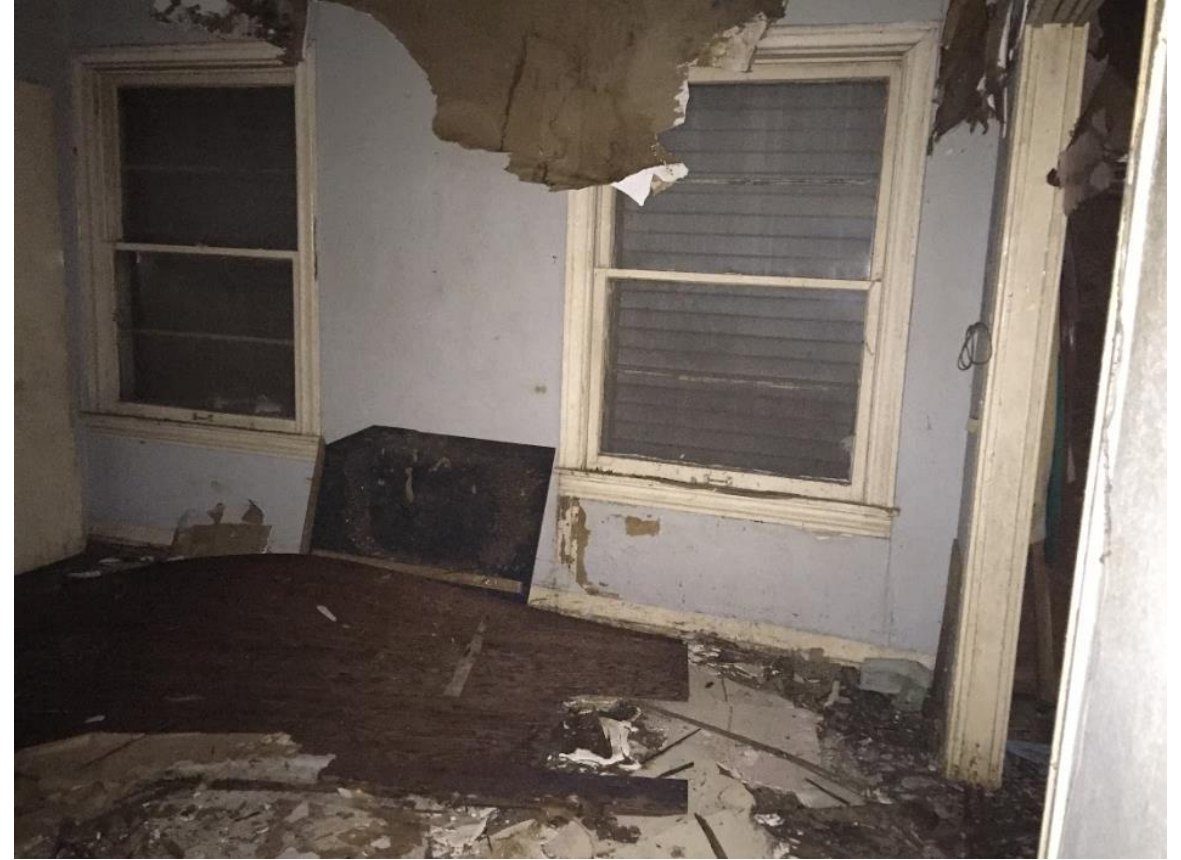
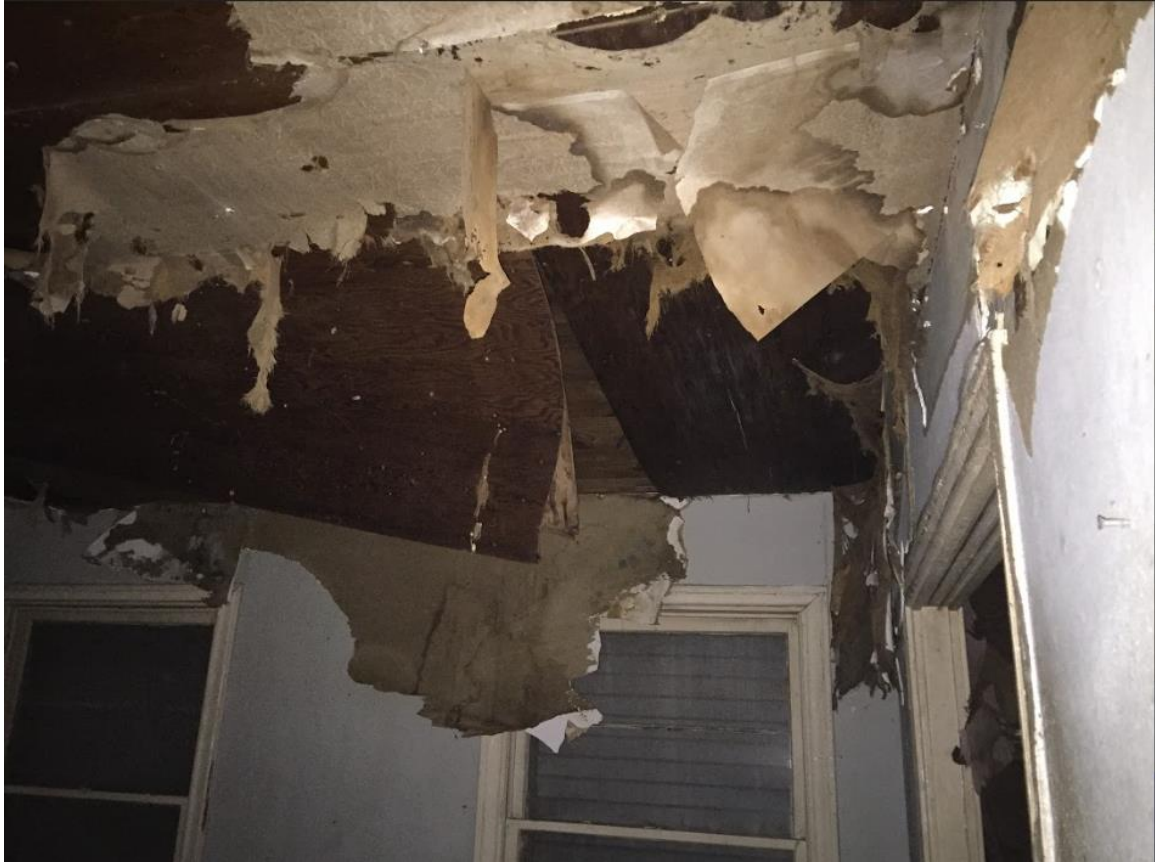
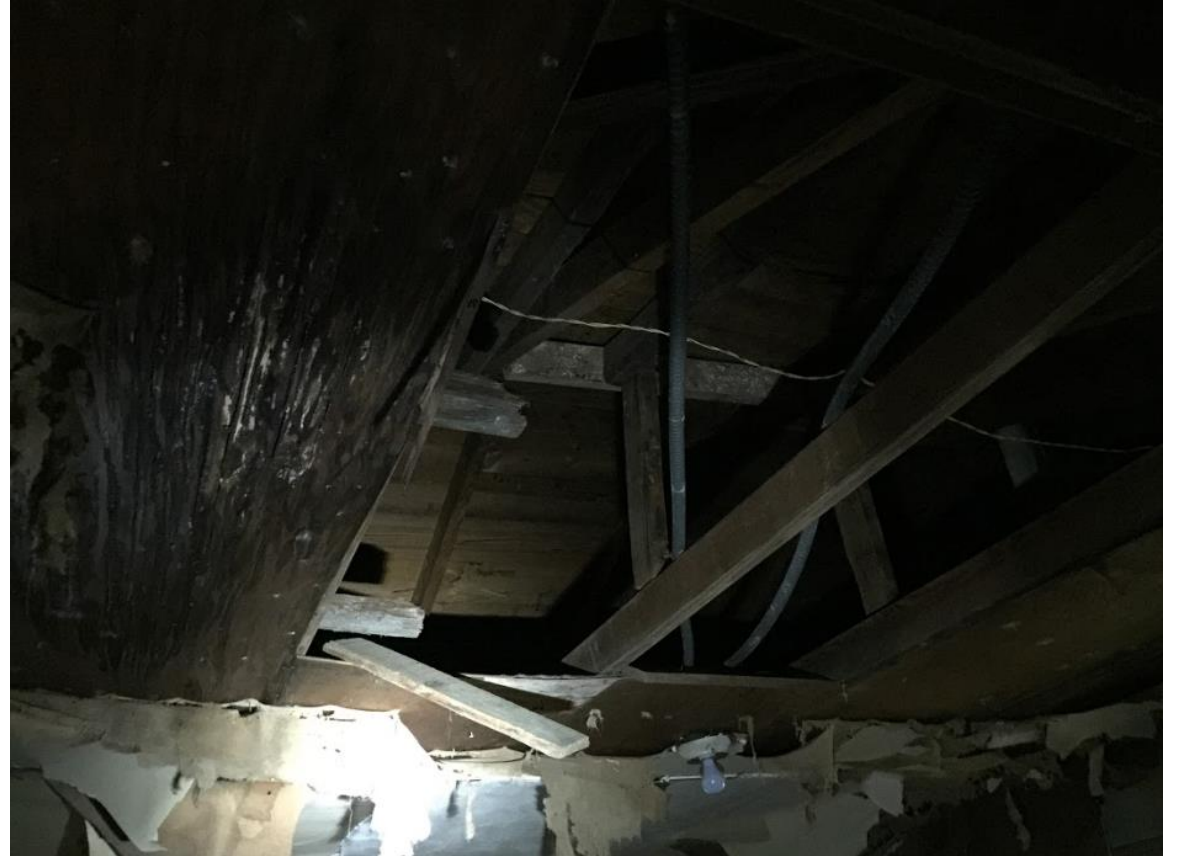
205 Ostrom Drive  
Interior Photo's  
23 Years Abandoned

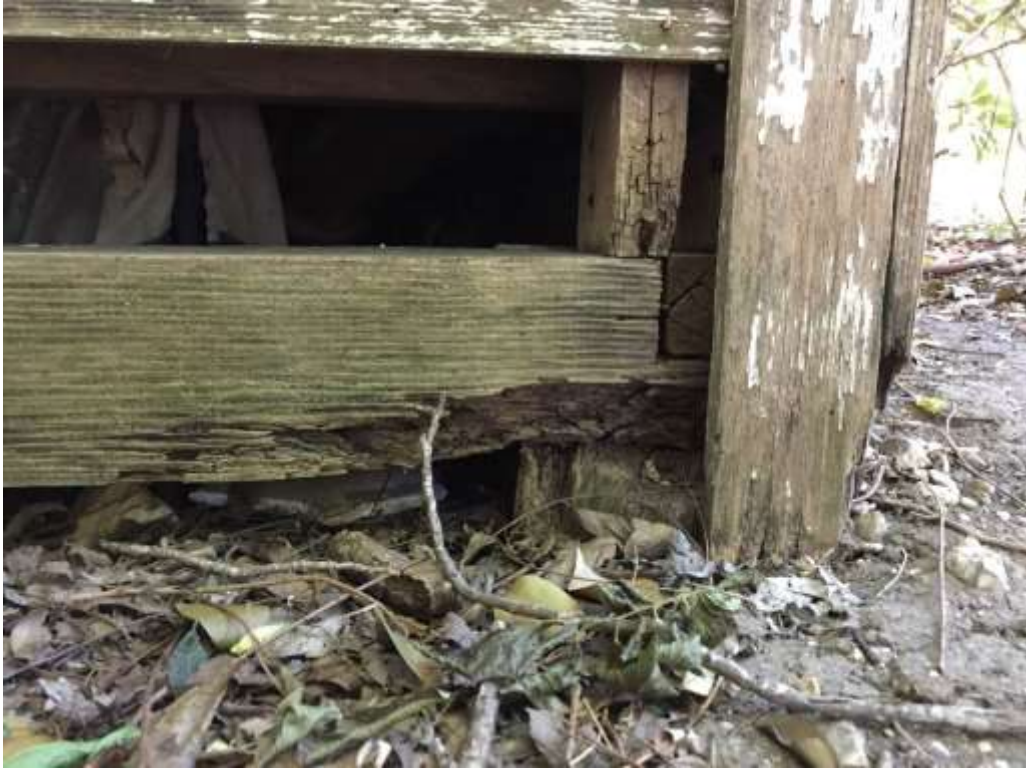
Figure 4: Severe rot and decay in the wooden joists and support posts of the structure.

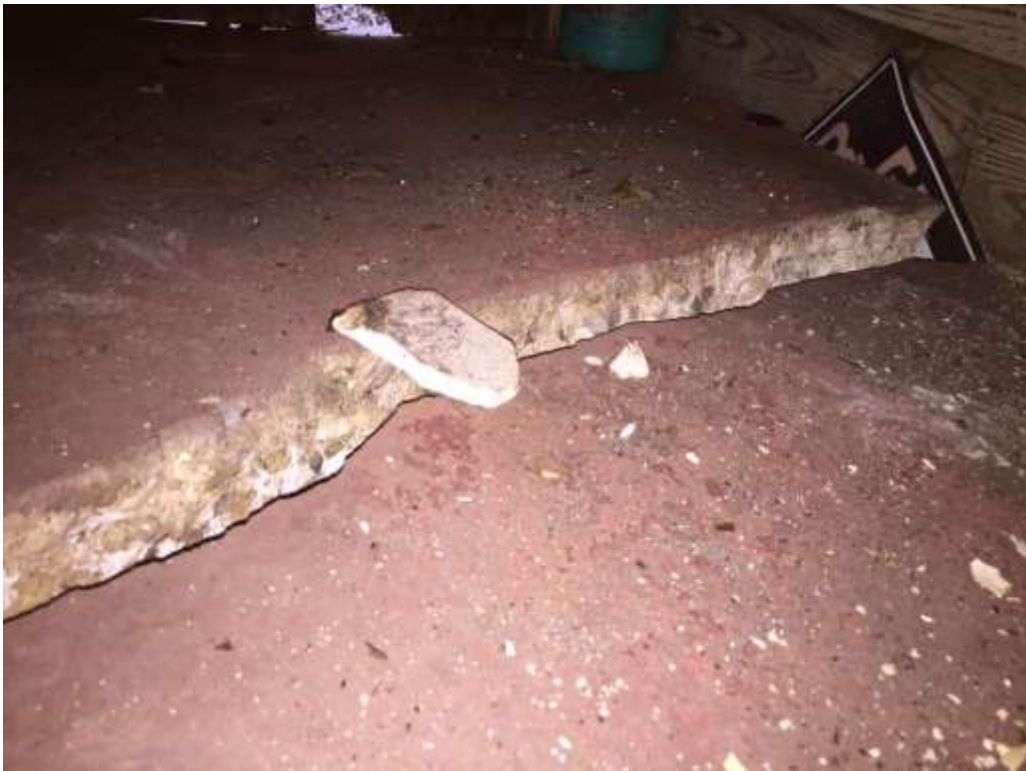
Figure 4: Cross-section of the concrete foundation showing severe deterioration and hollowing.

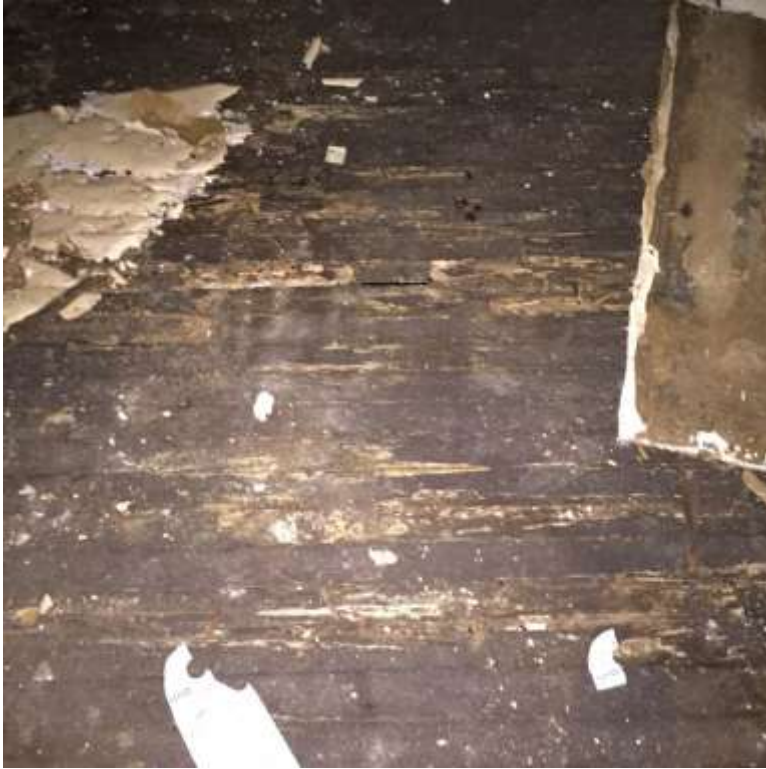
Figure 5: Close-up of damaged wooden floor joists.

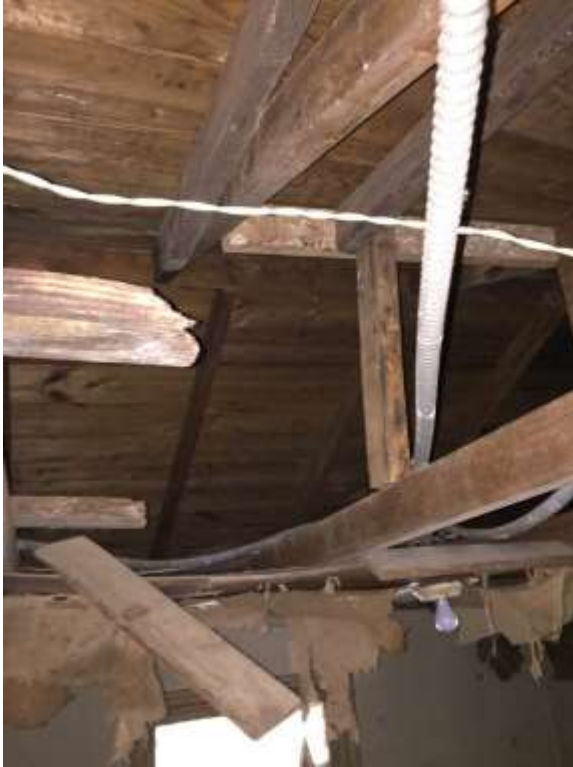
Photograph of damaged wooden roof framing with a white corrugated pipe running through it.

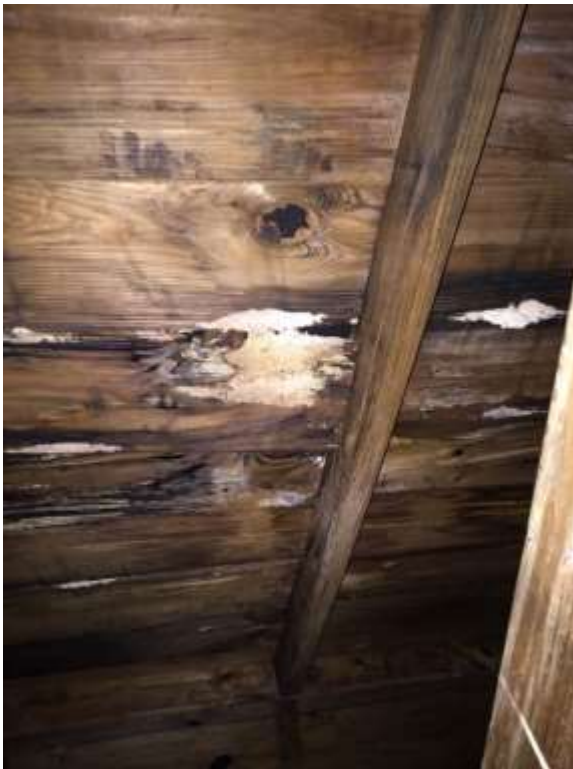
Close-up photograph of a wooden beam showing signs of fungus infestation for roof's wooden framing
