HISTORIC AND DESIGN REVIEW COMMISSION

July 18, 2018

HDRC CASE NO: 2018-350
ADDRESS: 555 CLUB DR
553 CLUB DR
LEGAL DESCRIPTION: NCB 6757 BLK G LOT 35 N 25 FT OF 34
ZONING: MF-33, H
CITY COUNCIL DIST.: 7
DISTRICT: Monticello Park Historic District
TYPE OF WORK: Window replacement
APPLICATION RECEIVED: July 09, 2018
60-DAY REVIEW: September 08, 2018
REQUEST:

The applicant is requesting a Certificate of Appropriateness for approval to replace 9 metal casement windows with vinyl windows.

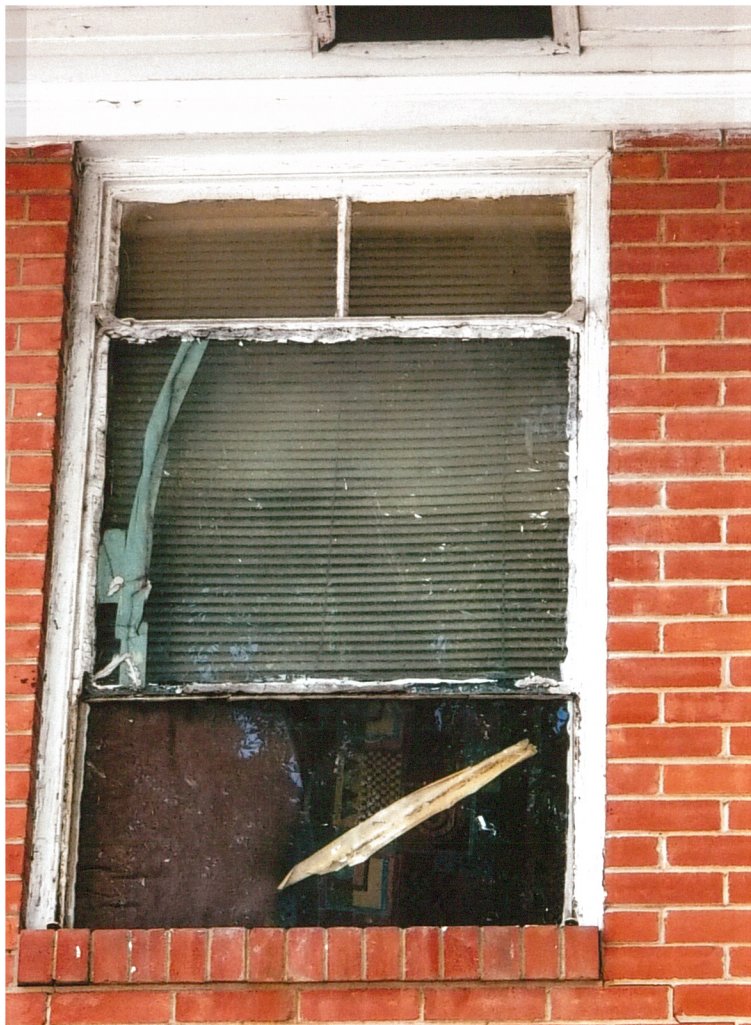
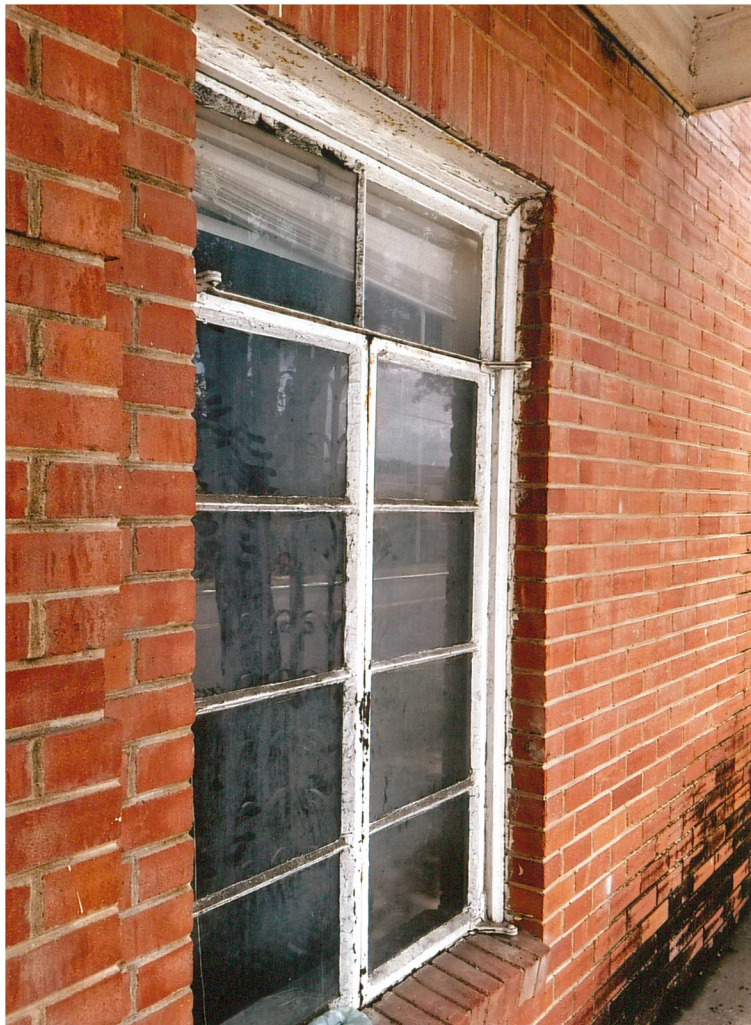
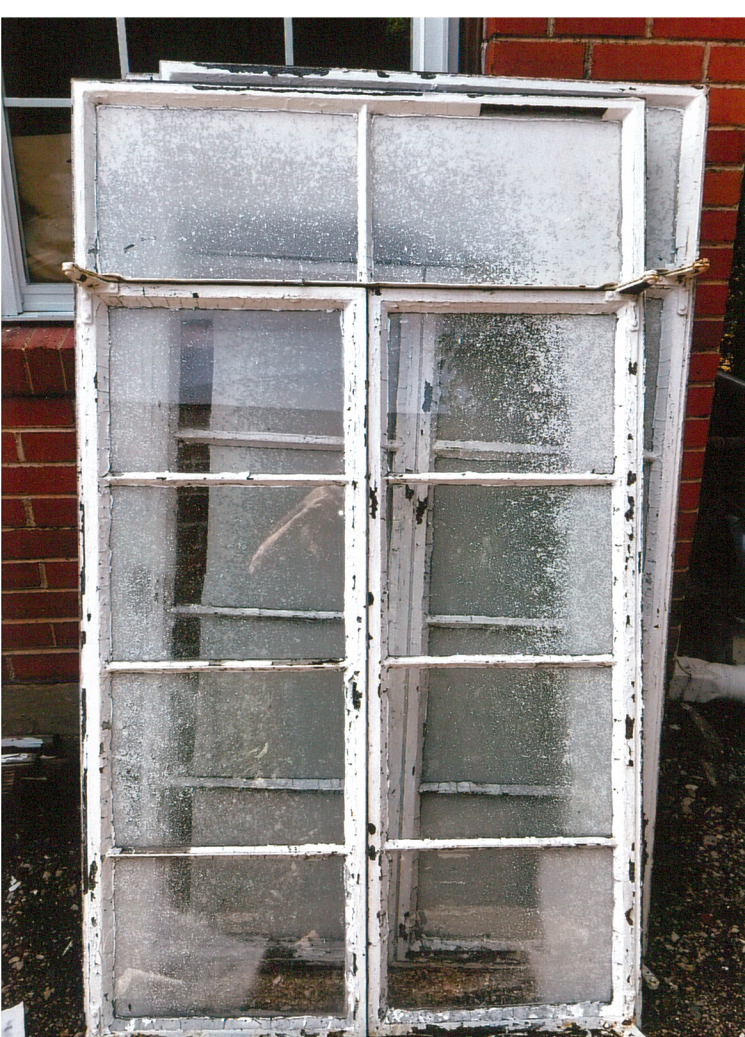
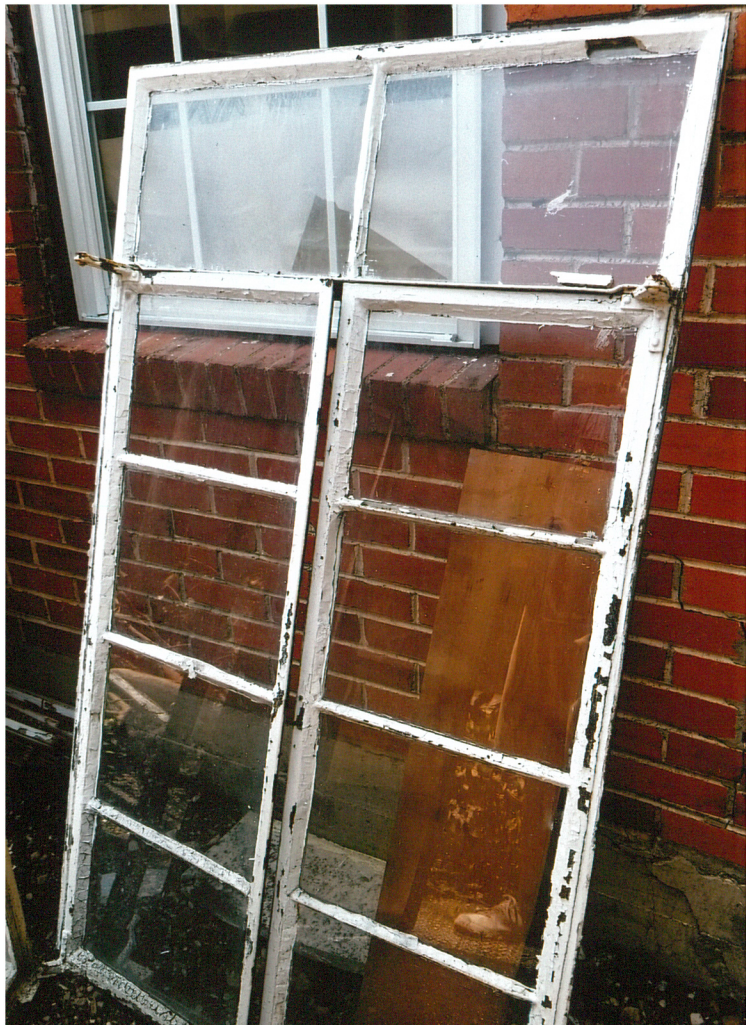
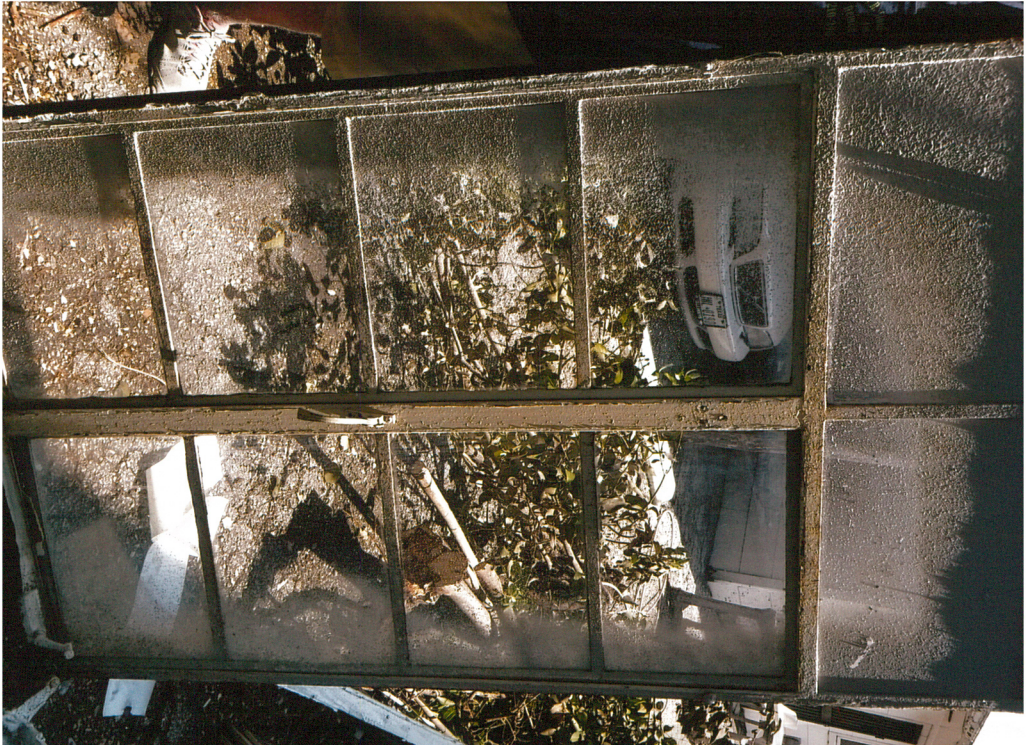
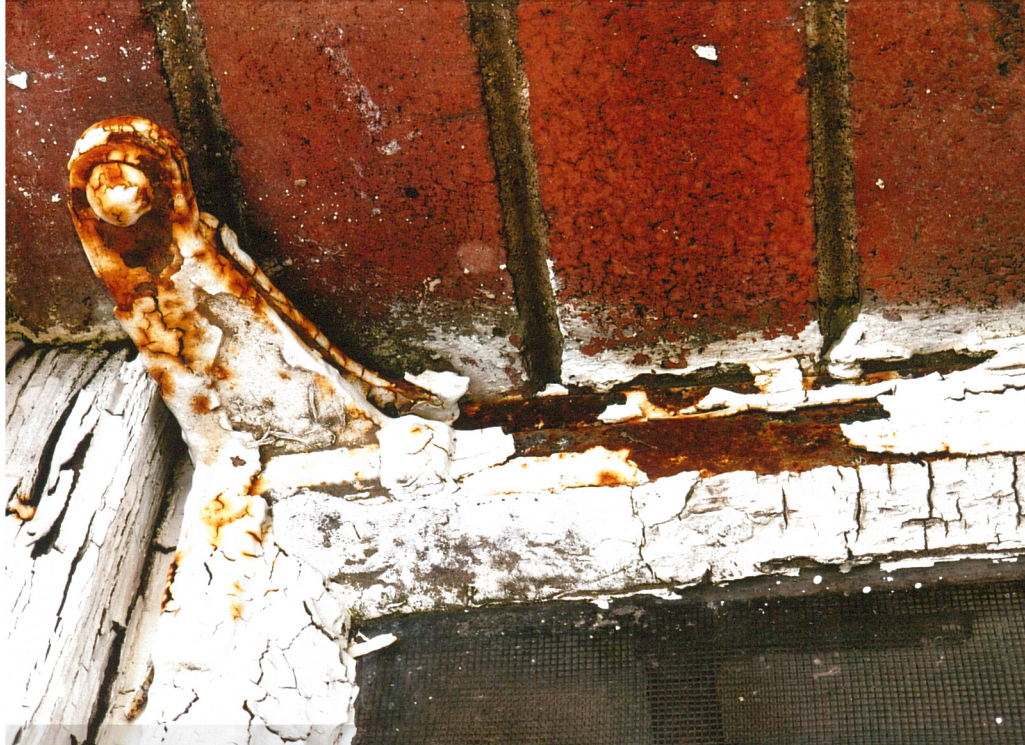
The original windows are metal casement. We made several attempts over the years to repair the existing windows to prolong their life, but in many cases, the hinges and cranks are extremely rusted and bent. After decades of neglect it was determined by my repairmen that salvaging the windows was not possible. I've included pictures of the windows for review.
