## HISTORIC AND DESIGN REVIEW COMMISSION

September 19, 2018

**HDRC CASE NO:** 2018-461  
**ADDRESS:** 603 KAMPMANN BLVD  
**LEGAL DESCRIPTION:** NCB 6824 BLK LOT E 75 FT OF 18  
**ZONING:** R-6, H  
**CITY COUNCIL DIST.:** 7  
**DISTRICT:** Monticello Park Historic District  
**APPLICANT:** Daniel Campo/DC Civil Construction LLC  
**OWNER:** Daniel Campo/DC Civil Construction LLC  
**TYPE OF WORK:** Window Replacement, removal of window awnings and burglar bars  
**APPLICATION RECEIVED:** August 29, 2018  
**60-DAY REVIEW:** October 28, 2018

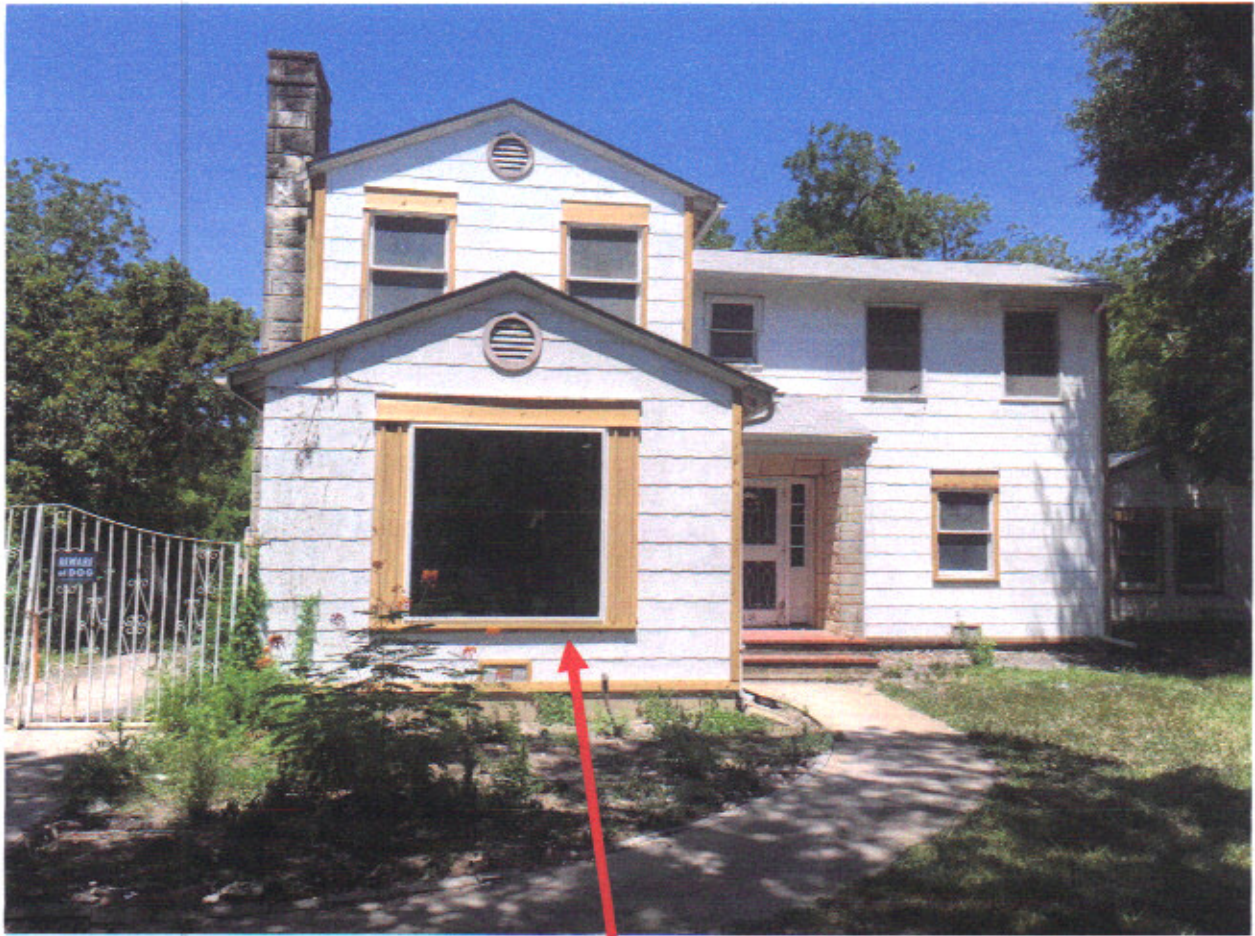
Front Window 6' x 6' Living Room

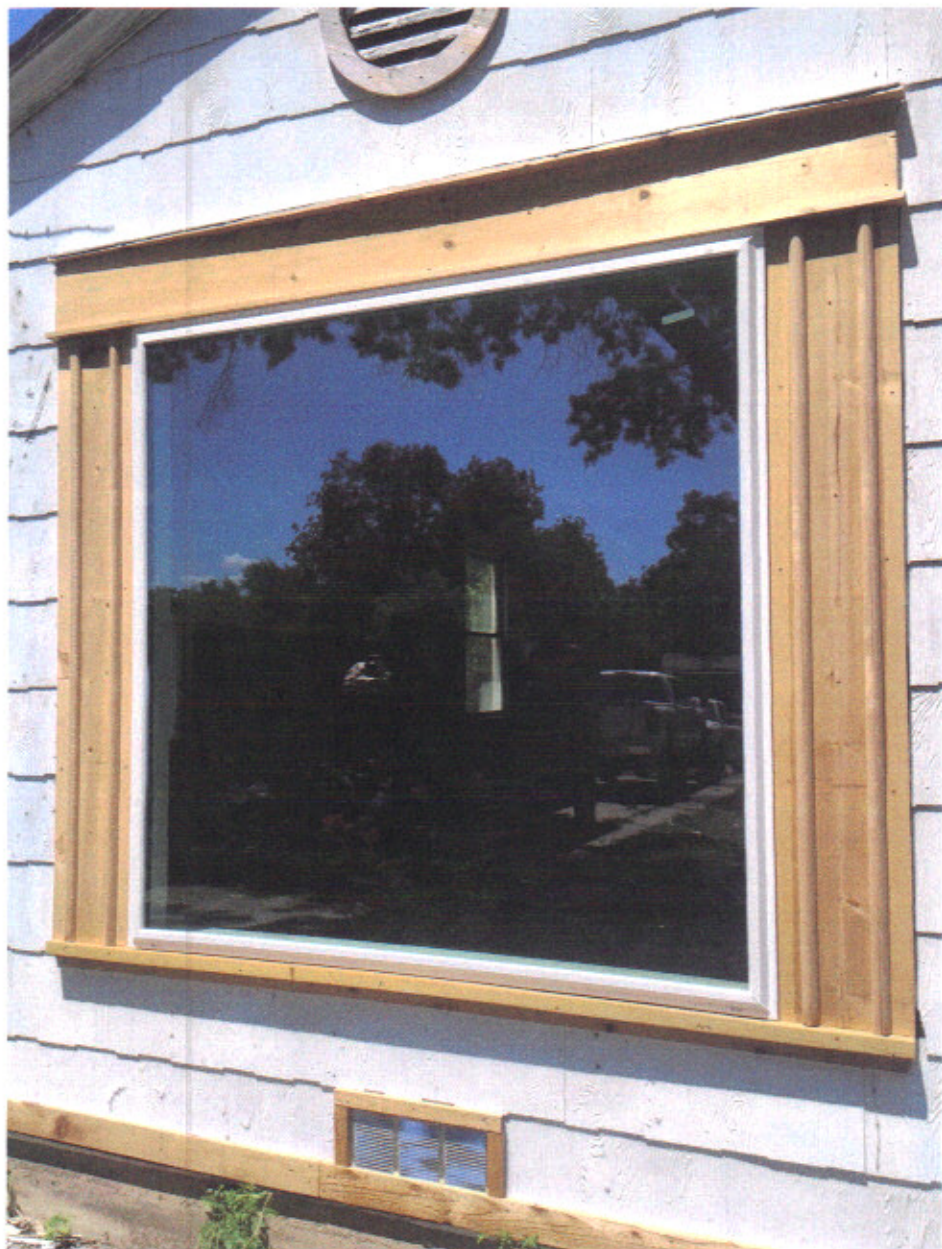
Front Window 6' x 6' Living Room

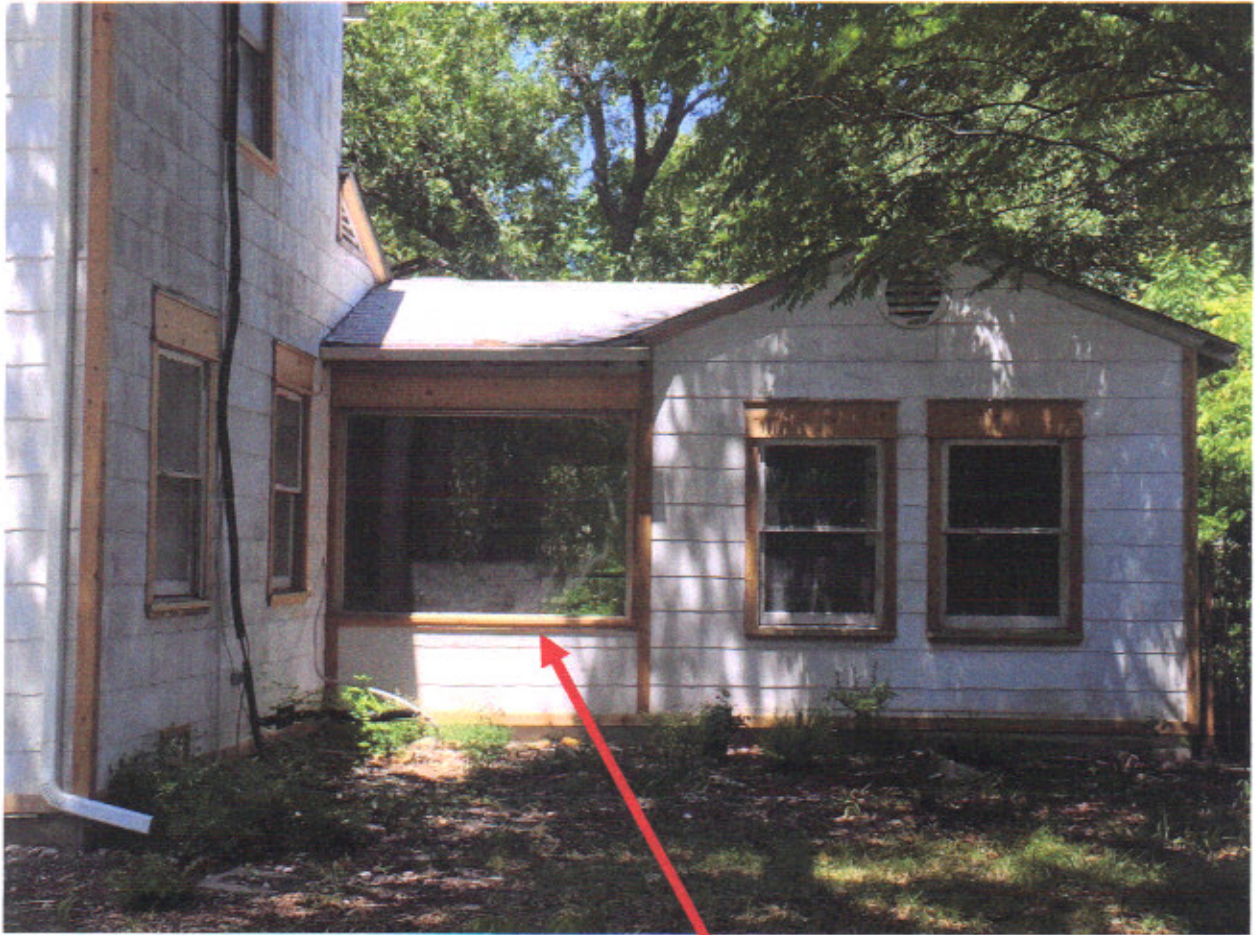
Front Window 7' x 5' ' Master Bed-Room

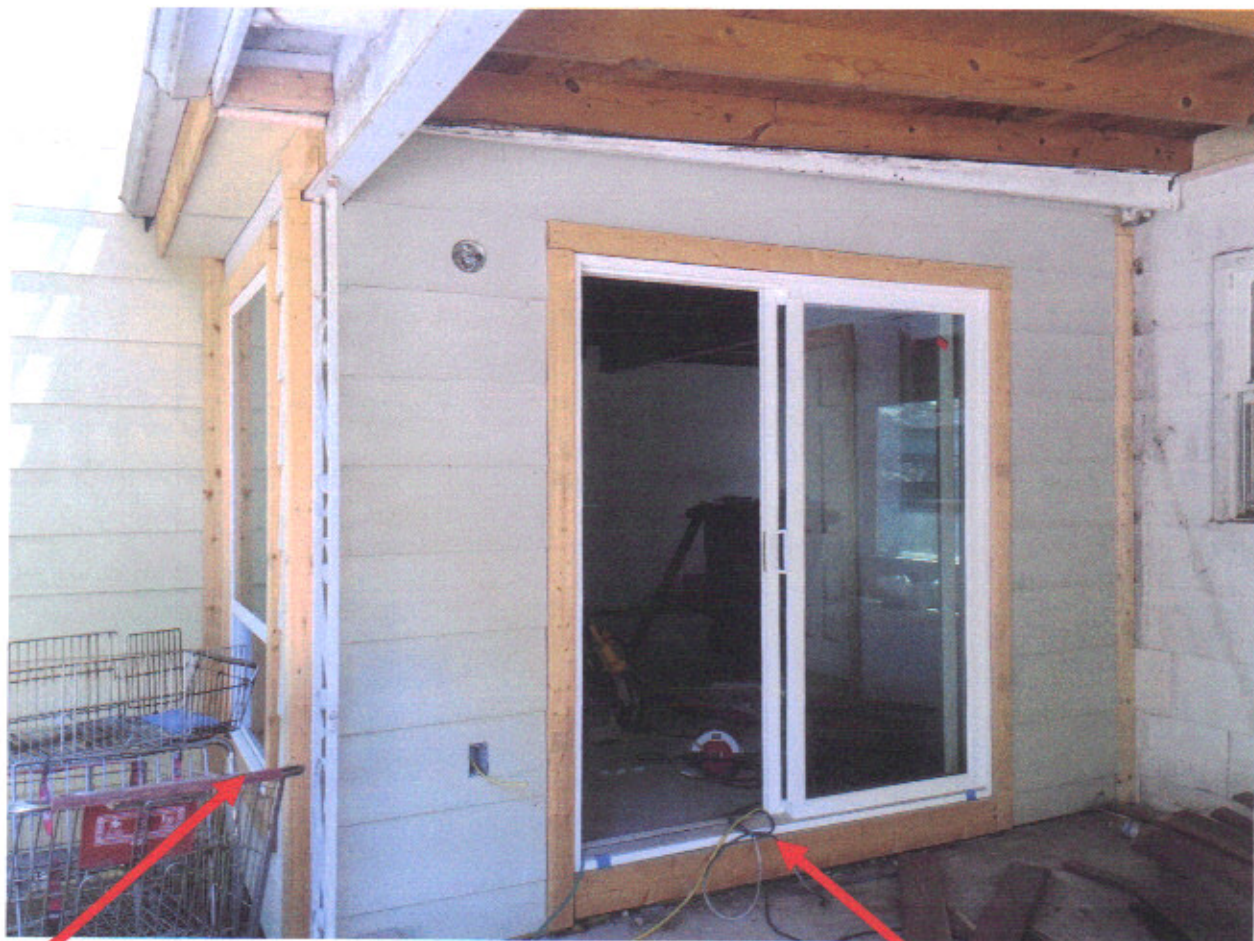
Back Windows 4' x 6' Master Bed-Room

Patio Sliding Door 5'x7' Master Bed-Room

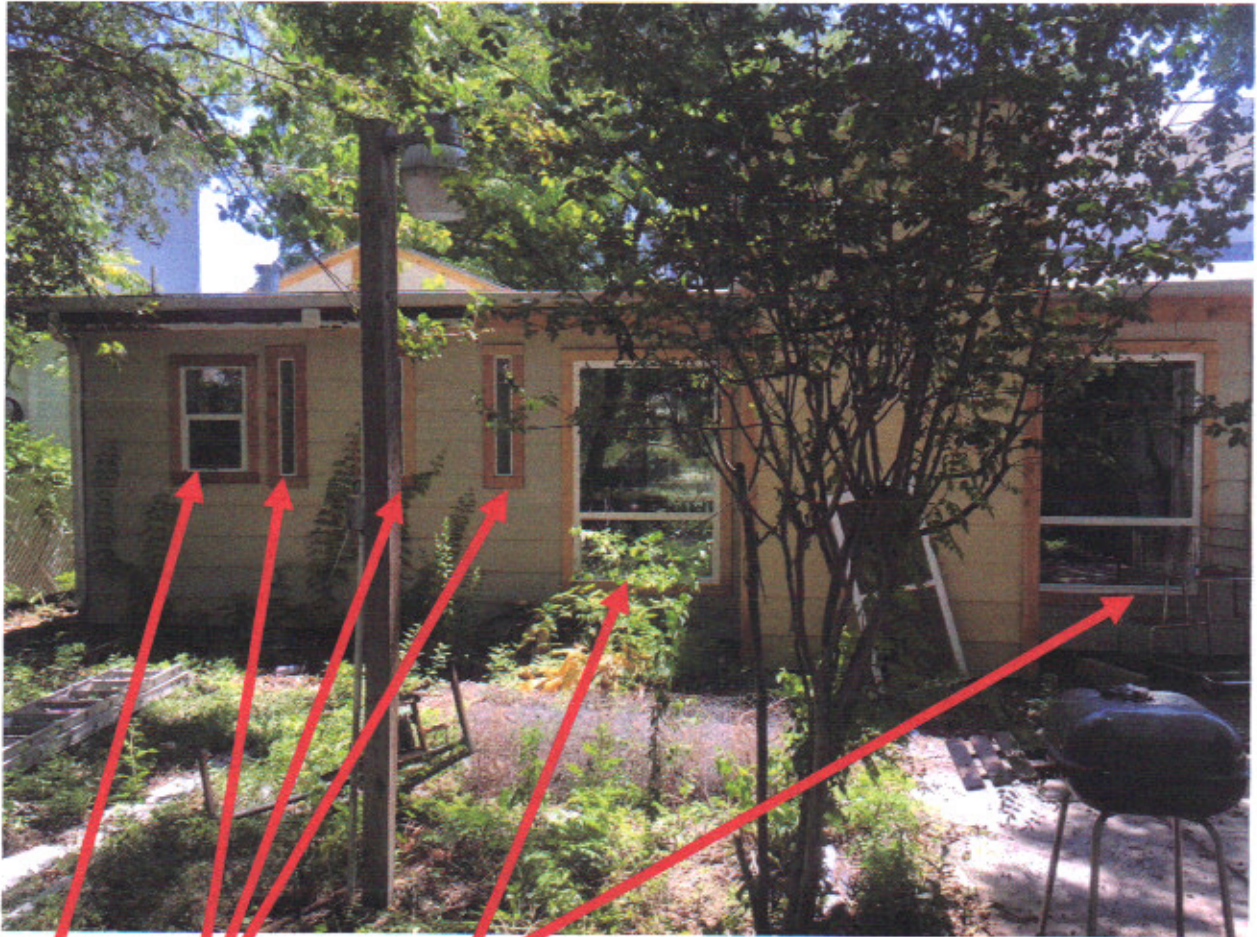
Back Windows 4' x 6' Master Bed-Room

Block Windows 6" x 40" Master Bathroom

Back Window 2' x 3' Master Bathroom

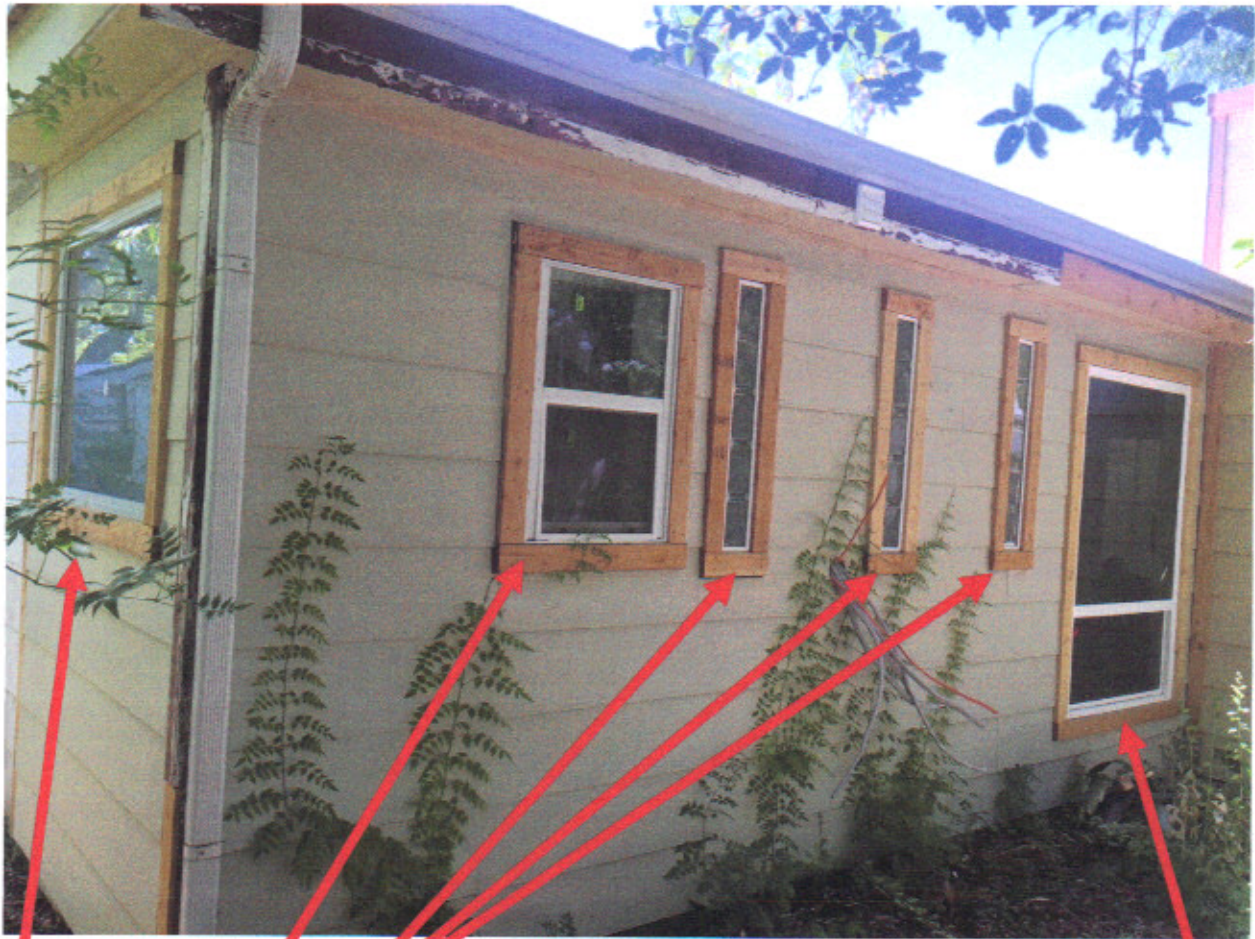
Back Windows 4' x 6' Master Bed-Room

Block Windows 6" x 40" Master Bathroom

Back Window 2' x 3' Master Bathroom

Back Window 4' x 3' Master Bathroom
