## HISTORIC AND DESIGN REVIEW COMMISSION

September 19, 2018

**HDRC CASE NO:** 2018-462  
**ADDRESS:** 201 E HUISACHE AVE  
**LEGAL DESCRIPTION:** NCB 3085 BLK 1 LOT 23  
**ZONING:** MF-33, H  
**CITY COUNCIL DIST.:** 1  
**DISTRICT:** Monte Vista Historic District  
**APPLICANT:** Patrick Christensen  
**OWNER:** SA Huisache Investors LLC  
**TYPE OF WORK:** Window/door replacement  
**APPLICATION RECEIVED:** August 31, 2018  
**60-DAY REVIEW:** October 30, 2018  
**REQUEST:**

The applicant is requesting a Certificate of Appropriateness for approval to replace wood windows and doors with aluminum windows and doors.

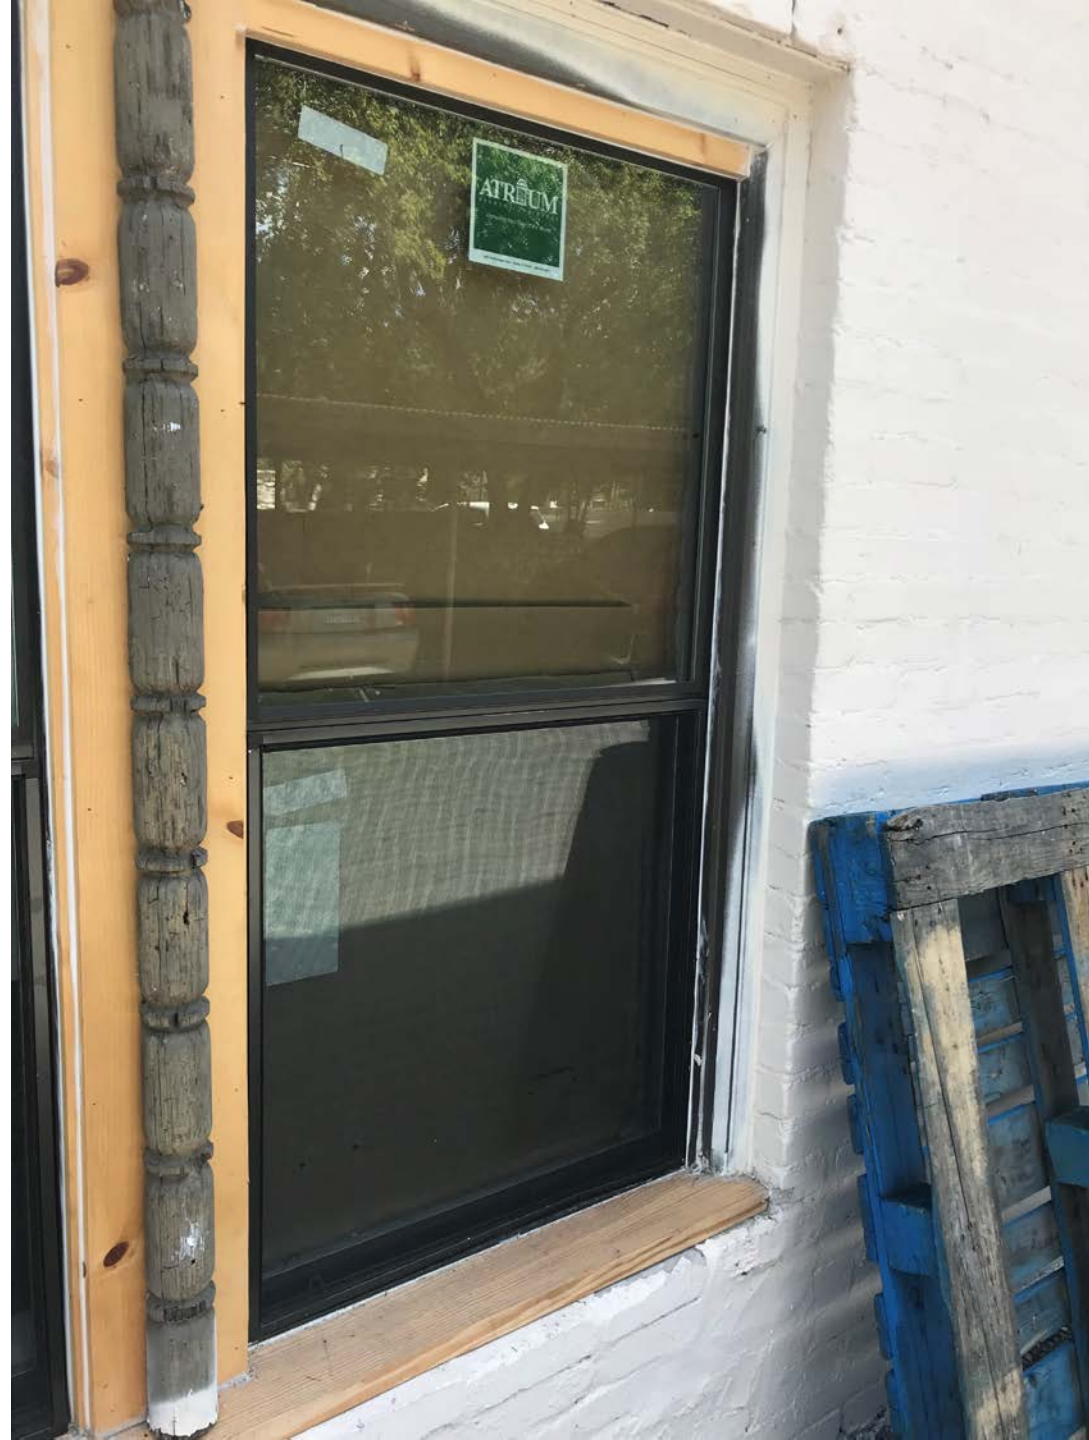
- e. NEW WINDOWS – The applicant has proposed to install black one-over-one aluminum windows. The Guidelines for Architectural Features 6.B.iv. notes that new windows are to match the historic or existing windows in terms of size, type, configuration, material, form, appearance, and details. Staff finds that the proposed windows are not compatible in style or materials with the original windows.

The following slides are the new windows:

For any window that has been permanently discarded, staff recommends in-kind replacement with the standard stipulations for new windows: *Meeting rails that are no taller than 1.25” and stiles no wider than 2.25”. White manufacturer’s color is not allowed, and color selection must be presented to staff. There should be a minimum of two inches in depth between the front face of the window trim and the front face of the top window sash. This must be accomplished by recessing the window sufficiently within the opening or with the installation of additional window trim to add thickness. Window trim must feature traditional dimensions and an architecturally appropriate sill detail. Window track components must be painted to match the window trim or concealed by a wood window screen set within the opening.*

For any door that has been permanently discarded, staff recommends in-kind replacement of the 3x5 divided-light wood doors.

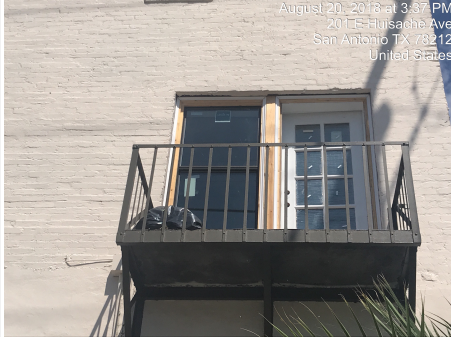
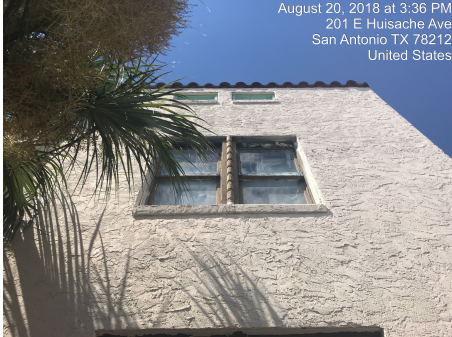
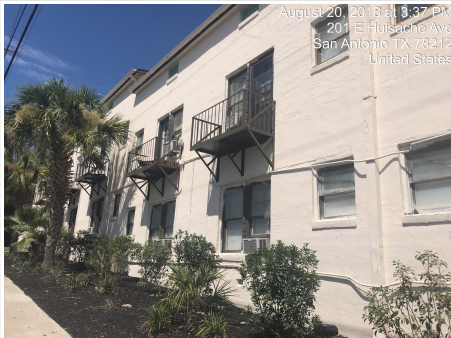
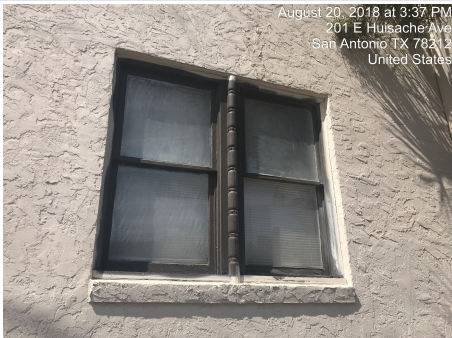
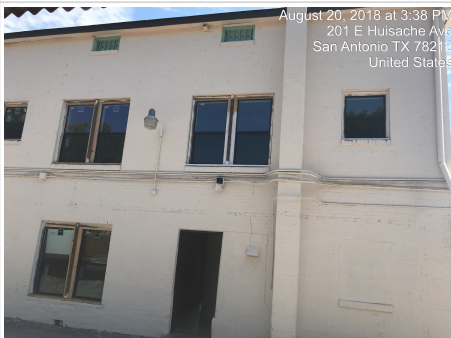
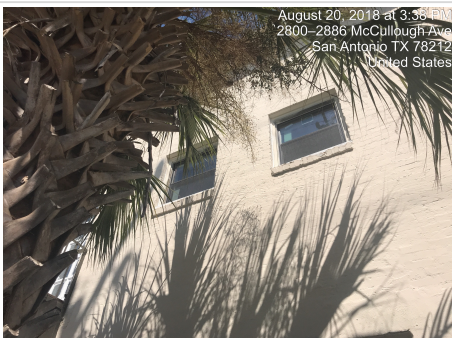
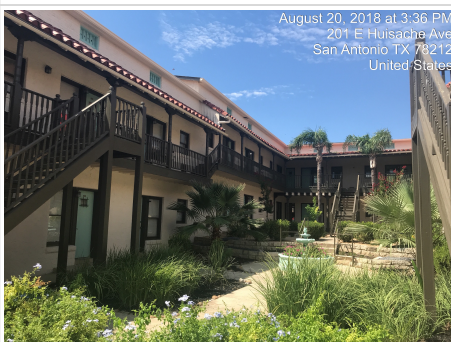
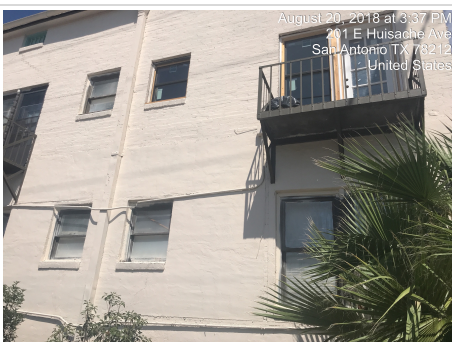
On a site visit conducted on August 20, 2018, staff found that approximately twenty windows and some doors have been replaced with aluminum windows and doors prior to the issuance of a Certificate of Appropriateness. The applicant submitted a request to be heard at an HDRC hearing on August 31, 2018. The \$500 post-work application fee has been paid.

Date	08/20/2018
Time	03:41 PM (-5 GMT)
Context	citizen report
Present Staff	Huy Pham
Present Individuals	None
Types of Work Observed	Exterior Maintenance and Alterations
Amount of Work Completed	75%
Description of work	Removal of over 20 wood windows and doors and installation of aluminum windows.
