HISTORIC AND DESIGN REVIEW COMMISSION

September 19, 2018

HDRC CASE NO: 2018-460
ADDRESS: 218 ADAMS ST
LEGAL DESCRIPTION: NCB 943 BLK 1 LOT 13
ZONING: RM-4,HS
CITY COUNCIL DIST.: 1
DISTRICT: King William Historic District
LANDMARK: Moths House
APPLICANT: Corie Boldt/Corie Properties
OWNER: Paresh Mehta
TYPE OF WORK: Front yard modifications; xeriscaping
APPLICATION RECEIVED: September 4, 2018
60-DAY REVIEW: November 3, 2018
REQUEST:

Investigation Report

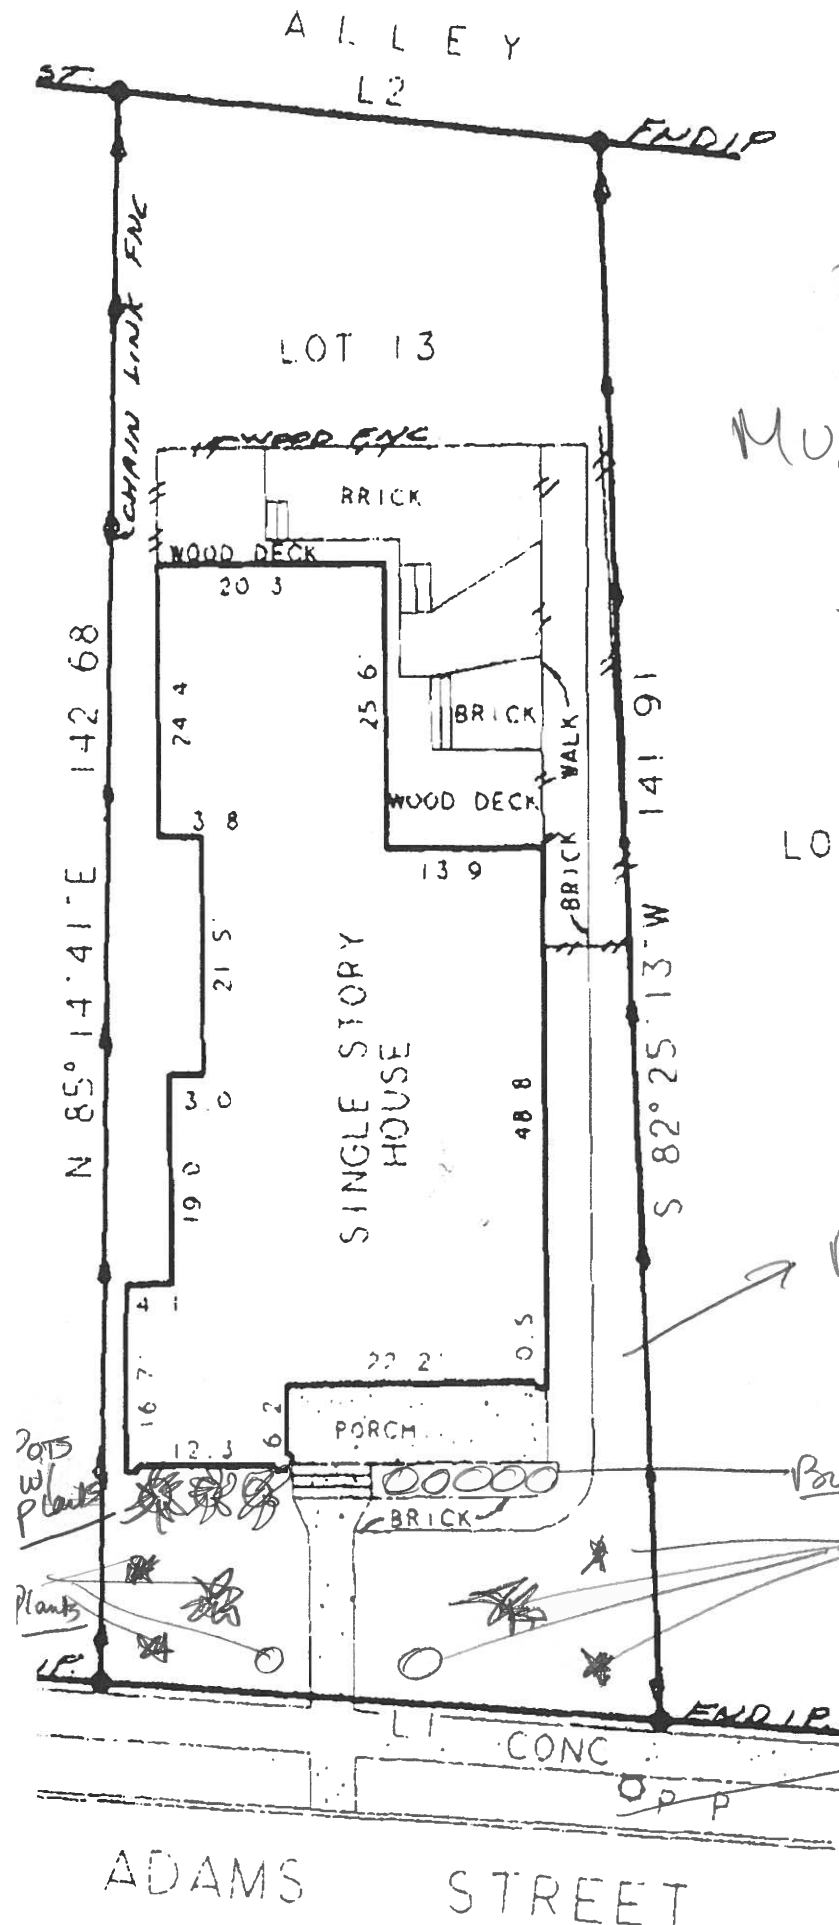
218 Adams Front Yard Changes

- 1) Plants will triple in size in 1 year
- 2) Add More of the smaller plants Area ①
- 3) Add More plants near street Area ②

- 4) Owner does NOT have irrigation. SO must use drought tolerant plants.

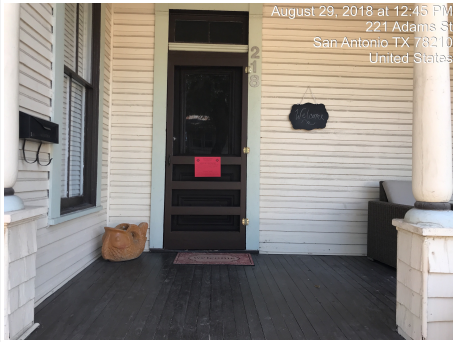
<p>August 29, 2018 at 12:45 PM 221 Adams St San Antonio TX 78210 United States</p>

Date	08/29/2018
Time	12:43 PM (-5 GMT)
Context	citizen report
Present Staff	Huy Pham
Present Individuals	None
Present Companies	CORIE Properties (Corie Boldt)
Types of Work Observed	Site Elements
Amount of Work Completed	Completed
Description of work	Removal of natural lawn and installation of river rock.

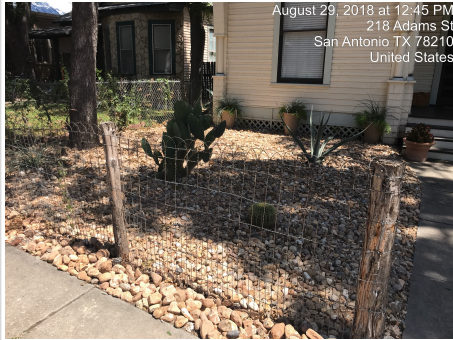
<p>August 29, 2018 at 12:45 PM 218 Adams St San Antonio TX 78210 United States</p>

- b. On a site visit conducted on August 29, 2018, staff found that the front lawn which previously featured natural lawn had been modified to feature primary whole river rock with approximately seven (7) plantings of cacti or agave. The applicant has been cooperative in seeking a xeriscaping proposal that is consistent with the Guidelines and submitted a request on September 4, 2018 to be heard at an HDRC hearing.

- i. Restoring at least 50% of the natural lawn or incorporating low-ground, native, and/or xeric plants where lawn has been removed.
- ii. Limiting the removal of lawn areas to mulched planting beds or pervious hardscapes in locations where they would historically be found, such as along fences, walkways, or drives.
