## HISTORIC AND DESIGN REVIEW COMMISSION

October 03, 2018

**HDRC CASE NO:** 2018-491  
**ADDRESS:** 1010 N HACKBERRY ST  
**LEGAL DESCRIPTION:** NCB 521 BLK 16 LOT S 52.53 FT OF N 100 FT OF 11 ARB 11D  
**ZONING:** IDZ, H  
**CITY COUNCIL DIST.:** 2  
**DISTRICT:** Dignowity Hill Historic District  
**APPLICANT:** Cory Johnson  
**OWNER:** Nicole Johnson  
**TYPE OF WORK:** Rear addition, window and door replacement, fenestration changes.  
**APPLICATION RECEIVED:** September 17, 2018  
**60-DAY REVIEW:** November 16, 2018  
**REQUEST:**

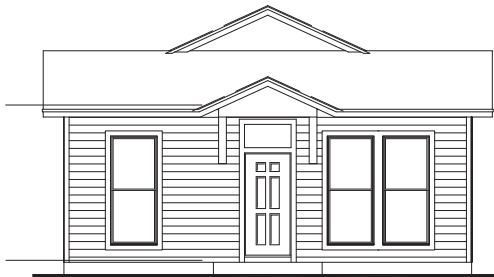
#### FRONT ELEVATION

REMOVE EXISTING WINDOWS AND  
PLASTER GIBNEY

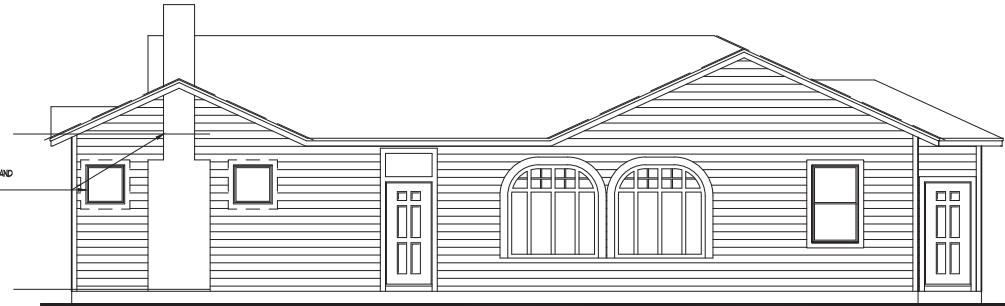
#### RIGHT ELEVATION

#### **WINDOWS DO NOT ALIGNED WITH OBSERVED ALTERATIONS, INCLUDING ONE WINDOW NOT DEPICTED OR REQUESTING TO BE REMOVED**

Staff comment: (1) The depicted roof form and fenestration does not match the modifications staff observed on site nor the applicants verbal description. (2) The set of arched casement windows are closer to the door, unless the applicant is proposing to relocate the windows (3) The rear gable features a centered set of two-over-two sash windows, unless the applicant is proposing to remove and relocate the windows.

Item 2 & 3. Staff does not recommend approval of window replacement, or the removal, resizing, or relocation of any window openings at this time based on findings j through m. Staff recommends that all window openings be restored to their original configuration and location, and all wood windows that have been permanently discarded to be replaced with new windows matching in material, size, and configuration. A window restoration plan must be submitted to staff prior to

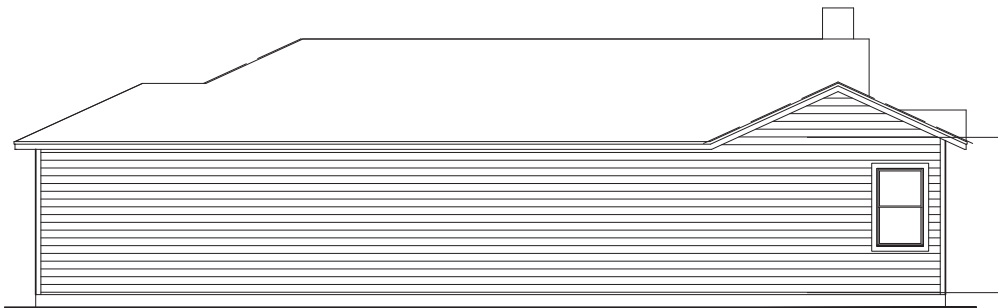
#### LEFT ELEVATION

#### **SIX (6) WINDOWS NOT DEPICTED OR REQUESTING TO BE REMOVED**

Staff comment: (1) The depicted fenestration does not match the modifications staff observed on site nor the applicants verbal description. (2) The front gable features two individual one-over-one wood windows, unless the applicant is proposing to remove one. (3) The intermediate wall features two picture windows and a covered sash window, unless the applicant is proposing to remove all three window openings. (4) The rear gable features a set of one-over-one wood windows, unless the applicant is proposing to remove those windows.
