HISTORIC AND DESIGN REVIEW COMMISSION

HDRC CASE NO: 2018-520

ADDRESS: 2020 W HUISACHE AVE **LEGAL DESCRIPTION:** NCB 1953 BLK LOT 23

OWNER: Five Missions Properties
TYPE OF WORK: Window replacement
APPLICATION RECEIVED: September 28, 2018
60-DAY REVIEW: November 27, 2018

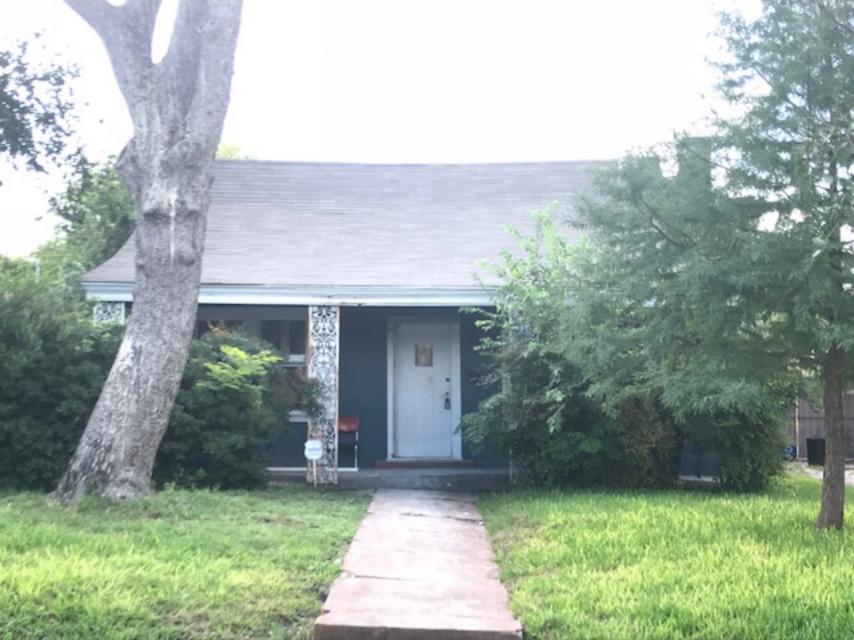
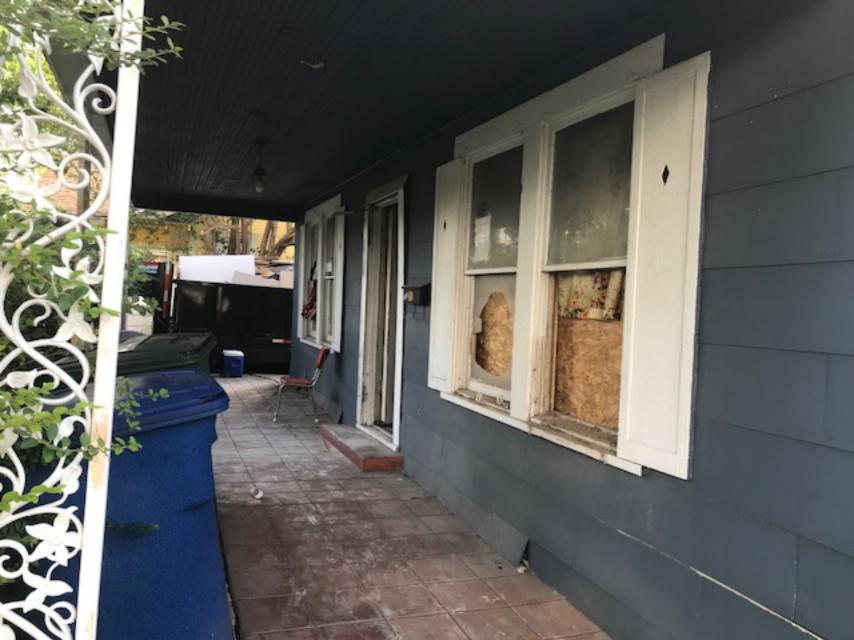
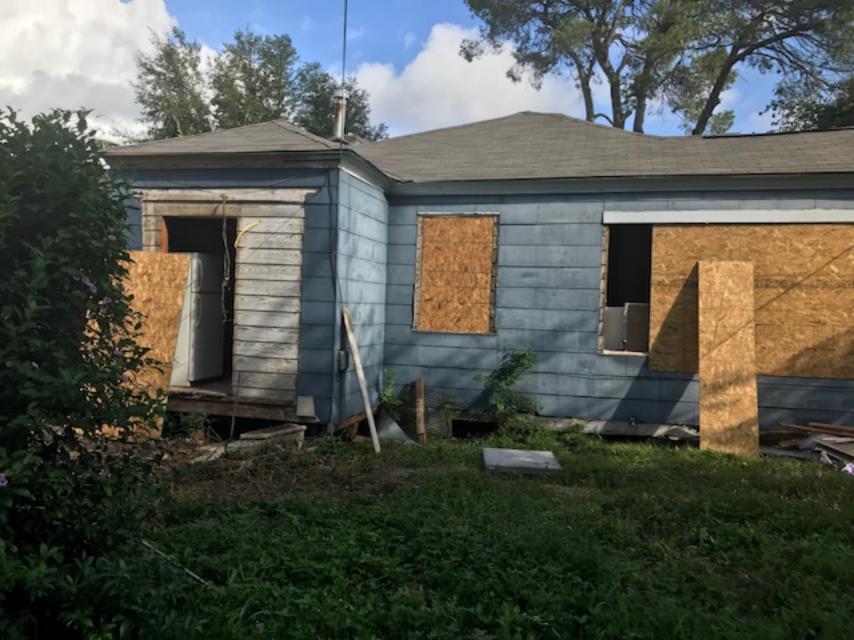
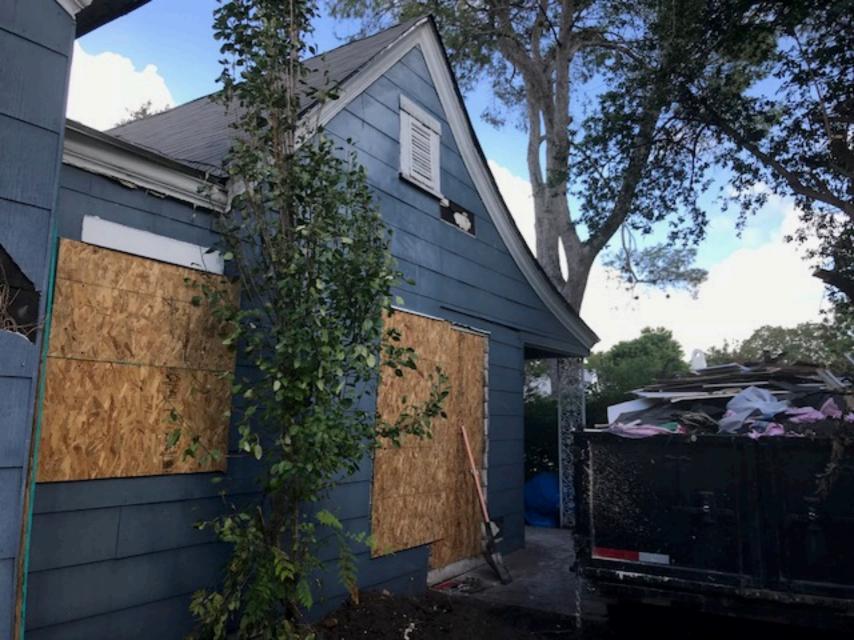
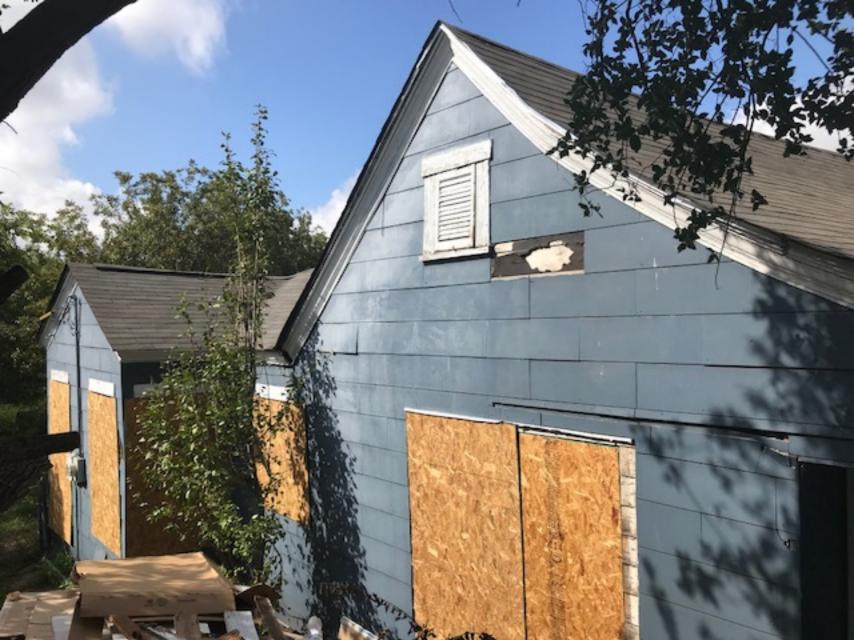
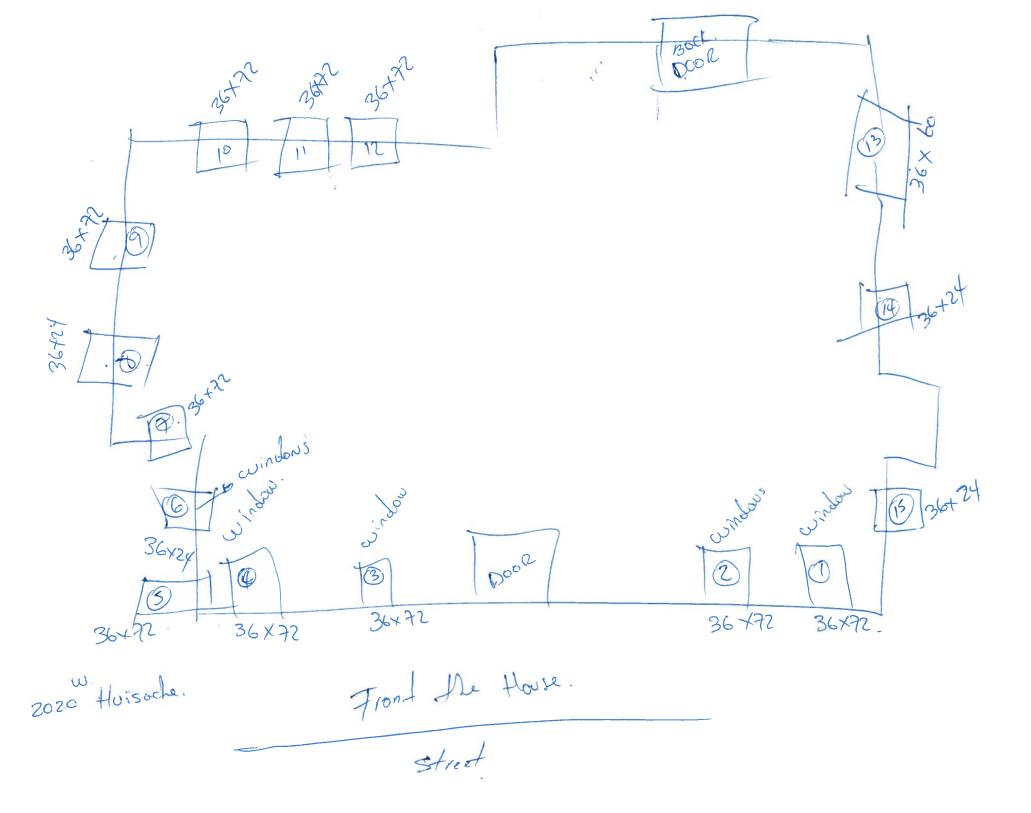
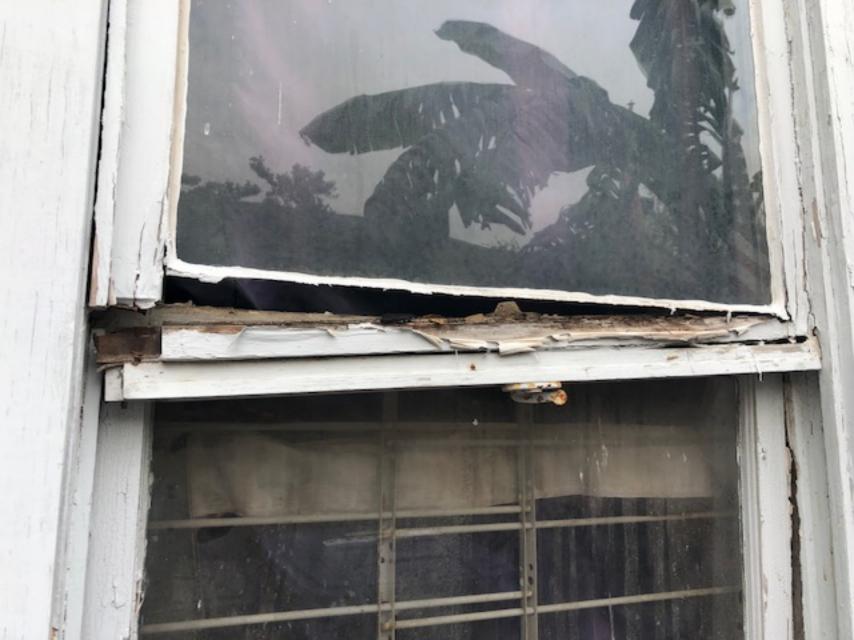
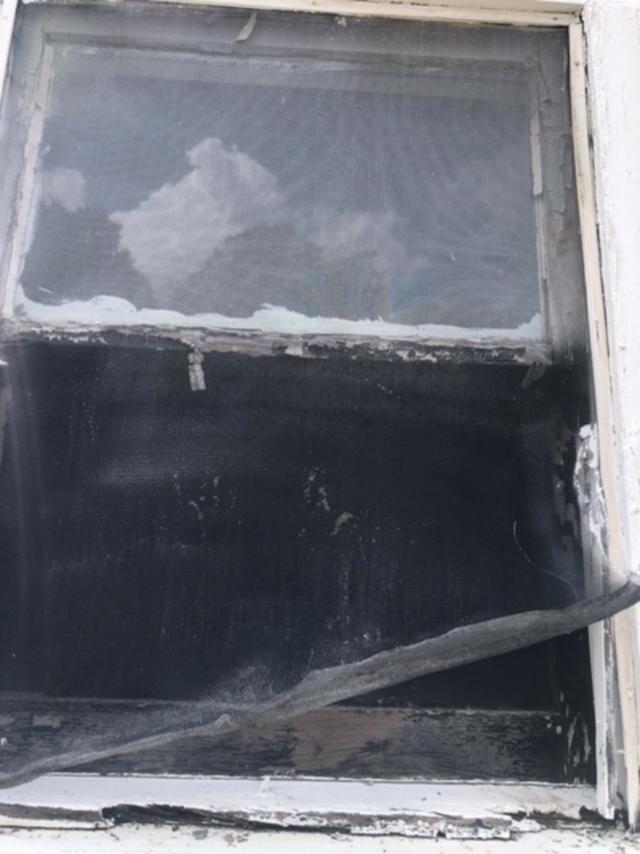
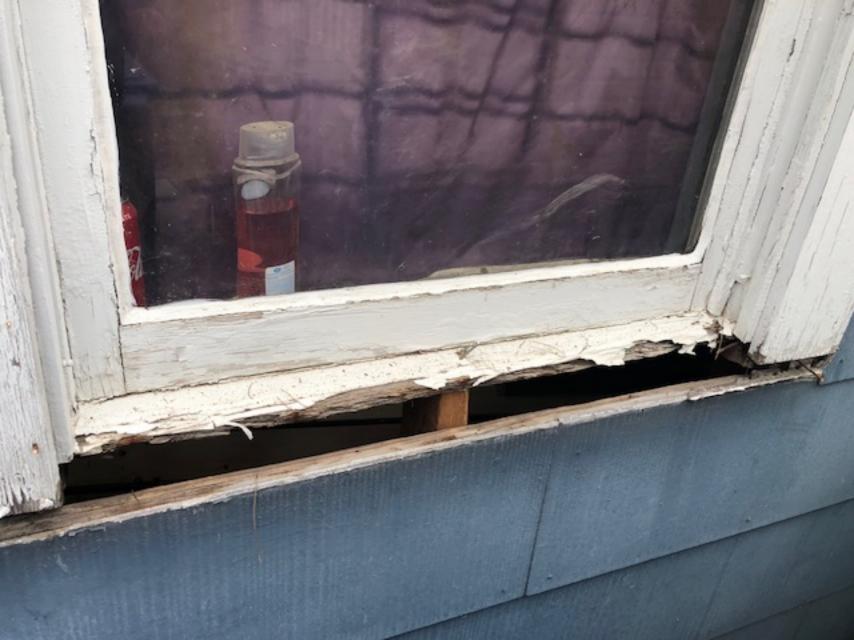
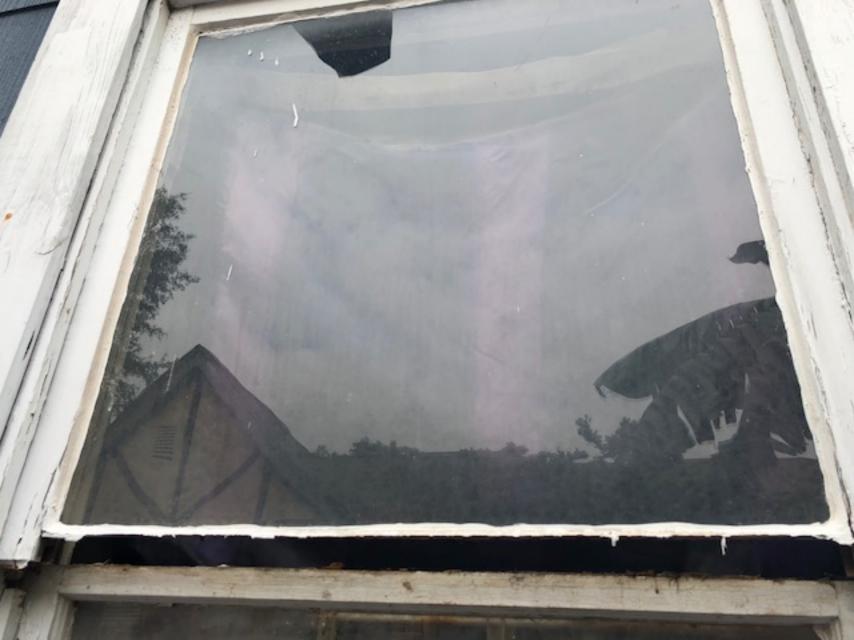
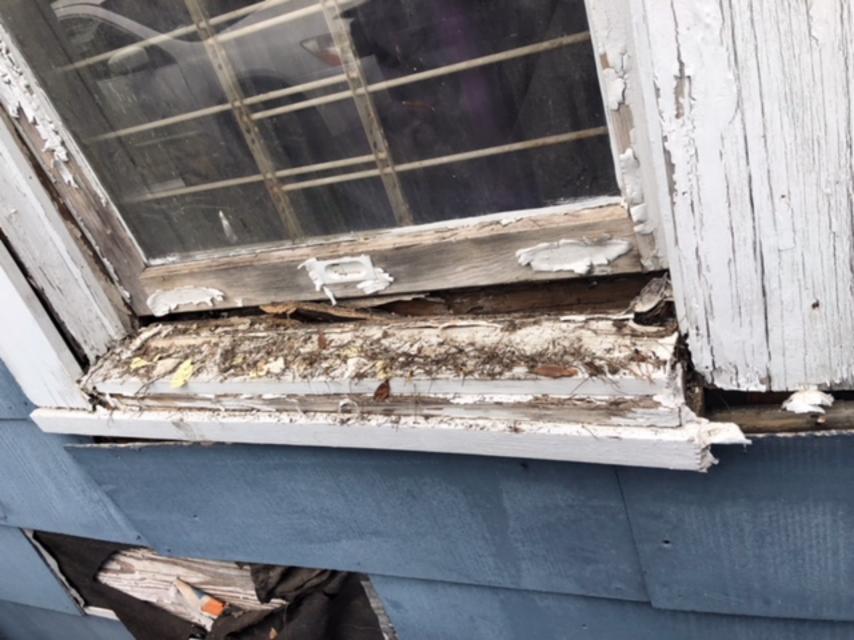
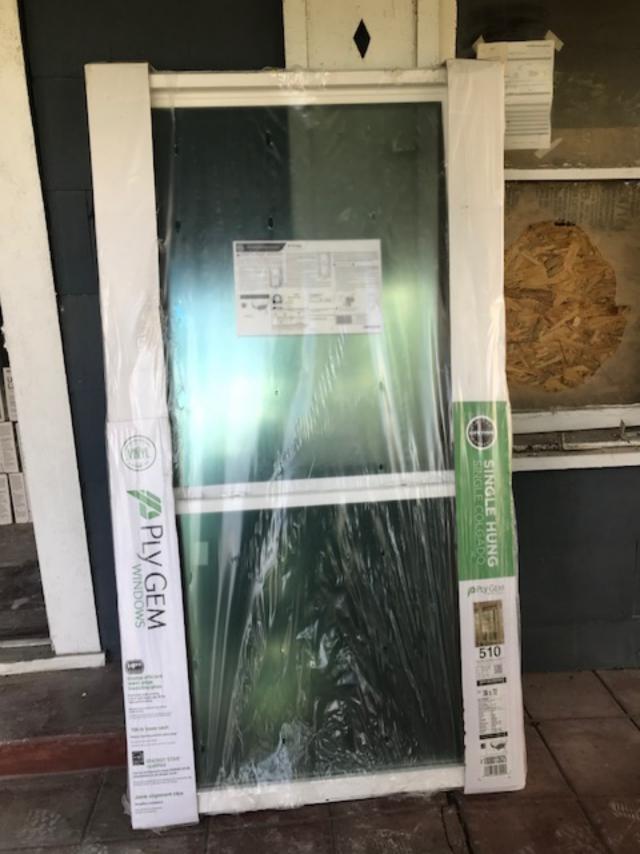
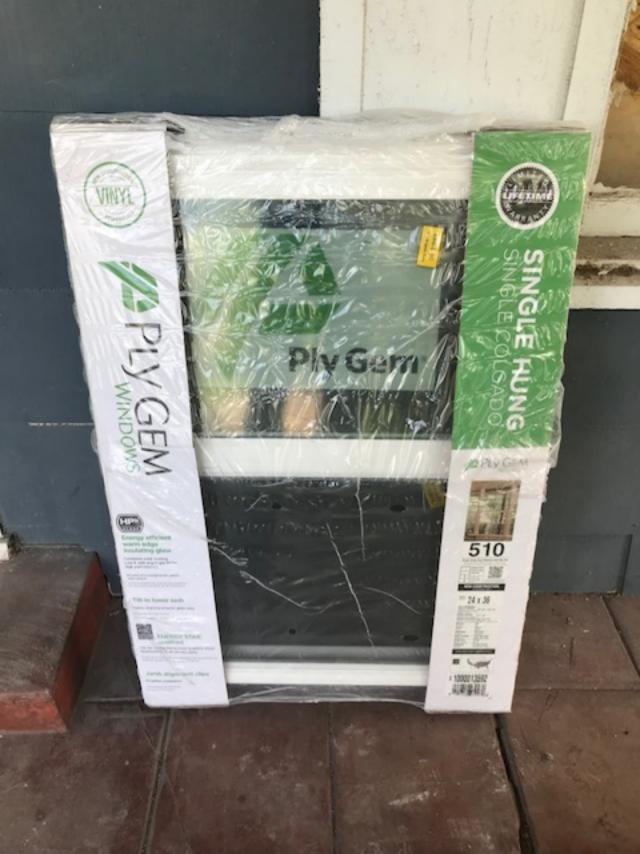
- b. EXISTING WINDOWS: CONDITION The applicant has provided multiple photographs of the existing windw condition. Several openings are boarded up and do not contain sashes. Other windows exhibit severe deterioration, including dropped meeting rails and rotted bottom rails. A few windows in the photographs are in repairable condition based on staff's observation. Based on Google Maps images, several windows were covered with aluminum exterior screens or by the front porch, which may contribute to better sash conditions in these areas. Staff finds that several windows are eligible for replacement and some are repairable based on the photographs.

- i. That the applicant retains the windows that are not deteriorated beyond repair as determined by staff. Photographic evidence or a site visit, in conjunction with an updated window schedule, is required to delineate which windows will be restored and which will be replaced. If the applicant believes all windows to be deteriorated beyond repair, the aforementioned site visit and updated documentation may be submitted for staff review and approval prior to the issuance of a Certificate of Appropriateness.

- ii. That the replacement windows be wood in lieu of the proposed vinyl. The applicant must submit a final window specification for the proposed windows to staff for review and approval. Meeting rails must be no taller than 1.25" and stiles no wider than 2.25". There should be a minimum of two inches in depth between the front face of the window trim and the front face of the top window sash. This must be accomplished by recessing the window sufficiently within the opening or with the installation of additional window trim to add thickness. Window trim must feature traditional dimensions and architecturally appropriate sill detail. Window track components must be painted to match the window trim or concealed by a wood window screen set within the opening.
