HISTORIC AND DESIGN REVIEW COMMISSION

December 05, 2018

HDRC CASE NO: 2018-567
ADDRESS: 555 CLUB DR
553 CLUB DR
LEGAL DESCRIPTION: NCB 6757 BLK G LOT 35 N 25 FT OF 34
ZONING: MF-33
CITY COUNCIL DIST.: 7
DISTRICT: Monticello Park Historic District
APPLICANT: Donna Crabtree/Sophus Properties
OWNER: Ryan and Yanzhi Kwong
TYPE OF WORK: Window replacement
APPLICATION RECEIVED: October 26, 2018
60-DAY REVIEW: December 25, 2018
REQUEST:

The applicant is requesting a Certificate of Appropriateness for a window master plan, including replacement, relocation, and repair – in response to the commission action issued at the July 18, 2018, hearing.

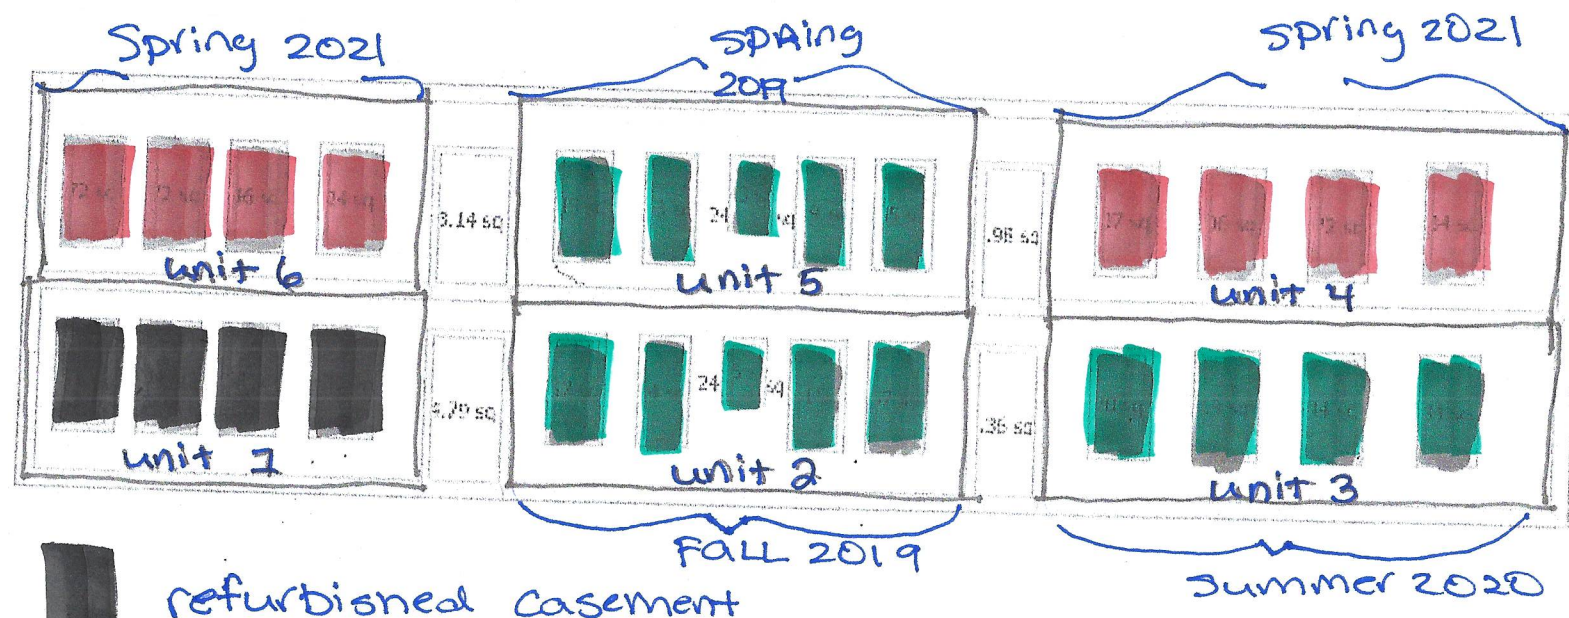
Front

Current state 9/18

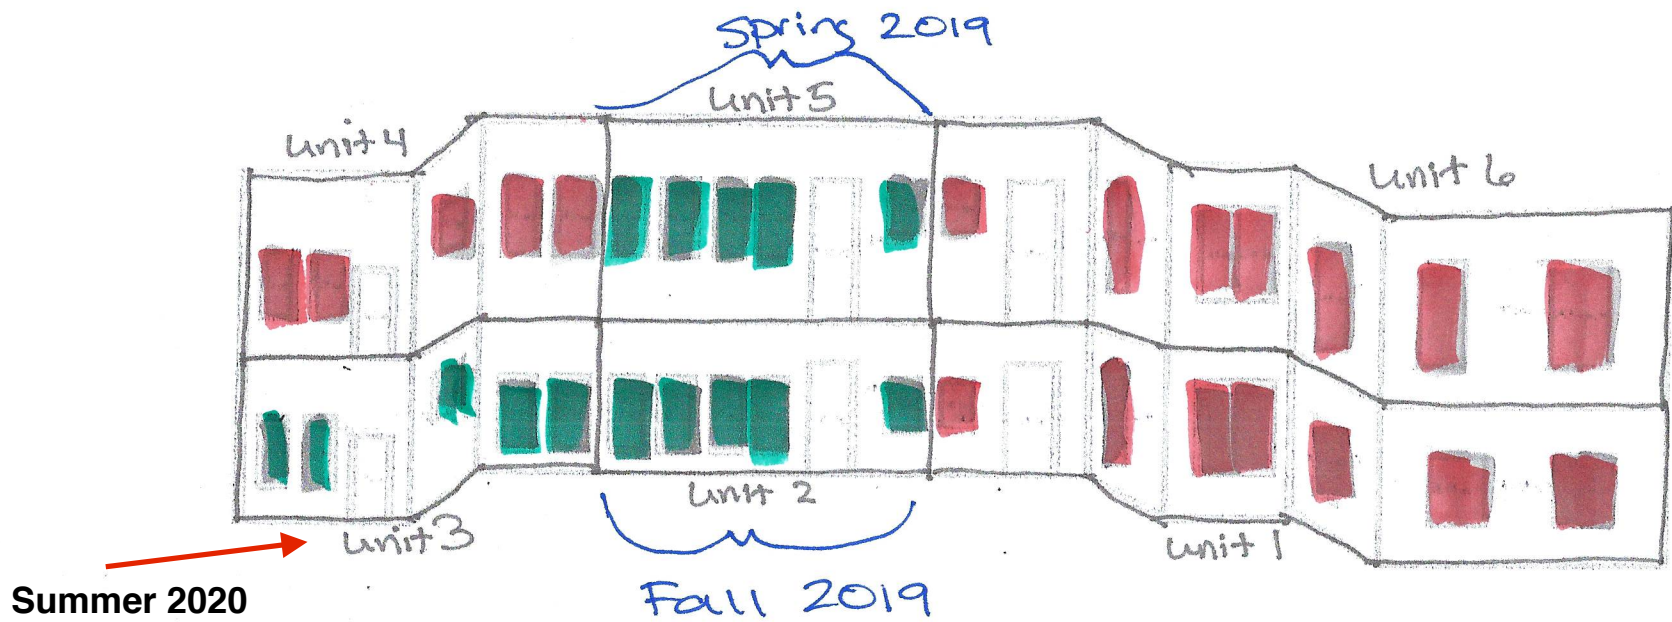
Back side

Current status 9/18

replaced vinyl

old casement to be replaced with vinyl

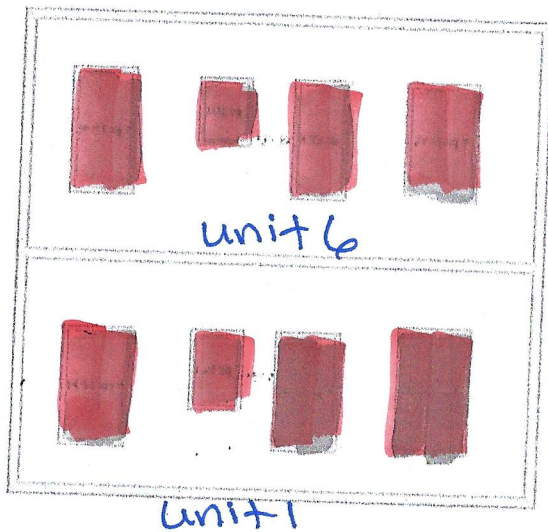
Left SIDE

Current Status 9/18

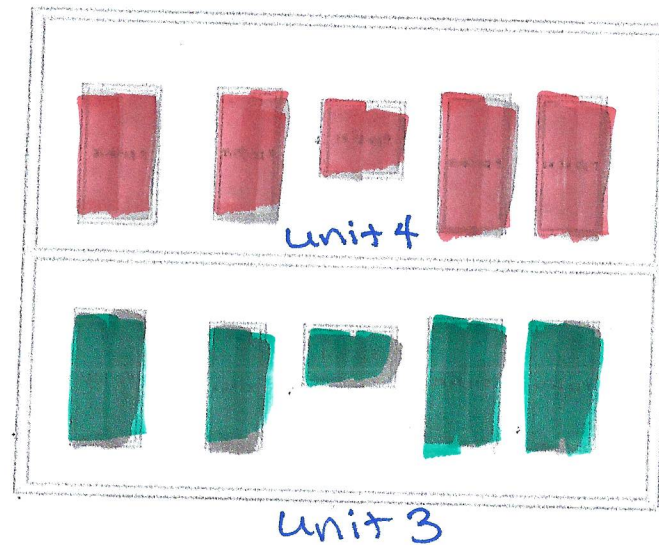
Right SIDE

replaced vinyl

OLD casement to be replaced with vinyl.

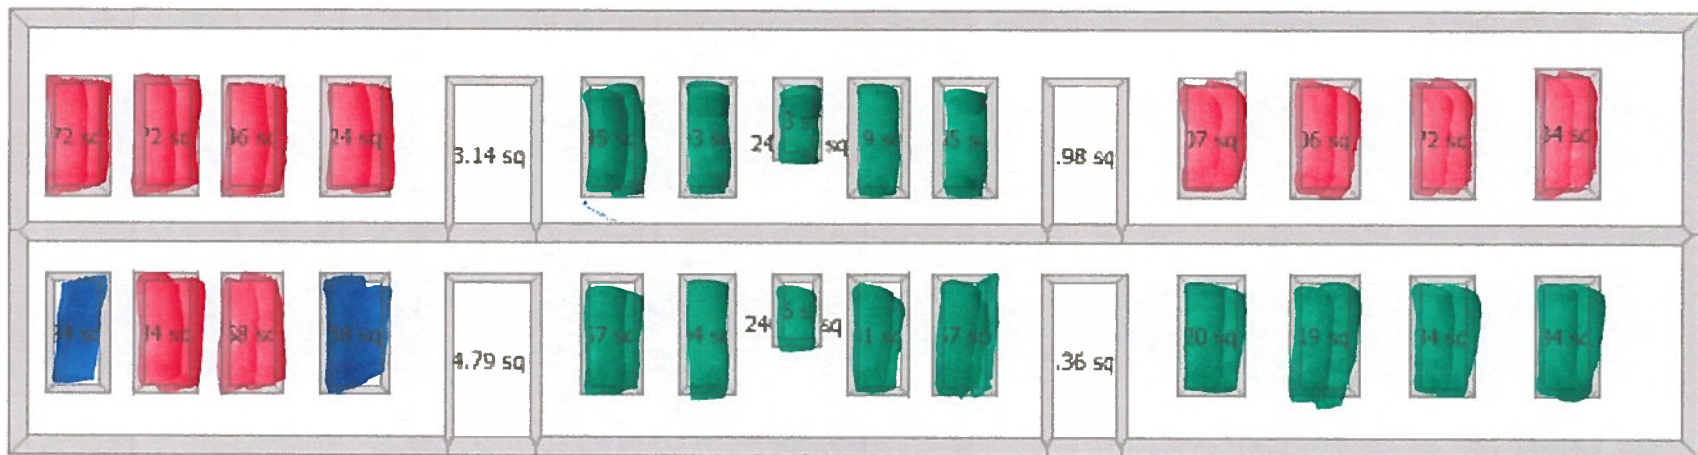
Front

previously replaced

currently requesting approval to replace

old casement

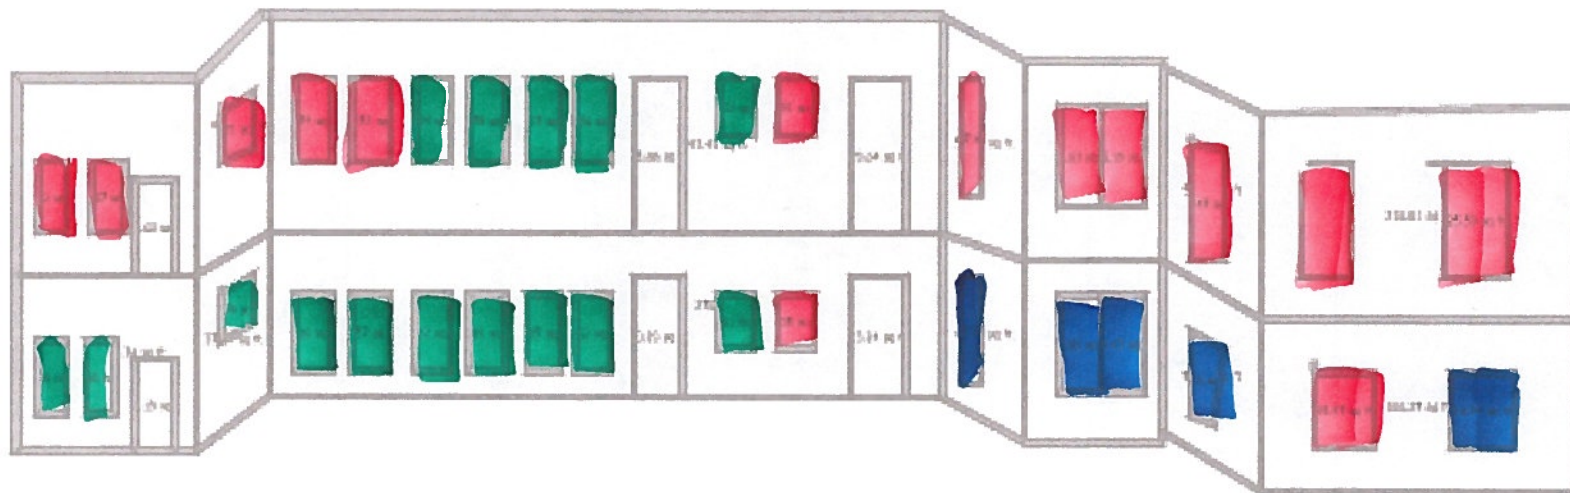
Back side

previously replaced

currently requesting approval to replace

old casement

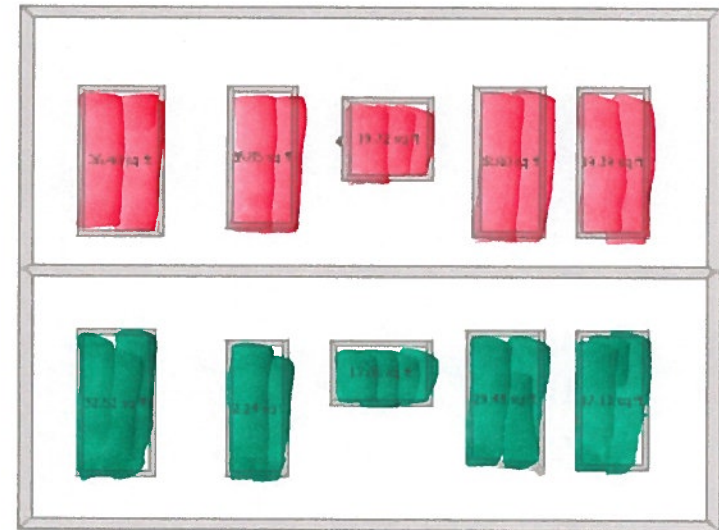
Right SIDE

previously replaced

currently requesting approval to replace

old casement
