HISTORIC AND DESIGN REVIEW COMMISSION

December 19, 2018

HDRC CASE NO: 2018-462
ADDRESS: 201 E HUISACHE AVE
LEGAL DESCRIPTION: NCB 3085 BLK 1 LOT 23
ZONING: MF-33
CITY COUNCIL DIST.: 1
DISTRICT: Monte Vista Historic District
APPLICANT: Patrick Christensen
OWNER: SA Huisache Investors LLC
TYPE OF WORK: Window replacement
APPLICATION RECEIVED: November 20, 2018
60-DAY REVIEW: January 19, 2018
REQUEST:

Investigation Report

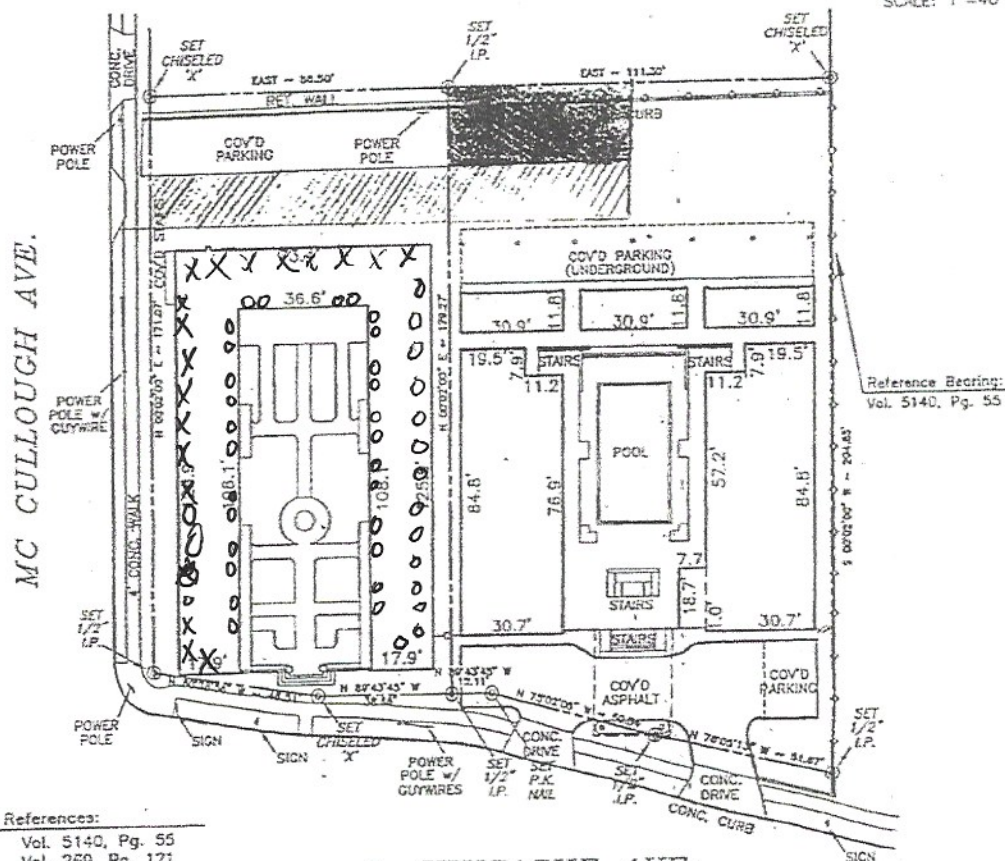
Exhibit "A"

Please find attached site plan showing the 25 replaced windows. I only intended to replace two more units (total 27) as the replacement was in response to significant water infiltration issues and damage to frames and sills from neglect of previous ownership. We repaired and replaced significant areas of the roof and kept the tile roof as well to solve this and keep with the character of the building. We have replaced second floor balcony doors, but with wood (not vinyl).

Second floor
O = old wood
X = new vinyl

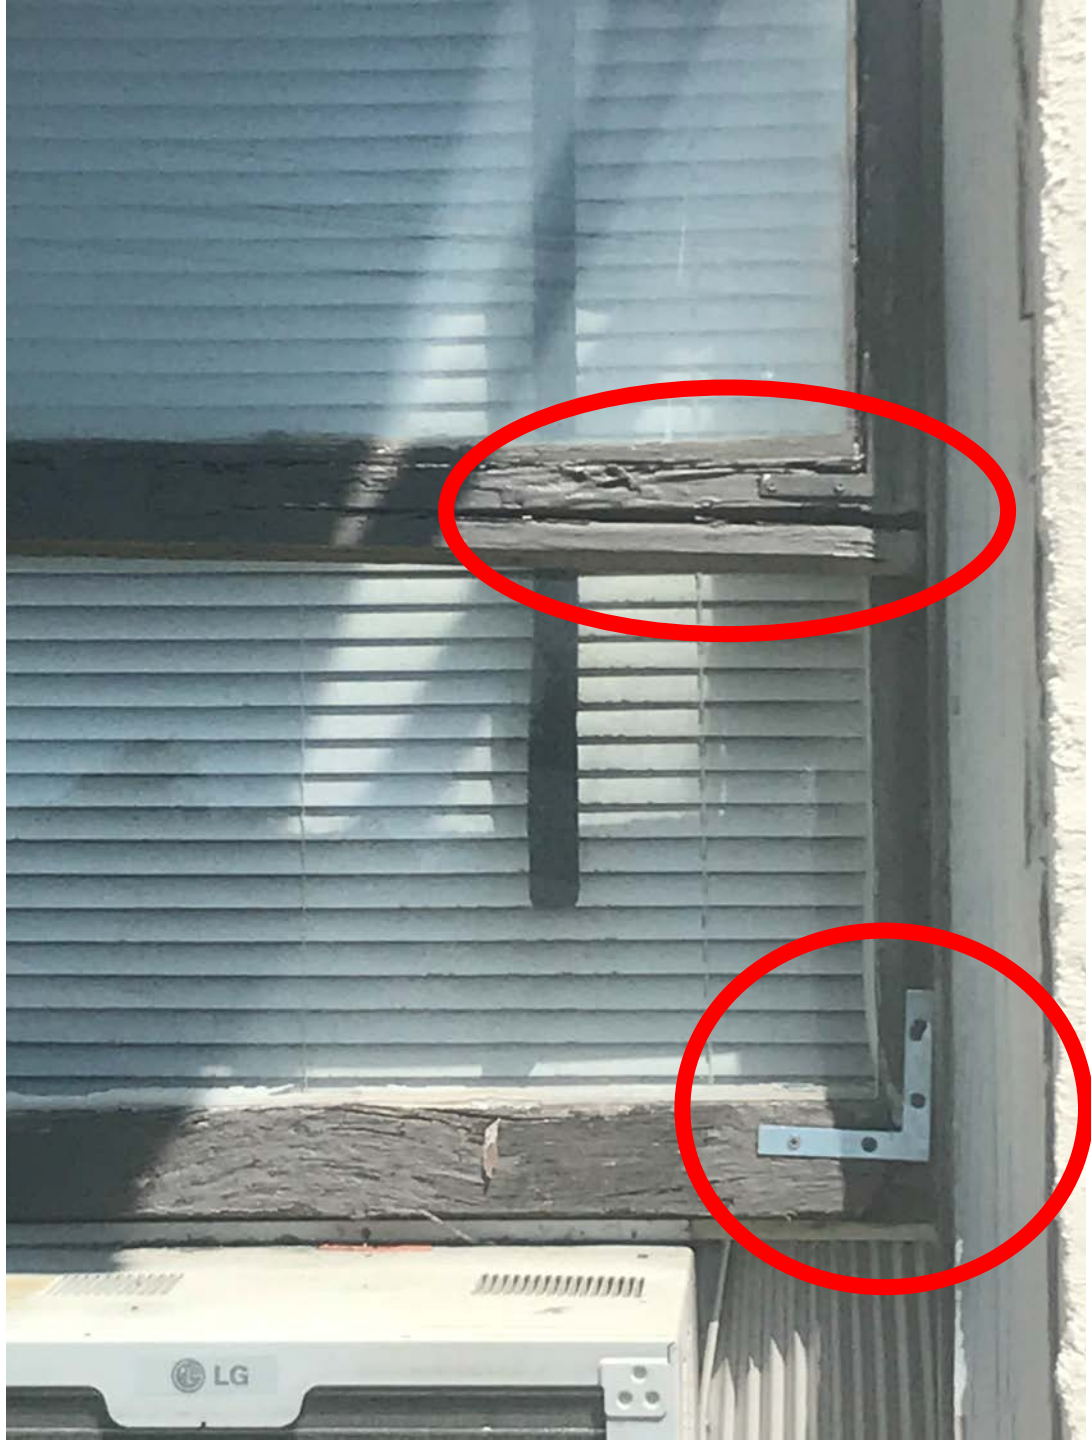
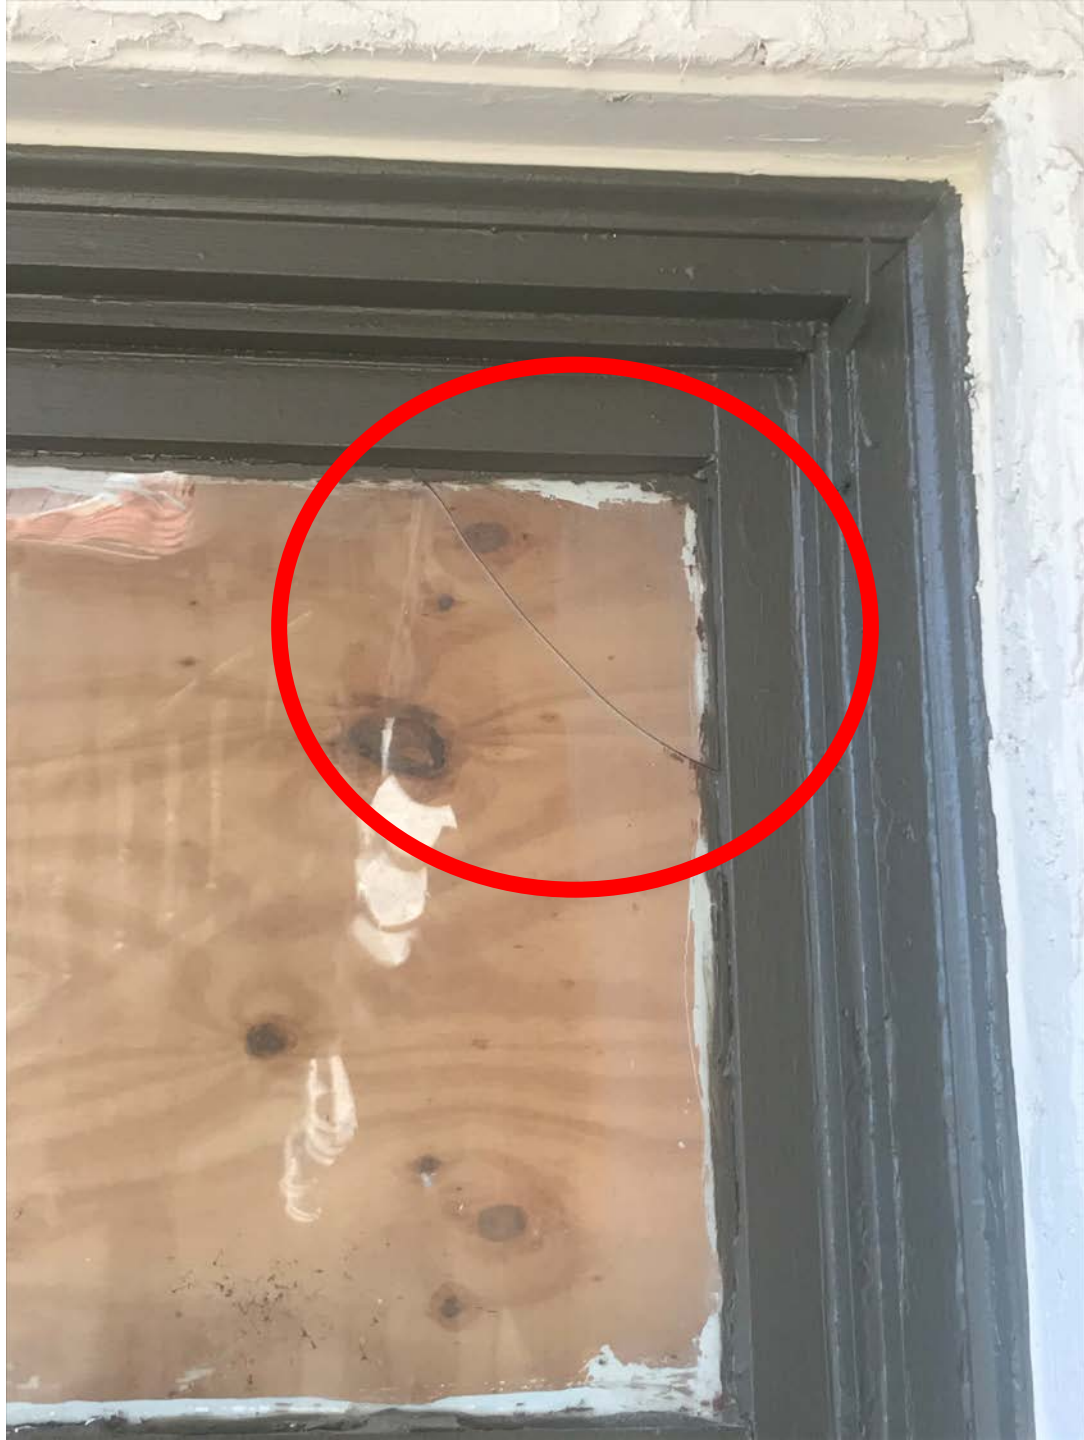
- d. EXISTING WINDOWS – Prior to replacement without approval, the structure featured one-over-one wood windows with a decorative spindle trim as a center piece between each set of windows. The property features approximately 120 windows.

The following photos are existing window conditions:

Staff does not recommend approval as proposed based on finding b through f. Staff recommends in-kind wood window replacement where they are deteriorated beyond repair.

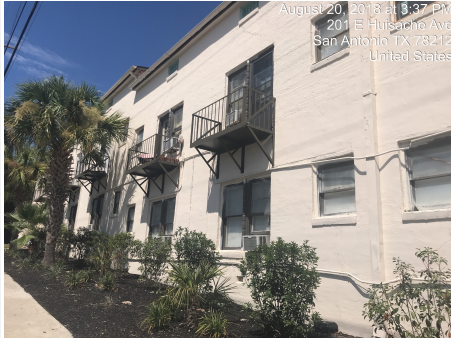
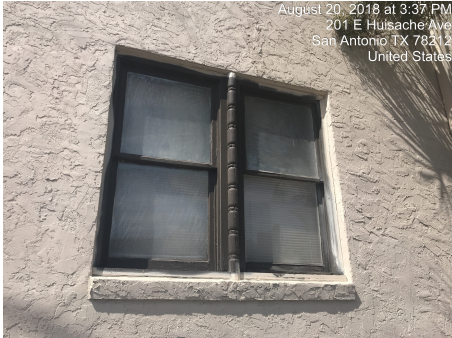
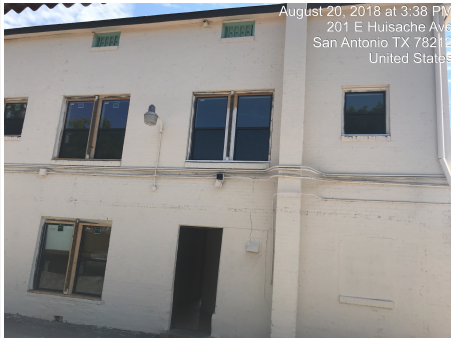
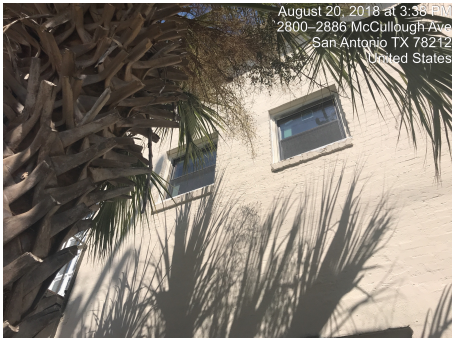
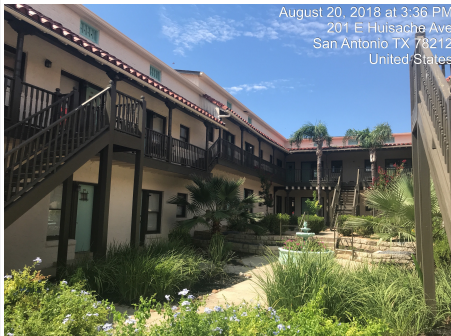
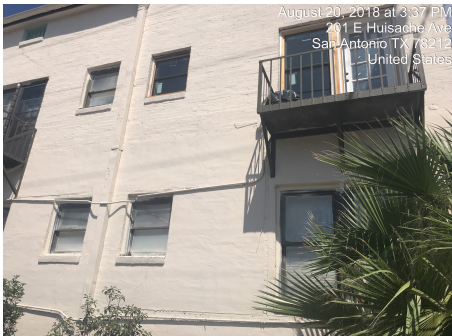
Photographs

Date	08/20/2018
Time	03:41 PM (-5 GMT)
Context	citizen report
Present Staff	Huy Pham
Present Individuals	None
Types of Work Observed	Exterior Maintenance and Alterations
Amount of Work Completed	75%
Description of work	Removal of over 20 wood windows and doors and installation of aluminum windows.

Violation Type	No Certificate of Appropriateness (Code 35-451a)
OHP Action	posted "Notice of Investigation", posted "Stop Work Notice"
Deadline to contact office	08/20/2018
