HISTORIC AND DESIGN REVIEW COMMISSION

HDRC CASE NO: 2018-616
ADDRESS: 1405 S FLORES ST
LEGAL DESCRIPTION: NCB 1009 BLK LOT 40B
ZONING: I-1,HS
CITY COUNCIL DIST.: 1
LANDMARK: SAP Cleaners & Dyers
APPLICANT: Kris Feldmann
OWNER: HB Properties I, LLC
TYPE OF WORK: Rehabilitation, exterior modifications, signage, storefront restoration, window replacement, roofing
APPLICATION RECEIVED: December 05, 2018
60-DAY REVIEW:
REQUEST:

Antiques Warehouse Lofts
November 30, 2018

HDRC SUBMITTAL | 2018.11.30
1405 S. FLORES, SAN ANTONIO TX, 78204

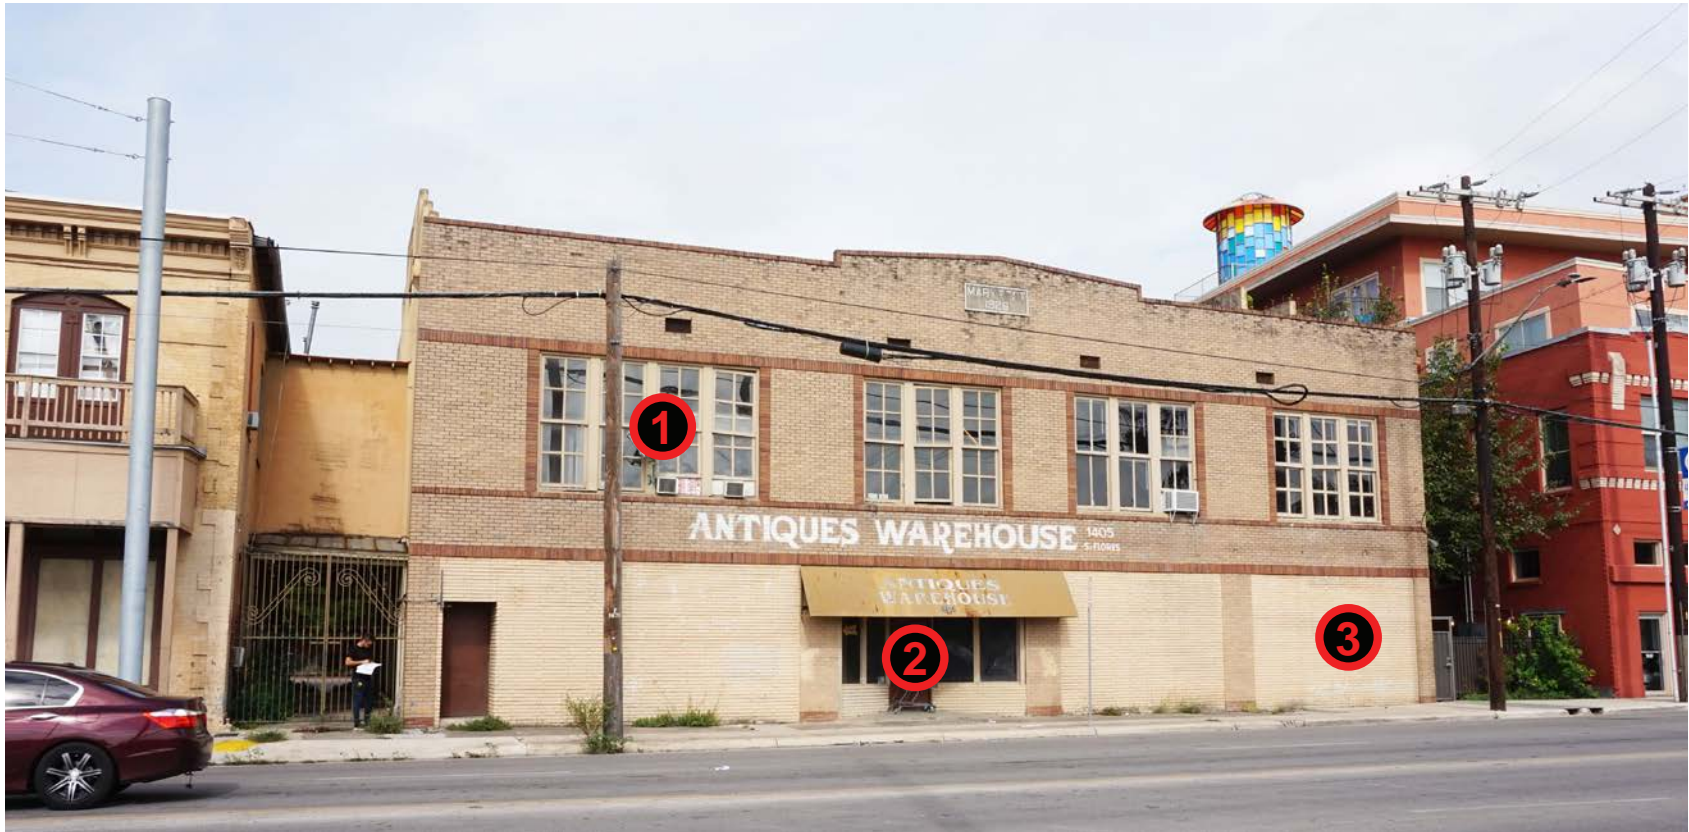
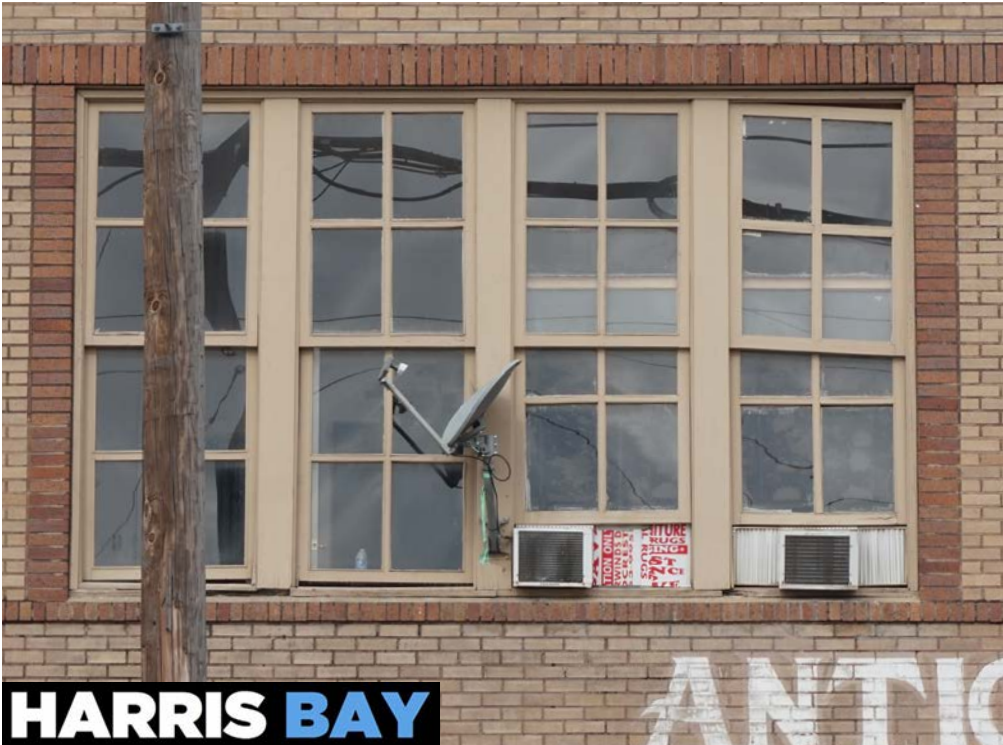
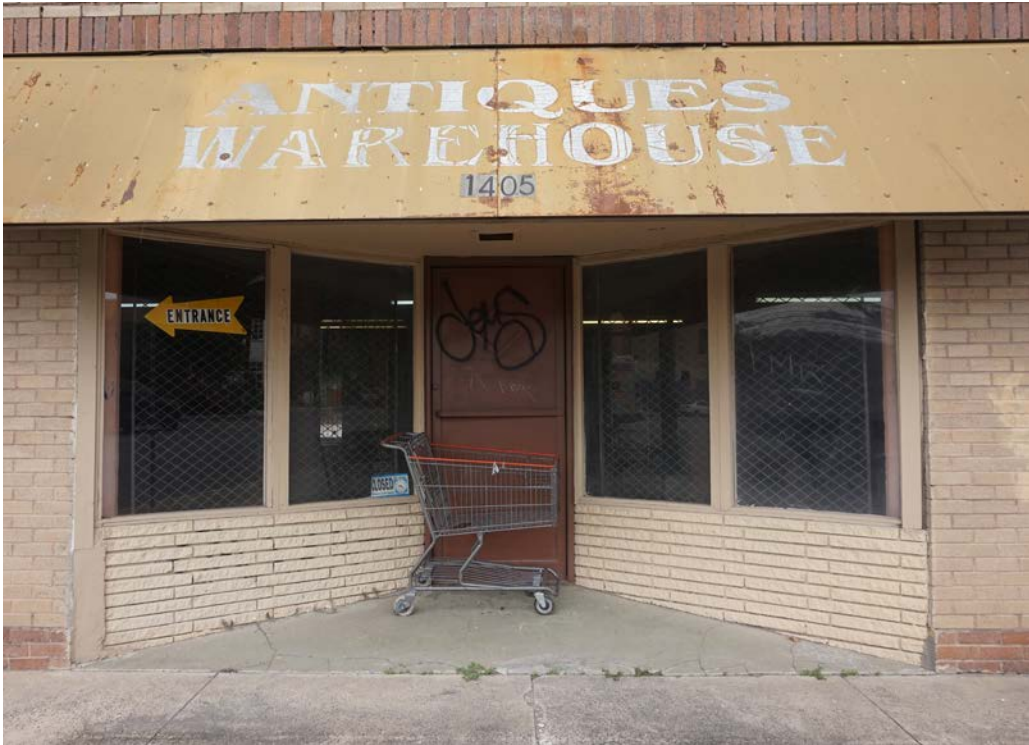
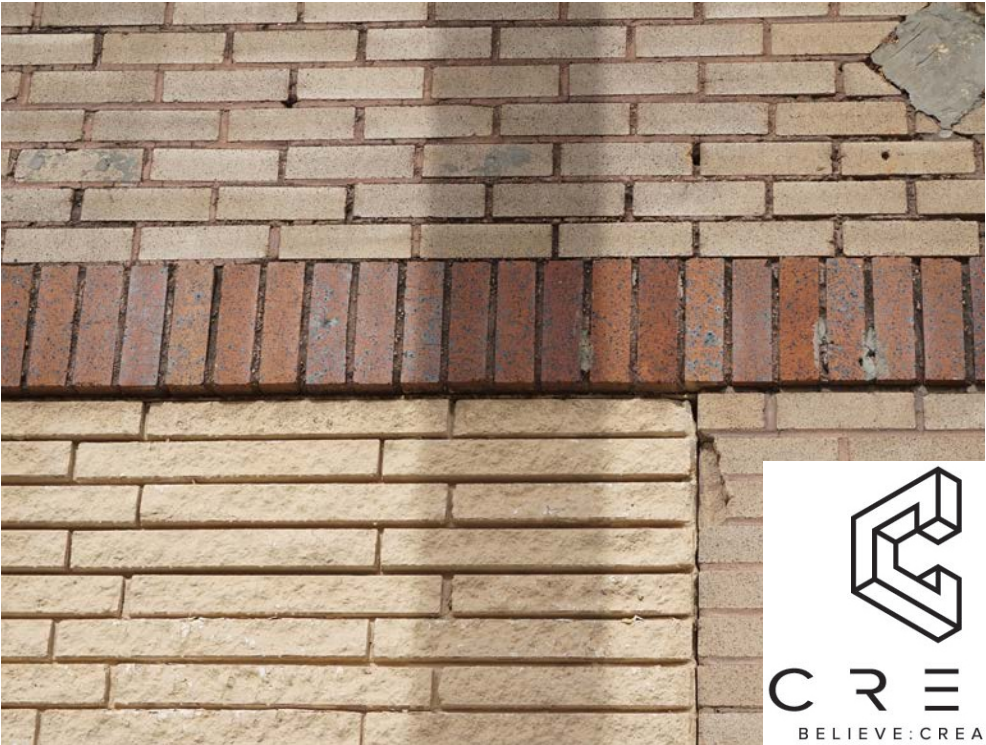
EAST ELEVATION - EXISTING DETAILS

① DETERIORATING SINGLE PANE WOOD FRAMED WINDOWS - TO BE REPLACED (REF. WINDOW SPEC EXHIBIT)

② NON-ORIGINAL FRONT VESTIBULE BUMP-IN AND AWNING

③ STONE INFILL AT AREAS OF ORIGINAL STOREFRONT.

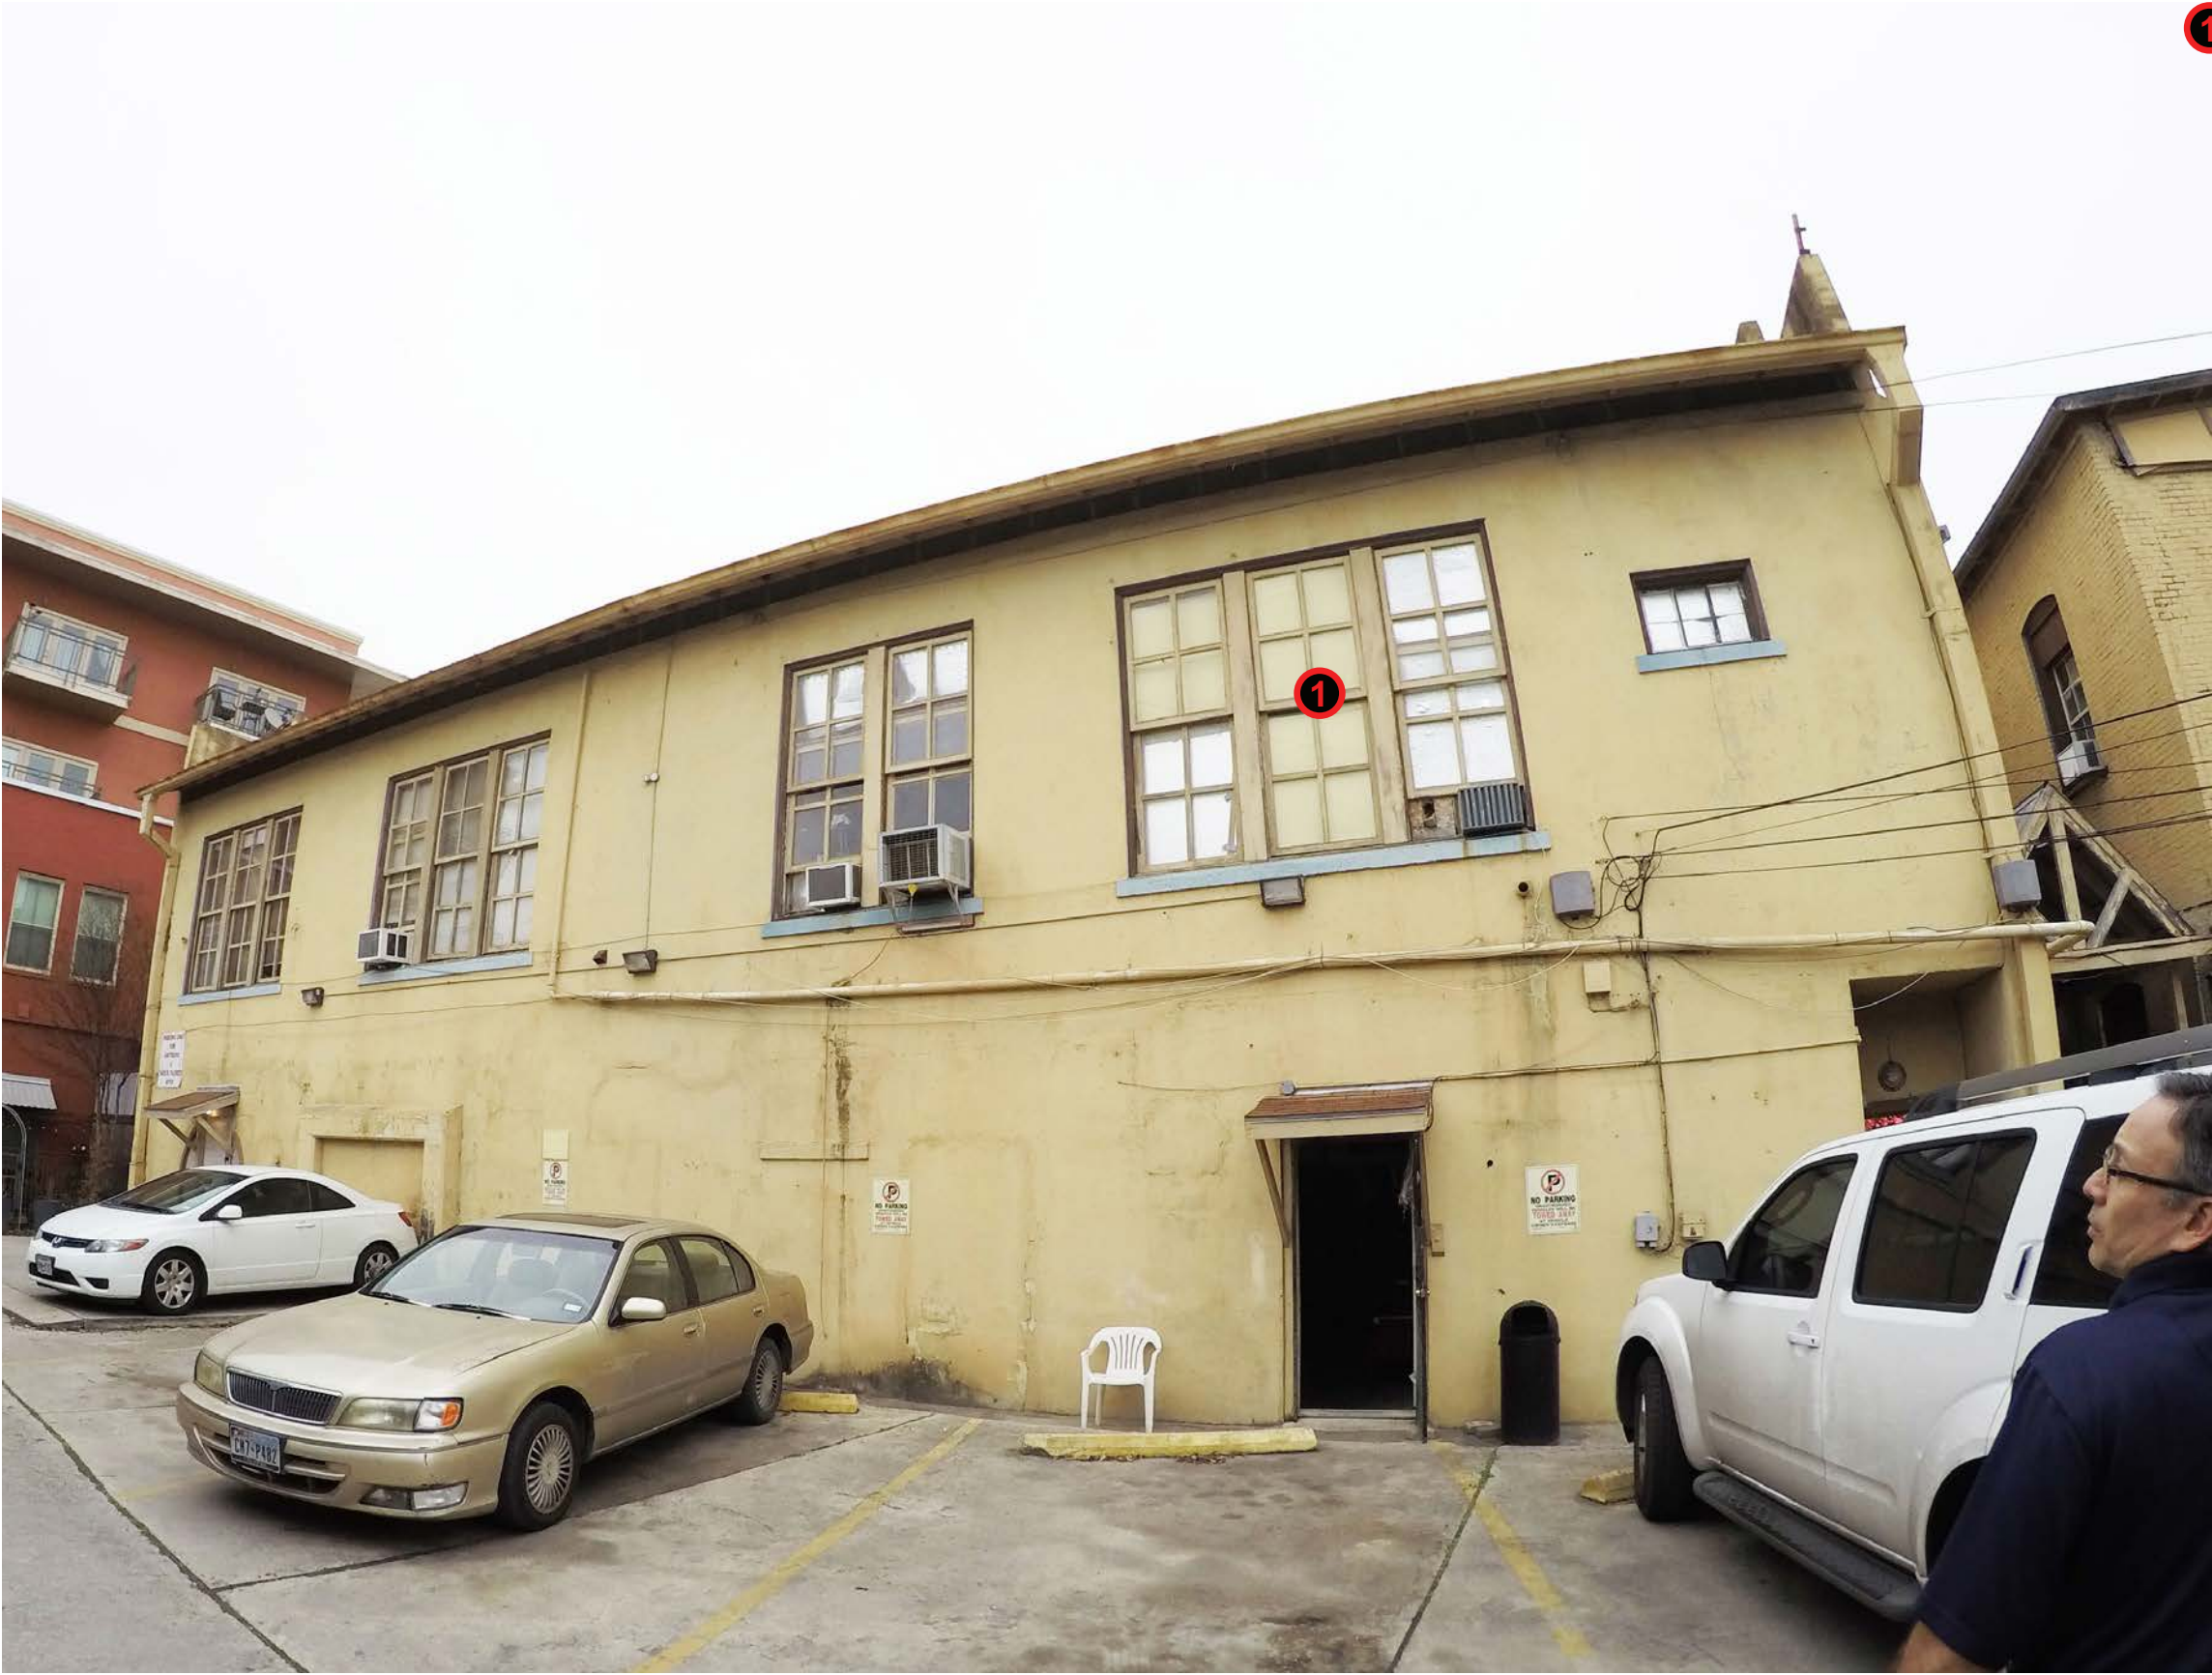
EXISTING EXTERIOR CONDITION - WEST (PARKING LOT) ELEVATION

1 DETERIORATING SINGLE PANE WOOD
FRAMED WINDOWS - TO BE REPLACED
(REF. WINDOW SPEC EXHIBIT)

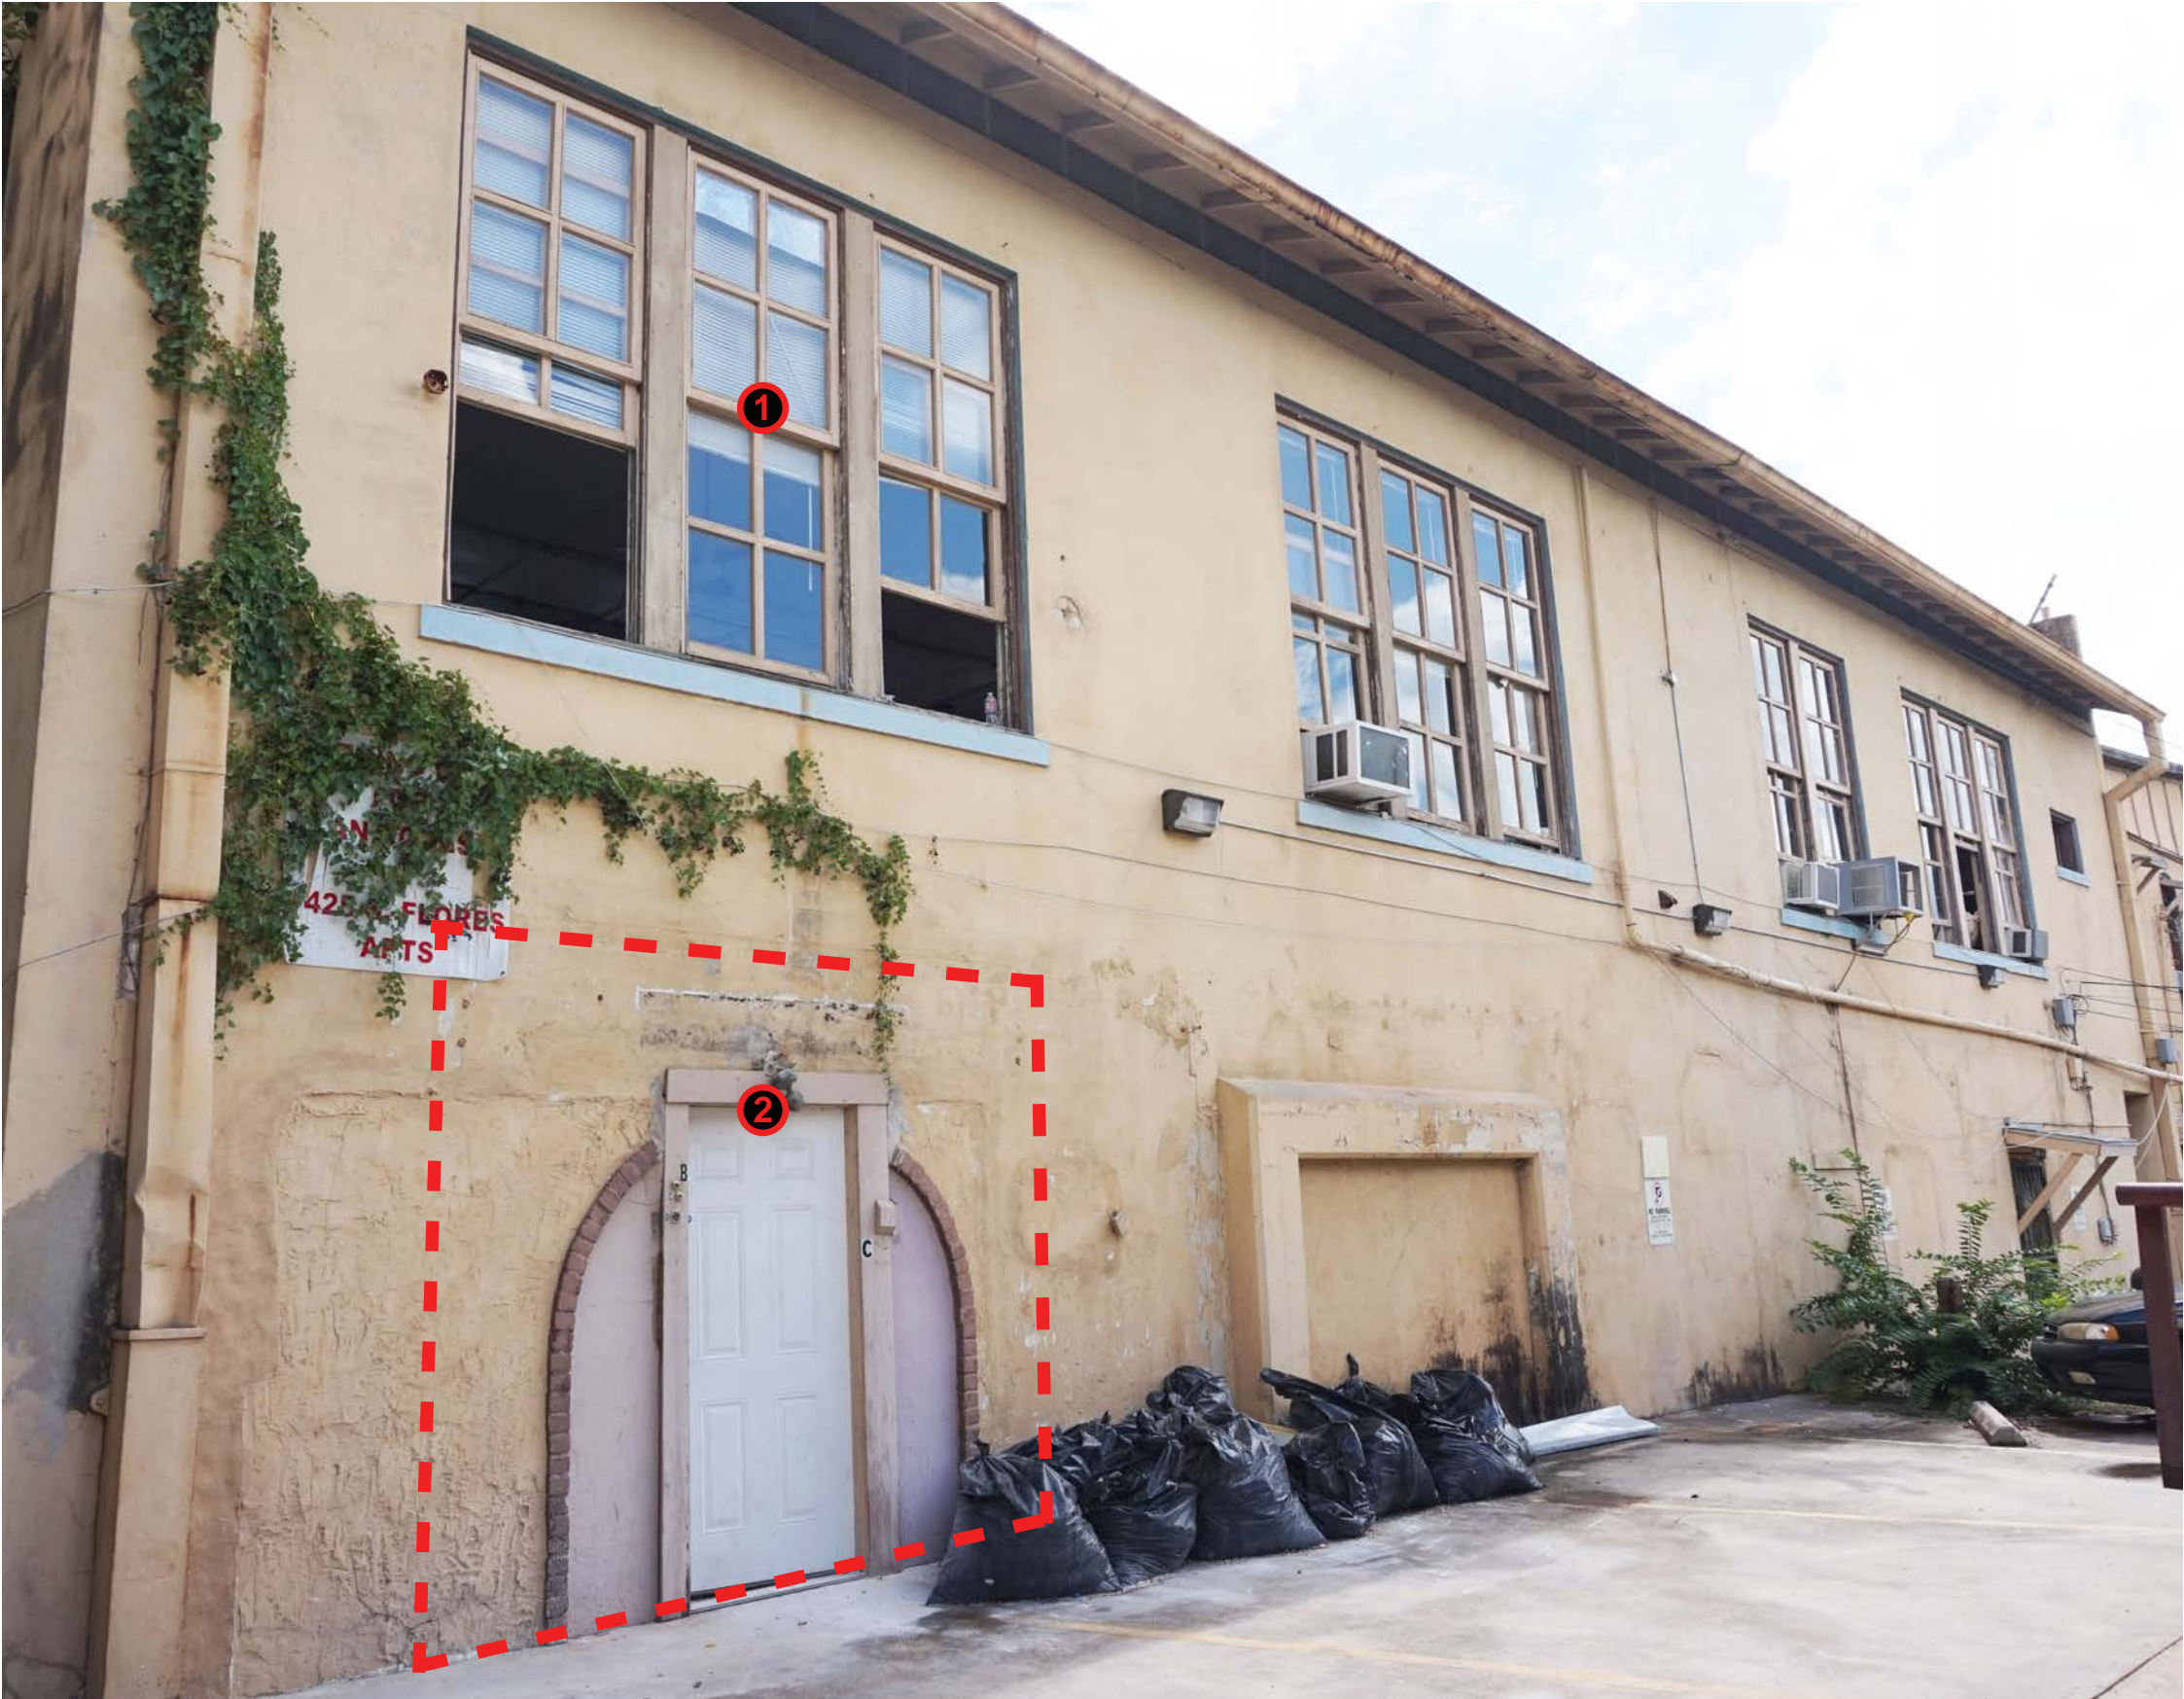
EXISTING EXTERIOR CONDITION - WEST (PARKING LOT) ELEVATION

- ① DETERIORATING SINGLE PANE WOOD FRAMED WINDOWS - TO BE REPLACED (REF. WINDOW SPEC EXHIBIT)
- ② AREA FOR PROPOSED LOFT ENTRY STOREFRONT

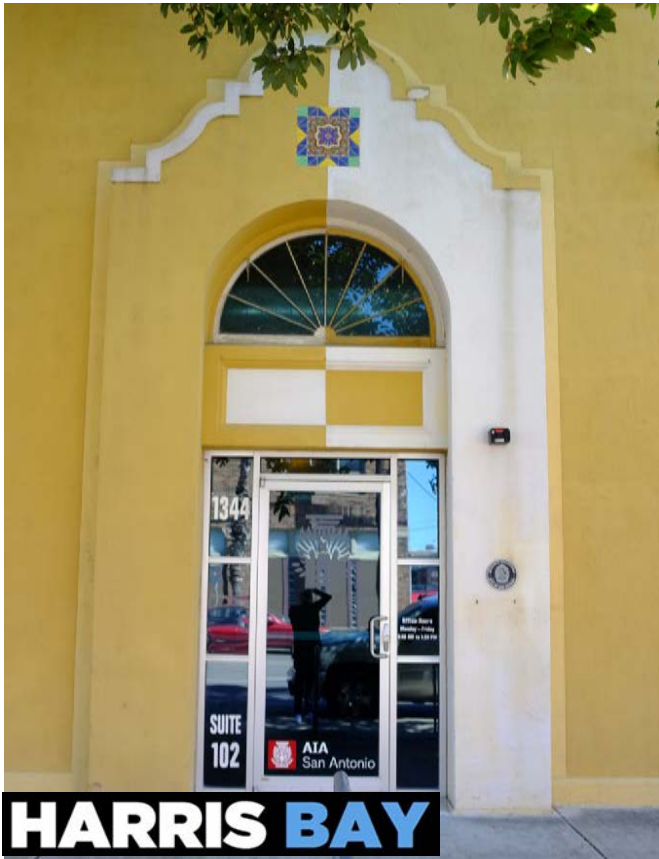
C EXHITBIT C
NON-HISTORIC ALUMINUM
STOREFRONT ON EXISTING
OPENING

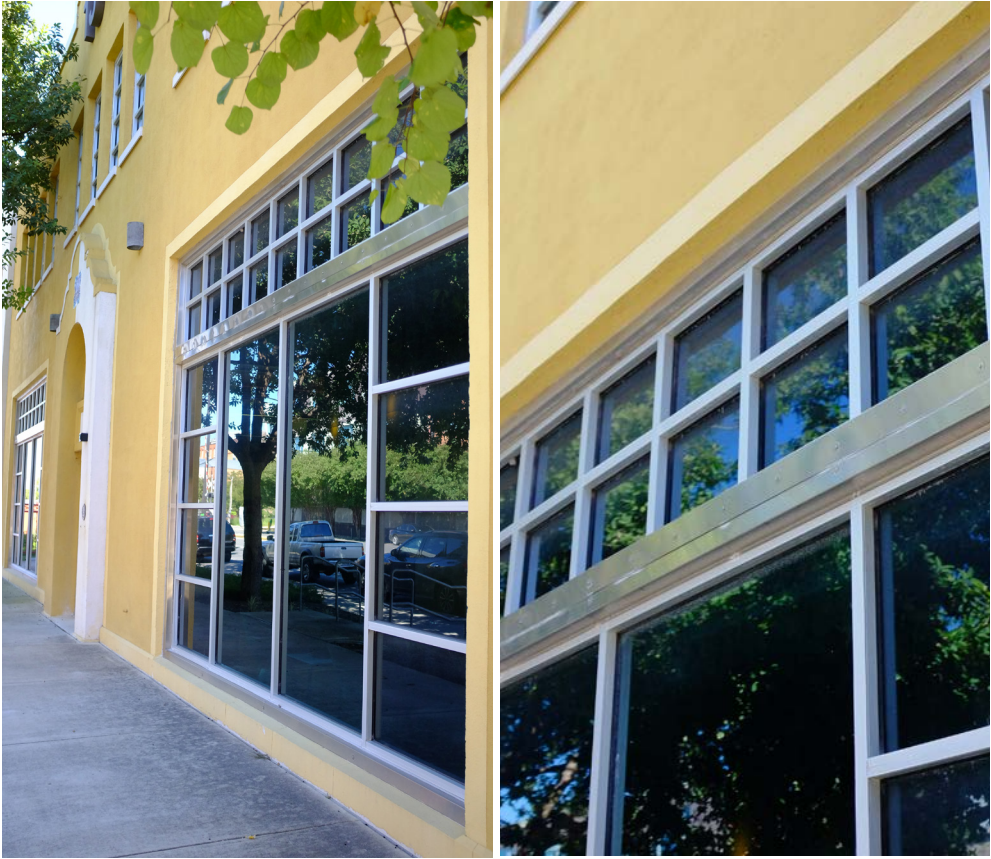
D EXHITBIT D
NON-HISTORIC ALUMINUM
STOREFRONT W/ TINTED
GLASS ON EXISTING OPENING

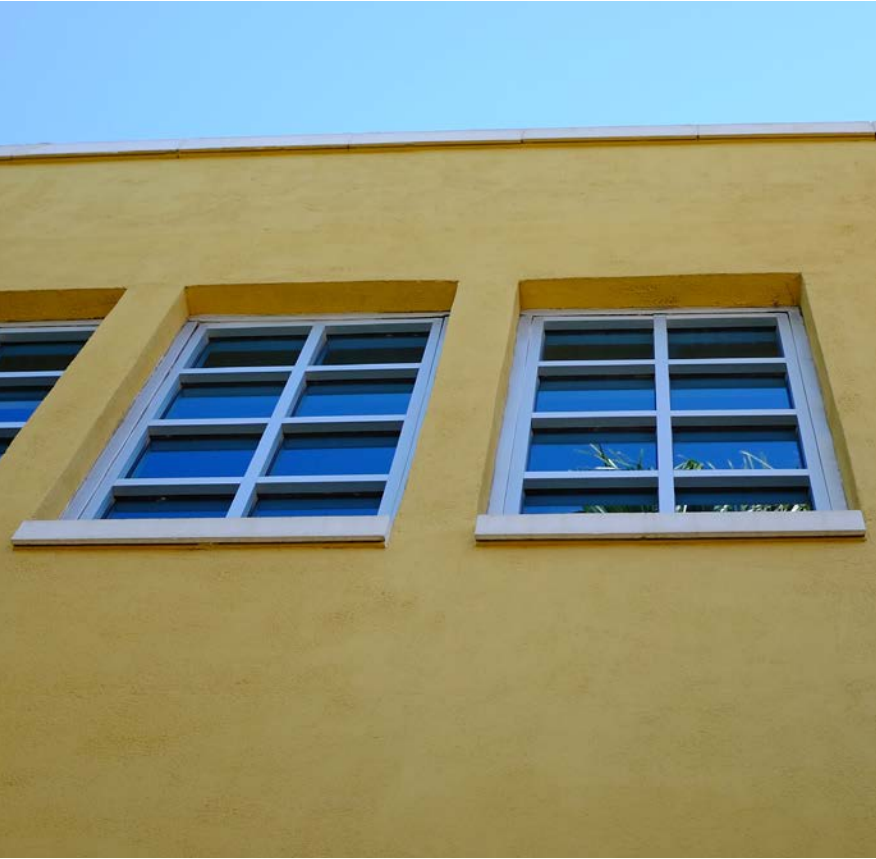
E EXHITBIT E
NON-HISTORIC ALUMINUM
WINDOWS W/ TINTED
GLASS ON EXISTING OPENING

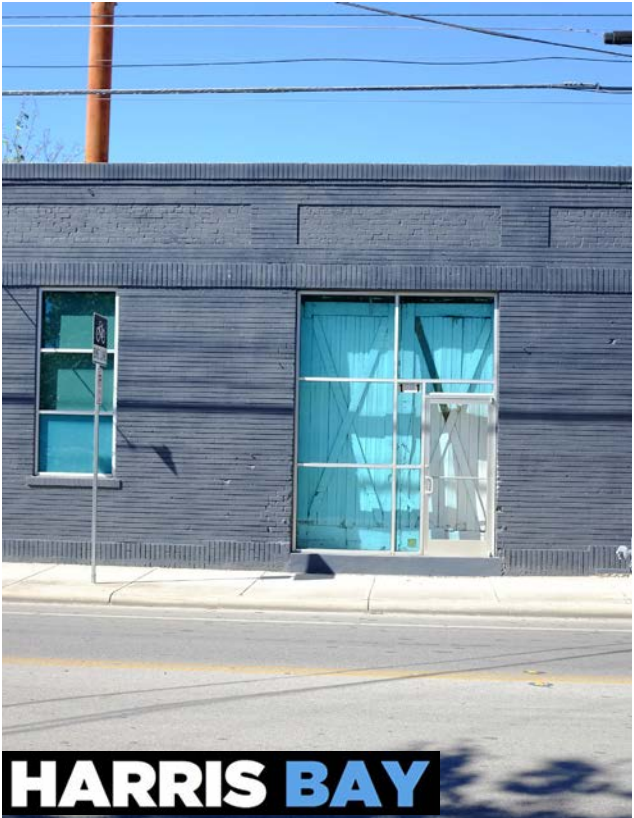
F EXHITBIT F
PAINTED BRICK FACADE AND
NON- HISTORIC ALUMINUM
STOREFRONT ON EXISTING
OPENINGS

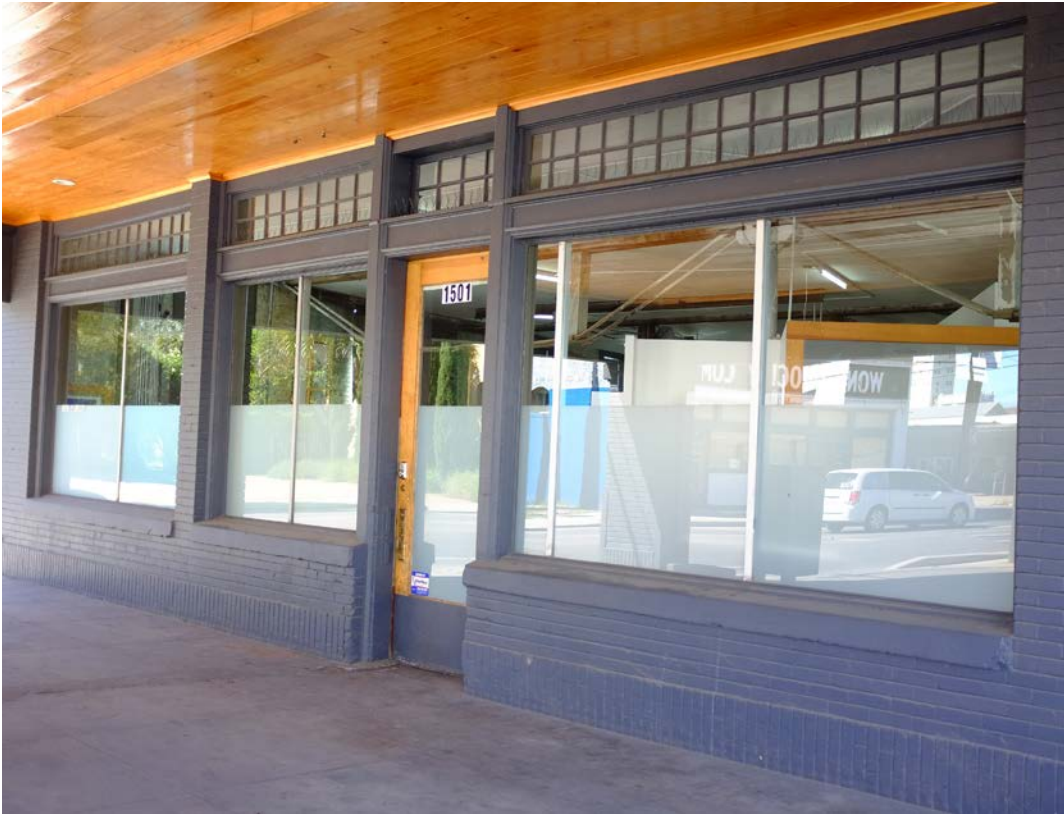
G EXHITBIT G
NON-HISTORIC ALUMINUM
STOREFRONT W/ FROSTED FILM
ON EXISTING STOREFRONT
OPENING

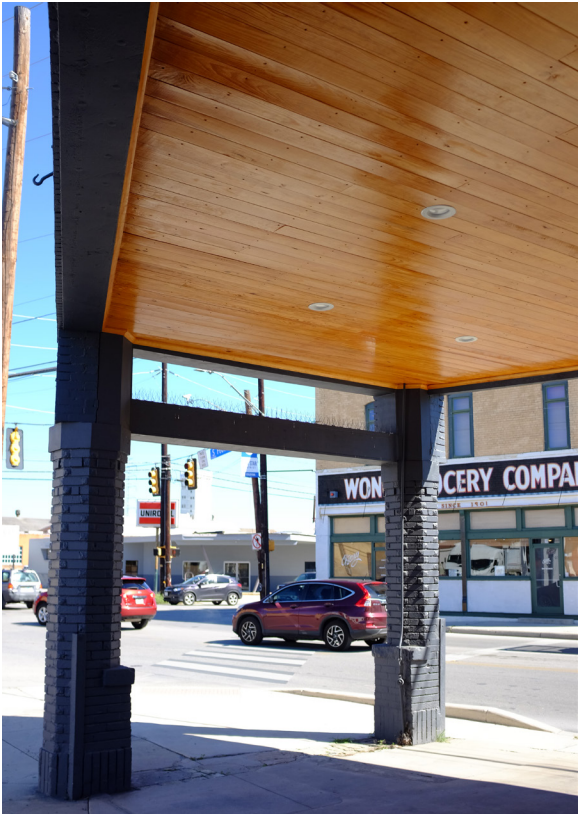
H EXHITBIT H
NON-HISTORIC TREATMENT OF
EXTERIOR PORCH SOFFIT
