HISTORIC AND DESIGN REVIEW COMMISSION

December 19, 2018

HDRC CASE NO: 2018-622
ADDRESS: 914 LAMAR ST
LEGAL DESCRIPTION: NCB 1655 BLK C LOT 11
ZONING: R-5
CITY COUNCIL DIST.: 2
DISTRICT: Dignowity Hill Historic District
APPLICANT: Andrea Frias
OWNER: Juan and Oralia DeLeon
TYPE OF WORK: Front porch modifications
APPLICATION RECEIVED: December 05, 2018
60-DAY REVIEW: February 04, 2019
REQUEST:

The applicant is requesting a Certificate of Appropriateness for approval to replace Folk Victorian porch elements with square columns, cattle panel fencing, and 2x6 wood decking.

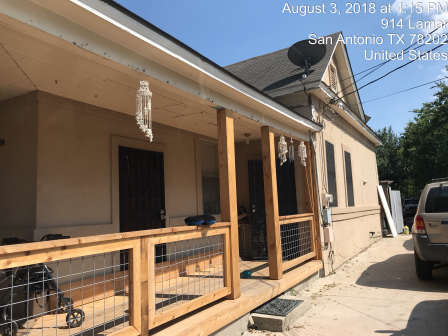
August 3, 2018 at 4:15 PM
914 Lamar
San Antonio TX 78202
United States

- b. On a site visit conducted on August 3, 2018, staff found that the front porch that once features Folk Victorian elements were replaced with cattle-panel fencing, square columns, and 2x6 wood decking. Staff advised that the original columns that were still on site be retained until the conclusion of an HDRC hearing. The applicant submitted the design as installed on December 5, 2018 and had notified staff that the original columns have been discarded. The \$500 post-work application fee has not been paid at this time.

Staff does not recommend approval of the porch modifications based on finding b and c. Staff recommends the reconstruction of the original porch configuration featuring:

- i. Salvaged turned wood columns
- ii. Wood spindle railing at a similar height as seen in photographic documentation
- iii. Tongue-and-groove wood decking no wider than 3”

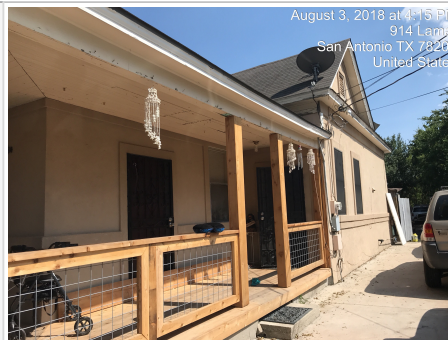
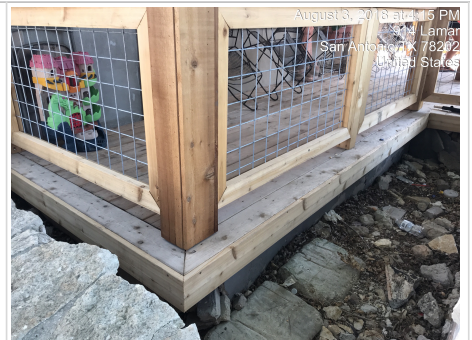
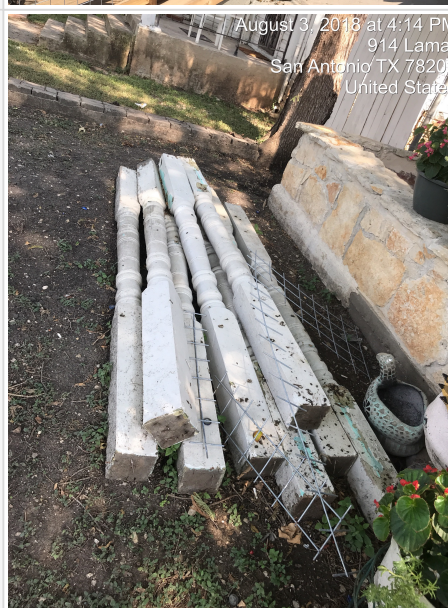
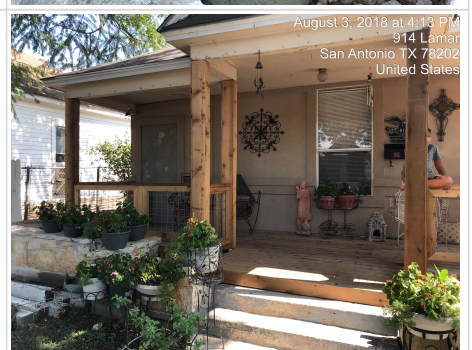
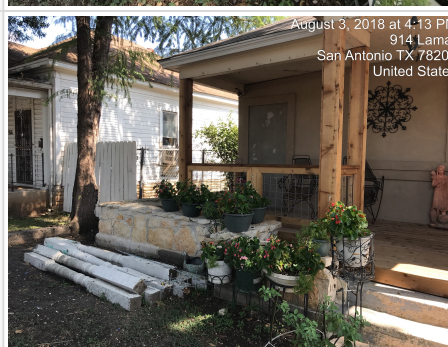
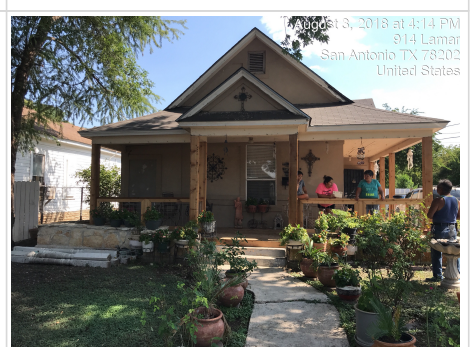
Photographs

Date	08/03/2018
Time	04:23 PM (-5 GMT)
Context	drive-by
Present Staff	Huy Pham
Present Individuals	Homeowner
Types of Work Observed	Exterior Maintenance and Alterations
Amount of Work Completed	Completed
Description of work	Front porch modifications including the removal of wood columns. Original columns are still onsite.
Description of interaction	Staff spoke with homeowner's daughter Andrea. Staff explained that work within historic districts require the issuance of a COA and provided contact information to OHP. Andrea and her family were cooperative and understood to stop work until approved.
