## HISTORIC AND DESIGN REVIEW COMMISSION

February 06, 2019

**HDRC CASE NO:** 2019-042  
**ADDRESS:** 125 W ASHBY PLACE  
**LEGAL DESCRIPTION:** NCB 1885 BLK LOT A1  
**ZONING:** R-6, H  
**CITY COUNCIL DIST.:** 1  
**DISTRICT:** Monte Vista Historic District  
**APPLICANT:** Craig Scott/CROSS  
**OWNER:** David and Alicia Garrett  
**TYPE OF WORK:** Basement window installation  
**APPLICATION RECEIVED:** January 22, 2019  
**60-DAY REVIEW:** March 21, 2019

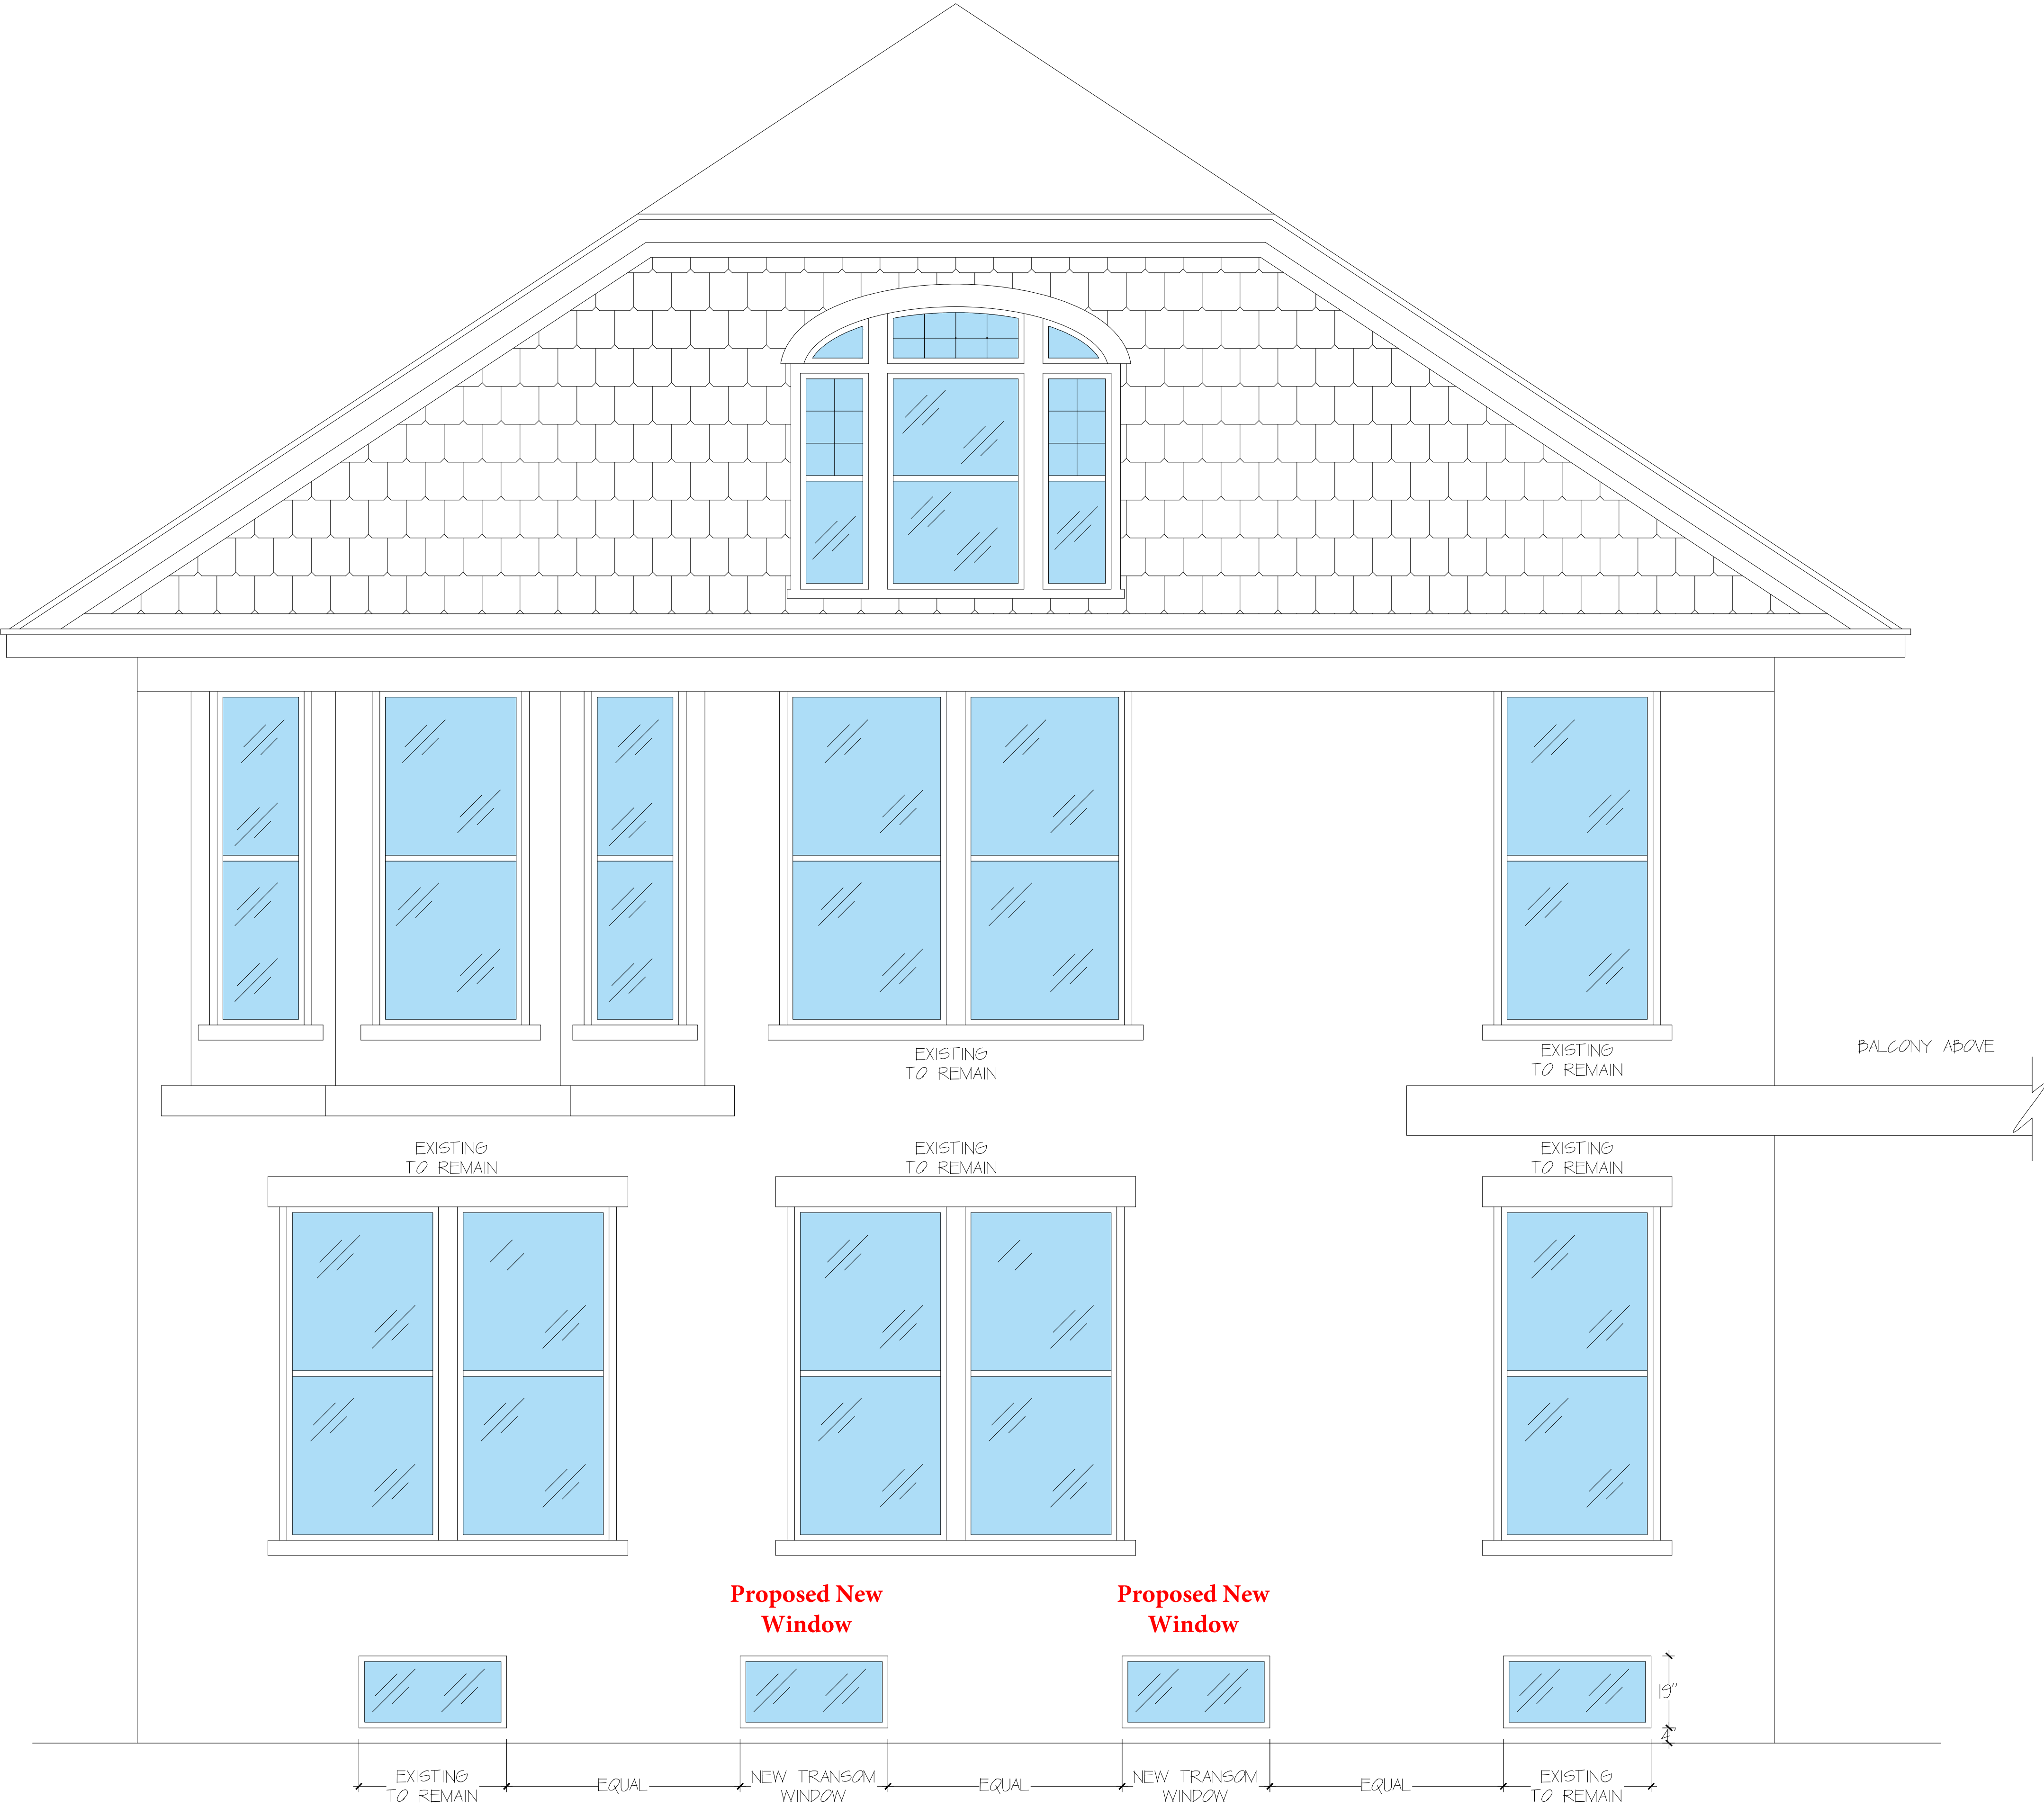
WEST EXTERIOR ELEVATION

- Homeowners would like to replace two existing windows with the same like and quality
- Create two additional window openings with the same original detail to the basement
- A total of four new awning windows would be installed
- Window Type: MARVIN Wood exterior, size RO 37 3/8" x 19 15/16"
- CROSS will carefully remove the basement exterior brick, to be re-used.

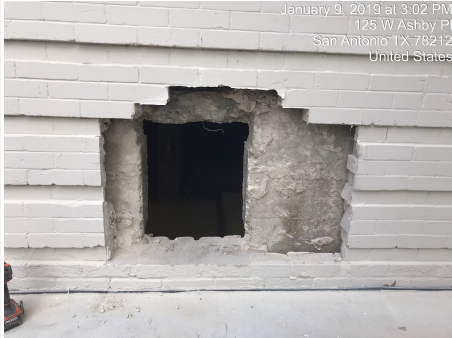
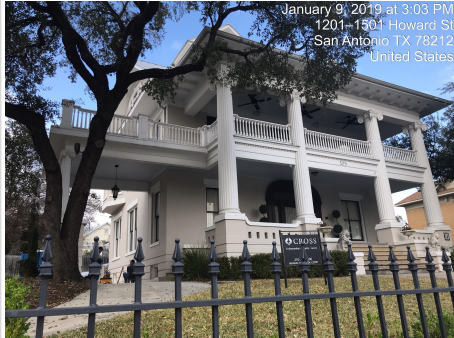
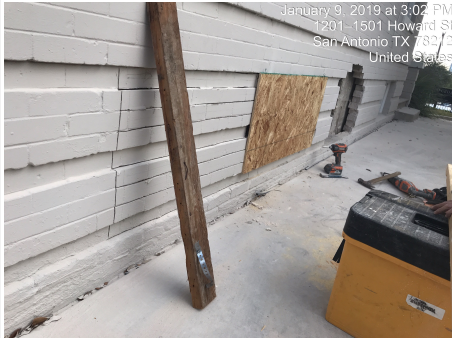
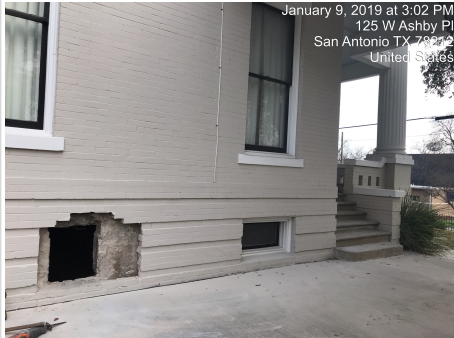
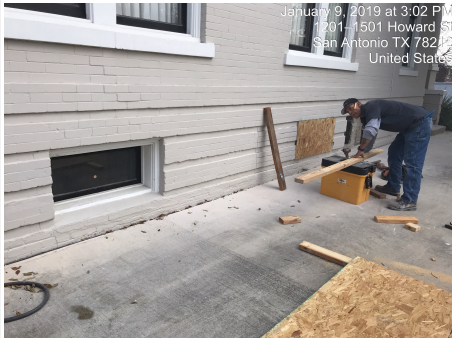
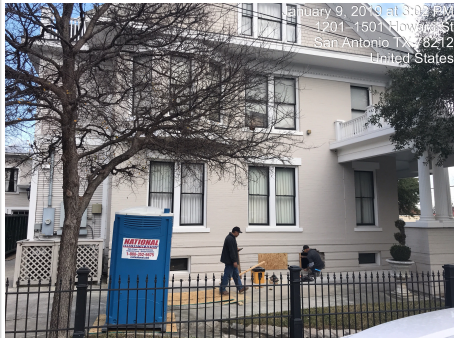
Photographs

- b. VIOLATION – On a site visit conducted on January 9, 2019, staff found that masonry had been removed from the basement level skirting to install new window openings. After staff notified the contractors of the violation, they were cooperative towards compliance and submitted an application on January 22, 2019, to be heard at the next HDRC hearing.

Date	01/09/2019
Time	03:04 PM (-6 GMT)
Context	citizen report
Present Staff	Huy Pham
Present Individuals	Contractor(s), Crew member(s)
Present Companies	Cross
Types of Work Observed	Exterior Maintenance and Alterations
Amount of Work Completed	50%
Description of work	Removal of basement level brick to initiate installation of two new windows.

Description of interaction	Two contractors from Cross Contractors were present. Staff spoke with the management over the phone who was very cooperative and instructed the two present contractors to stop work. They will submit an application for the installation of two new windows at the basement level on the side of the property to match the existing windows. All removed bricks have not been discarded at this time and have been instructed to be retained until the conclusion of the hearing.
----------------------------	---

- i. That the new windows match the existing windows in size, depth, material, and installed in an equidistant pattern.
- ii. That the historic masonry removed from the new window openings remain on site for reuse.
