HISTORIC AND DESIGN REVIEW COMMISSION

February 06, 2019

HDRC CASE NO: 2018-462
ADDRESS: 201 E HUISACHE AVE
LEGAL DESCRIPTION: NCB 3085 BLK 1 LOT 23
ZONING: MF-33, H
CITY COUNCIL DIST.: 1
DISTRICT: Monte Vista Historic District
APPLICANT: Patrick Christensen
OWNER: SA Huisache Investors LLC
TYPE OF WORK: Window replacement
APPLICATION RECEIVED: January 16, 2019
60-DAY REVIEW: March 15, 2019
REQUEST:

The applicant is requesting a Certificate of Appropriateness for approval of a window master plan in response to the commission action at the HDRC hearing on August 19, 2018.

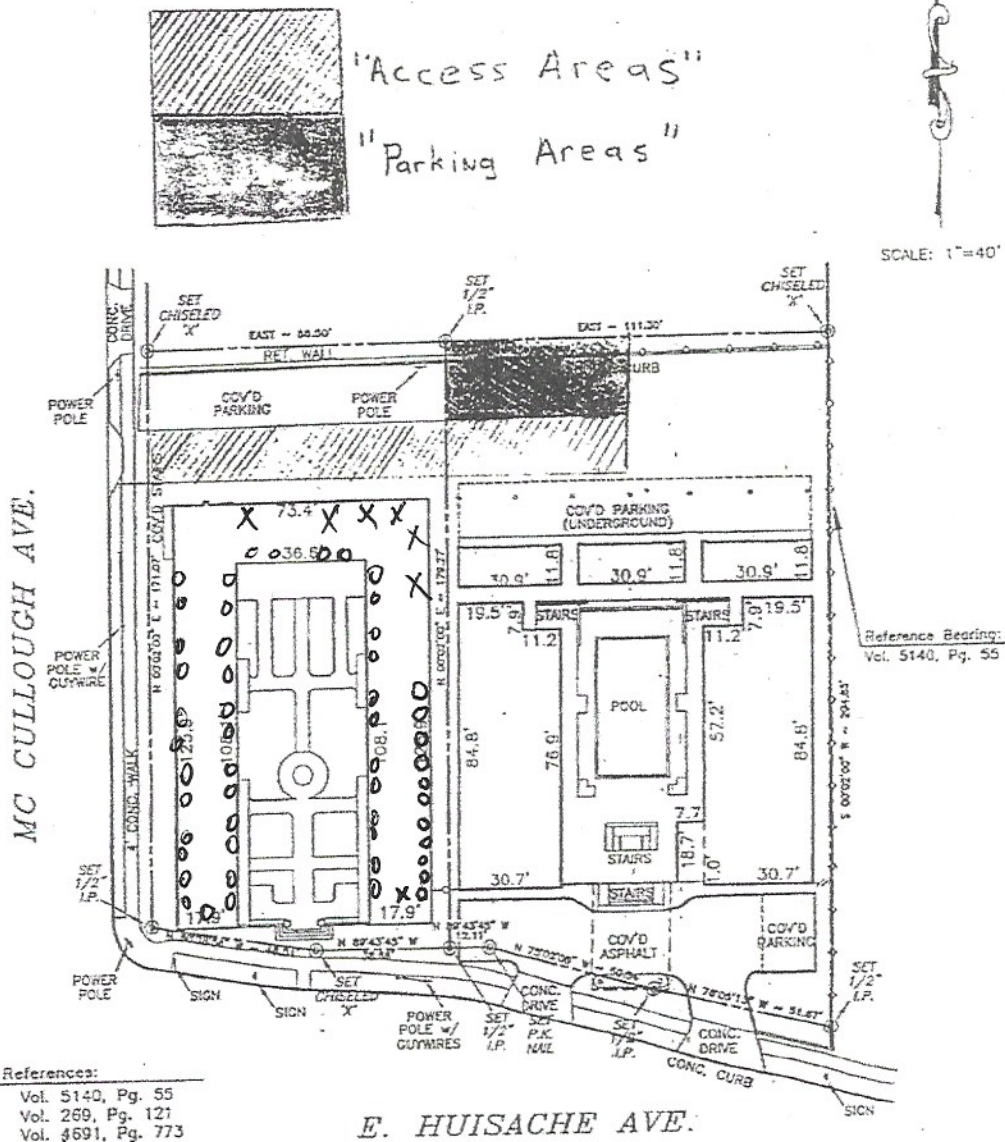
First floor
O = old wood
X = new vinyl

Please find attached site plan showing the 25 replaced windows. I only intended to replace two more units (total 27) as the replacement was in response to significant water infiltration issues and damage to frames and sills from neglect of previous ownership. We repaired and replaced significant areas of the roof and kept the tile roof as well to solve this and keep with the character of the building. We have replaced second floor balcony doors, but with wood (not vinyl).

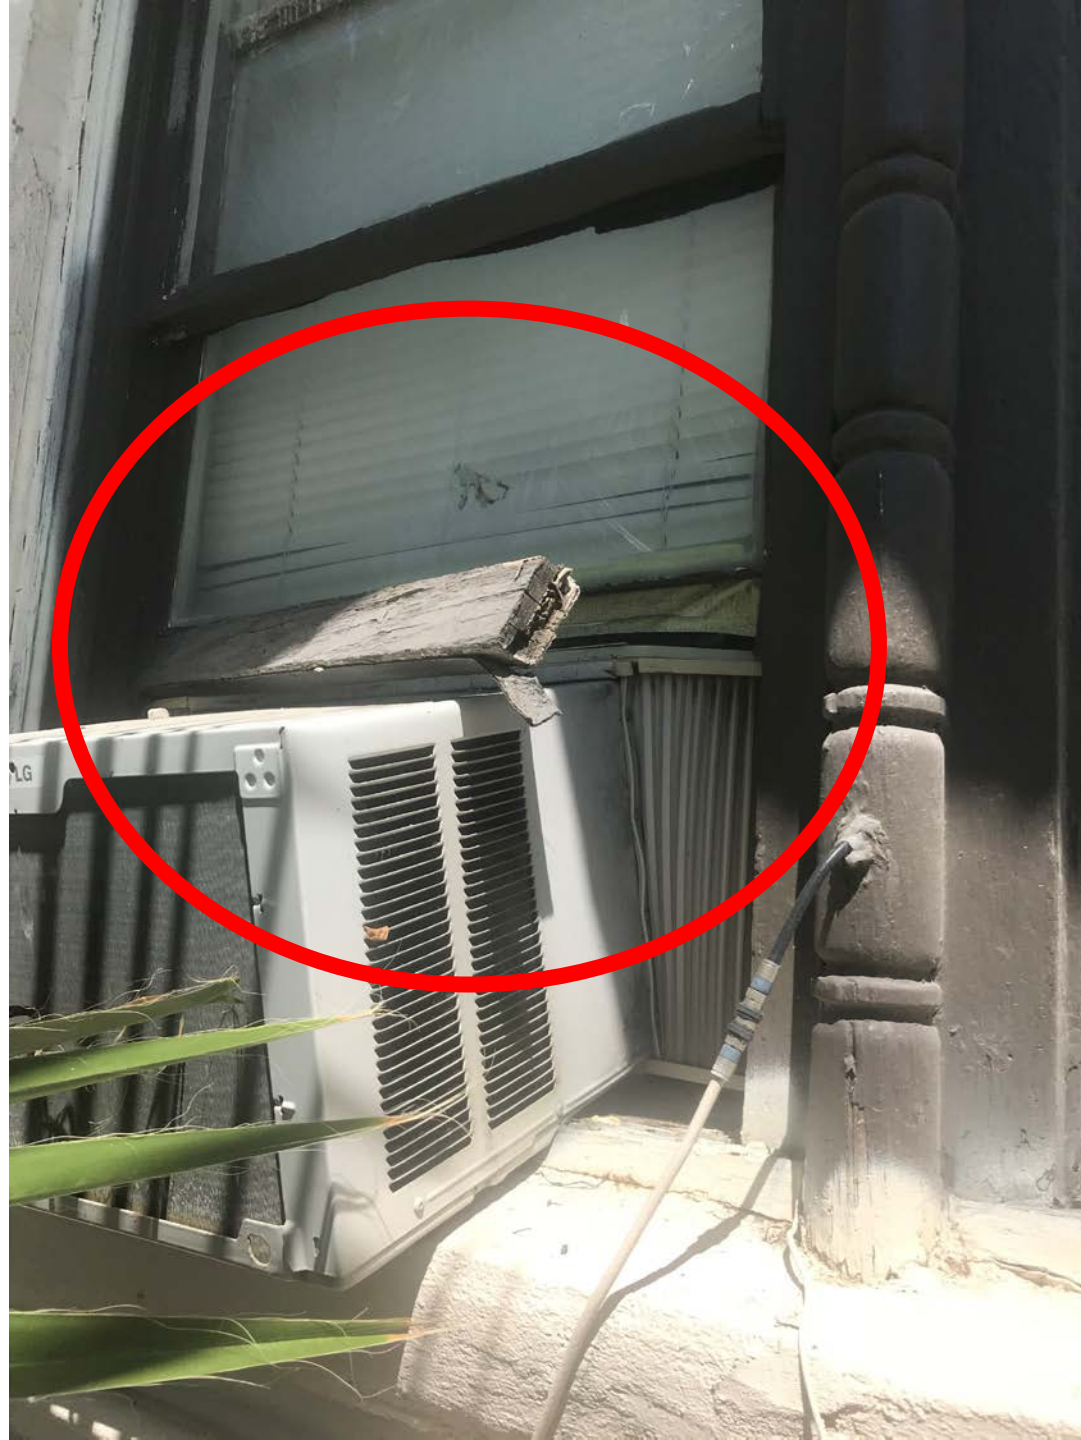
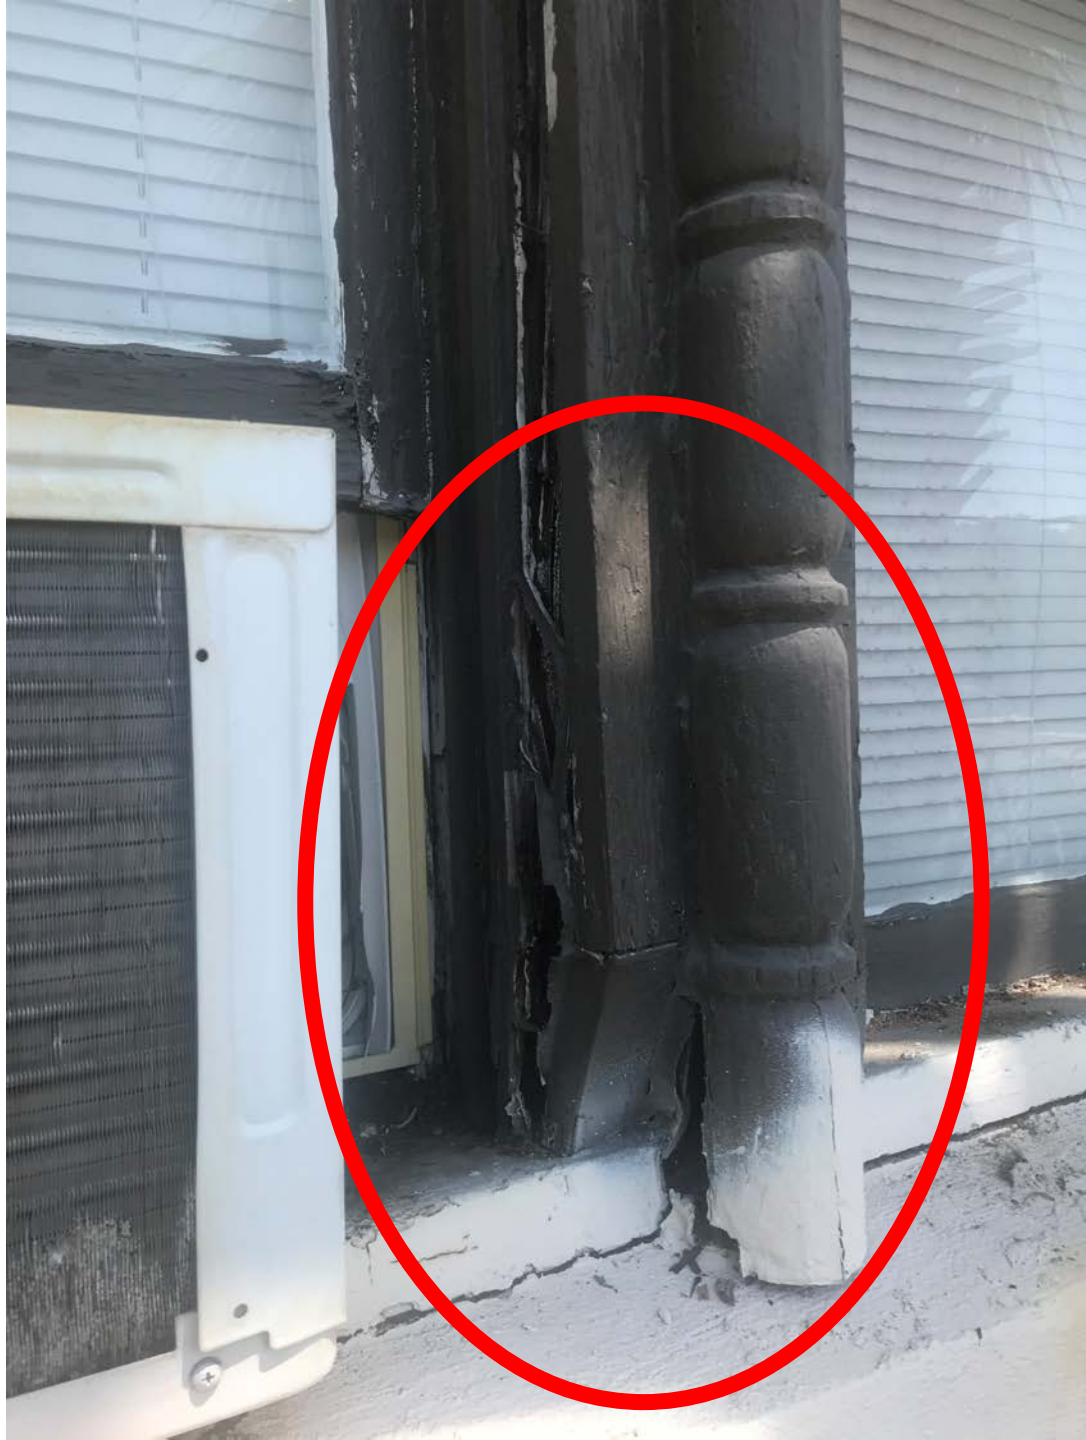
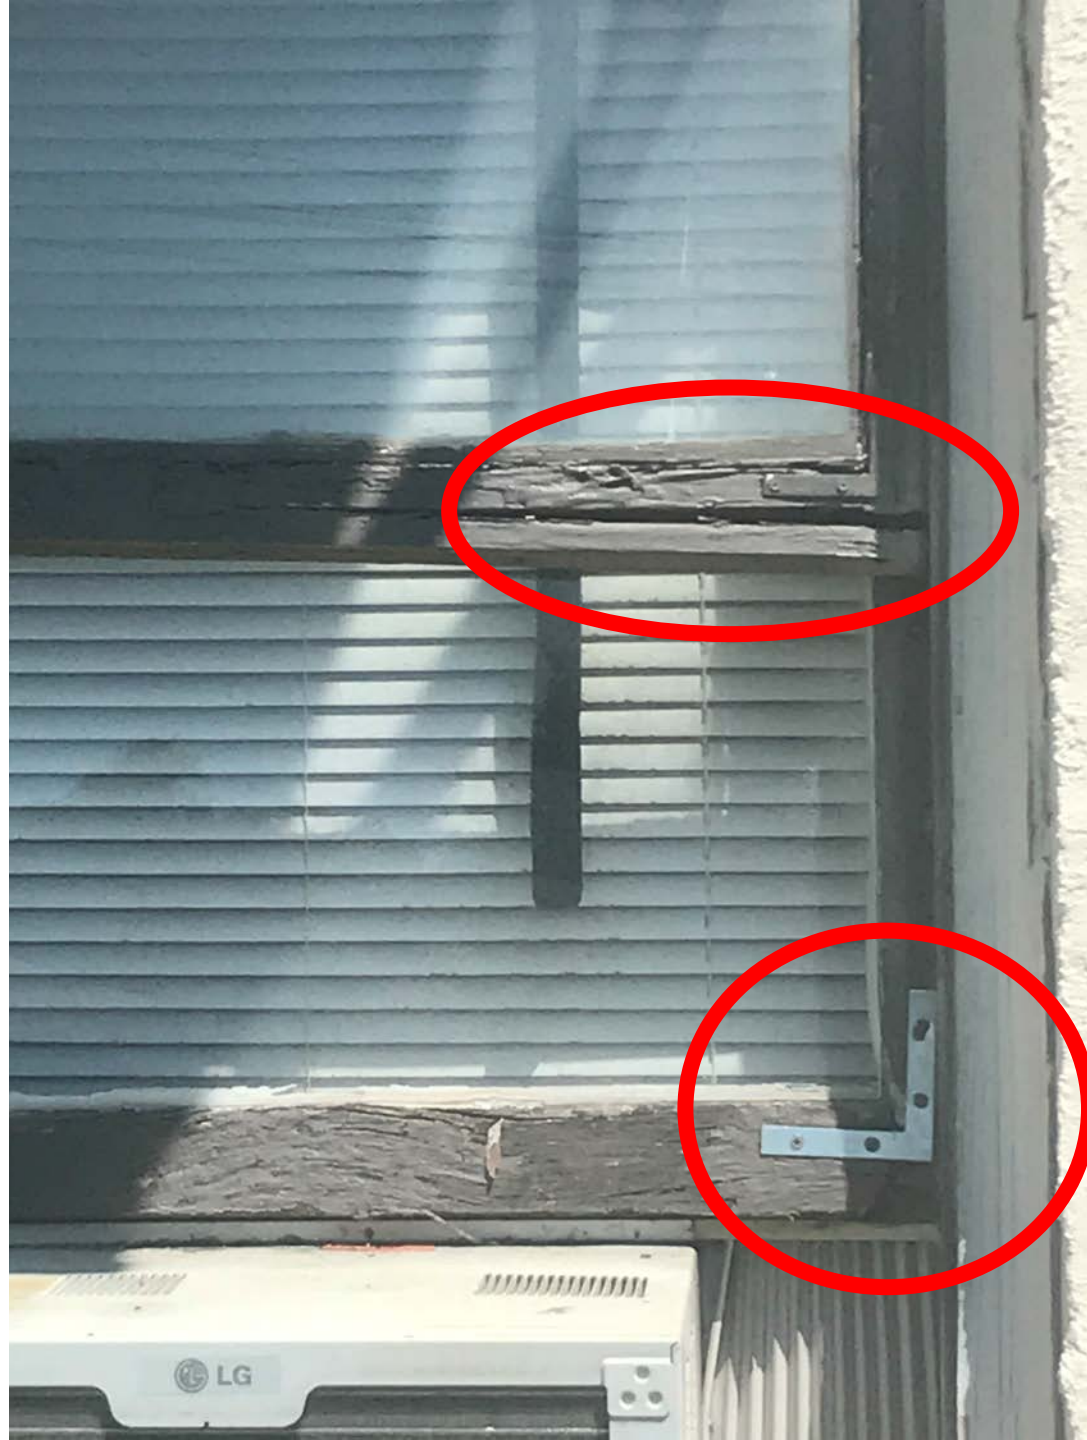
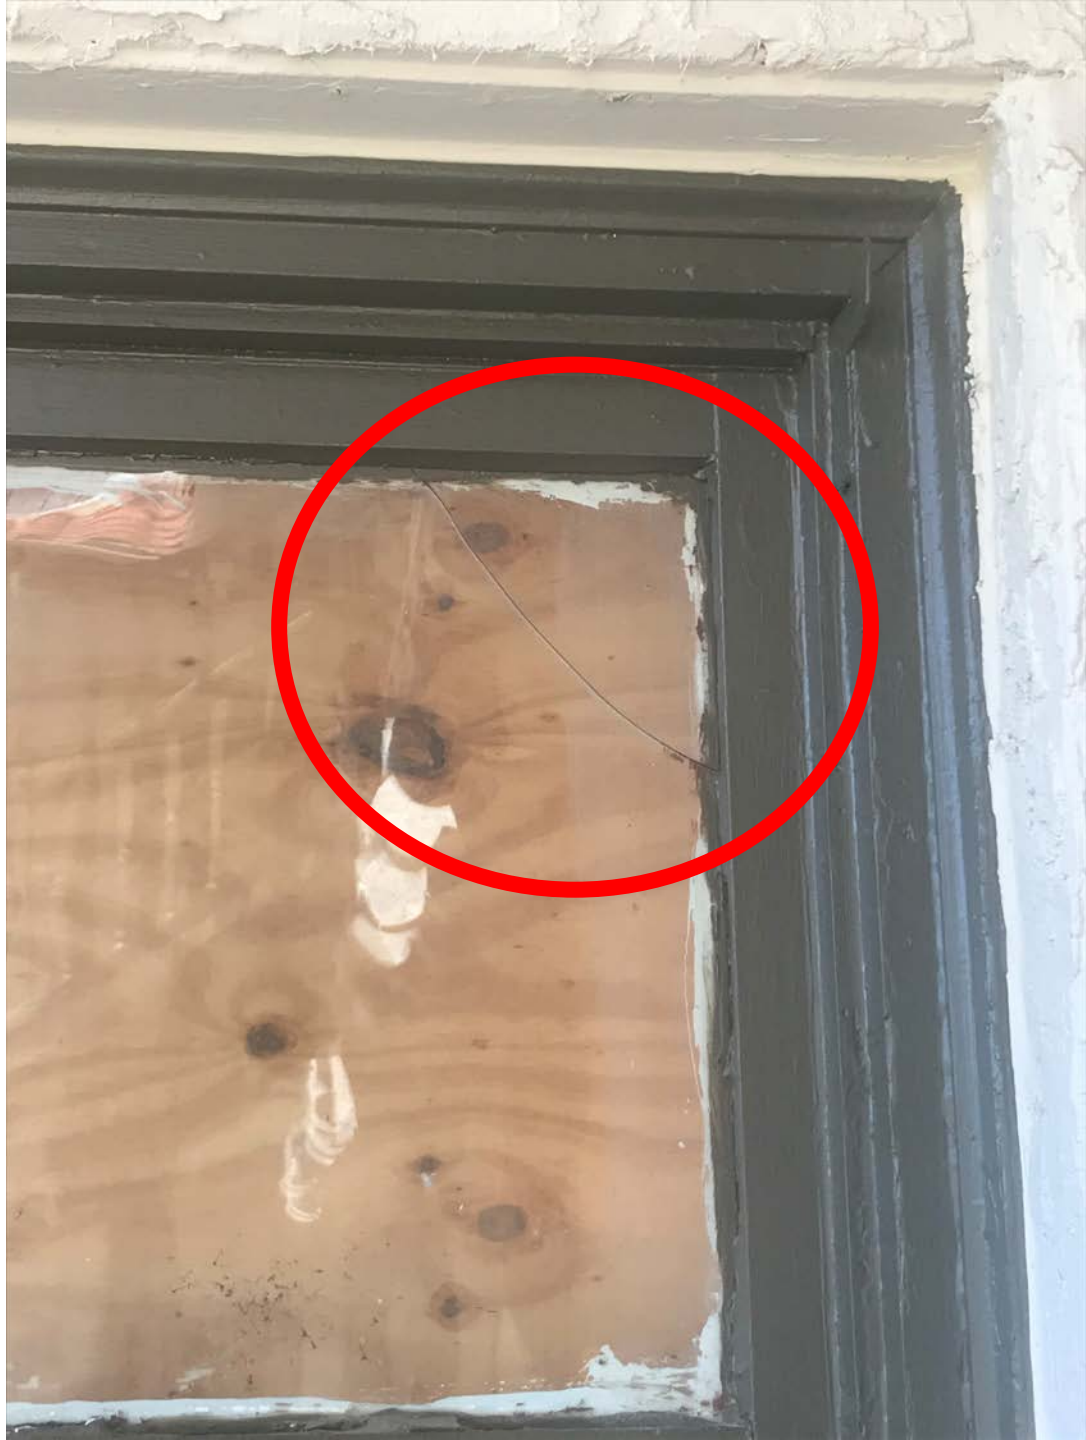
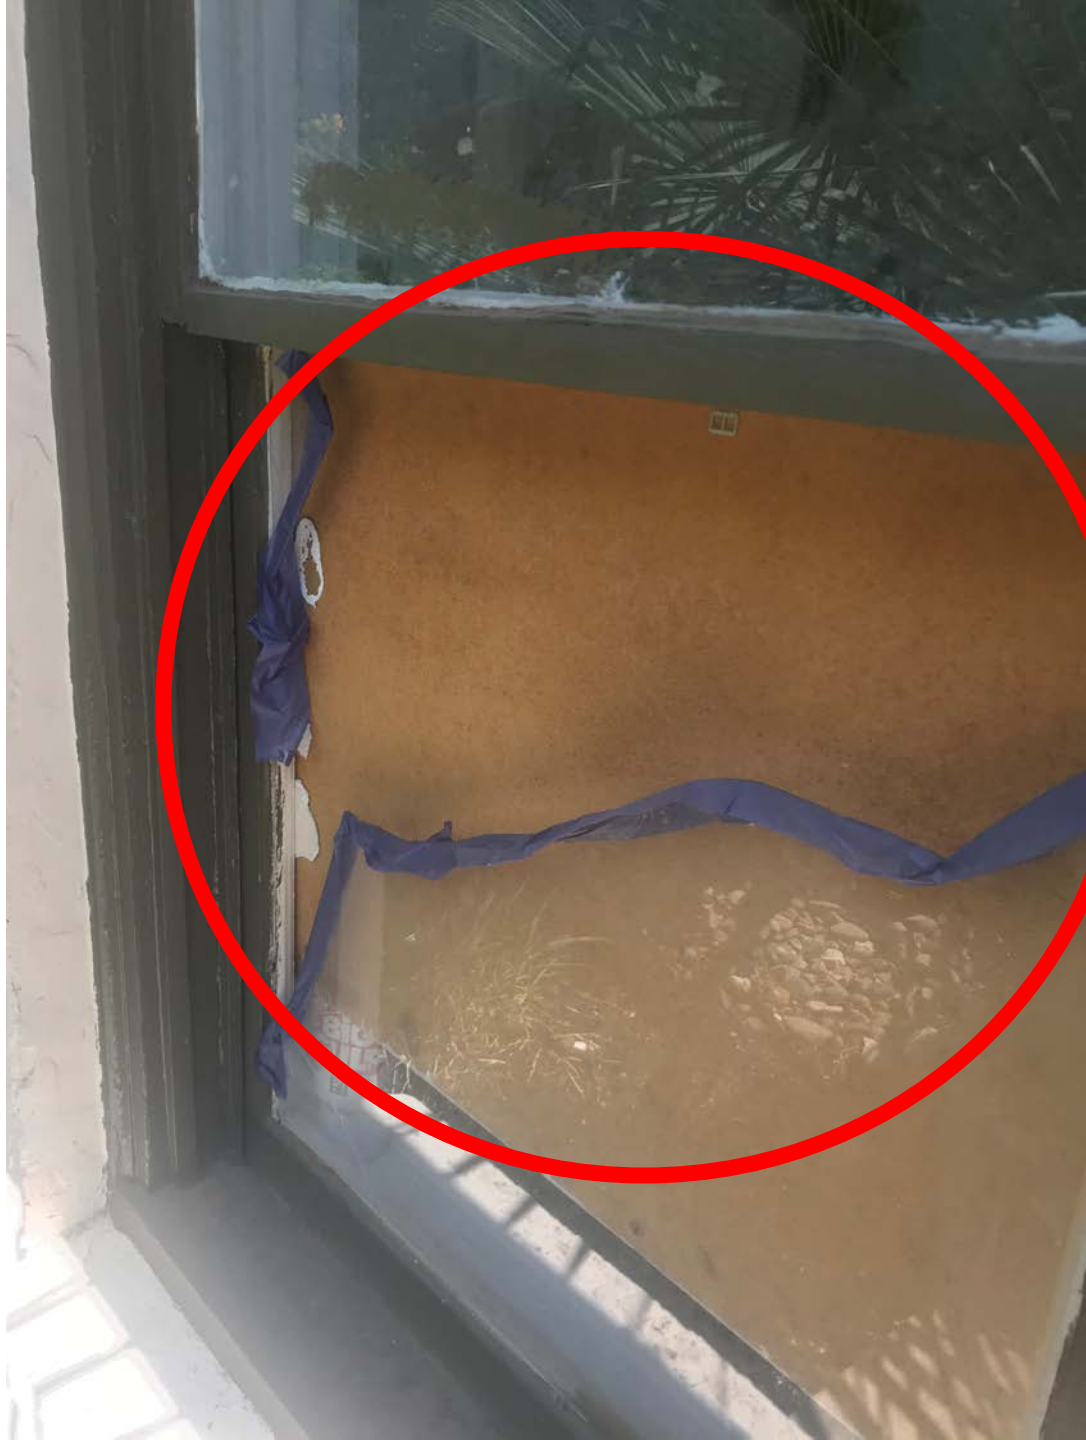
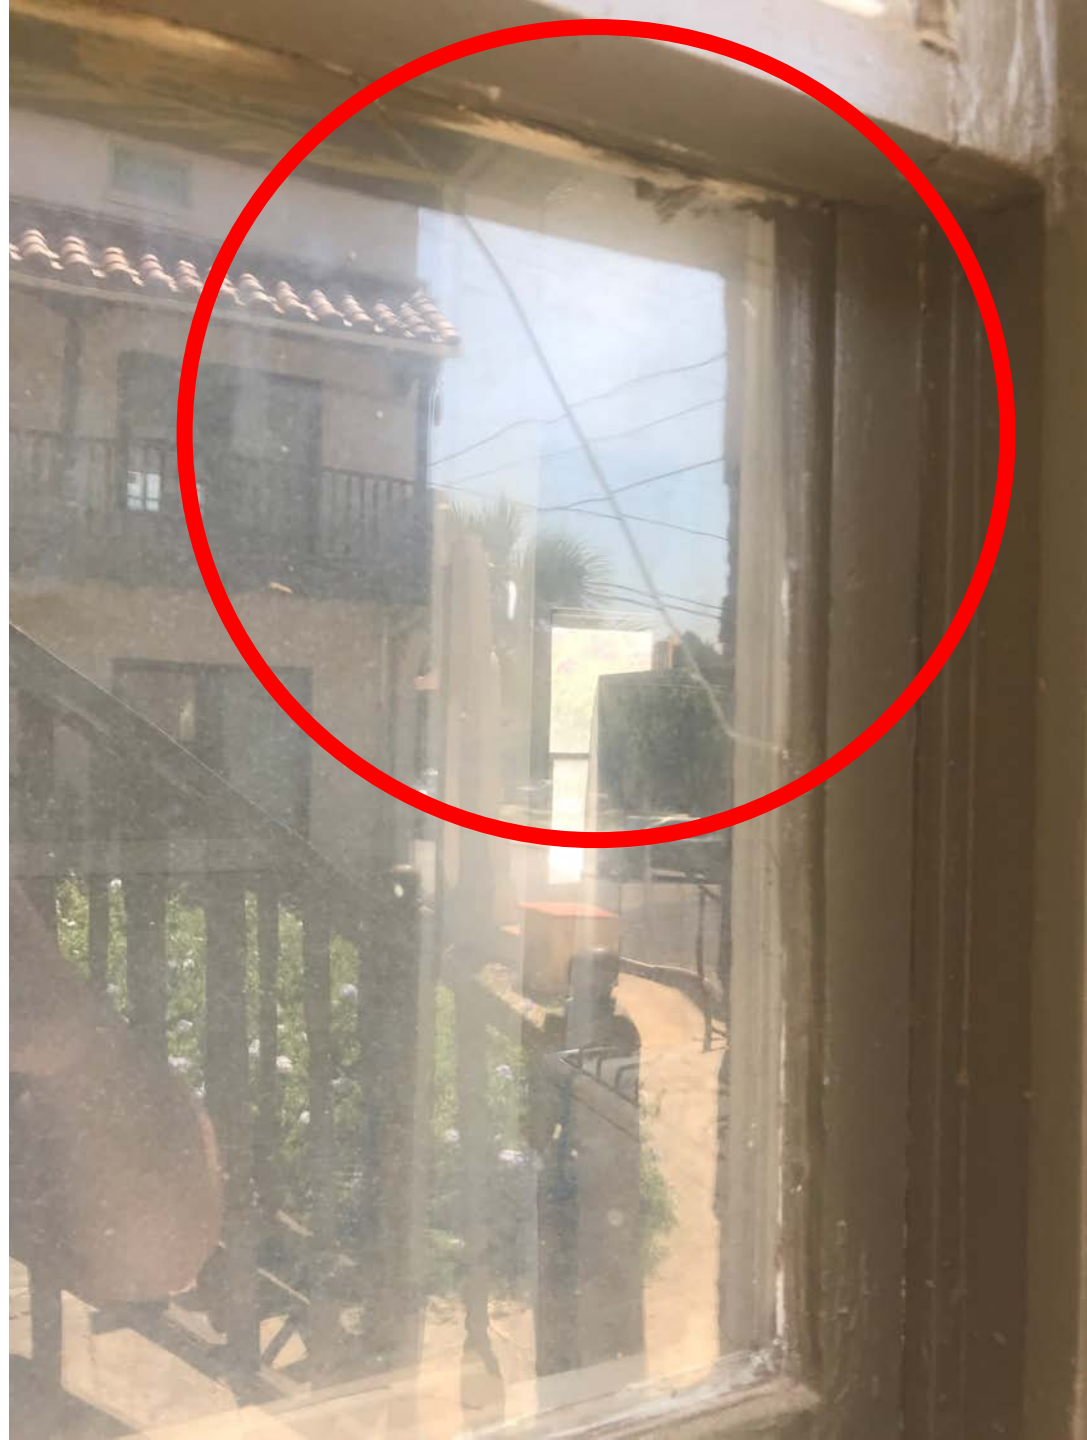
The following photos are existing window conditions:

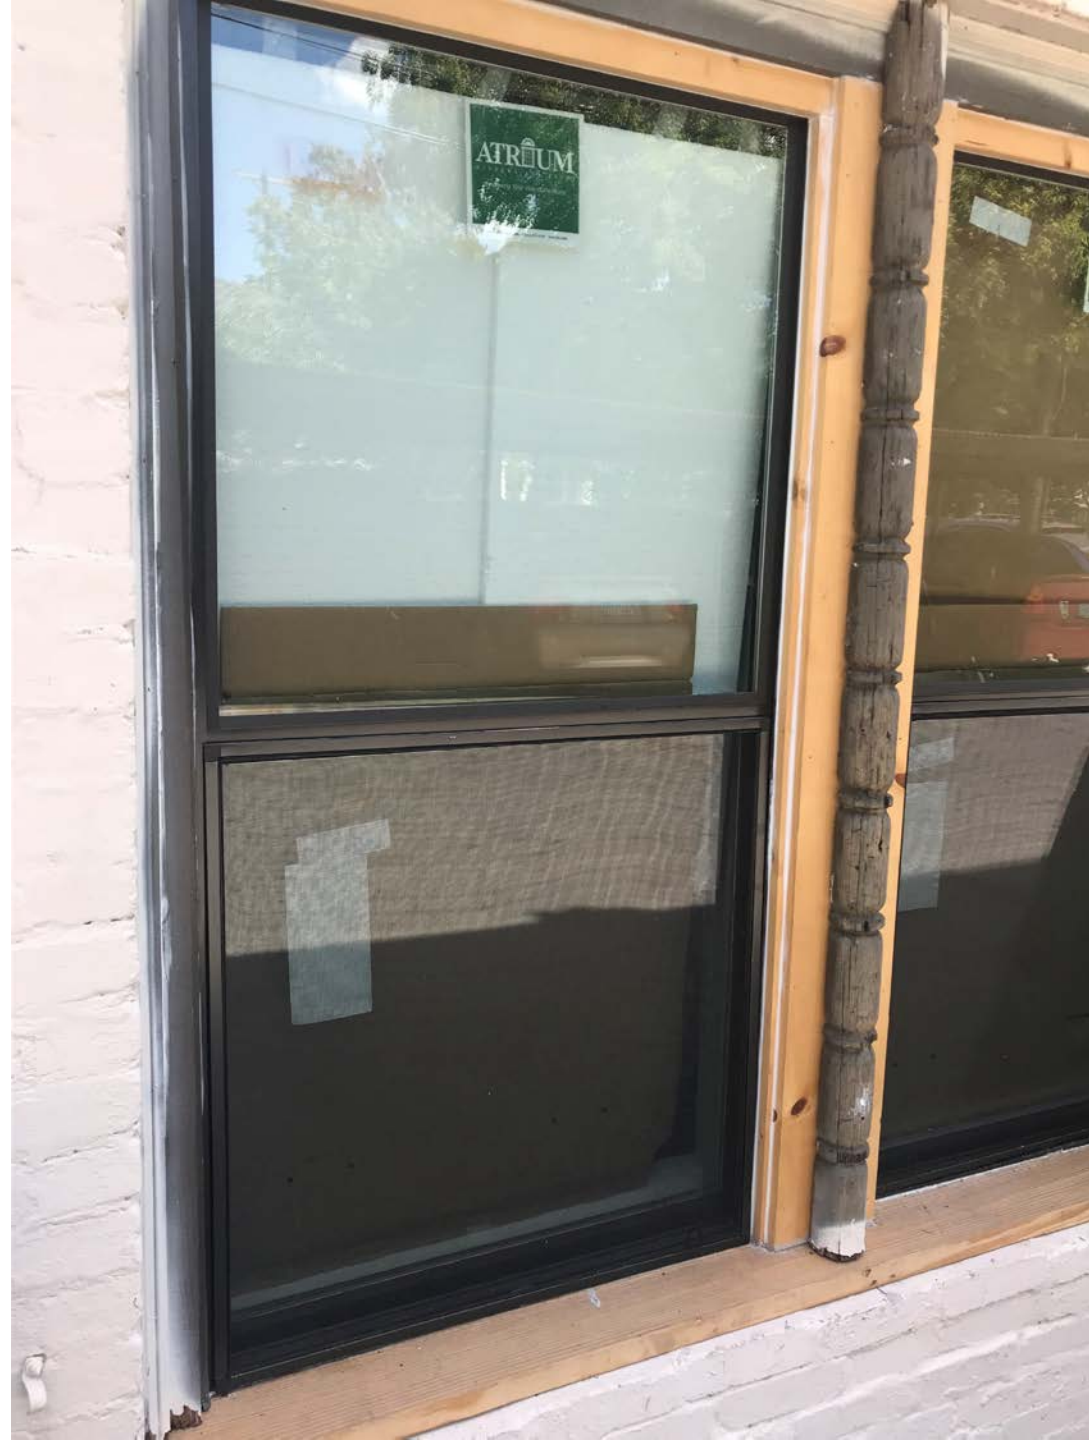
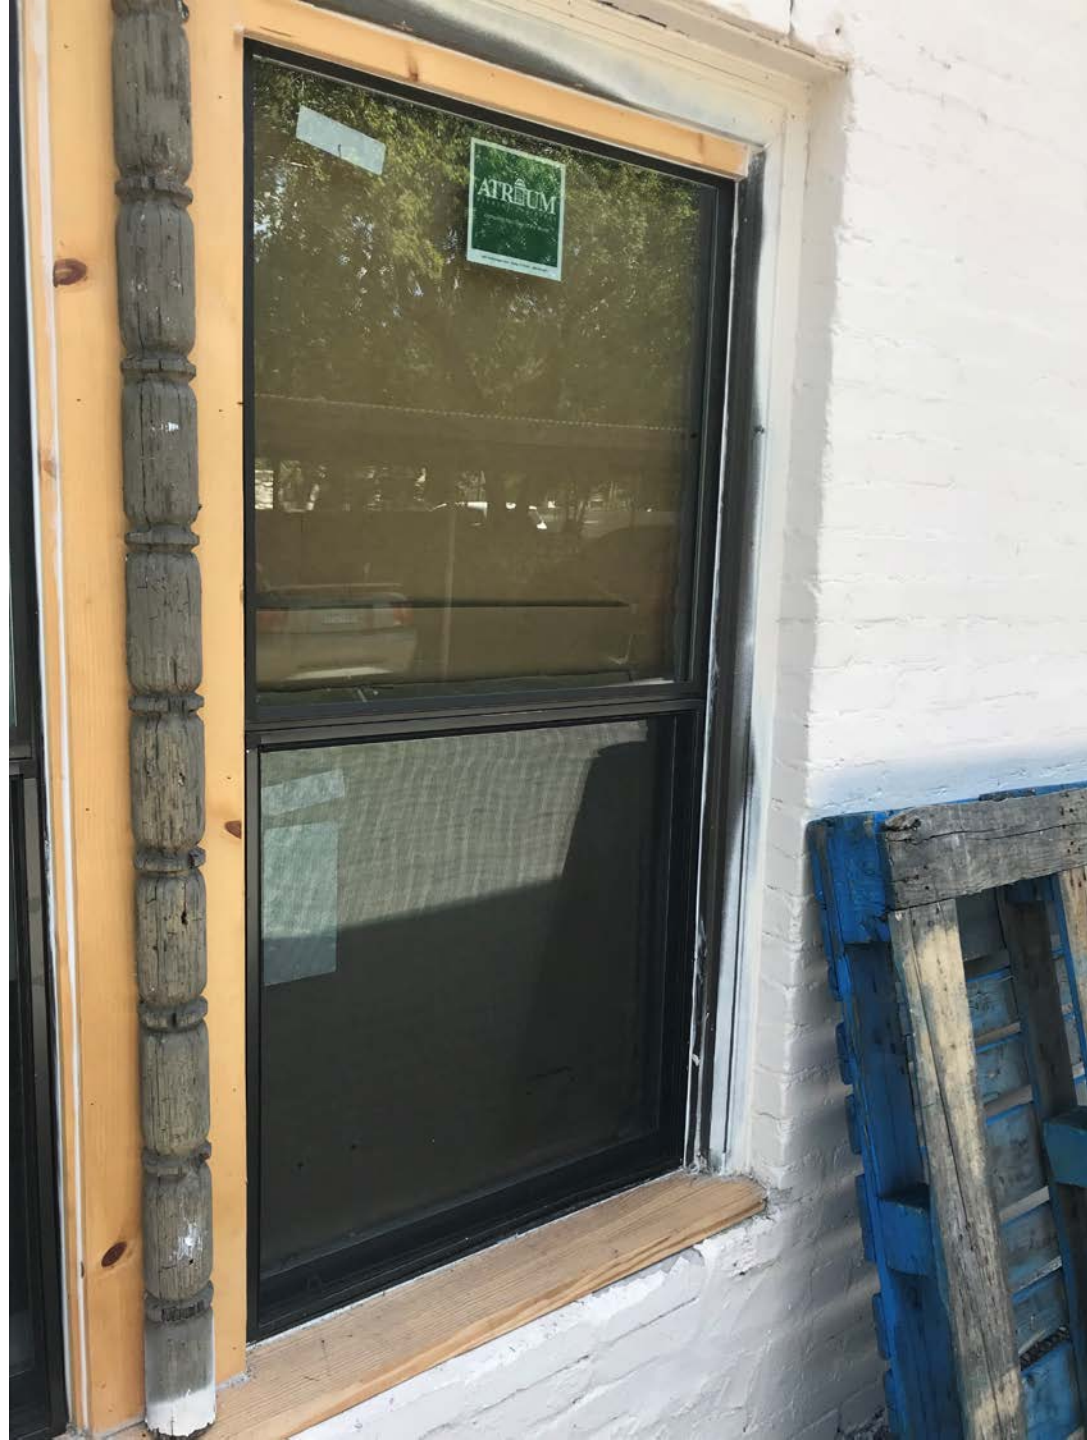
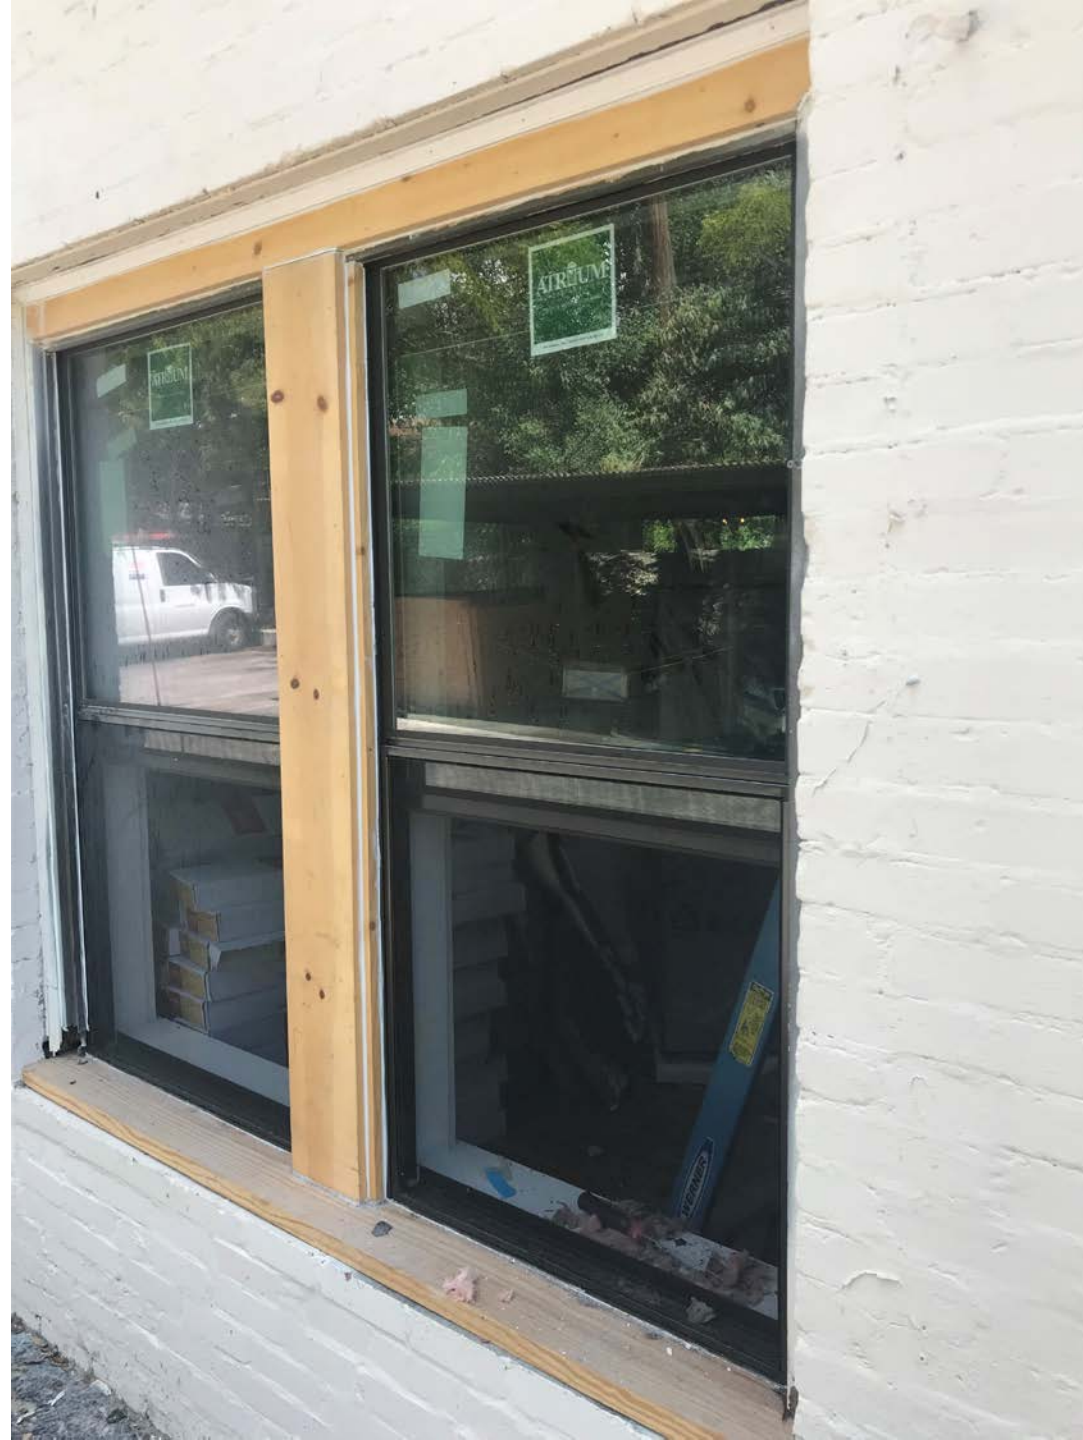
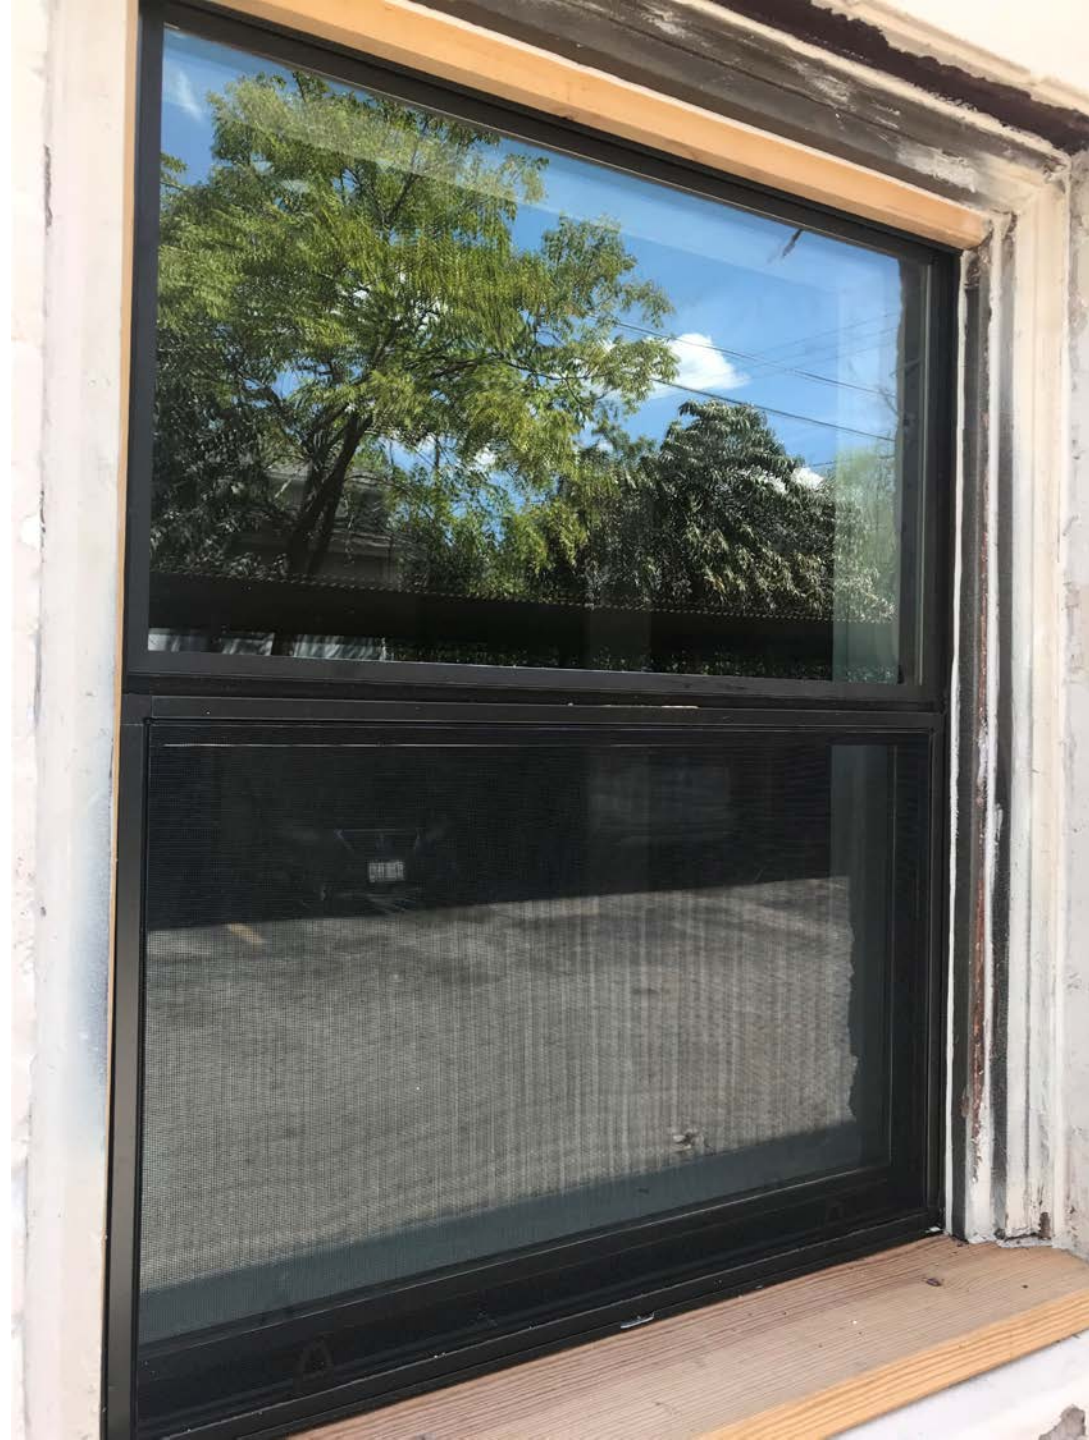
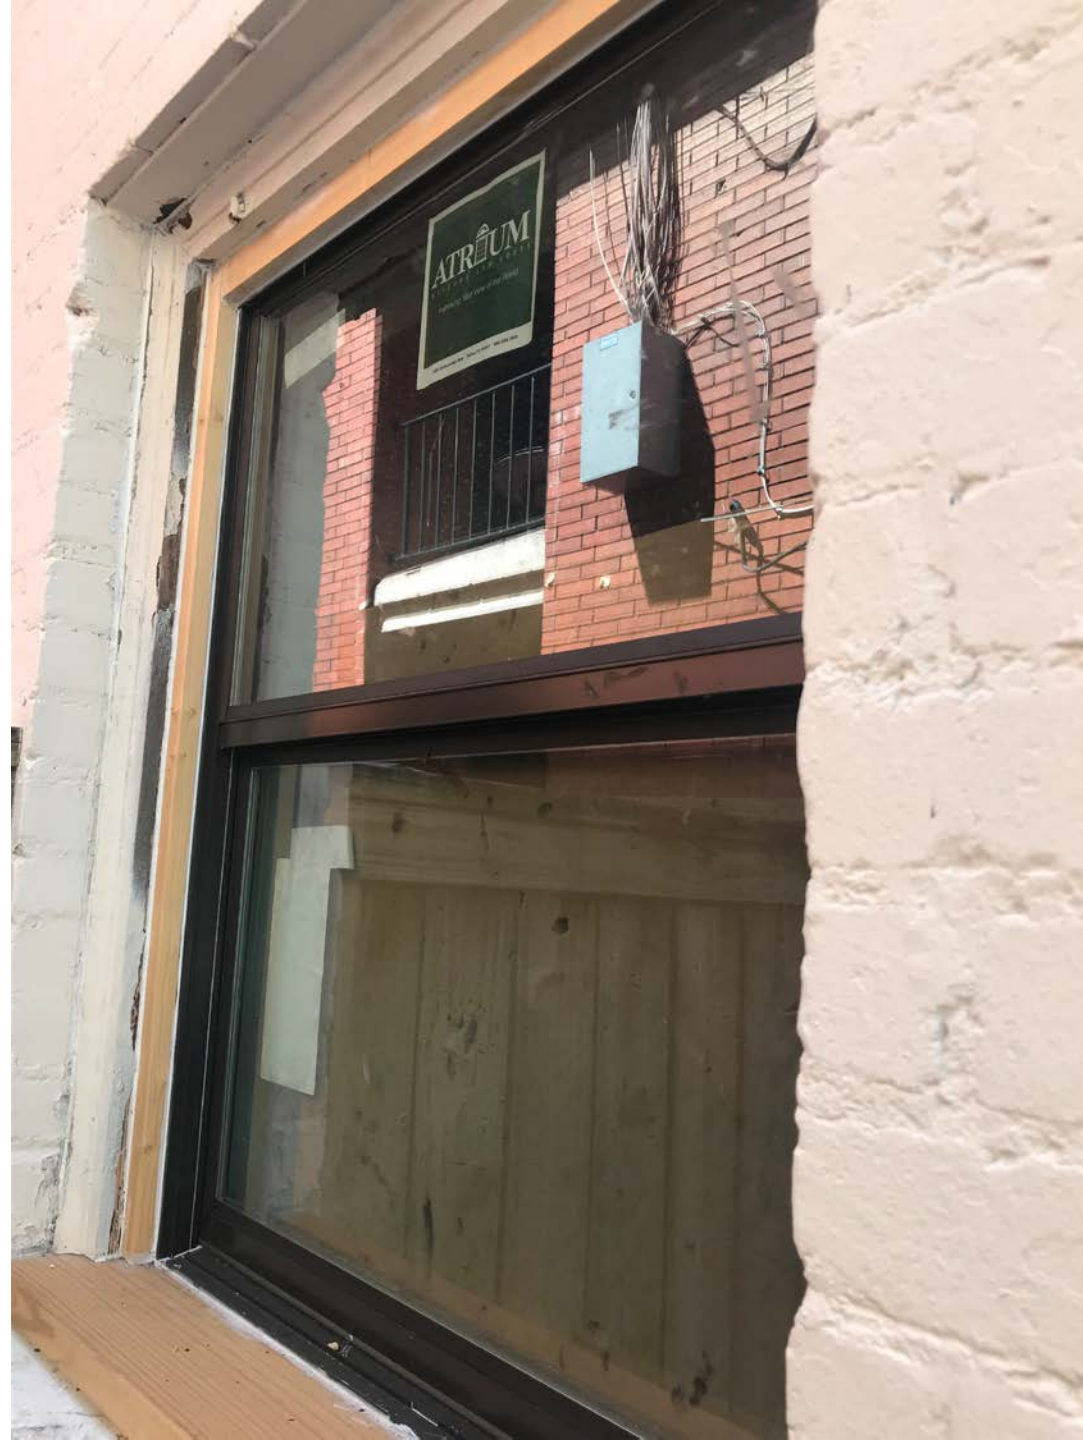
- f. **NEW WINDOWS** – The applicant has proposed to install black, one-over-one vinyl windows. The Guidelines for Architectural Features 6.B.iv. notes that new windows are to match the historic or existing windows in terms of size, type, configuration, material, form, appearance, and details. Staff finds that the proposed windows are not compatible in style or materials with the original windows.

The following slides are the new windows:

Staff does not recommend approval based on finding b through f. Staff recommends in-kind wood window replacement where they are deteriorated beyond repair or to comply with the comments presented at the Design Review Committee meeting.

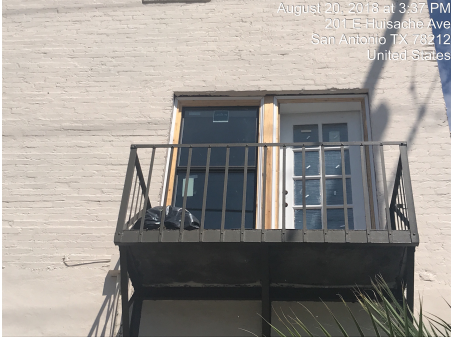
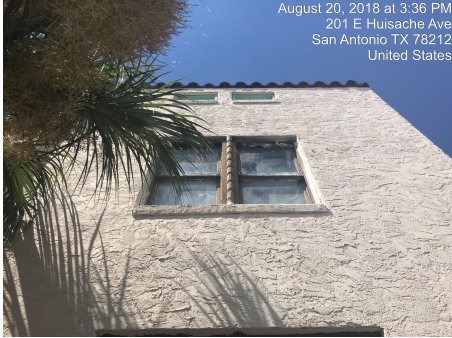
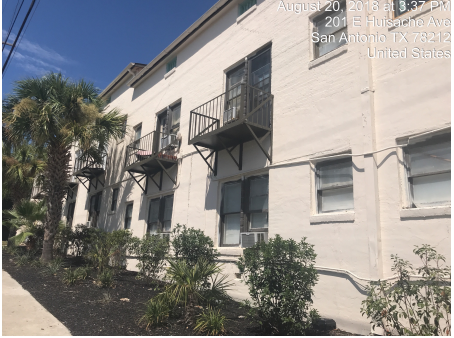
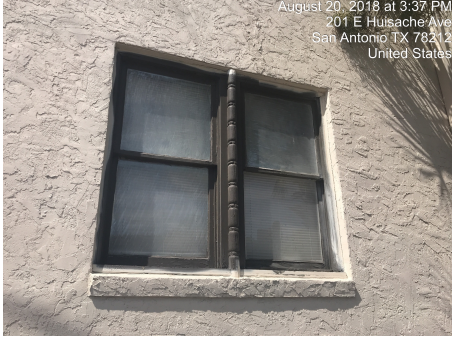
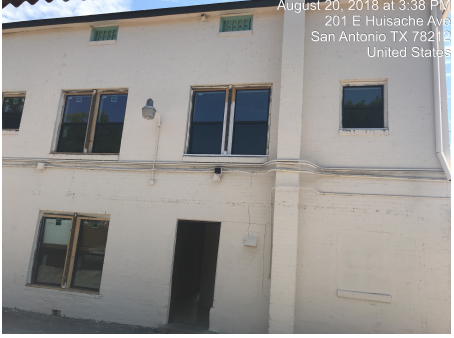
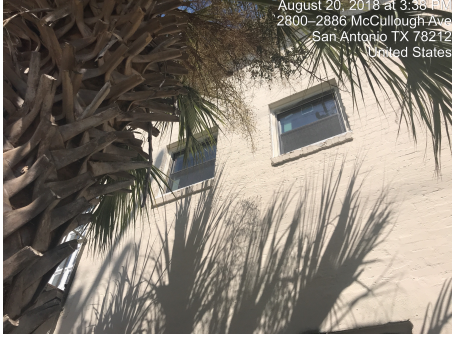
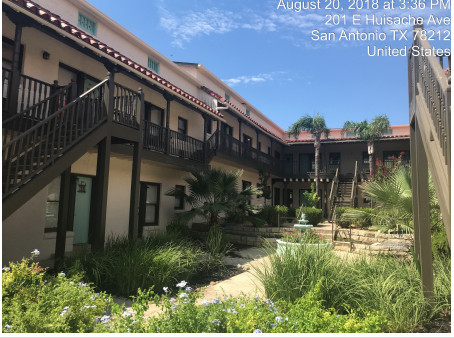
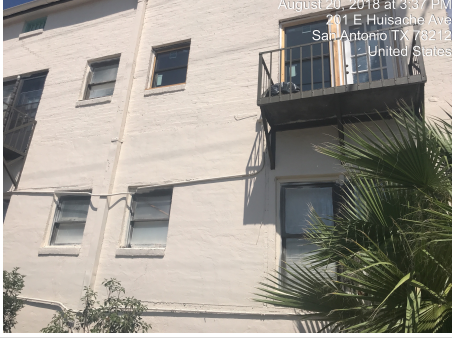
Date	08/20/2018
Time	03:41 PM (-5 GMT)
Context	citizen report
Present Staff	Huy Pham
Present Individuals	None
Types of Work Observed	Exterior Maintenance and Alterations
Amount of Work Completed	75%
Description of work	Removal of over 20 wood windows and doors and installation of aluminum windows.

Violation Type	No Certificate of Appropriateness (Code 35-451a)
OHP Action	posted "Notice of Investigation", posted "Stop Work Notice"
Deadline to contact office	08/20/2018
