HISTORIC AND DESIGN REVIEW COMMISSION

February 06, 2019

HDRC CASE NO: 2019-024
ADDRESS: 1201 E CROCKETT ST
LEGAL DESCRIPTION: NCB 1373 BLK 1 LOT W 77.4 FT OF 9 & 10
ZONING: MF-33, H
CITY COUNCIL DIST.: 2
DISTRICT: Dignowity Hill Historic District
APPLICANT: Nate Manfred/French and Michigan
OWNER: Keith Jones/JT Renovations
TYPE OF WORK: Amendments to previously approved materials
APPLICATION RECEIVED: January 18, 2019
60-DAY REVIEW: March 17, 2019

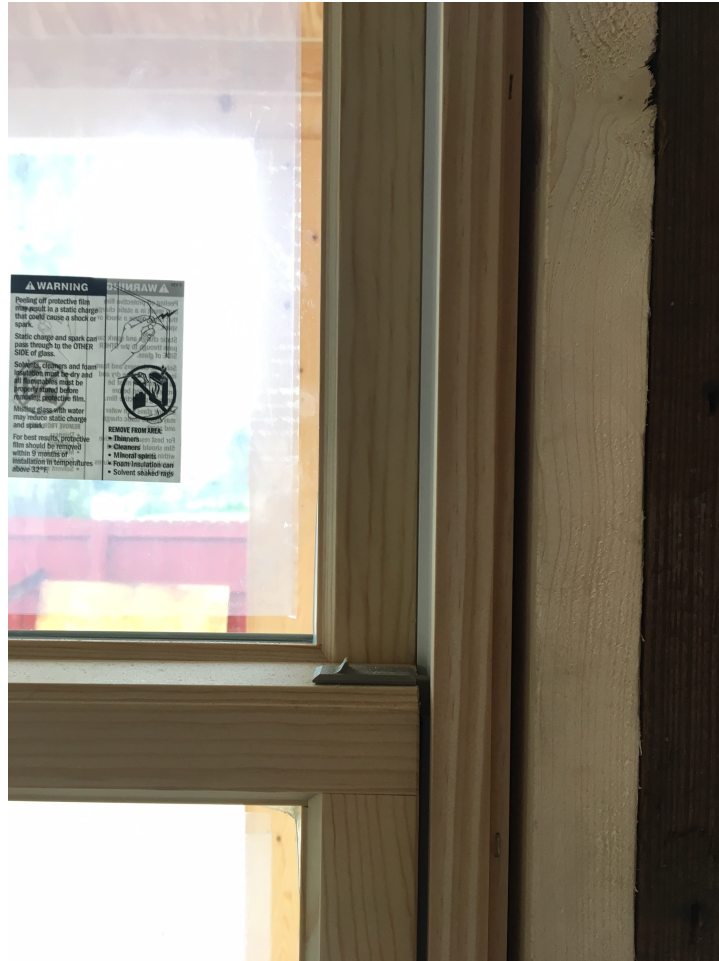
Wood Window (Aluminum Clad Exterior)

- e. WINDOW REPLACEMENT – The applicant has proposed to amend the previous approval to replace non-historic windows with wood windows to instead feature aluminum-clad wood window with faux divided lites. Per the Guidelines for Exterior Modifications and Alterations 6.B.iv. new windows are to match the historic or existing windows in terms of size, type, configuration, material, form, appearance, and detail when the original window are deteriorated beyond repair and 6.B.v. prohibiting the use of internal muntins sandwiched between layers of glass. While staff finds that the aluminum-clad wood window are an improvement upon the vinyl windows, the faux divided lites are consistent with the standard stipulations: *Meeting rails that are no taller than 1.25" and stiles no wider than 2.25". White manufacturer's color is not allowed, and color selection must be presented to staff. There should be a minimum of two inches in depth between the front face of the window trim and the front face of the top window sash. This must be accomplished by recessing the window sufficiently within the opening or with the installation of additional window trim to add thickness. Window trim must feature traditional dimensions and an architecturally appropriate sill detail. Window track components must be painted to match the window trim or concealed by a wood window screen set within the opening.*

1. The owner had already installed Anderson Aluminum Clad Wood Windows. The photos included with the application provide an exterior and interior photo of the replacement windows to provide evidence that the replacement windows are Aluminum Clad Wood Windows.
2. OHP Staff has requested that the owner replace the installed vertical skirting with horizontal lap siding. The photos provide evidence that the owner is replacing the vertical siding with horizontal lap siding.
3. The owner was asked by the OHP staff to remove the inappropriate horizontal siding covering the porch columns. As the included photos indicate, the owner is in the process of removing the horizontal siding on the columns and is replacing it with flat smooth siding and trim.

- i. Replacement of non-historic windows may be wood or aluminum-clad wood that do not feature faux divided lites and meet the standard stipulations: *Meeting rails that are no taller than 1.25" and stiles no wider than 2.25". White manufacturer's color is not allowed, and color selection must be presented to staff. There should be a minimum of two inches in depth between the front face of the window trim and the front face of the top window sash. This must be accomplished by recessing the window sufficiently within the opening or with the installation of additional window trim to add thickness. Window trim must feature traditional dimensions and an architecturally appropriate sill detail. Window track components must be painted to match the window trim or concealed by a wood window screen set within the opening.*

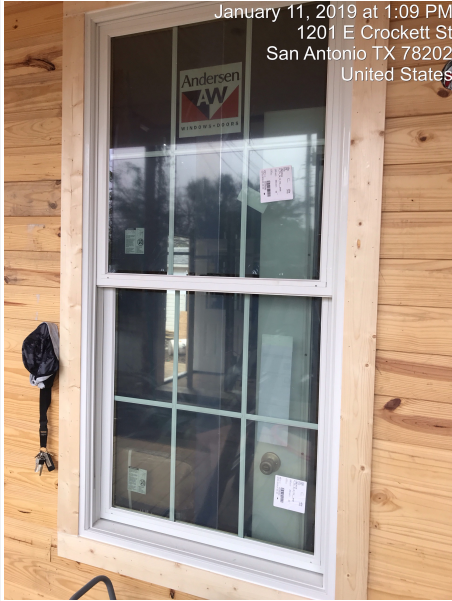
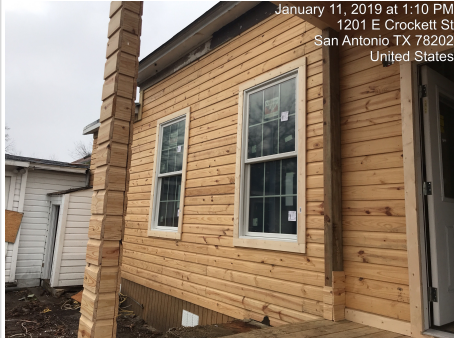
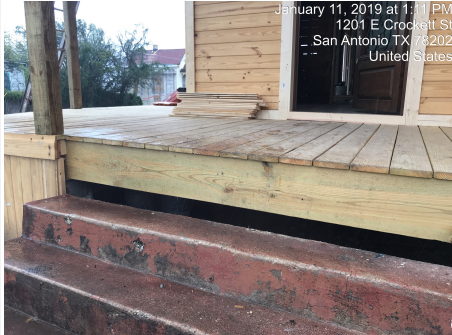
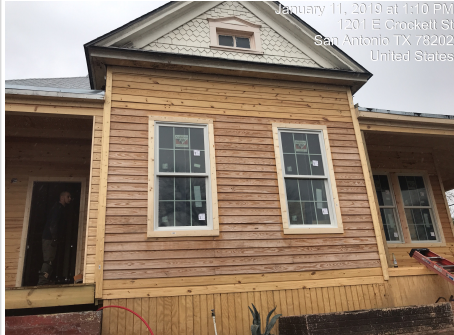
Photographs

Date	01/11/2019
Time	01:13 PM (-6 GMT)
Context	citizen report
Present Staff	Huy Pham
Present Individuals	Contractor(s), Crew member(s)
Present Companies	JT Renovations
Types of Work Observed	Exterior Maintenance and Alterations
Amount of Work Completed	50%
Description of work	Installation of vinyl windows, removal of window openings, installation of new skirting, replacement or modifications of existing Folk Victorian columns and spindle work.

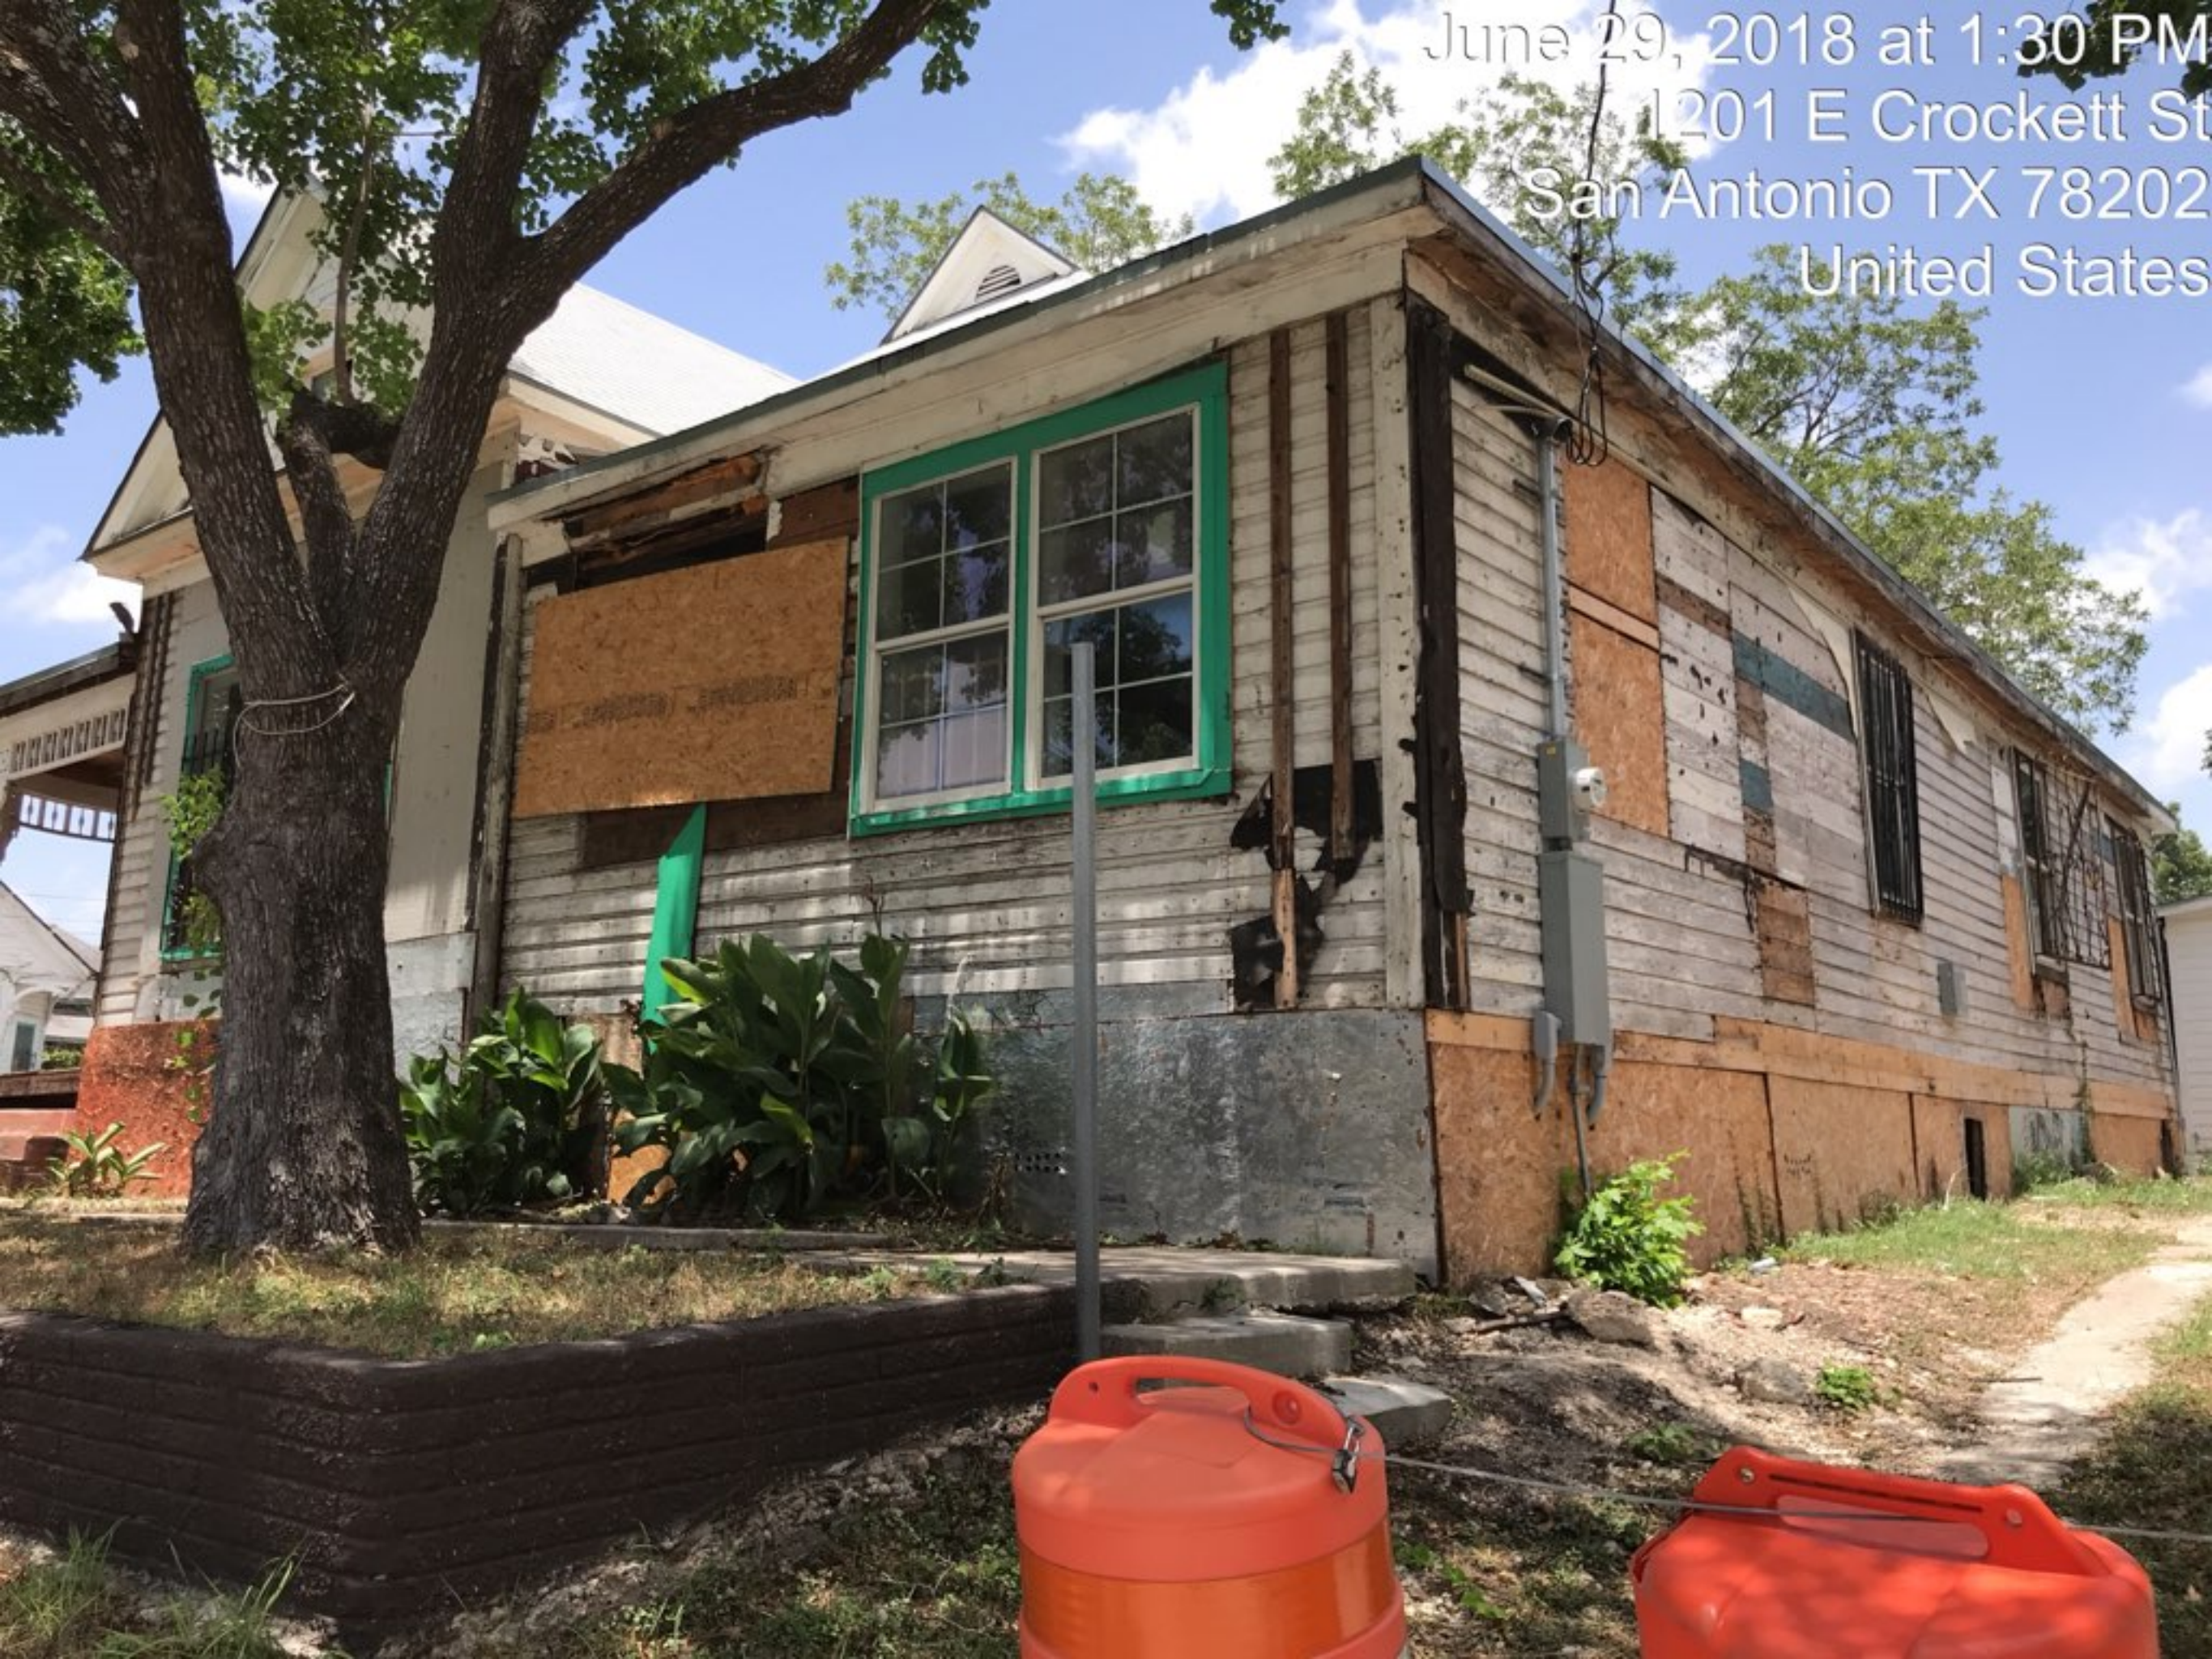
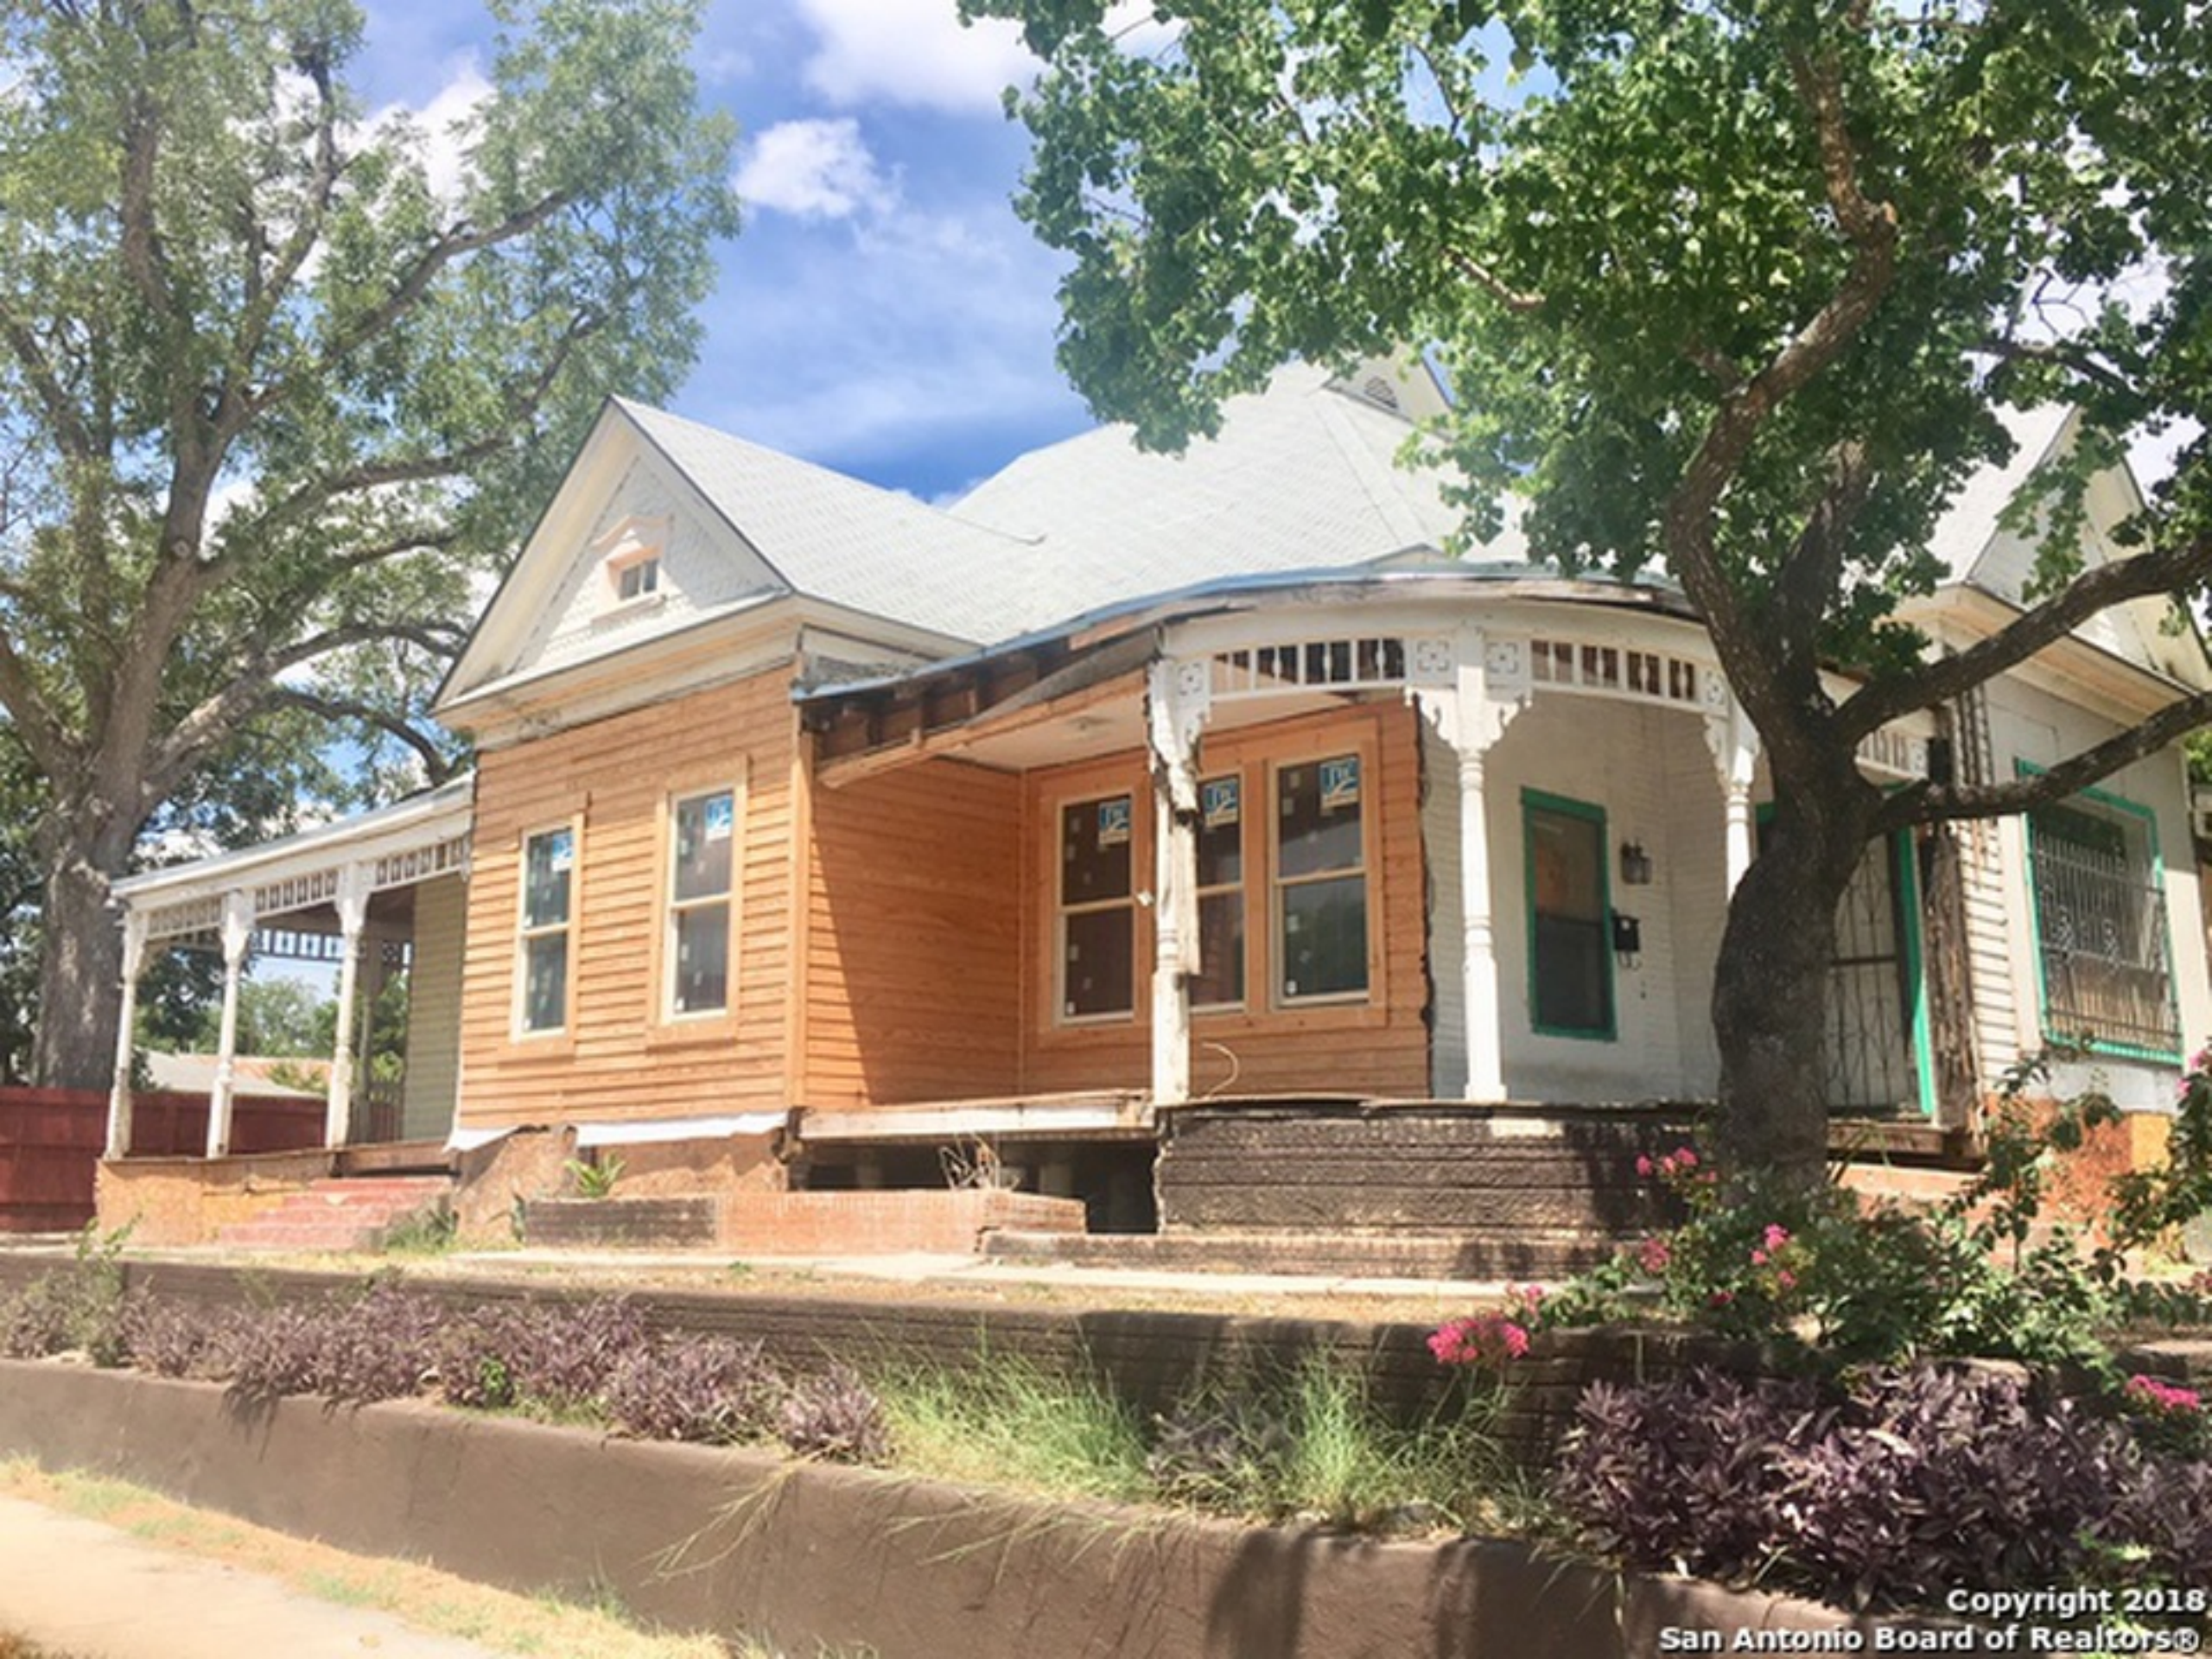
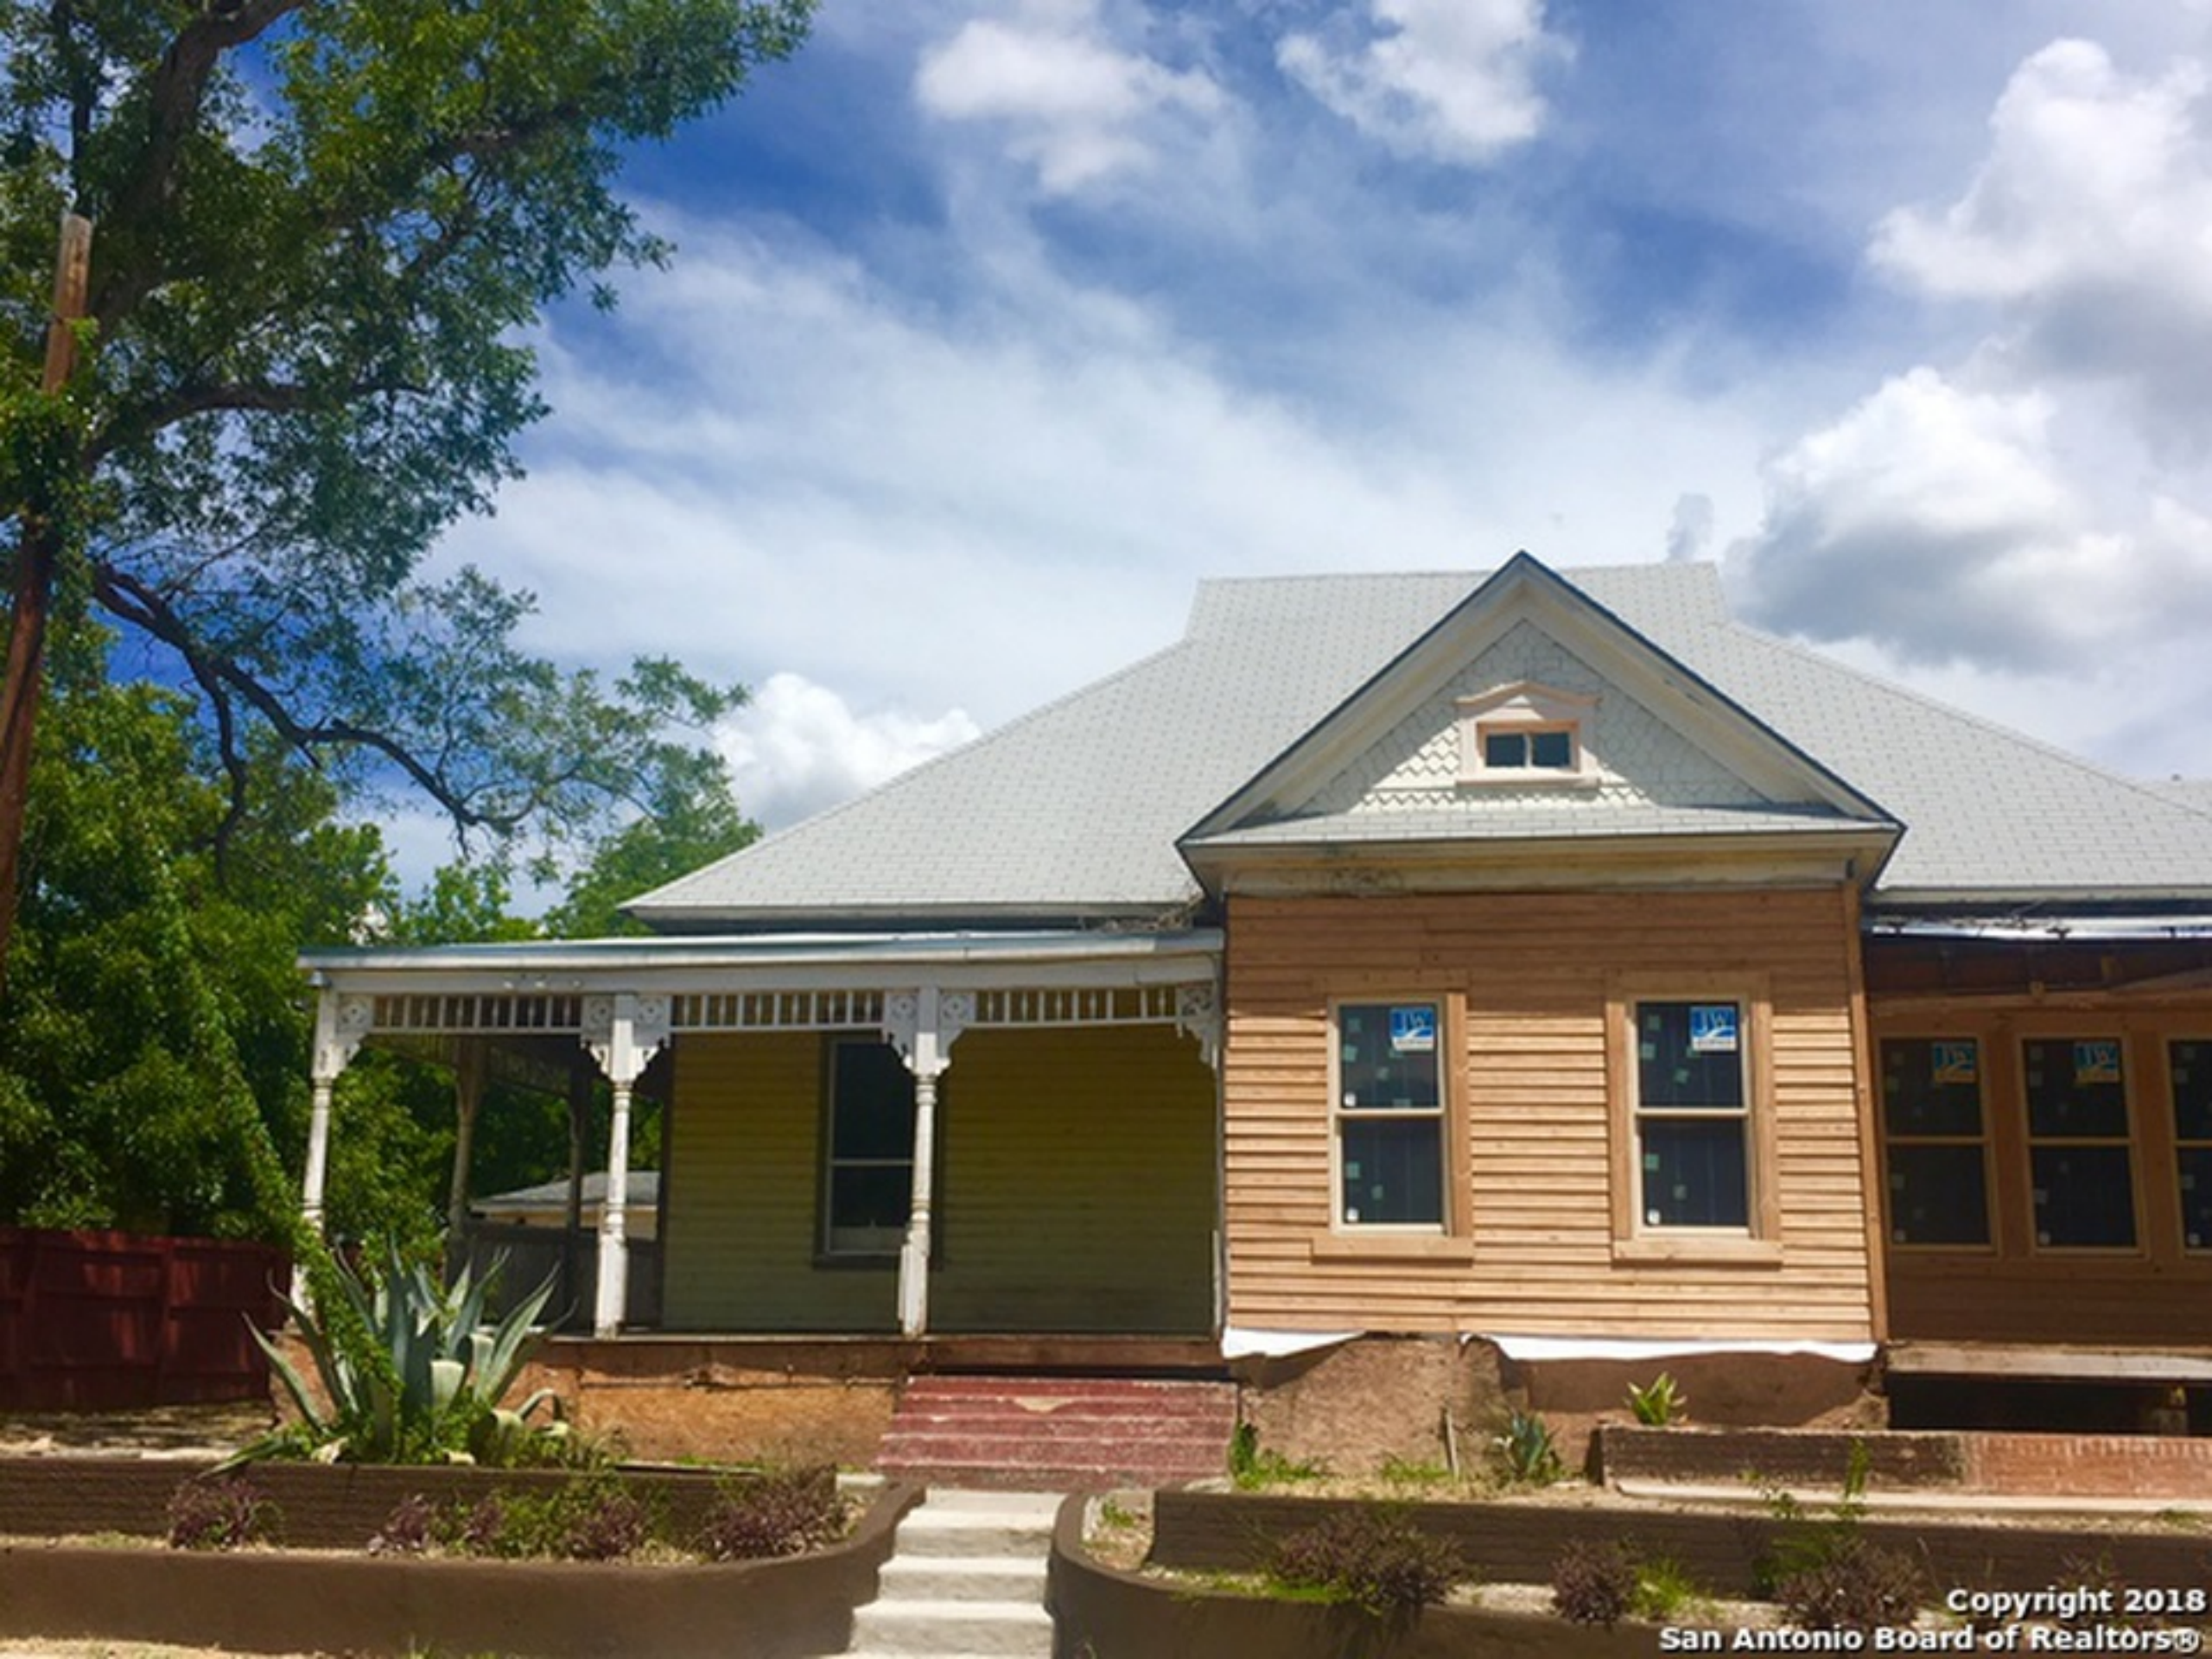
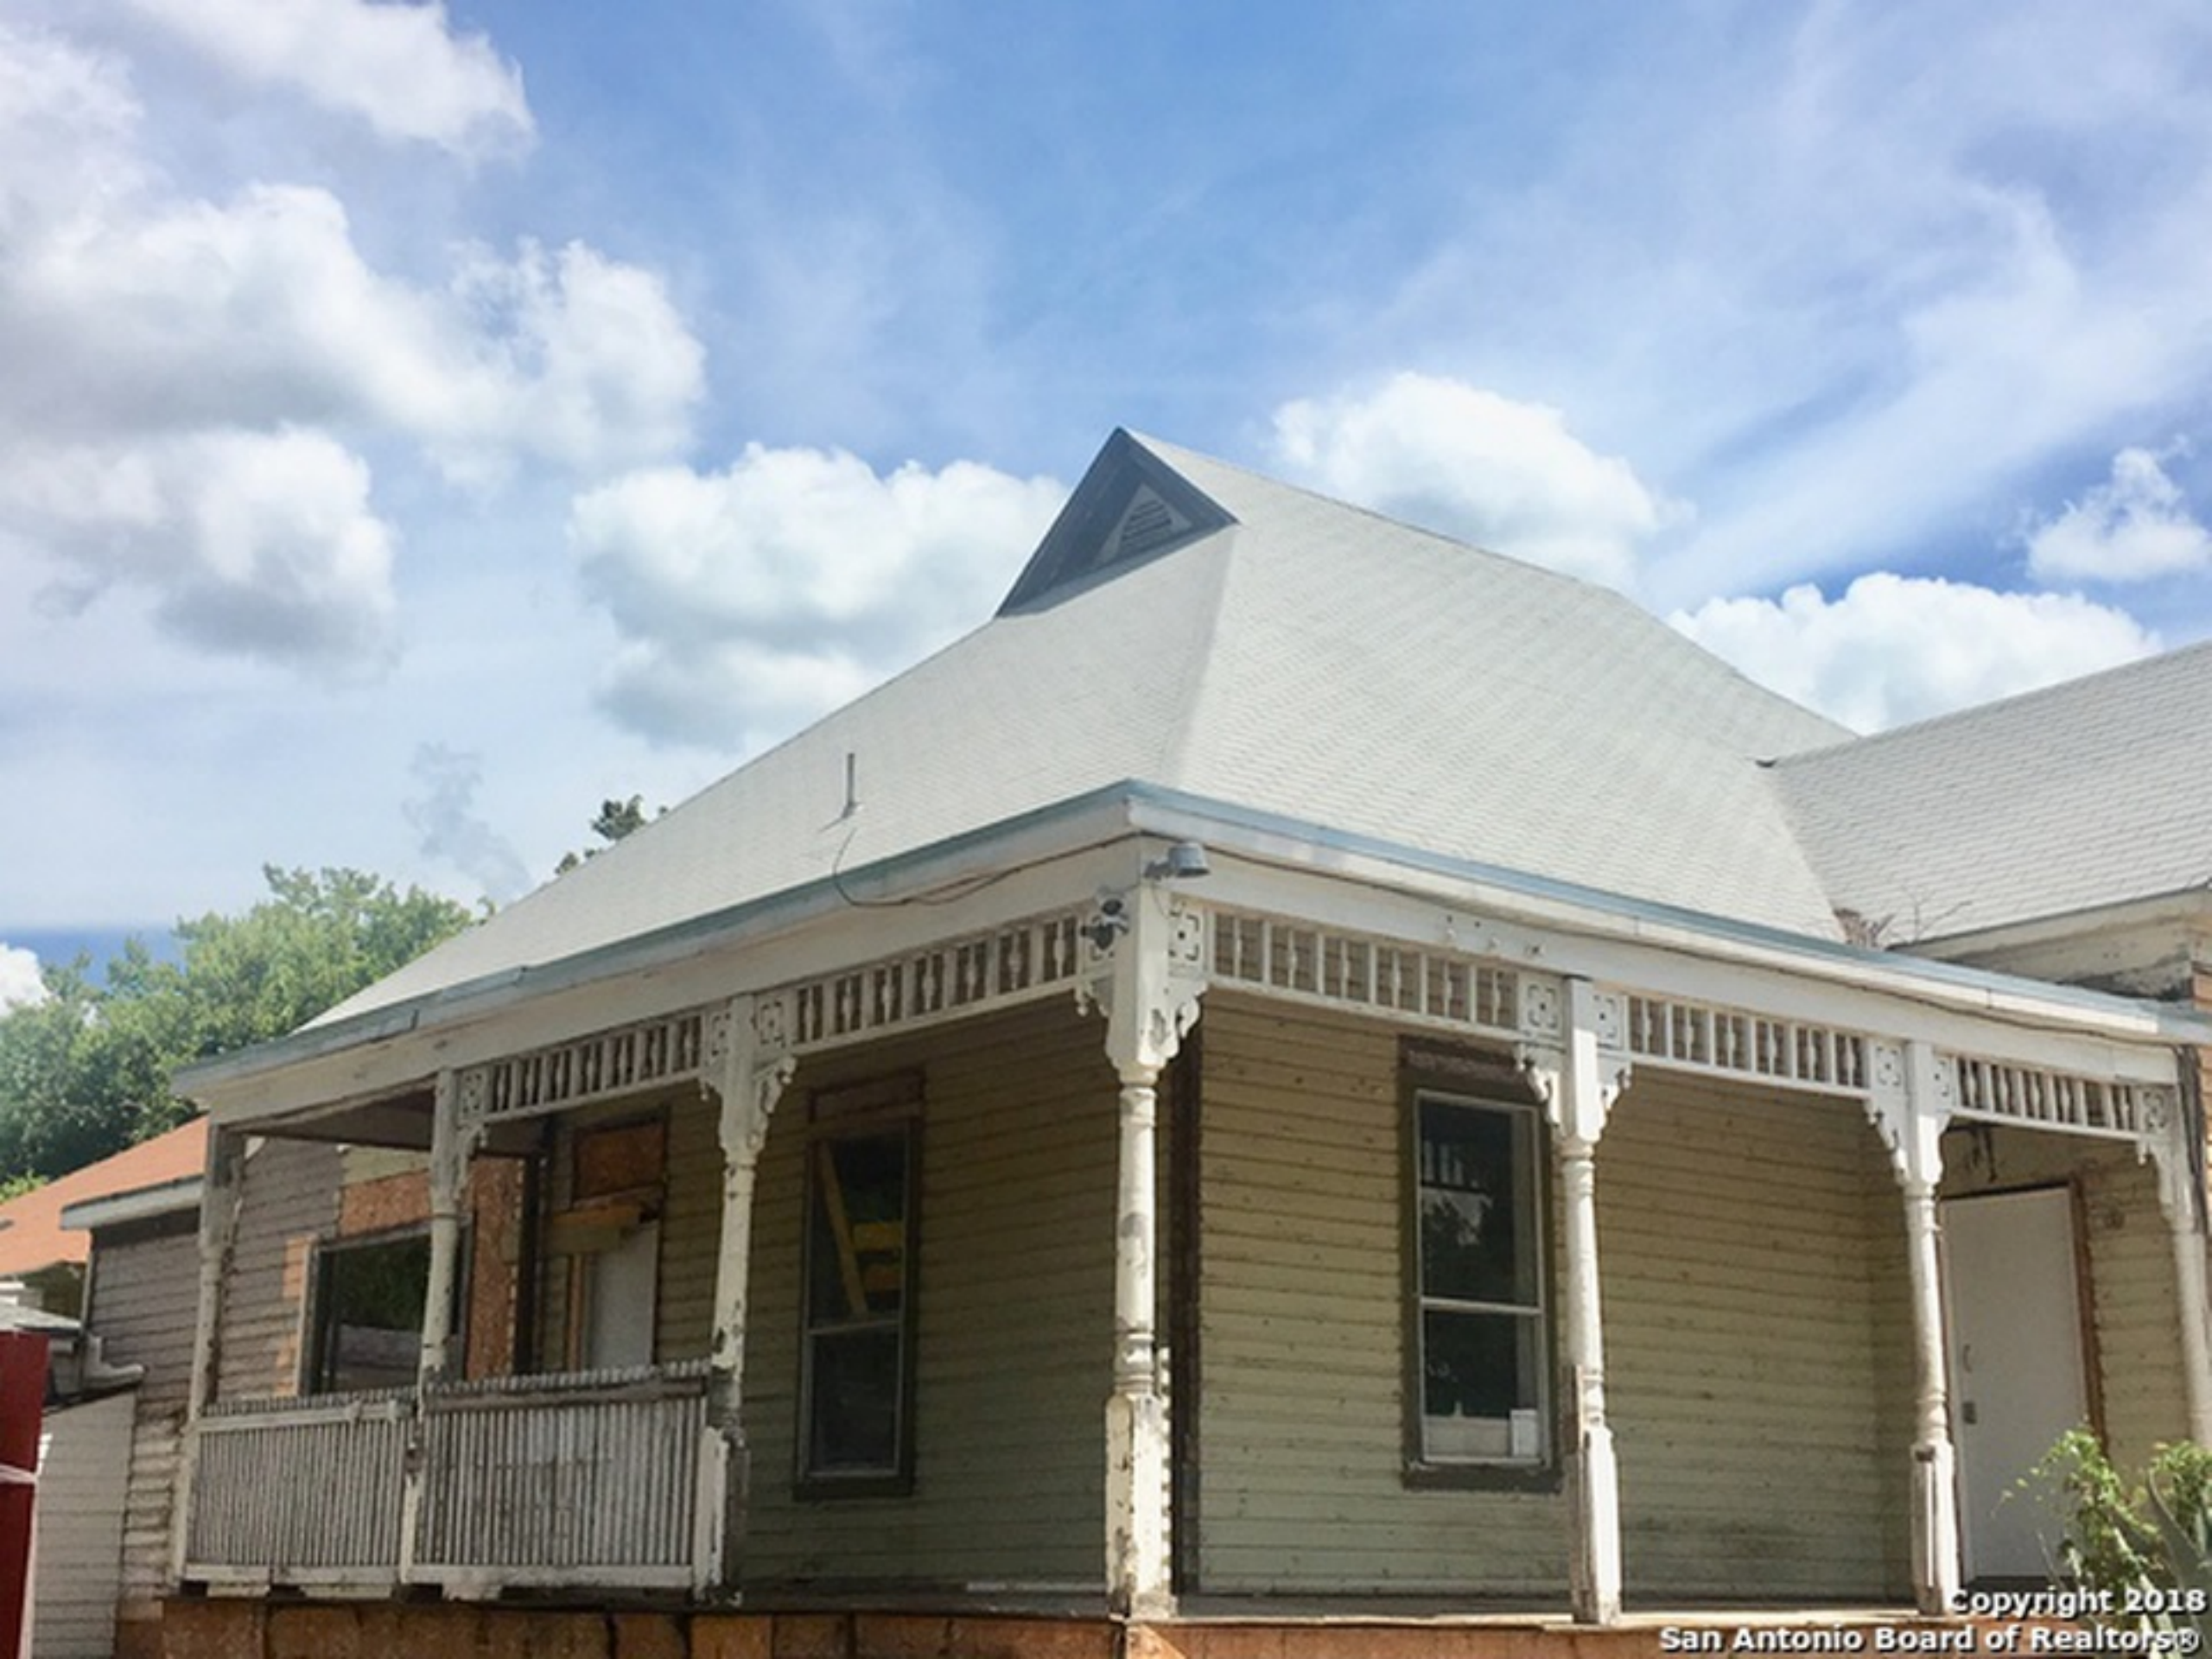
June 29, 2018 at 1:30 PM
1201 E Crockett St
San Antonio TX 78202
United States

- d. WINDOW REMOVAL – The applicant has proposed to remove and enclose five windows: a set (2) of windows on the E Crockett facade and three (3) windows on the east side elevation. According to the applicant, these windows were removed by the previous owner. Staff finds that these windows were in place on June 2018. Per the Guidelines for Exterior Modifications and Alterations 6.A.i., historic windows and doors should be preserved in size and not filled in. Staff that that 5 window openings should be restored.

- ii. The 5 removed window should be restored to their original location and configuration; new windows should match the specifications noted in finding e.
