HISTORIC AND DESIGN REVIEW COMMISSION

February 20, 2019

HDRC CASE NO: 2019-061
ADDRESS: 445 DEVINE ST
LEGAL DESCRIPTION: NCB 2957 BLK 1 LOT 12
ZONING: R-5, H
CITY COUNCIL DIST.: 1
DISTRICT: Lavaca Historic District
APPLICANT: Camden Greenlee
OWNER: Camden Greenlee
TYPE OF WORK: Window replacement
APPLICATION RECEIVED: February 01, 2019
60-DAY REVIEW: April 02, 2019
REQUEST:

The applicant is requesting a Certificate of Appropriateness for approval to replace approximately 18 existing wood windows with new Marvin Infinity brand fiberglass windows in the color Stone White.

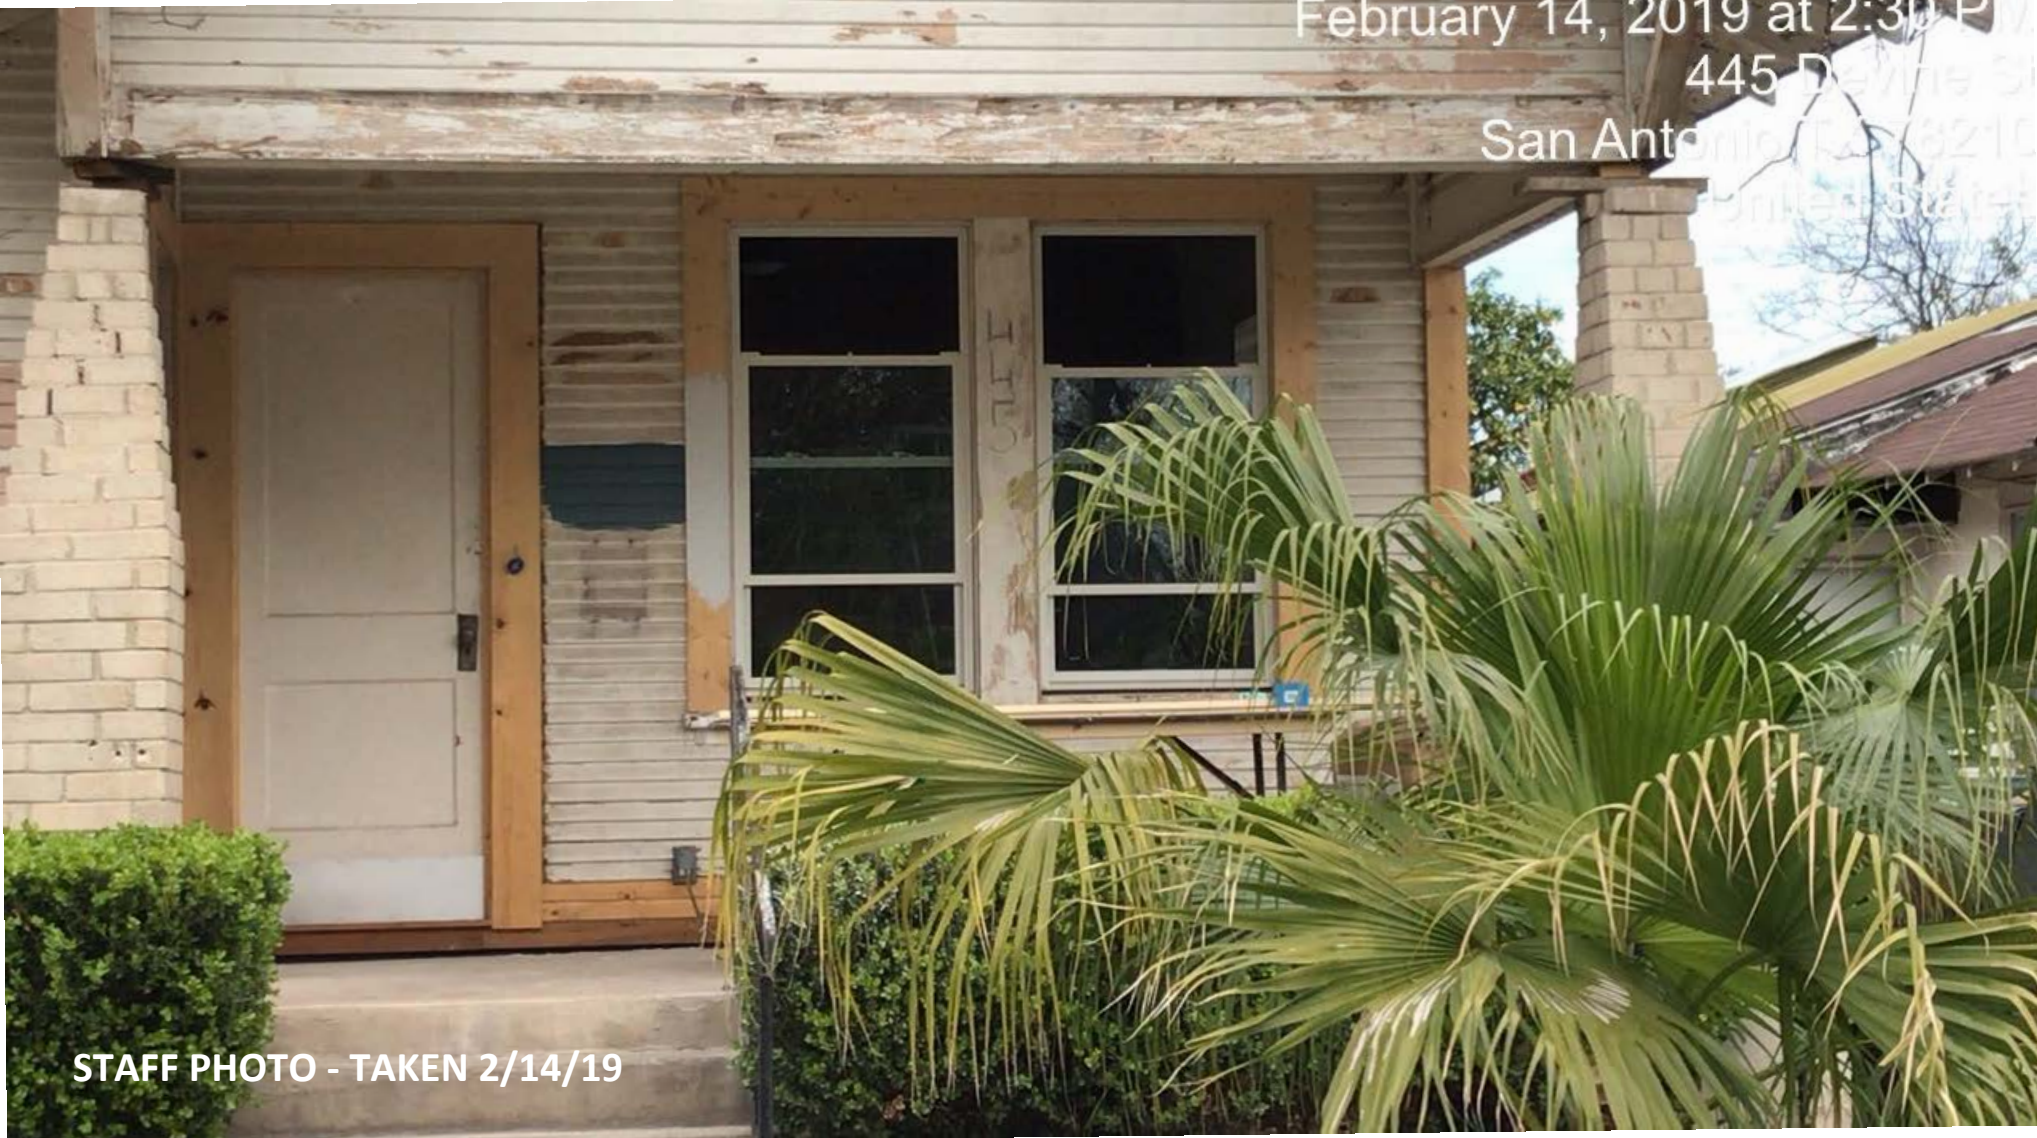
STAFF PHOTO - TAKEN 2/14/19

staff visited the site to place a public notice yard sign and observed the applicant installing the requested new windows prior to receiving a Certificate of Appropriateness.

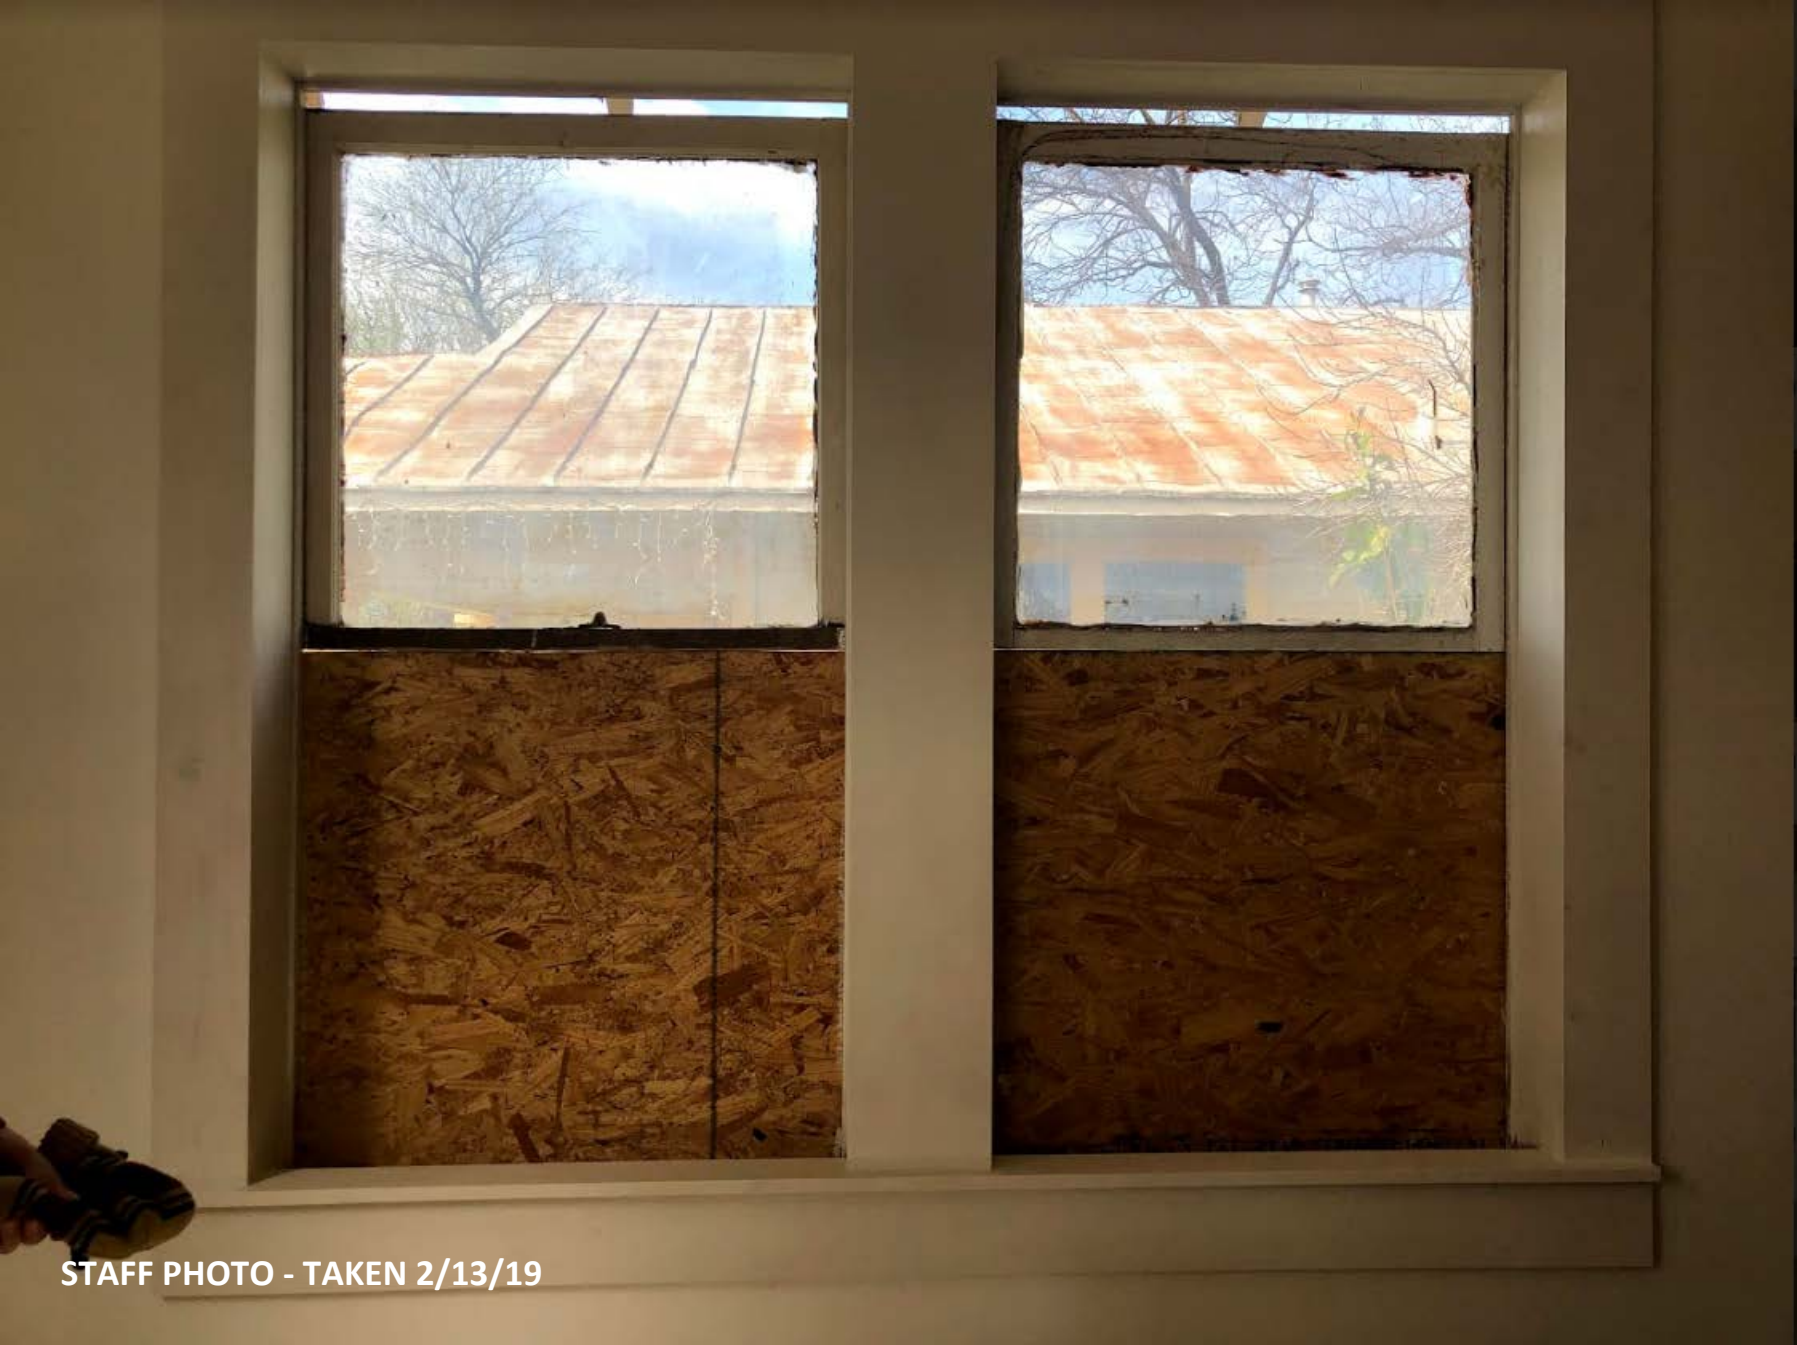
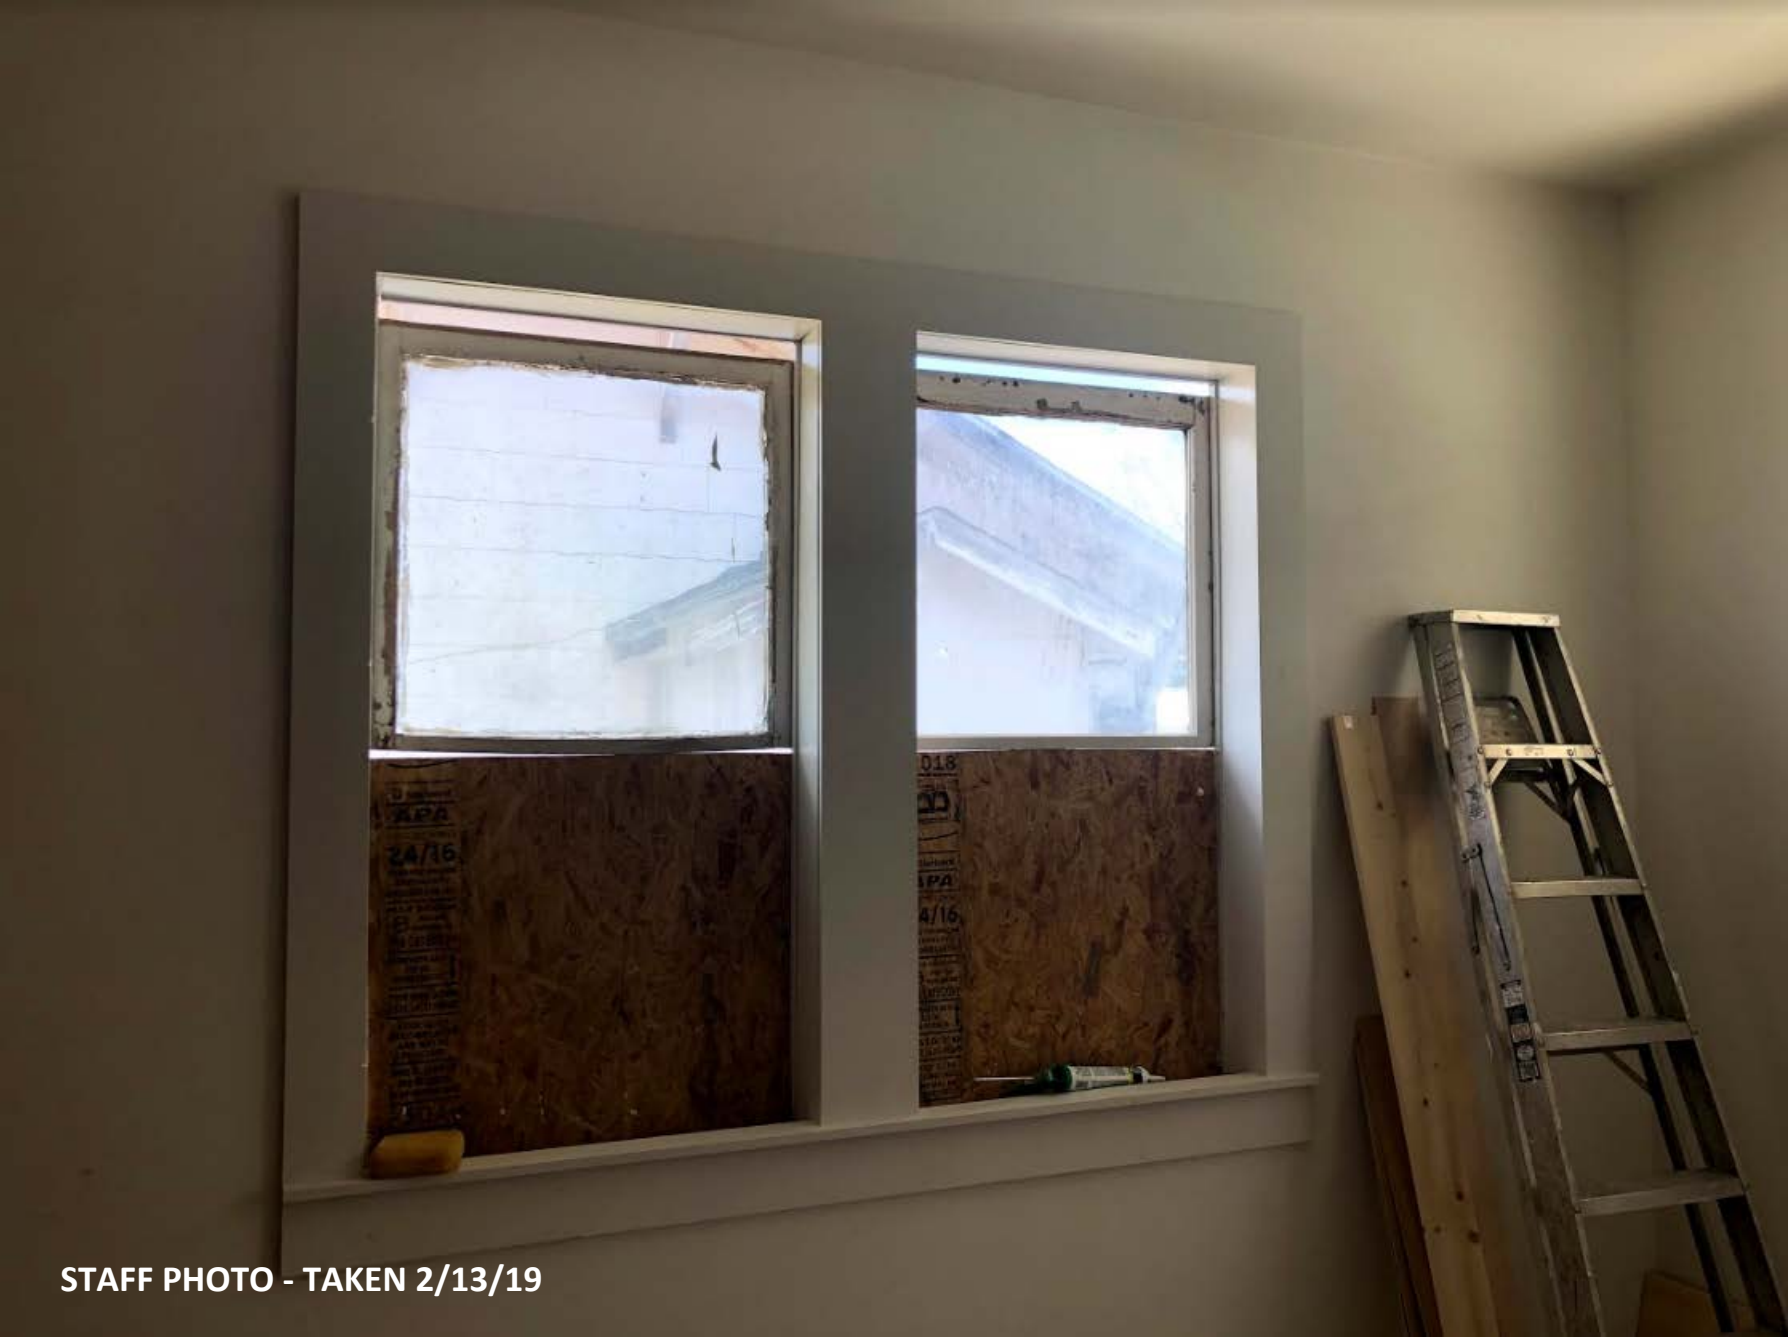
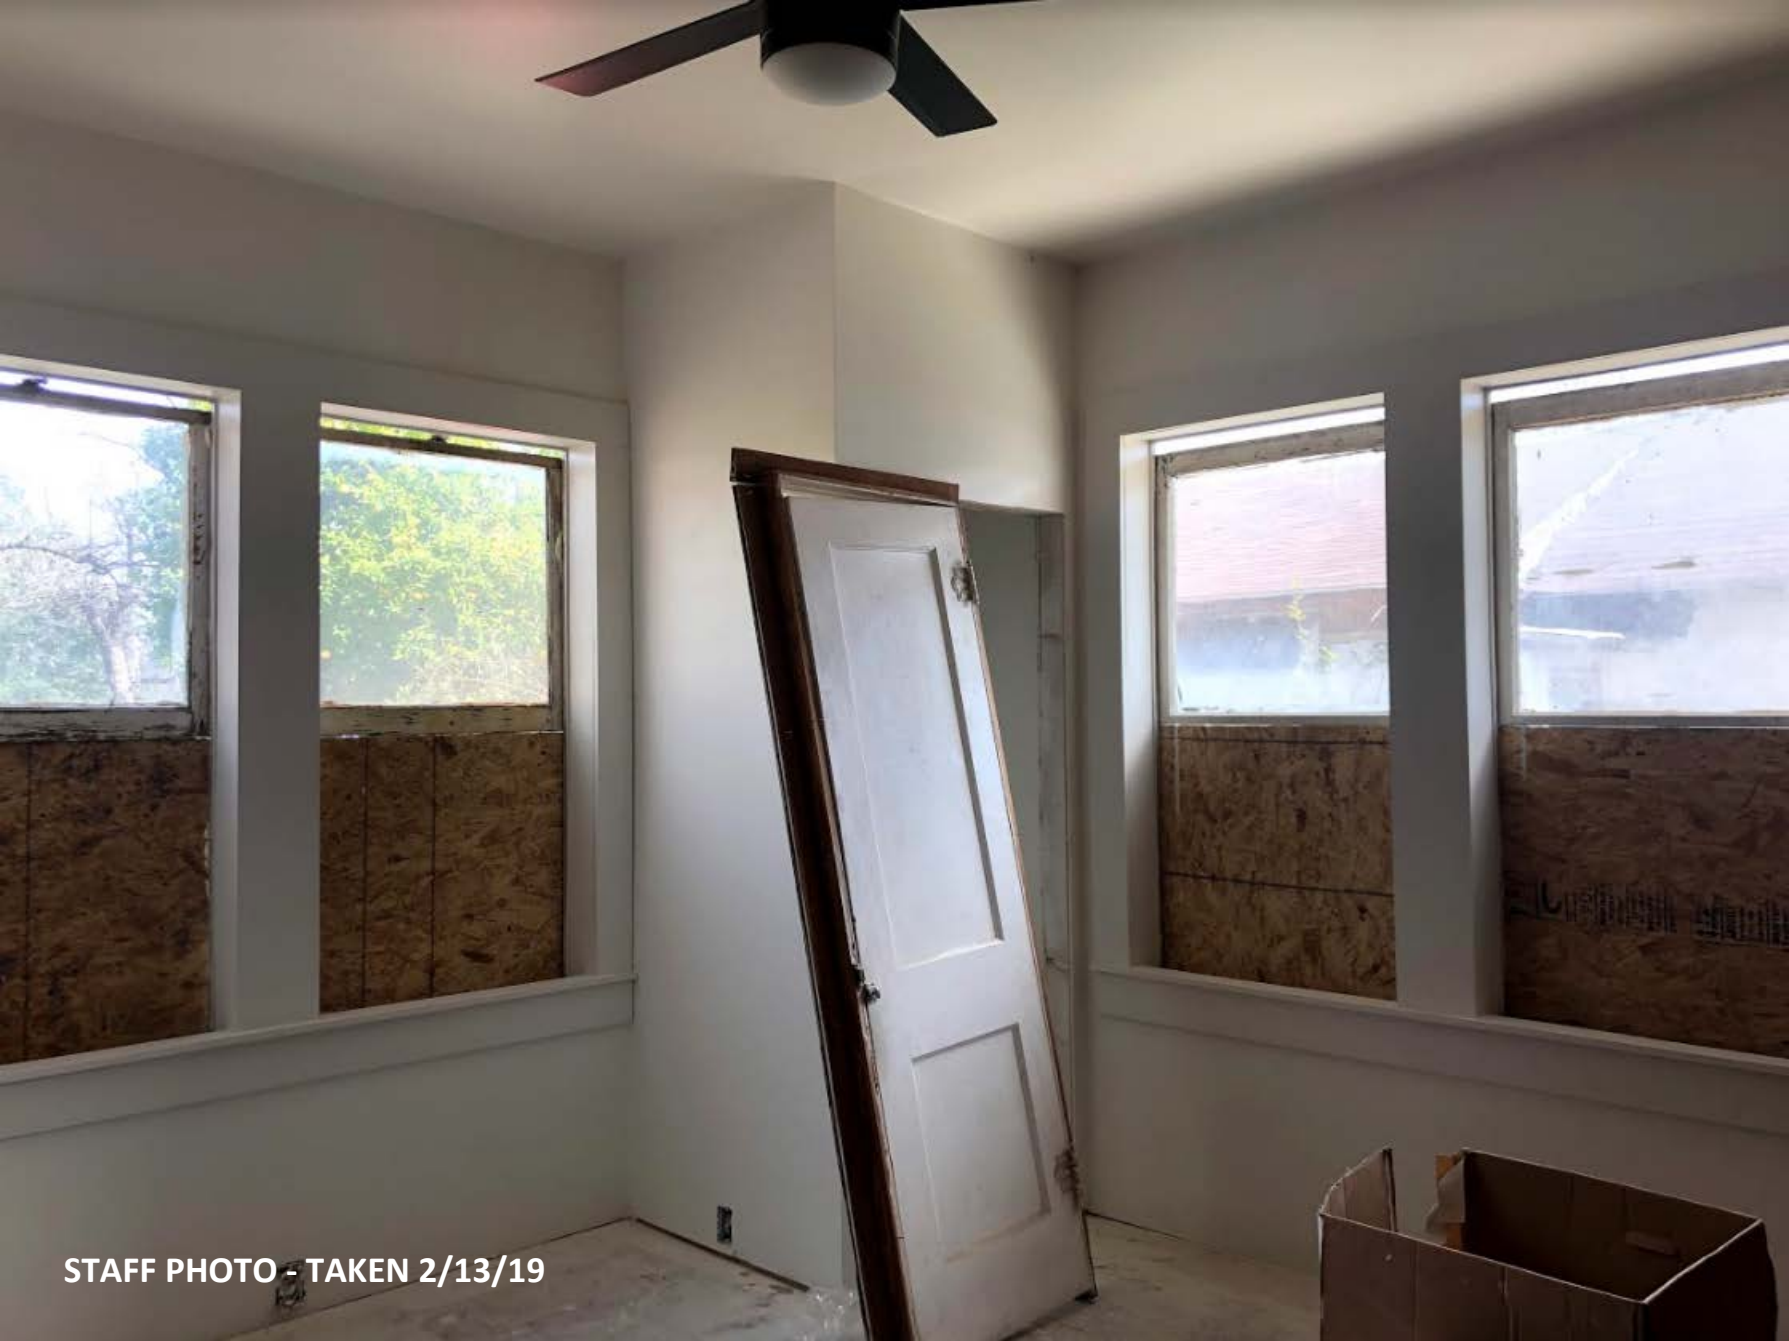
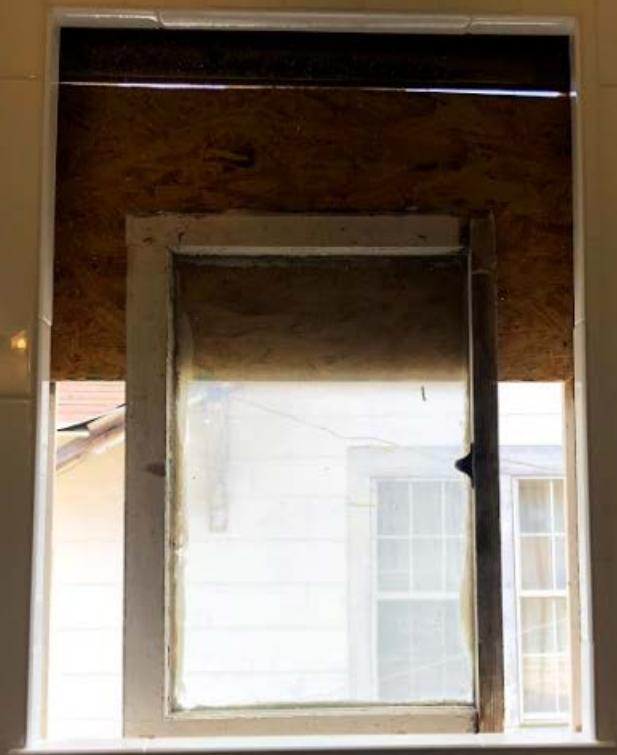
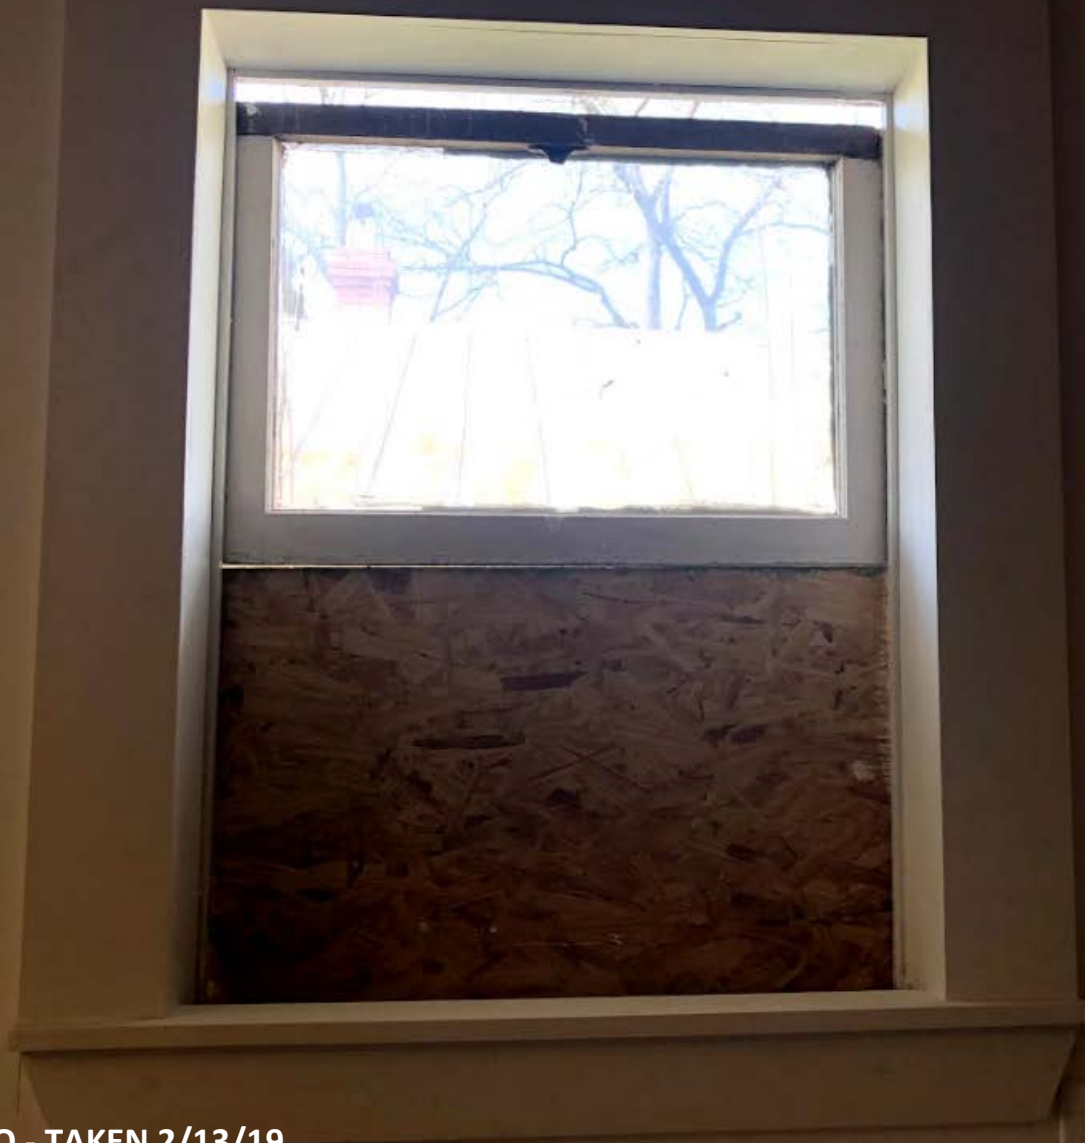
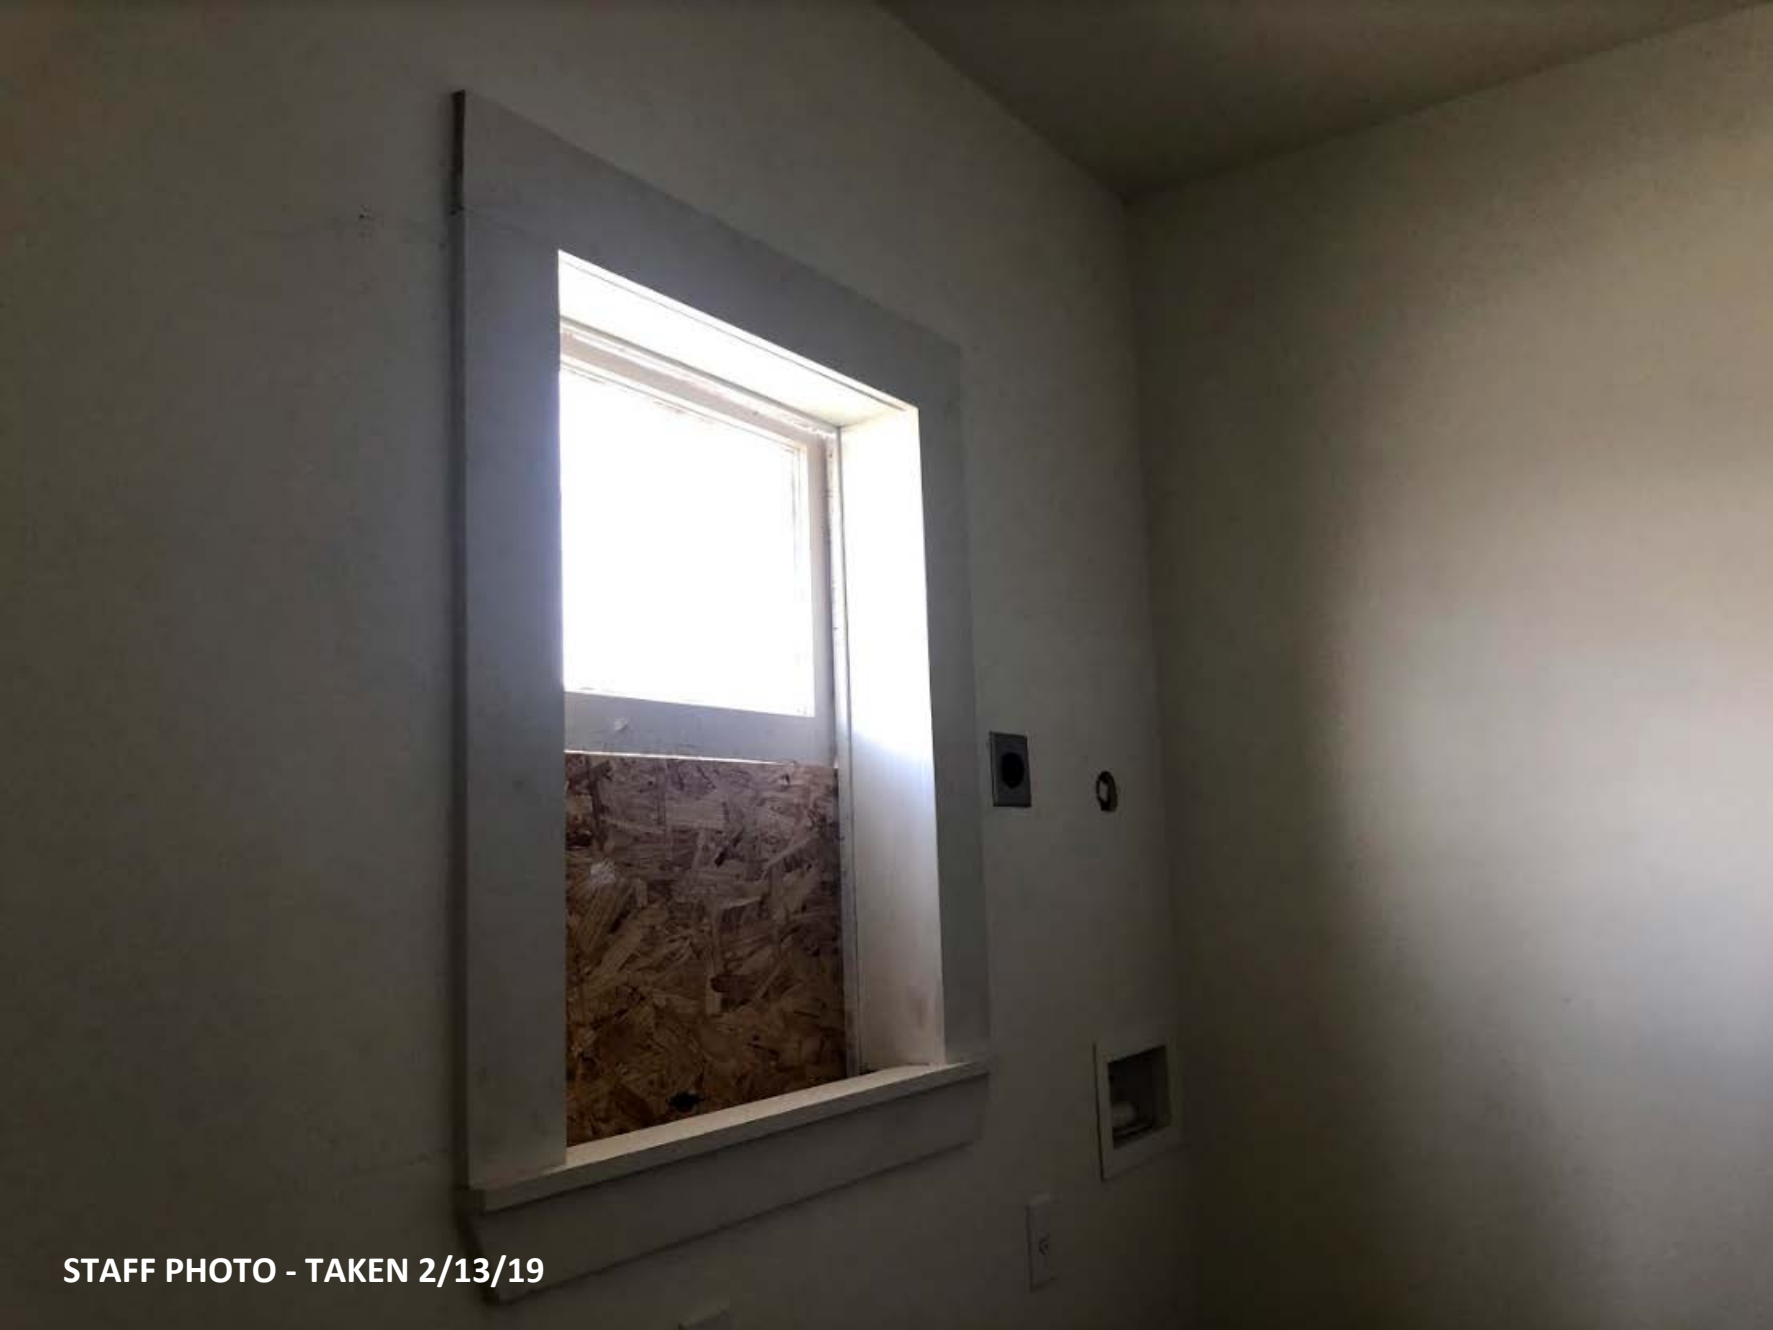
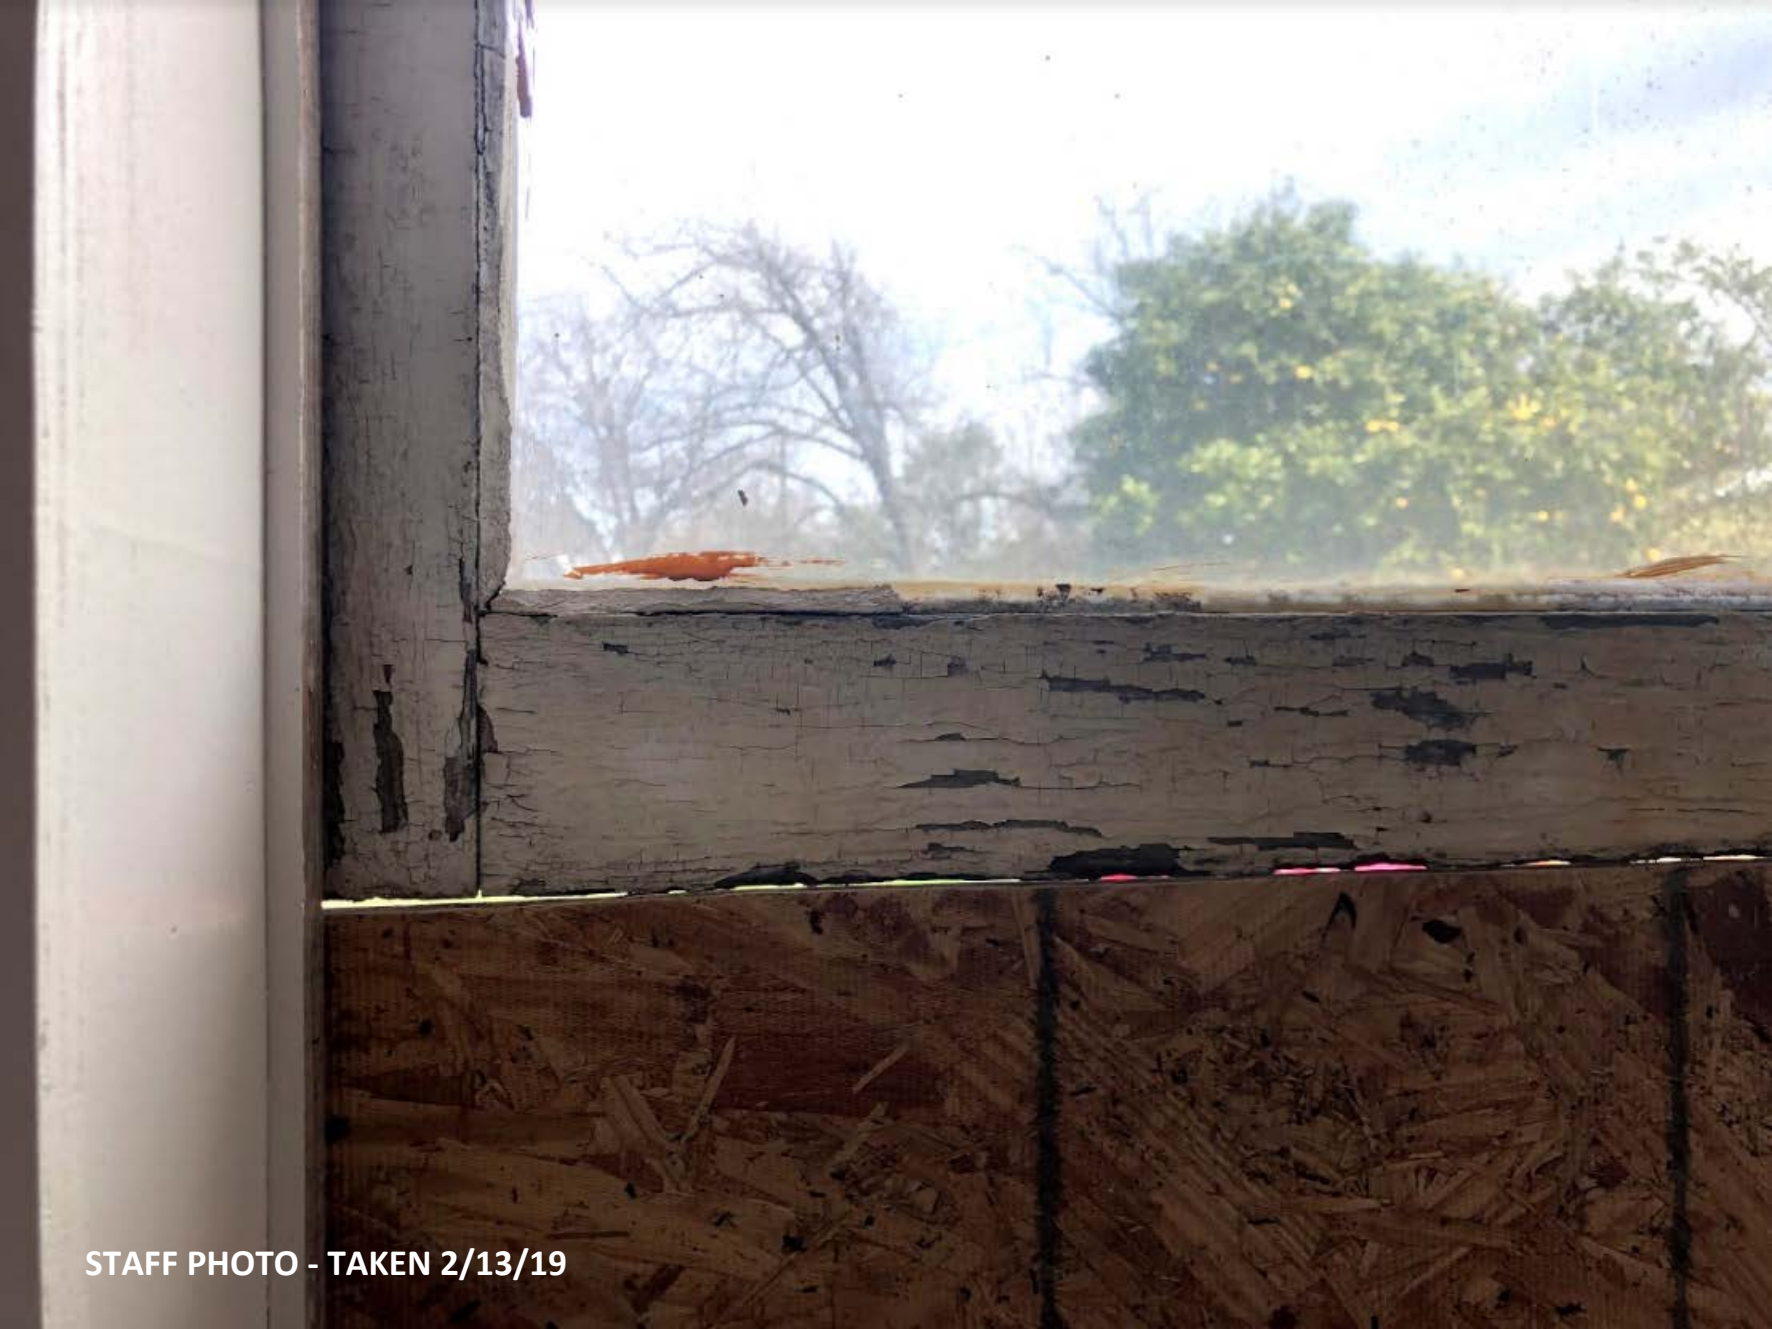
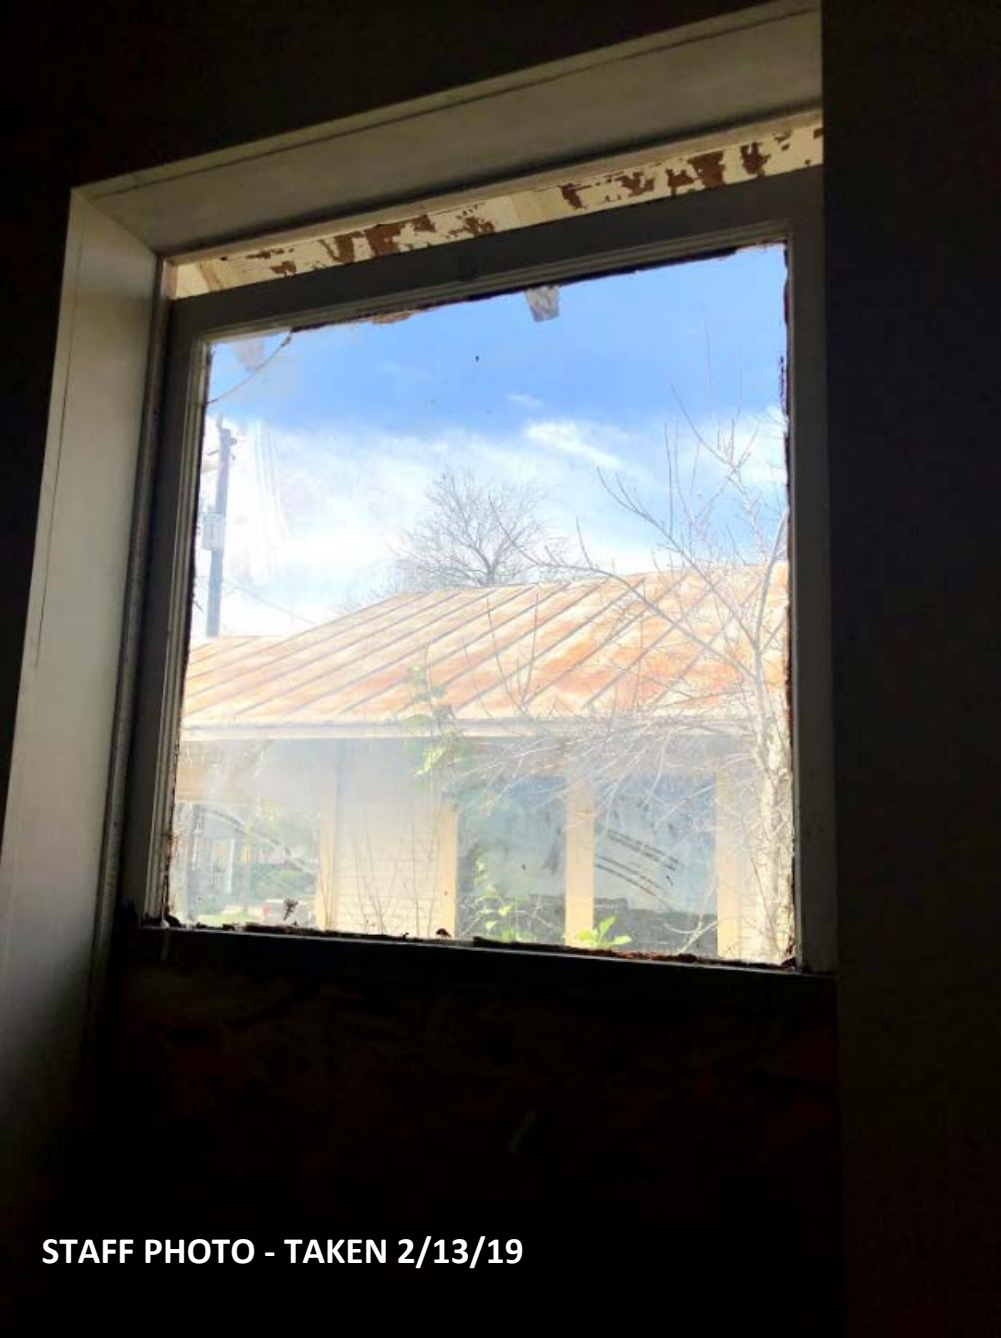
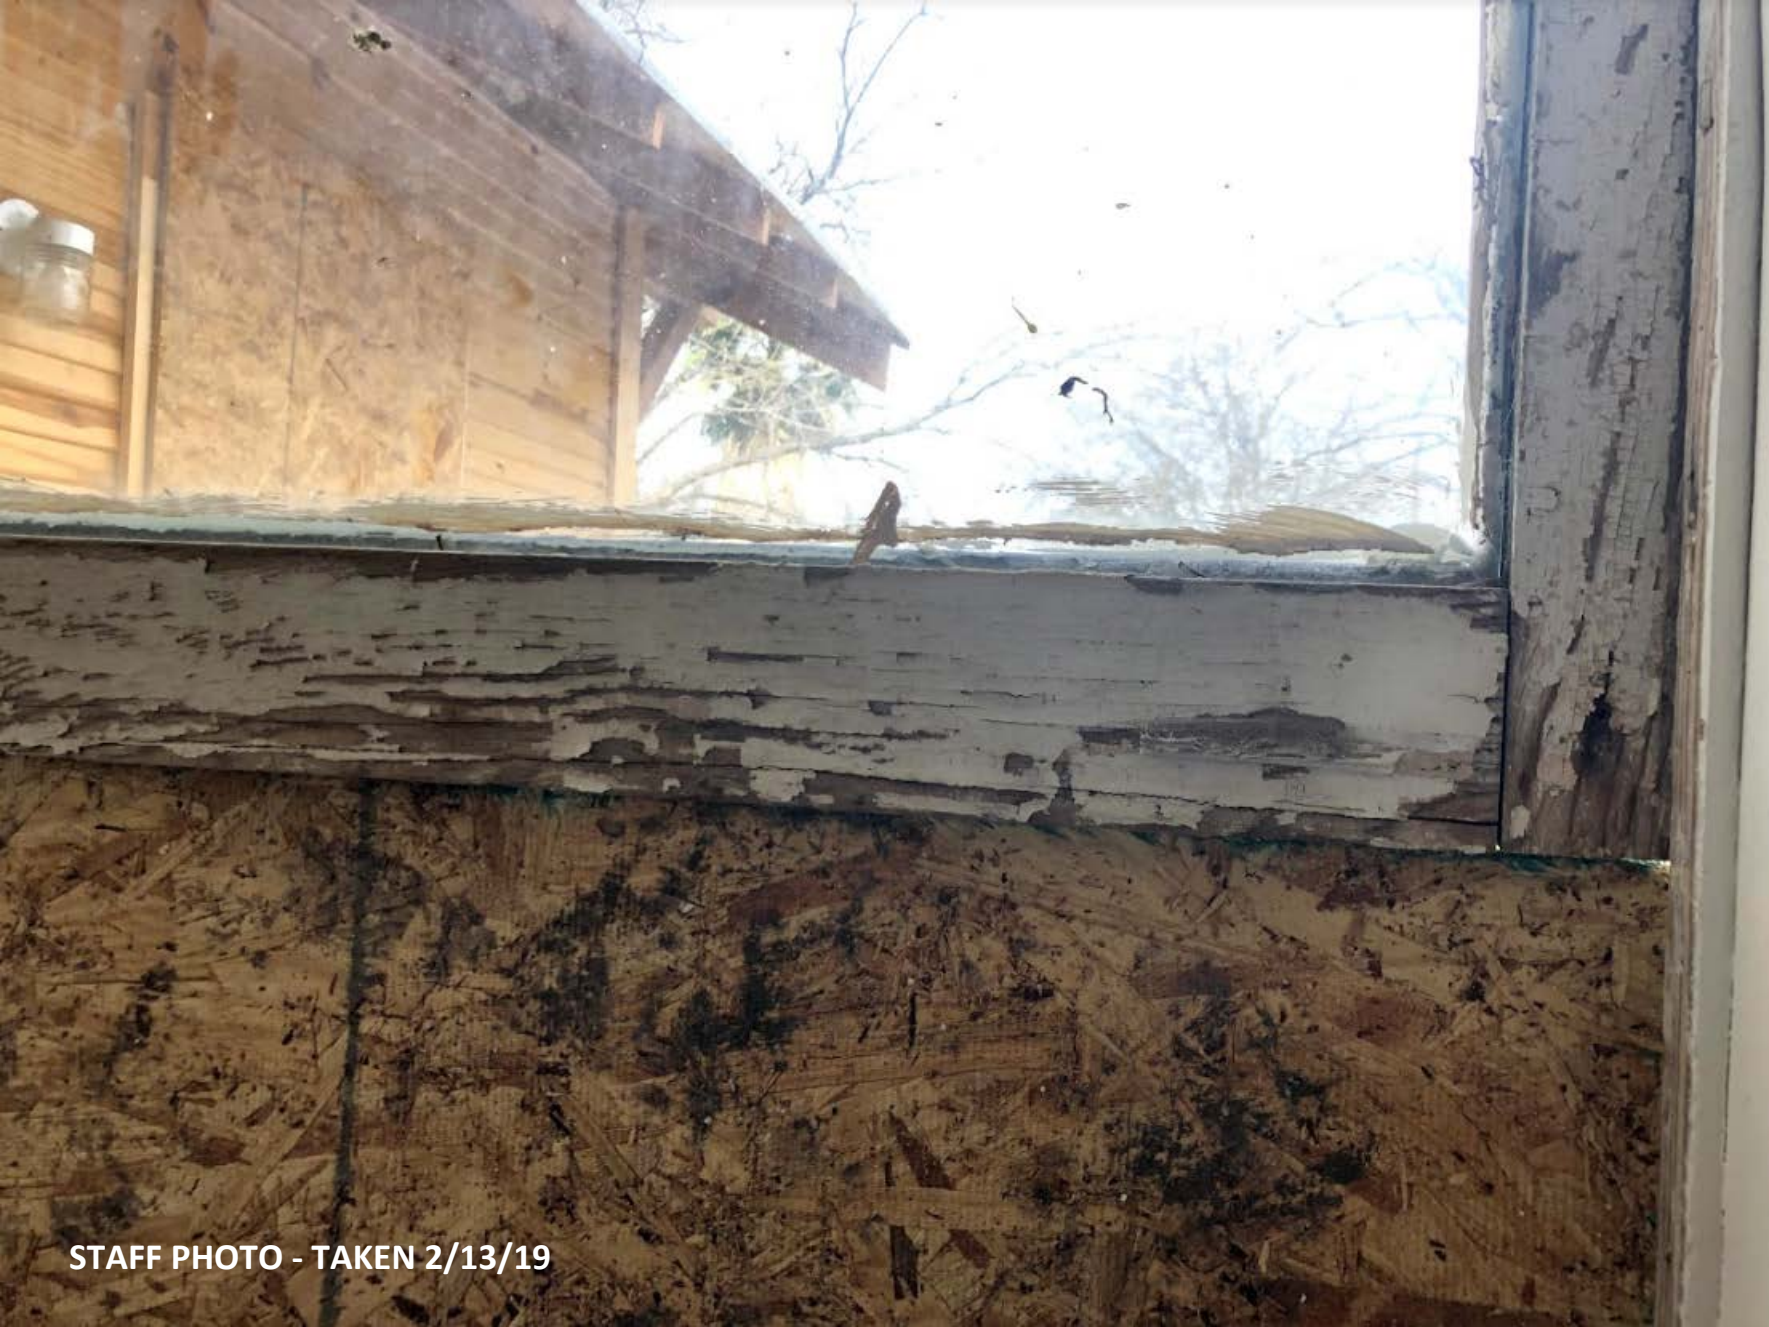
- b. **EXISTING WINDOWS: CONDITON** – A request for window replacement was heard by the Historic and Design Review Commission (HDRC) on June 7, 2017. At that time, staff noted that the windows were in repairable condition, and the HDRC did not approve the replacement request. The applicant at that time was instructed to repair the existing windows. Staff conducted a follow-up site visit with the previous owner on June 27, 2017. Staff observed that some of the windows featured broken glass, paint loss, and wood exposure, but that the windows overall were in good condition and fully repairable. Staff conducted a site visit with the current owner and applicant on February 13, 2019, to again assess the condition of the windows. Staff observed that the applicant had removed all weights, pulleys, and interior framing elements, including jambs, stops, and parting beads. The new framing as installed was void of parting beads, interior stops, and other components that allow for operability of historic wood windows. The original top sashes were in place in the existing openings and the original bottom sashes were stored in the backyard uncovered. Staff assessed the condition of the windows, which were similar to the site visit conducted in June 2017. While many of the glass panes had been broken and the pulley cords cut, staff found that no significant deterioration to the wood sashes had occurred since the prior request, and found the windows to be in repairable condition.

A request for window replacement was submitted by a previous owner and heard by the Historic and Design Review Commission (HDRC) on June 7, 2017. Based on a site visit and photographs, staff noted that the windows were in repairable condition, and the HDRC did not approve the replacement request. Staff conducted a site visit with the current applicant on February 13, 2019, to again examine the condition of the windows. Staff observed that the applicant had removed all weights, pulleys, and interior framing elements, including jambs, stops, and parting beads. The new framing as installed is void of parting beads, interior stops, and other components that allow for operability of historic wood windows. On February 14, 2019,

Staff does not recommend approval of the window replacement based on findings a through c. Staff recommends that the applicant repair the existing wood windows in place.
