HISTORIC AND DESIGN REVIEW COMMISSION

February 20, 2019

HDRC CASE NO: 2019-065
ADDRESS: 228 LAVACA ST
LEGAL DESCRIPTION: NCB 713 BLK 10 LOT E 3.7 OF N 95.1 OF 14, W 9 OF N 91.5 OF 15 & W 45.1 OF E 49.1 OF 15
ZONING: RM-4, H
CITY COUNCIL DIST.: 1
DISTRICT: Lavaca Historic District
APPLICANT: Clint Belew/LRRB Holdings LLC
OWNER: Clint Belew/LRRB Holdings LLC
TYPE OF WORK: Hardie skirting
APPLICATION RECEIVED: February 1, 2019
60-DAY REVIEW: April 1, 2019
REQUEST:

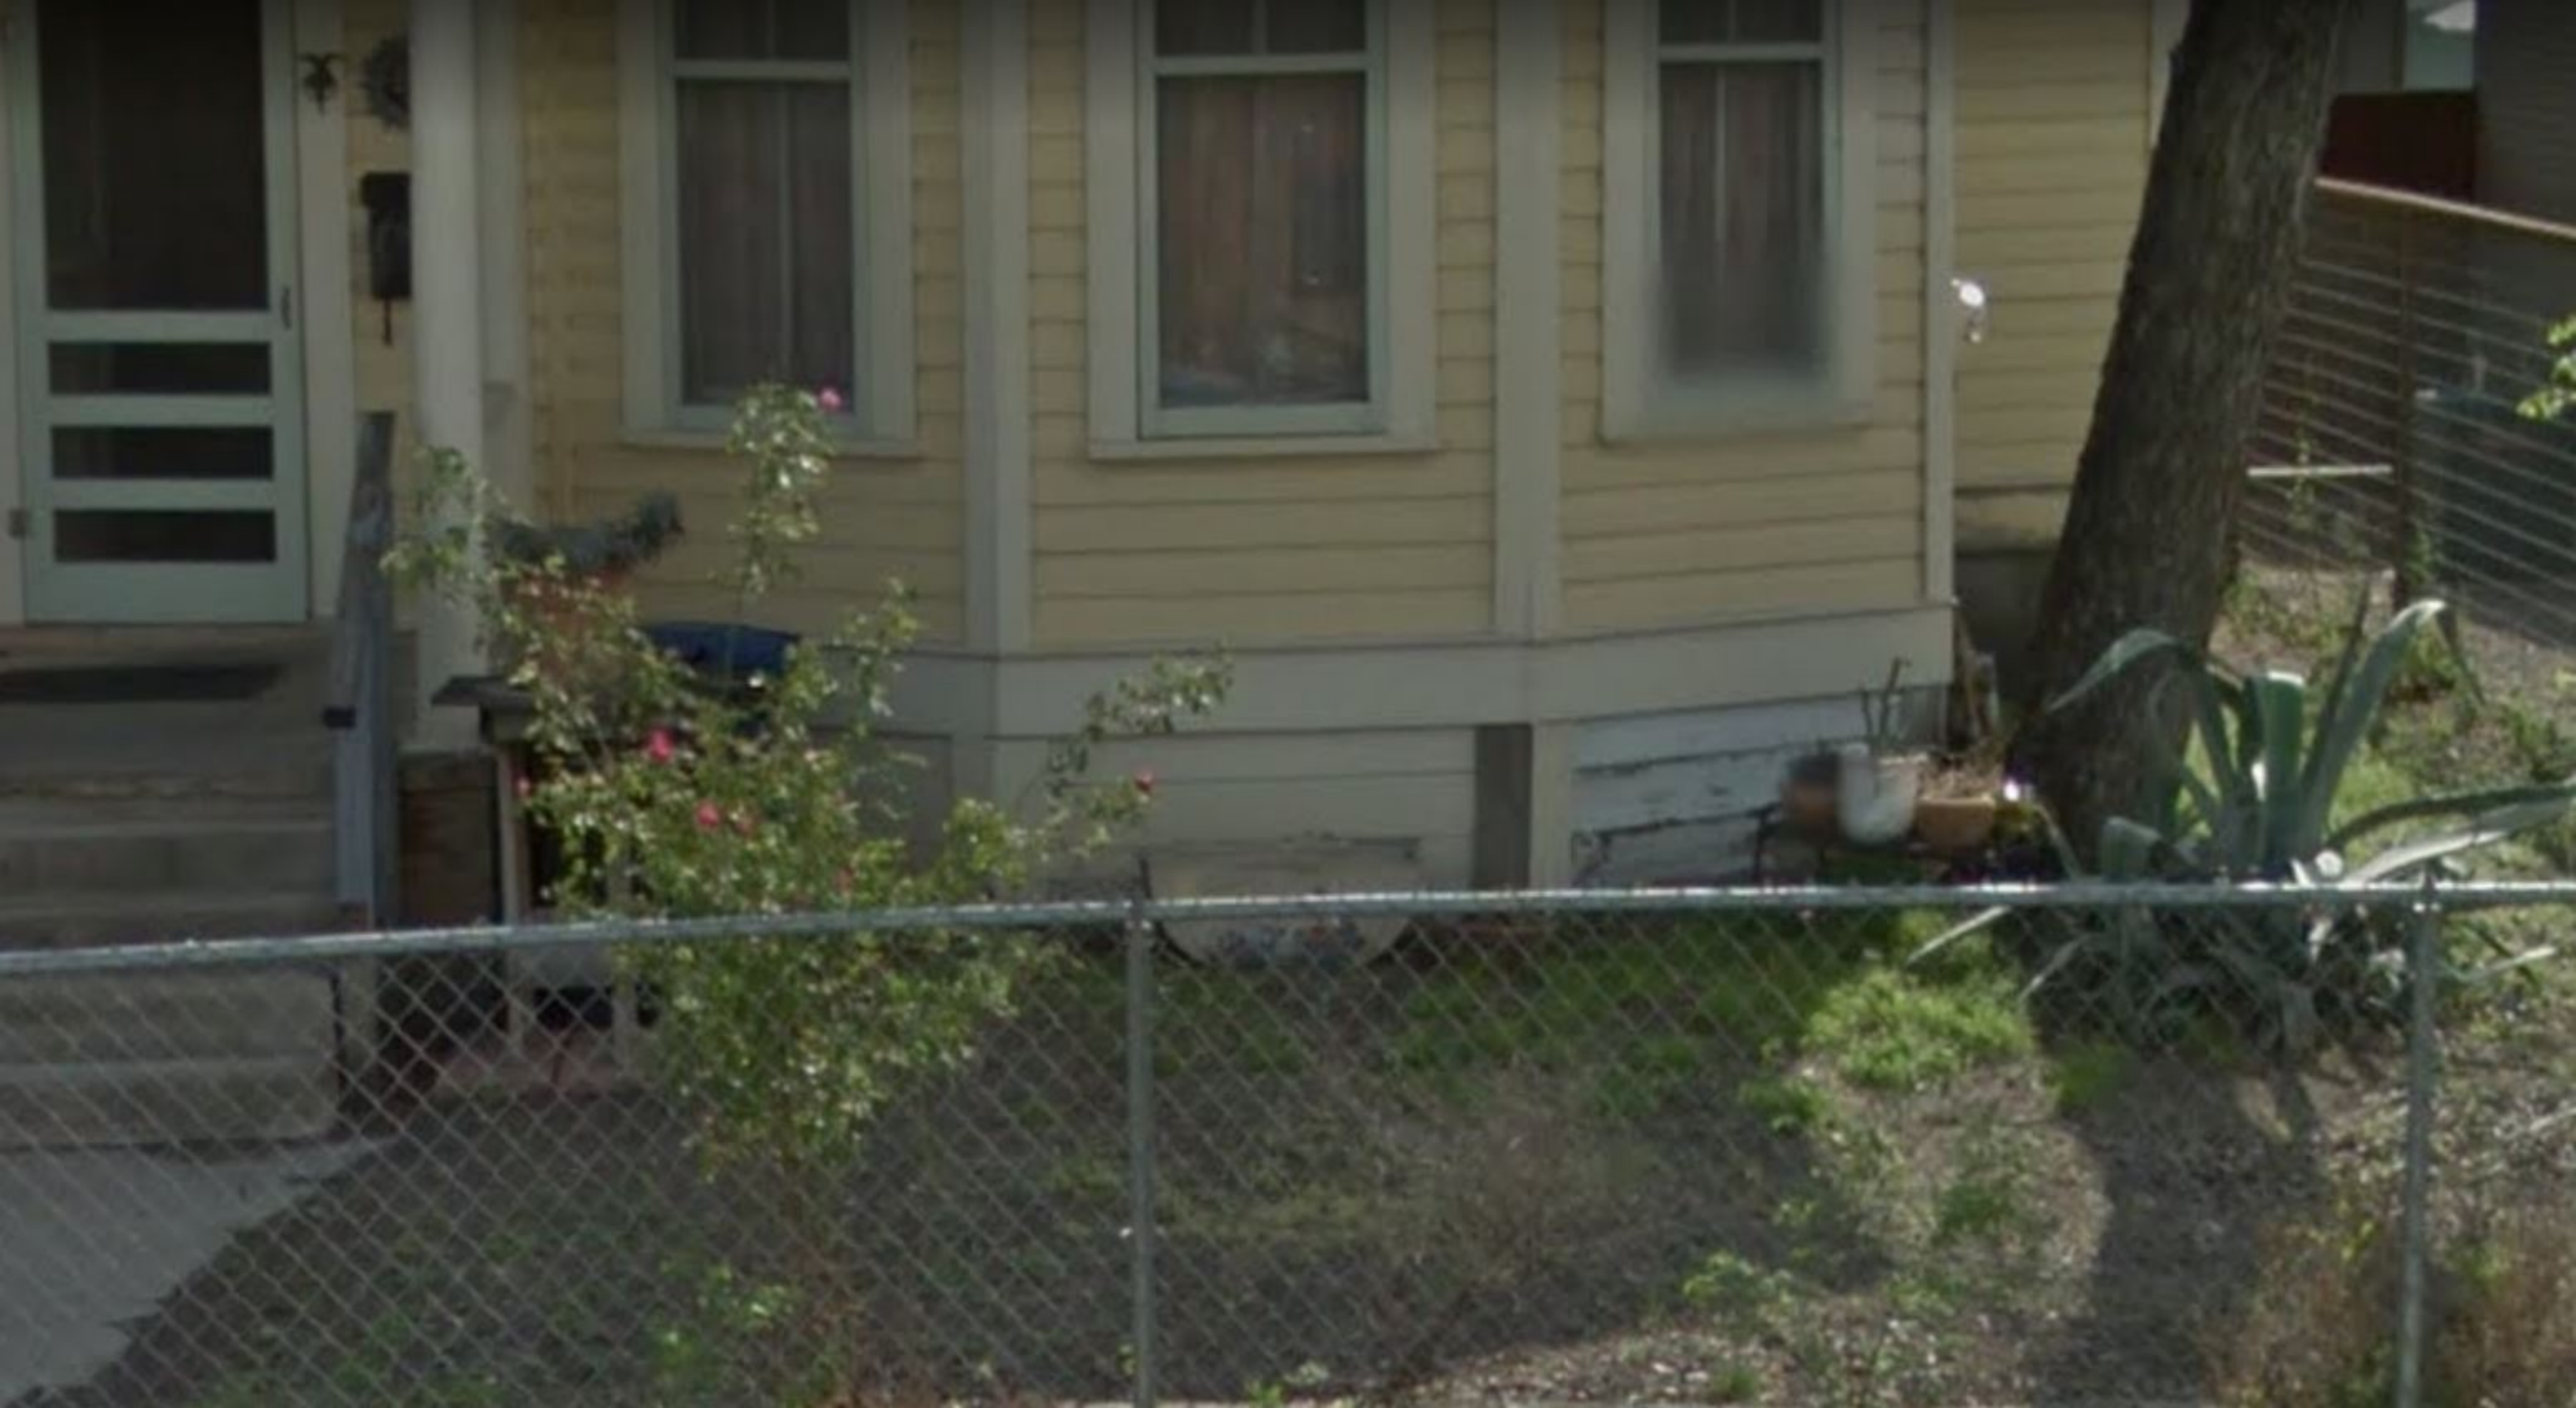
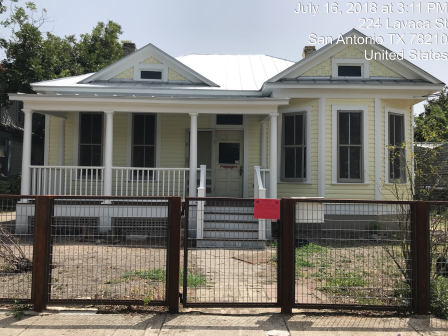
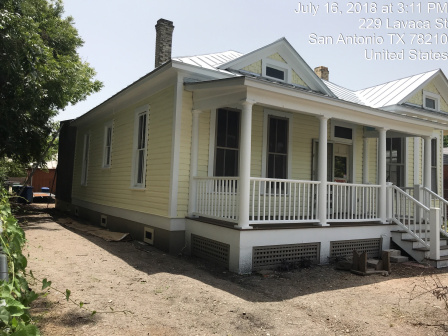
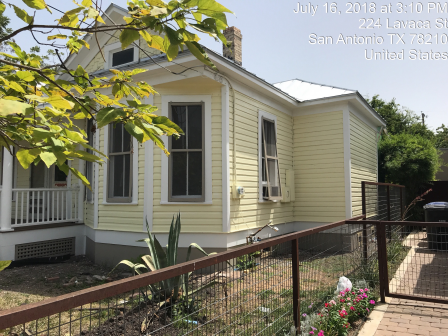
- c. VIOLATION – On site visit conducted on July 16, 2018, staff found that a side window was removed prior to approval and that the skirting on the foundation and porch was installed inconsistently with the scope of approval. The owner/applicant has restored the window and submitted an HDRC application to amend the detail regarding skirting on February 1, 2019, to be heard at the next HDRC hearing.

- d. FOUNDATION SKIRTING – The applicant has proposed to install flat Hardie siding in a continuous configuration instead of matching the original wood lap skirting with 4-6 inch exposure. Per the Guidelines 8.B.i., replacement skirting should consist of durable, proven materials, and should either match the existing siding or be applied to have minimal visual impact. Staff finds that the continuous Hardie board siding is a noticeable departure from the lap siding as it excludes the lap siding shadow lines and mimics the configuration of stucco or exposed concrete skirting.

- e. PORCH SKIRTING – The applicant has proposed to install lattice skirting on the porch instead of matching the

original wood lap skirting with 4-6 inch exposure. Per the Guidelines for Exterior Maintenance and Alterations 7.B.v., porches should be reconstructed based on accurate evidence of the original or on the architectural style of the building and historic patterns. Staff finds that lattice skirting on front porches, if found in the historic district, is a non-conforming alteration that should be avoided.

Staff does not recommended approval to amend previous approvals regarding skirting on the foundation and porch. Staff finds that the both elements should feature lap siding with 4 to 6 inch exposure with either smooth Hardie or wood.

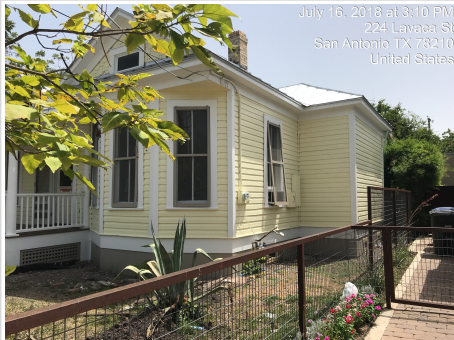
07/16/2018 03:15 PM

Date	07/16/2018
Time	03:12 PM (-5 GMT)
Context	citizen report
Present Staff	Huy Pham
Present Individuals	None
Types of Work Observed	Exterior Maintenance and Alterations
Amount of Work Completed	75%
Description of work	Removal of side window, installation of stucco skirting, potentially metal cattle fence prior to approval.
Description of interaction	Staff emailed applicant Clint Bellew on 7/13/2018. Notice of Investigation posted on property 7/16/2018.

Violation Type	No Certificate of Appropriateness (Code 35-451a), Beyond scope of Certificate of Appropriateness (Code 35-451h)
OHP Action	posted "Notice of Investigation"
Deadline to contact office	07/16/2018
Will post-work application fee apply?	Yes
