HISTORIC AND DESIGN REVIEW COMMISSION

March 06, 2019

HDRC CASE NO: 2019-078
ADDRESS: 124 GLORIETTA
LEGAL DESCRIPTION: NCB 576 BLK 15B LOT E 56.45 FT OF 5
ZONING: RM-4, H
CITY COUNCIL DIST.: 2
DISTRICT: Dignowity Hill Historic District
APPLICANT: Edward Casias
OWNER: Andres Casias
TYPE OF WORK: Window Replacement; removal of siding; side deck
APPLICATION RECEIVED: February 15, 2019
60-DAY REVIEW: April 14, 2019

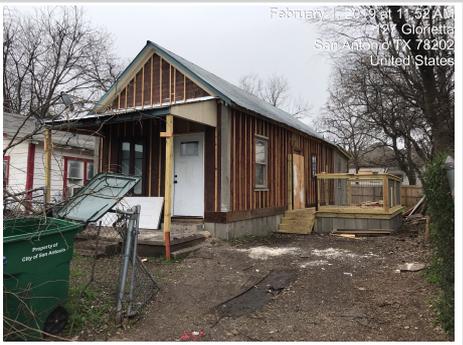
February 1, 2019 at 11:52 AM
126 Glorietta
San Antonio TX 78202
United States

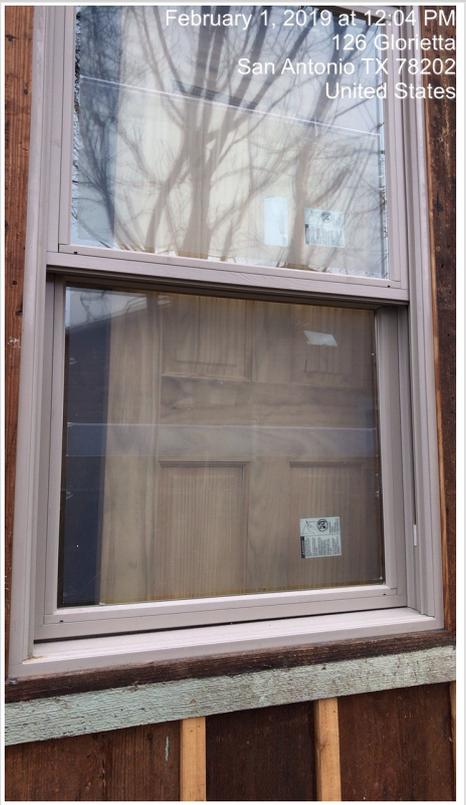
February 1, 2019 at 12:04 PM
126 Glorietta
San Antonio TX 78202
United States

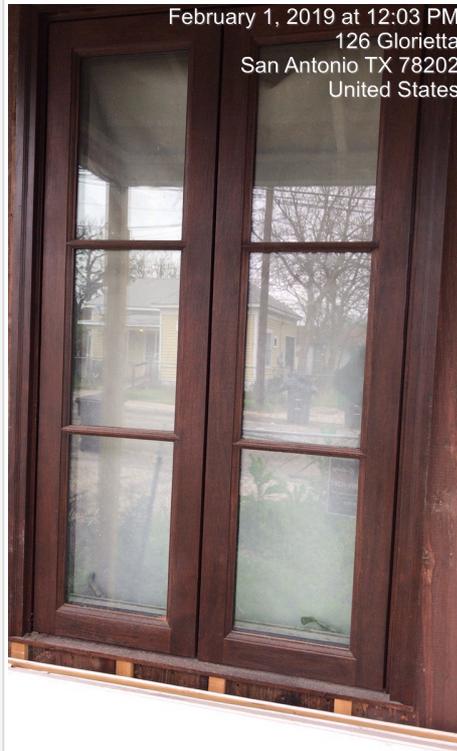
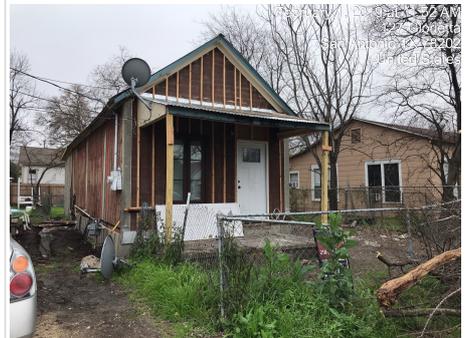
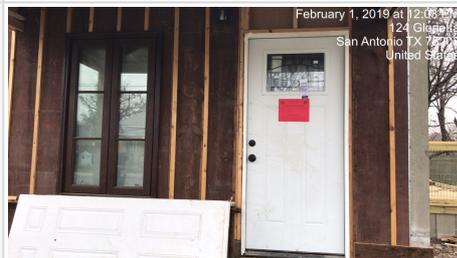
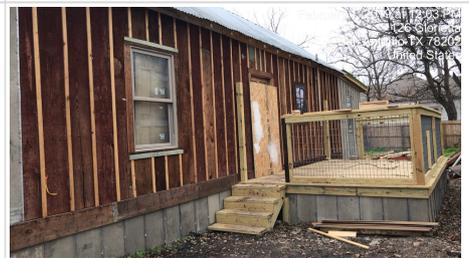
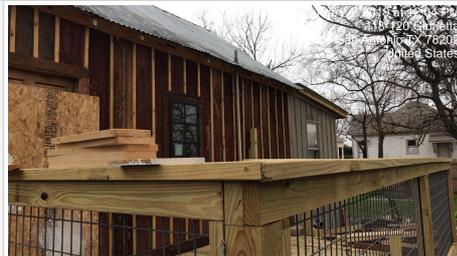
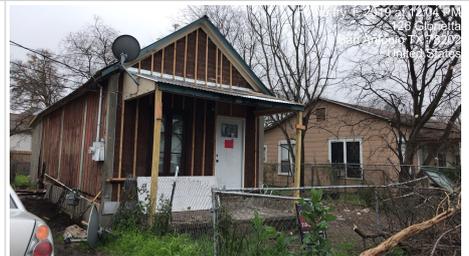
02/01/2019 12:09 PM

Date	02/01/2019
Time	12:00 PM (-6 GMT)
Context	drive-by
Present Staff	Huy Pham, Other
Present Individuals	None
Types of Work Observed	Exterior Maintenance and Alterations
Amount of Work Completed	75%
Description of work	Window replacement, door replacement, construction of a side deck, siding removal/repair.
