HISTORIC AND DESIGN REVIEW COMMISSION

March 20, 2019

HDRC CASE NO: 2019-074
ADDRESS: 413 CLUB DR
LEGAL DESCRIPTION: NCB 7014 BLK LOT W 35 FT OF 4 & E 16.5 FT OF 5
ZONING: RM-4, H
CITY COUNCIL DIST.: 7
DISTRICT: Monticello Park Historic District
APPLICANT: Ramiro Reyes
OWNER: Ramiro Reyes
TYPE OF WORK: Window replacement, exterior painting
APPLICATION RECEIVED: February 14, 2019
60-DAY REVIEW: April 13, 2019
REQUEST:

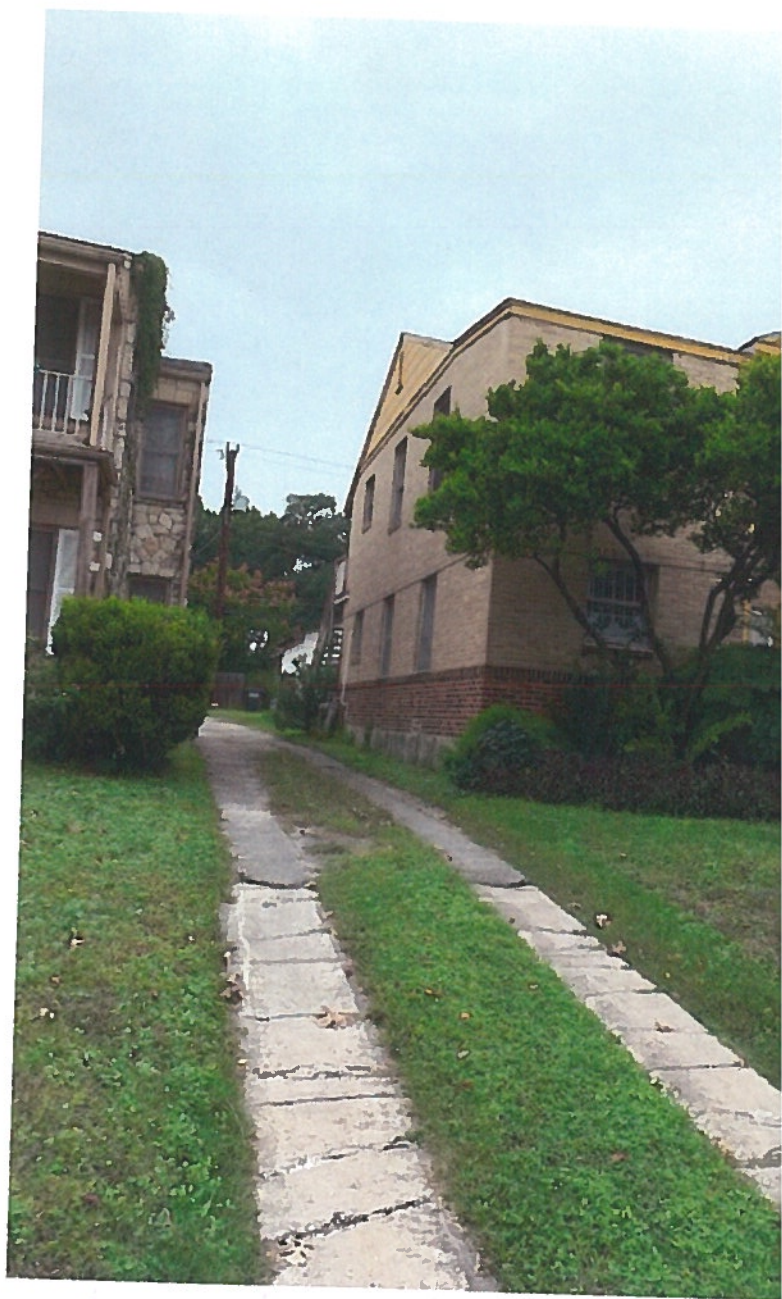
Old windows Left
Pre-Window Installation

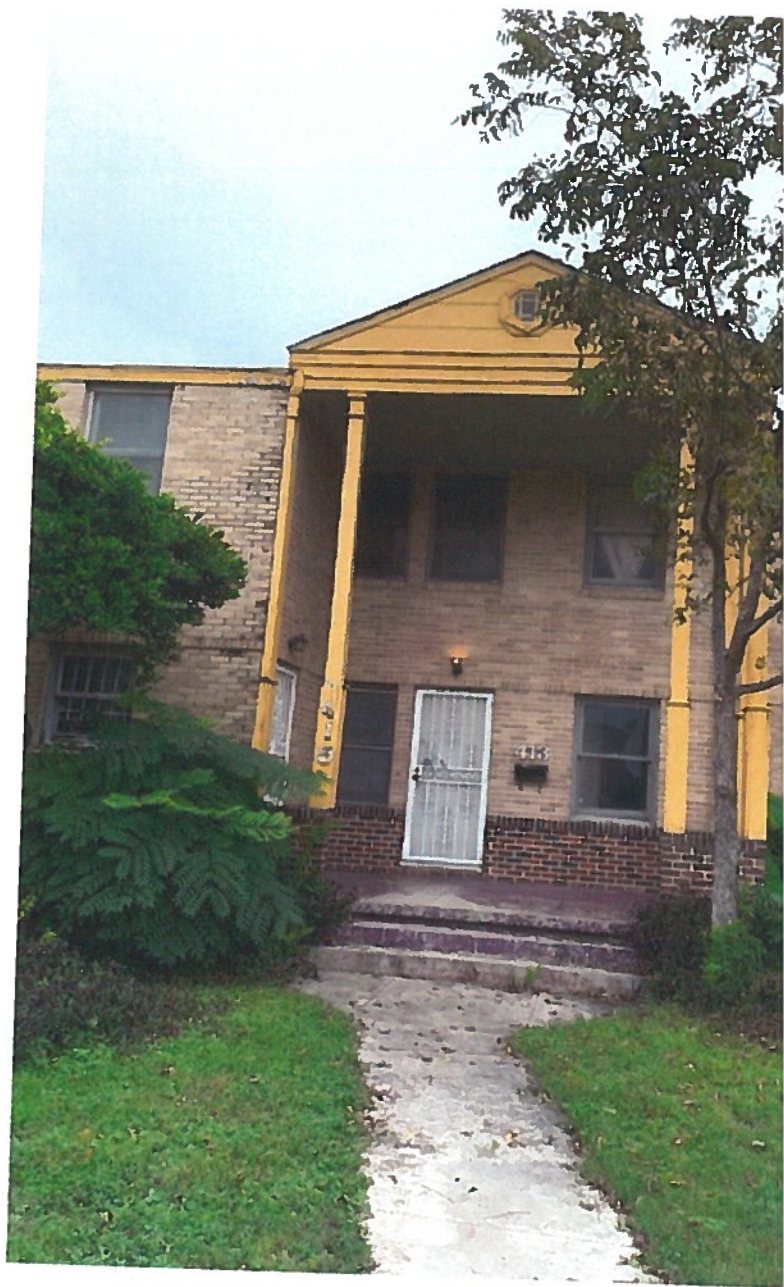
old windows Front

Pre-window Installation

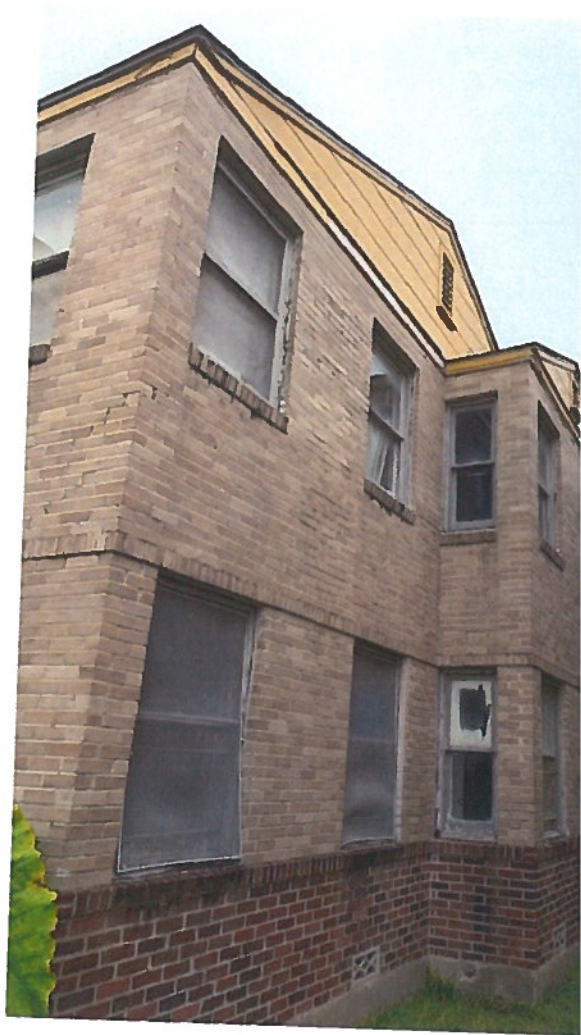
old windows

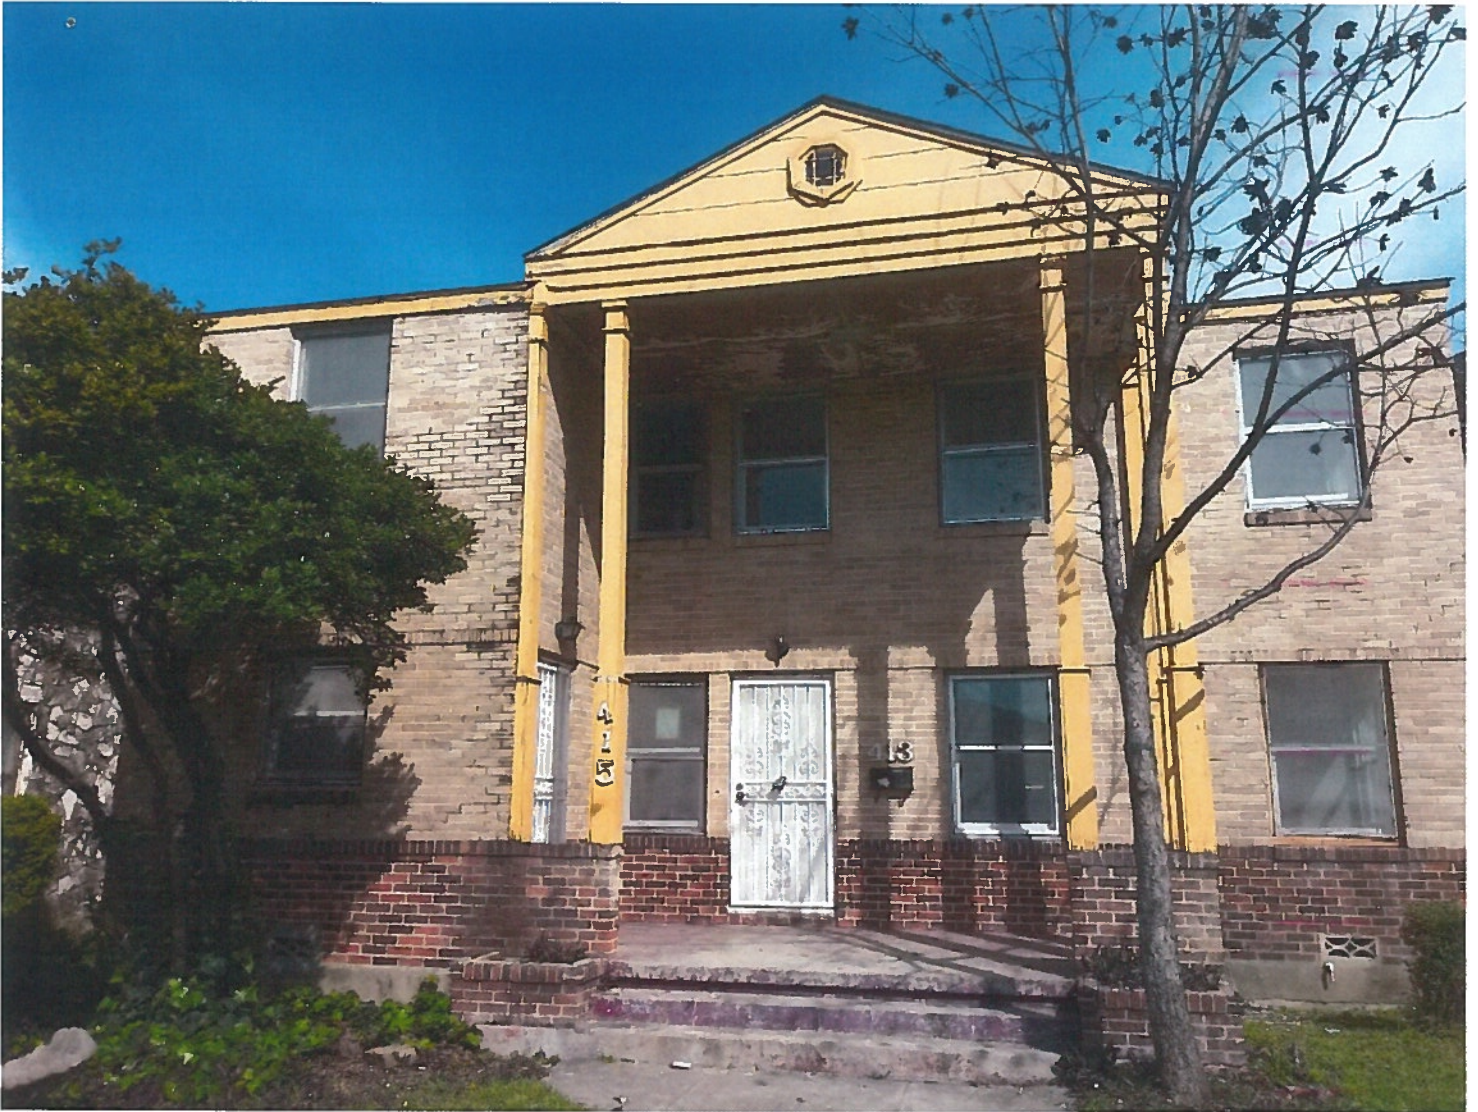
New windows Front side

Post-Window Installation

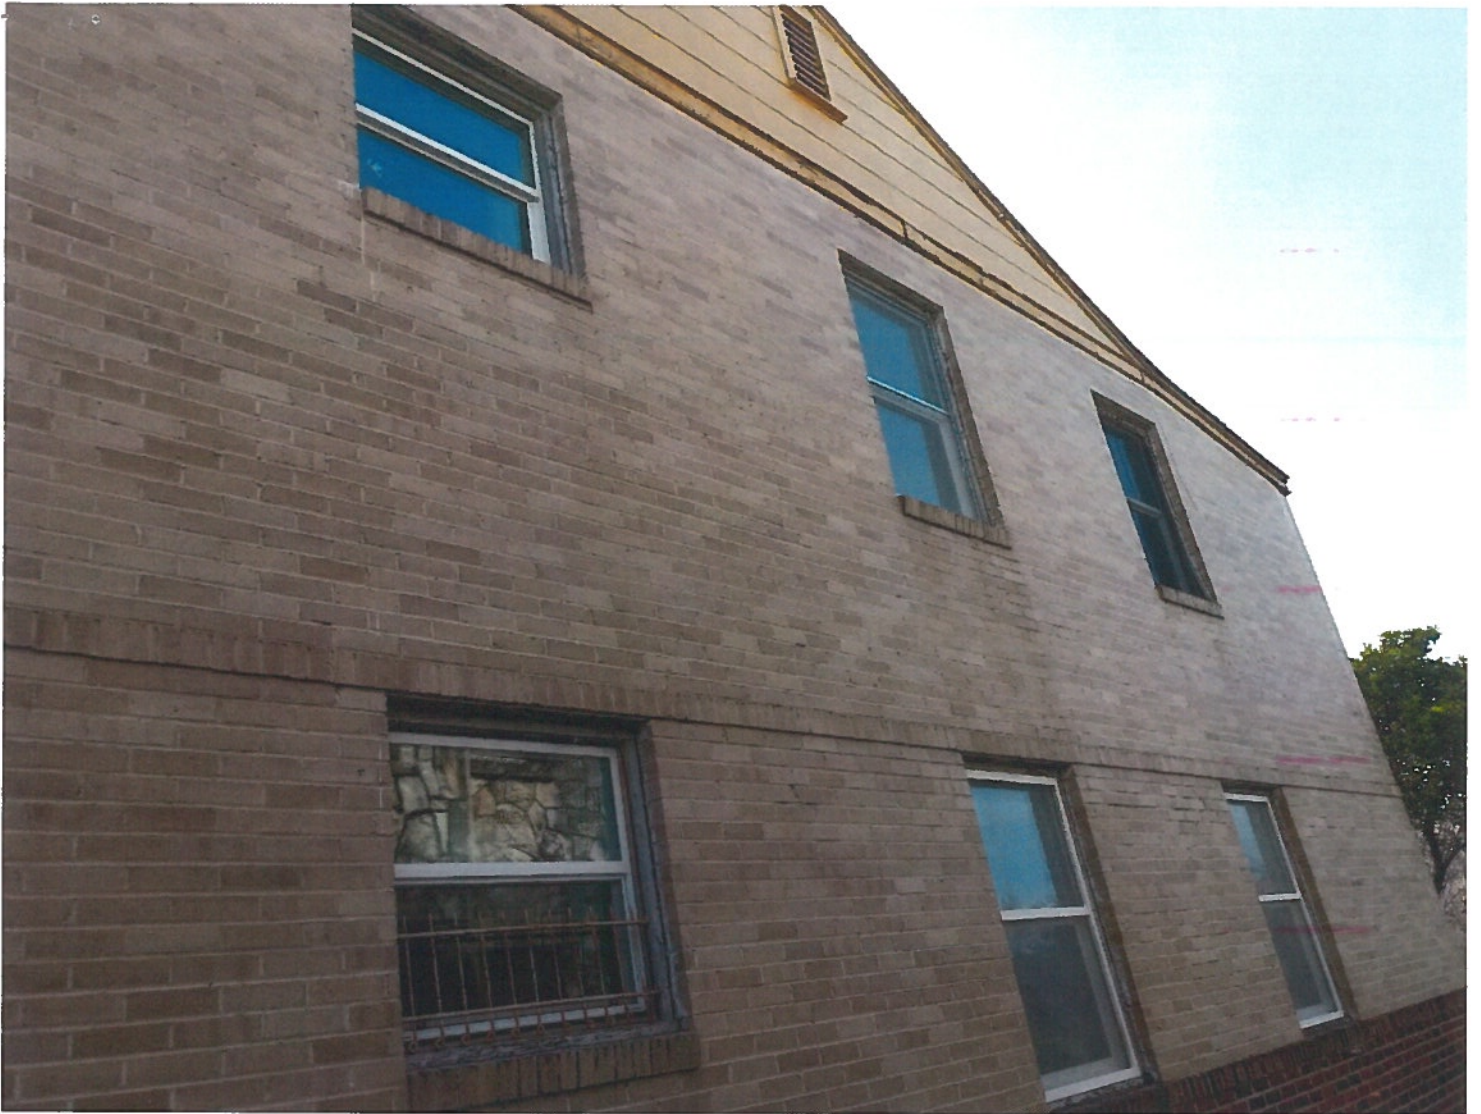
New windows left side

post - window installation

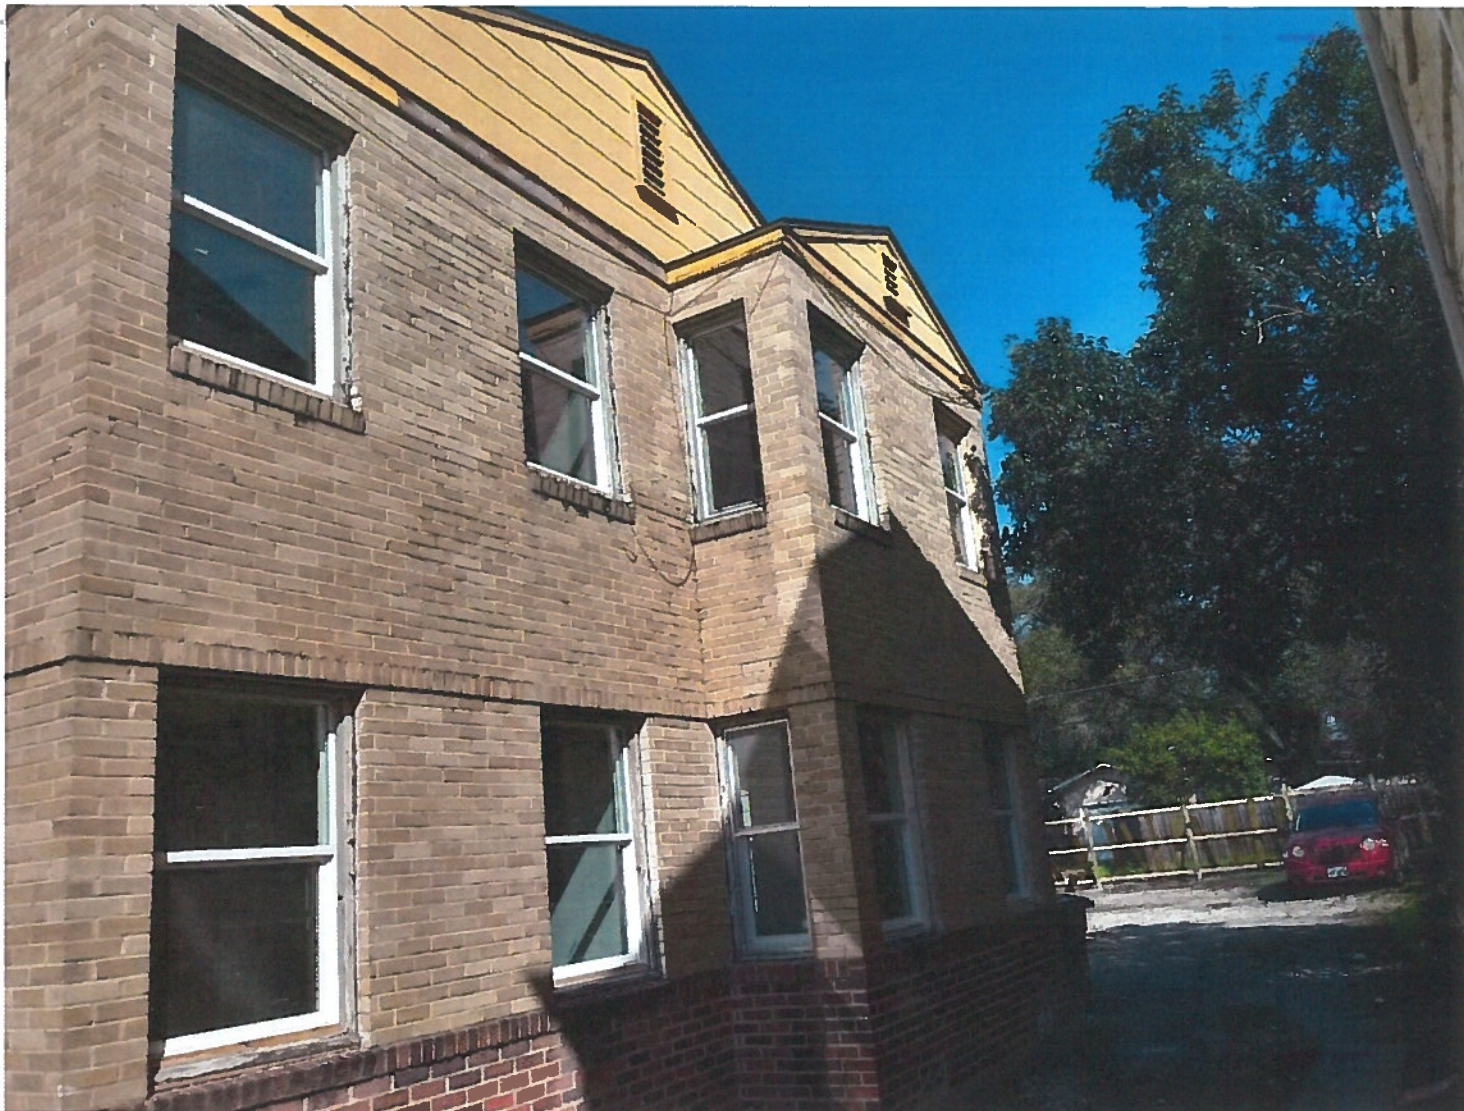
New windows Right side

post window installation

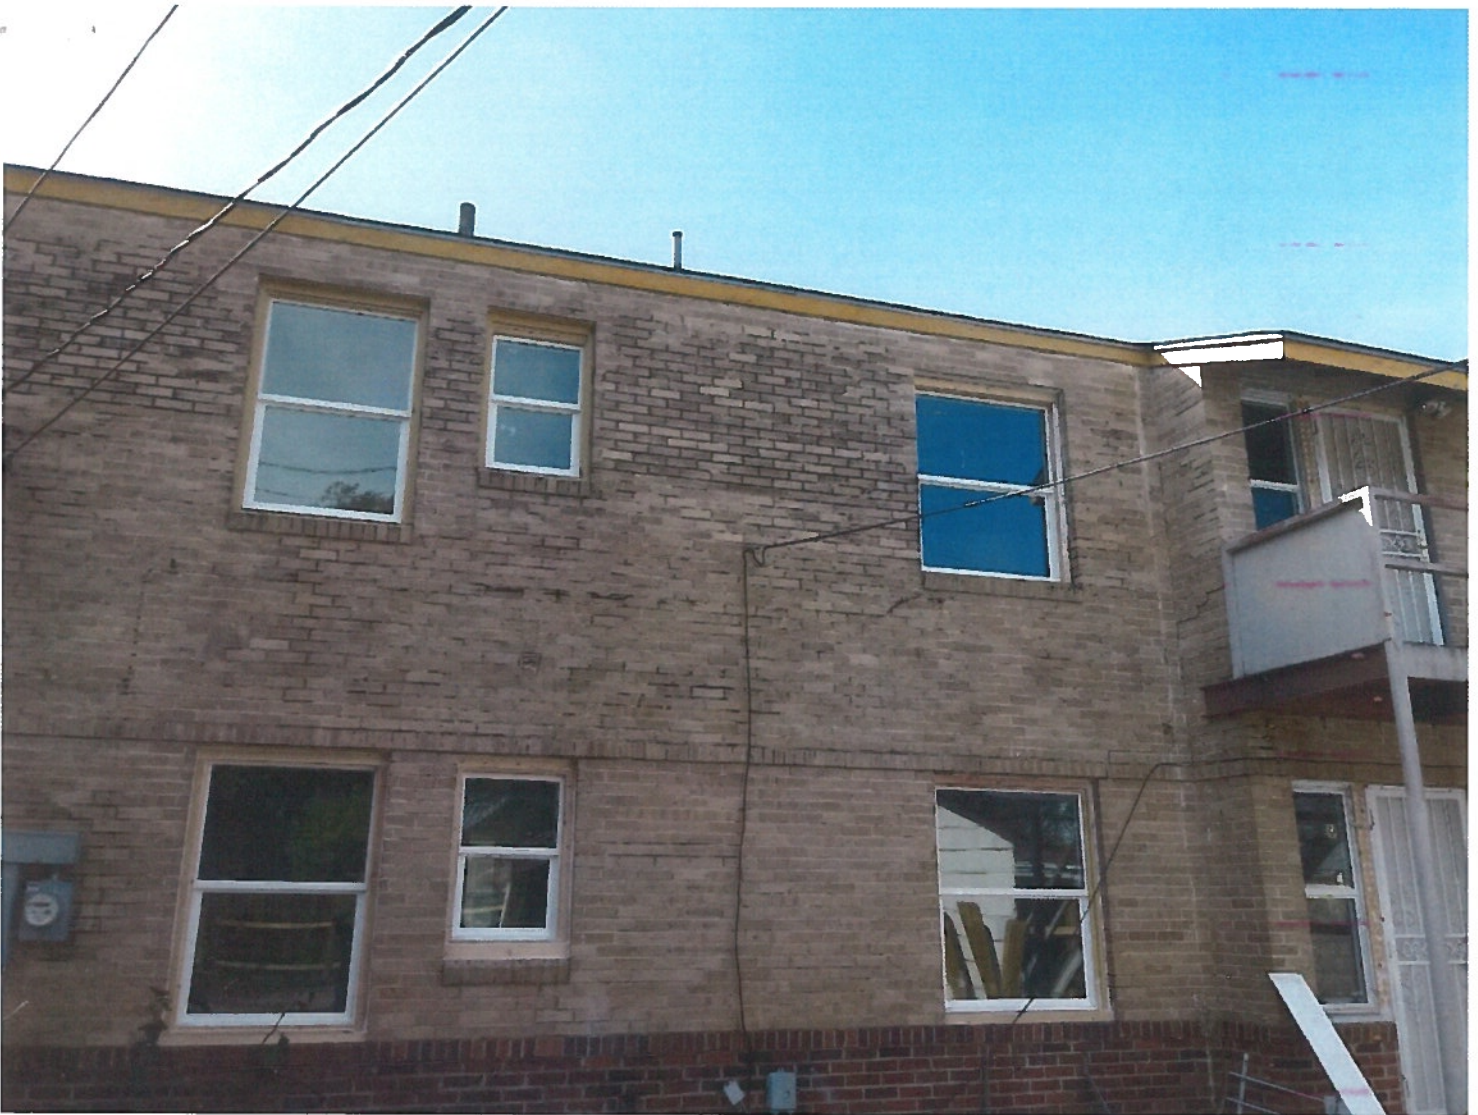
New windows back side

Post Window Installation

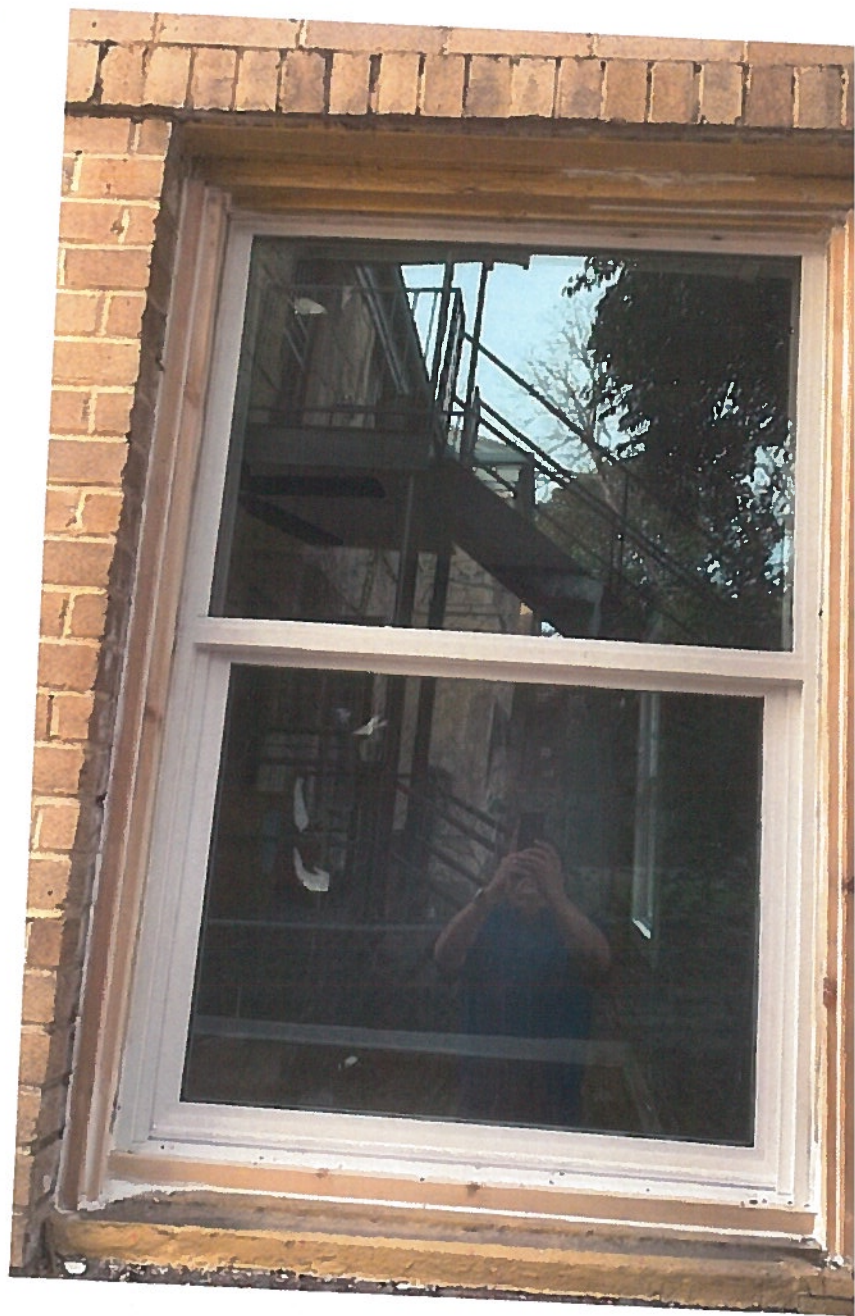
New windows

New windows w/ woodsc

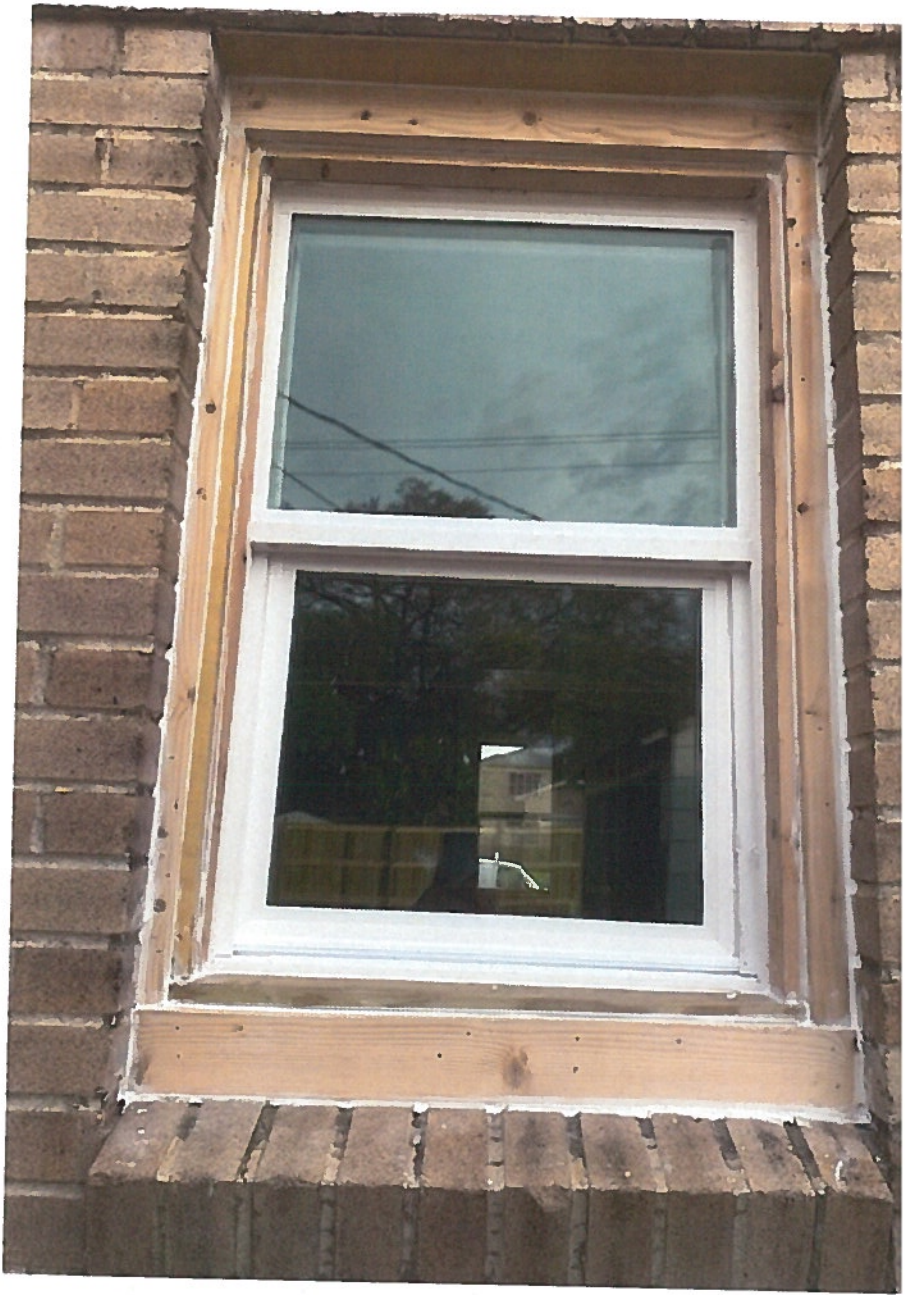
New windows w/ New trim

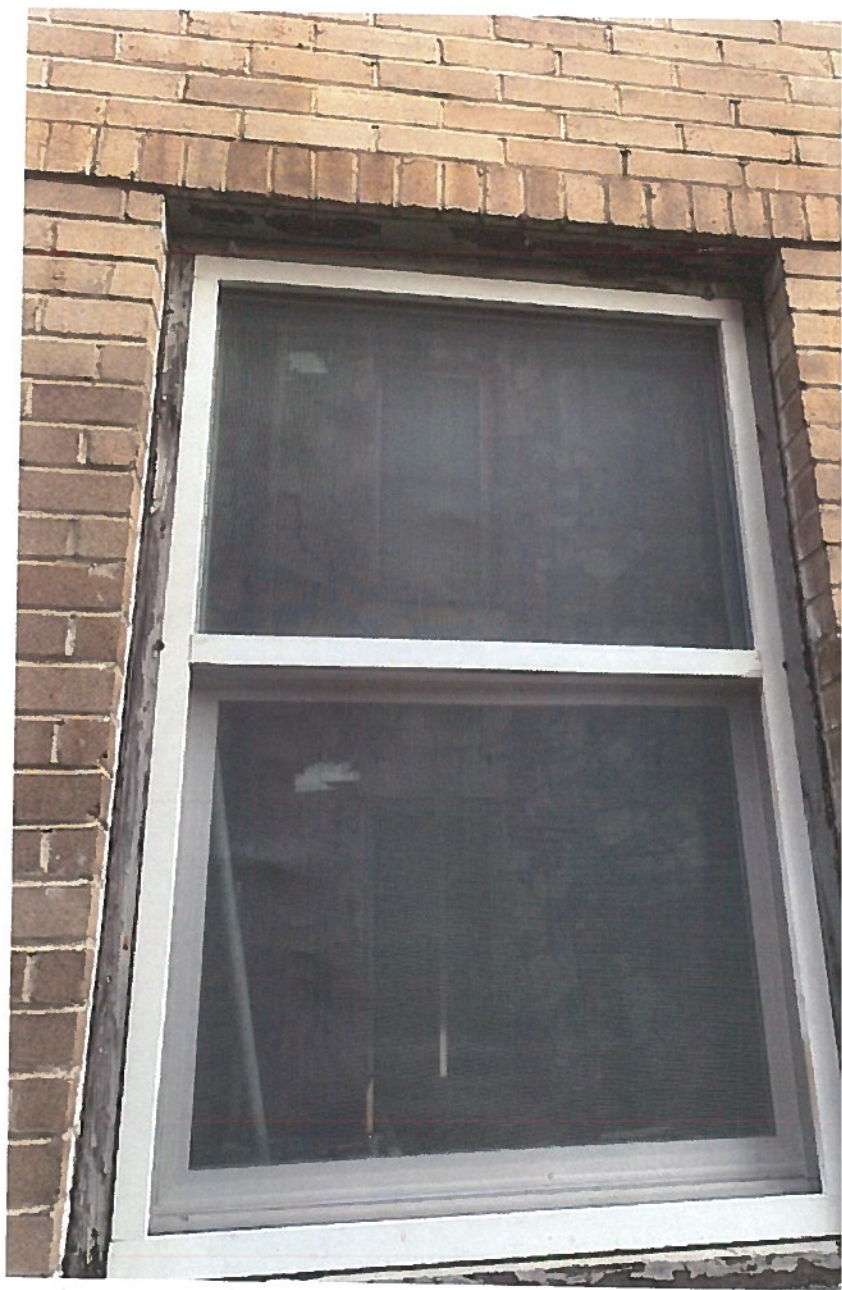
New windows
with wood screens

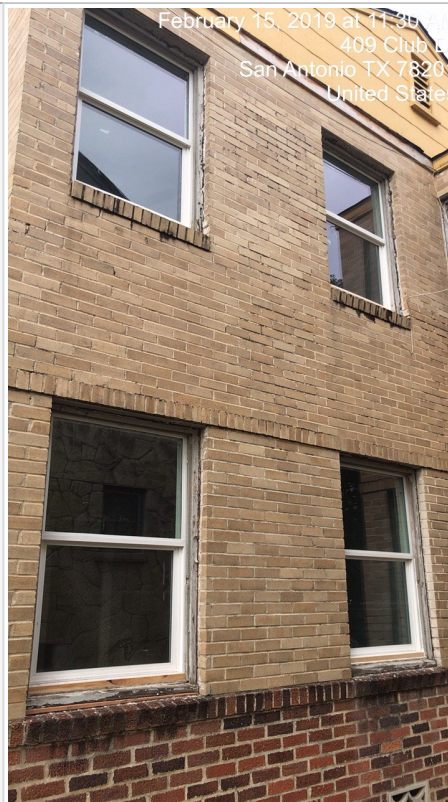
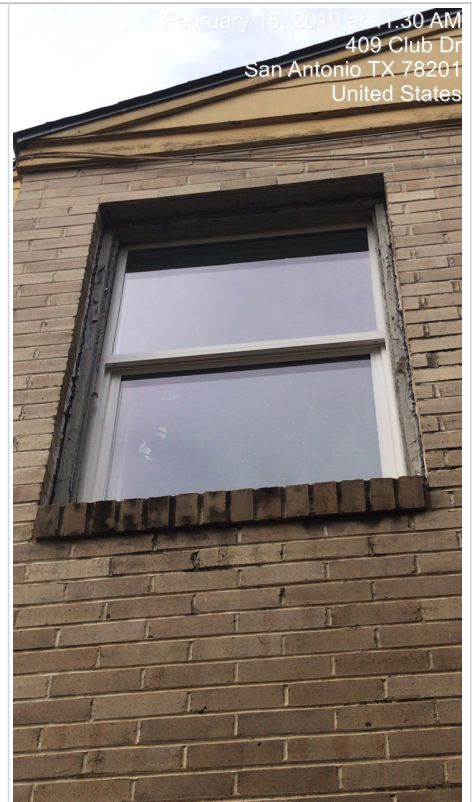
Photographs

Date	02/15/2019
Time	11:34 AM (-6 GMT)
Context	follow-up, citizen report
Present Staff	Huy Pham, Other
Present Individuals	Crew member(s)
Types of Work Observed	Exterior Maintenance and Alterations
Amount of Work Completed	75%
Description of work	Windows have been replaced with vinyl windows; some are covered with wood or aluminum screens. Some work was occurring on the rear accessory structure and interior of the property.
Description of interaction	Two crew members were on site who spoke Spanish. Staff provided a stop work order with Spanish translation and posted a Notice of Investigation on the front facade.
