HISTORIC AND DESIGN REVIEW COMMISSION

May 01, 2019

HDRC CASE NO: 2019-224
ADDRESS: 515 BURLESON ST
LEGAL DESCRIPTION: NCB 514 BLK 18 LOT 9
ZONING: R-6, H
CITY COUNCIL DIST.: 2
DISTRICT: Dignowity Hill Historic District
APPLICANT: Stephanie Padua/TexPro Painting and Renovations
OWNER: Patricia Gonzales
TYPE OF WORK: Window replacement, porch steps replacement, paint
APPLICATION RECEIVED: April 16, 2019
60-DAY REVIEW: June 15, 2019
CASE MANAGER: Huy Pham

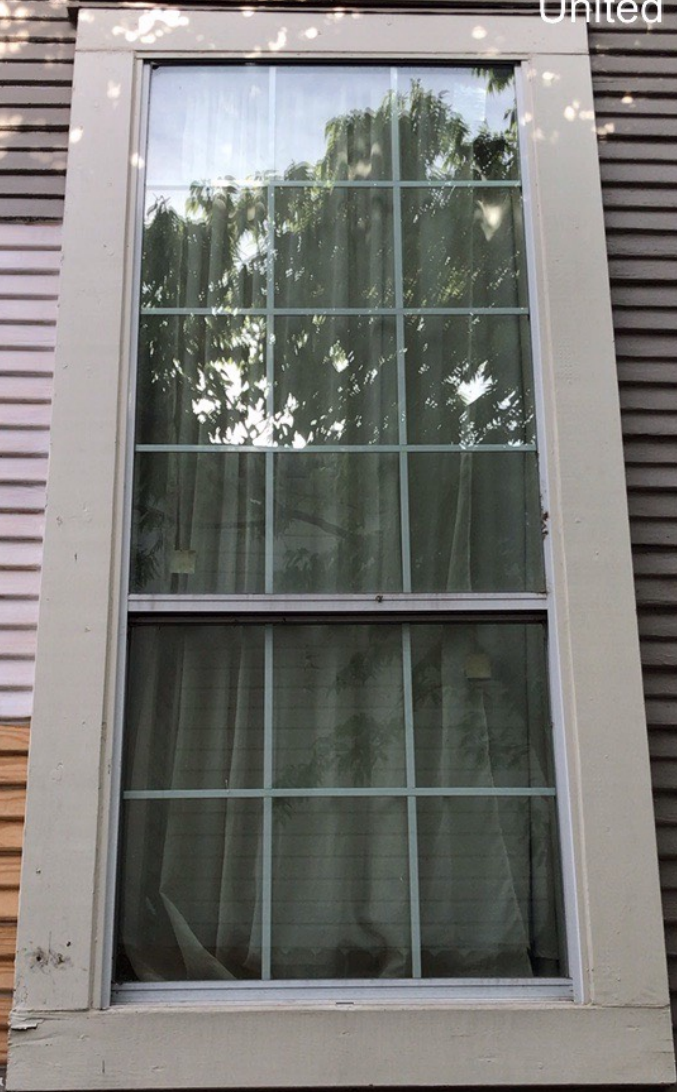
EXISTING NON-CONFORMING MODIFICATION
(BEFORE 2017)

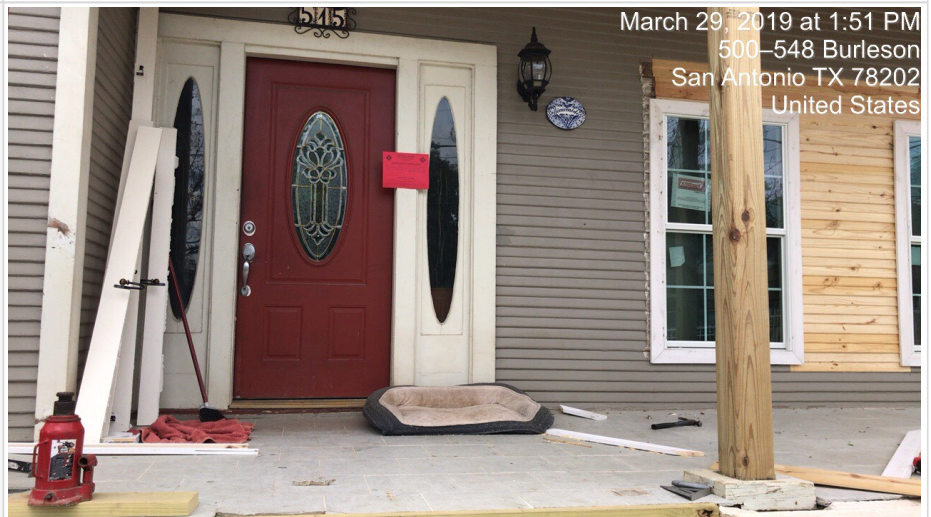
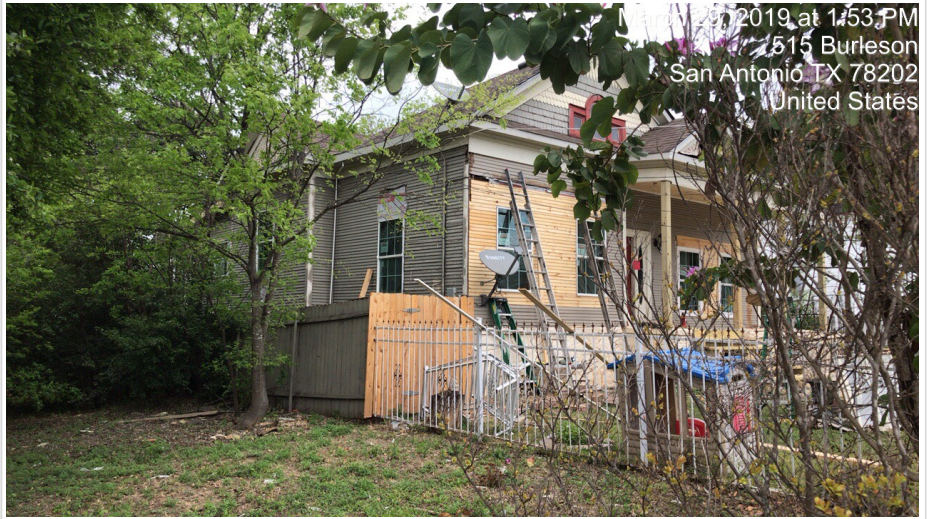
Date	03/29/2019
Time	01:47 PM (-5 GMT)
Context	drive-by
Present Staff	Huy Pham, Adam Rajper
Present Individuals	None
Types of Work Observed	Exterior Maintenance and Alterations
Amount of Work Completed	75%
Description of work	Window replacement on nearly all windows, front porch modifications to skirting and columns. Wood windows sashes are visible in the front yard and rear of driveway.
