## HISTORIC AND DESIGN REVIEW COMMISSION

May 01, 2019

**HDRC CASE NO:** 2019-225  
**ADDRESS:** 314 MISSION ST  
**LEGAL DESCRIPTION:** NCB 944 BLK 1 LOT 31  
**ZONING:** RM-4  
**CITY COUNCIL DIST.:** 1  
**DISTRICT:** King William Historic District  
**APPLICANT:** Isabelle Robledo  
**OWNER:** Jose Robledo  
**TYPE OF WORK:** Front porch, door replacement, exterior modifications to addition  
**APPLICATION RECEIVED:** April 16, 2019  
**60-DAY REVIEW:** June 15, 2019  
**CASE MANAGER:** Huy Pham

# 314 Mission St

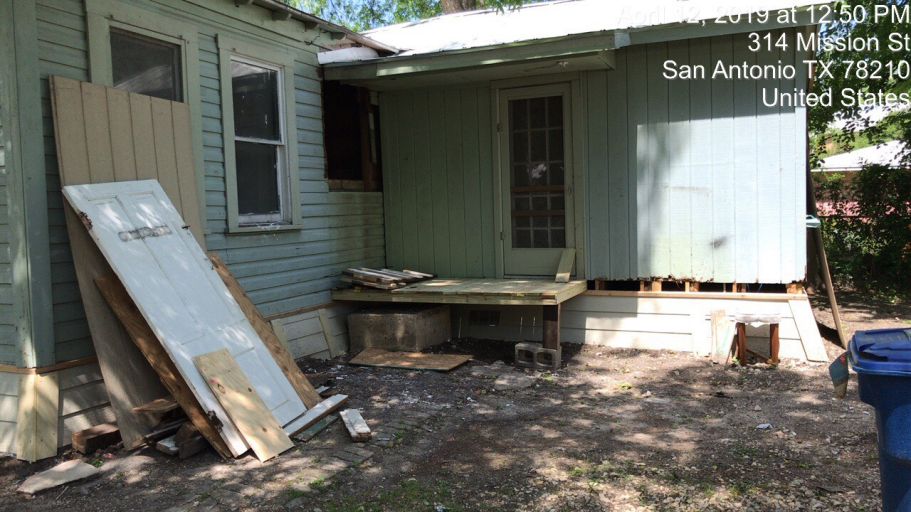
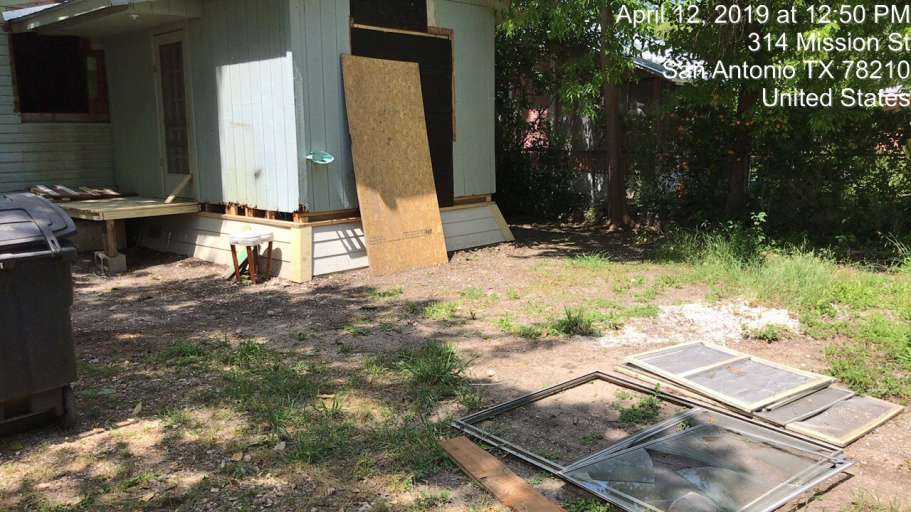
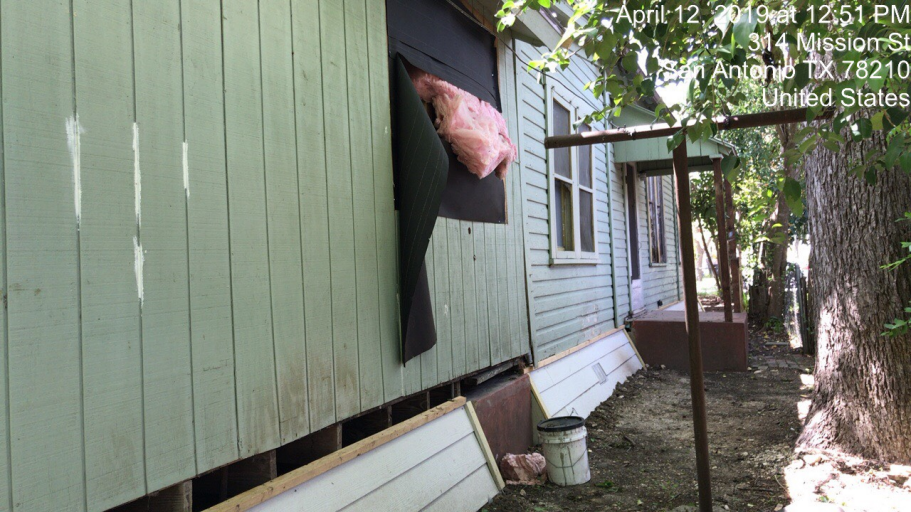
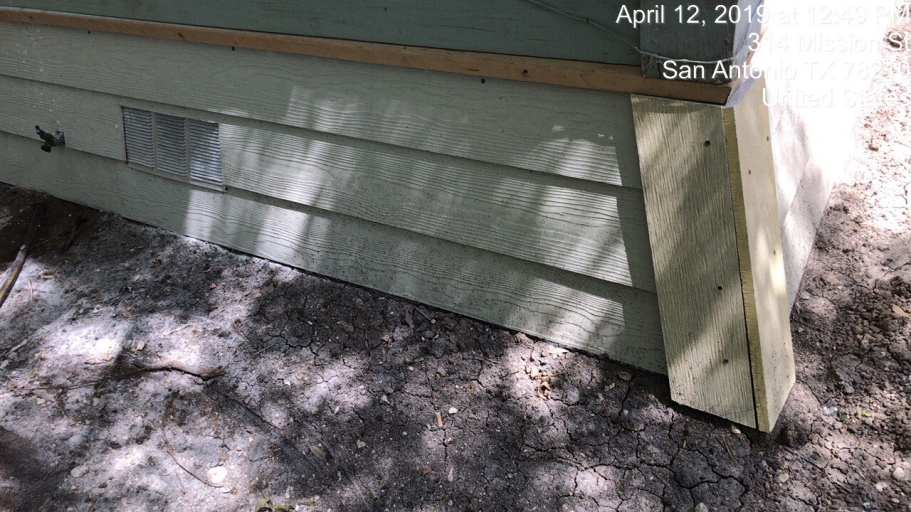
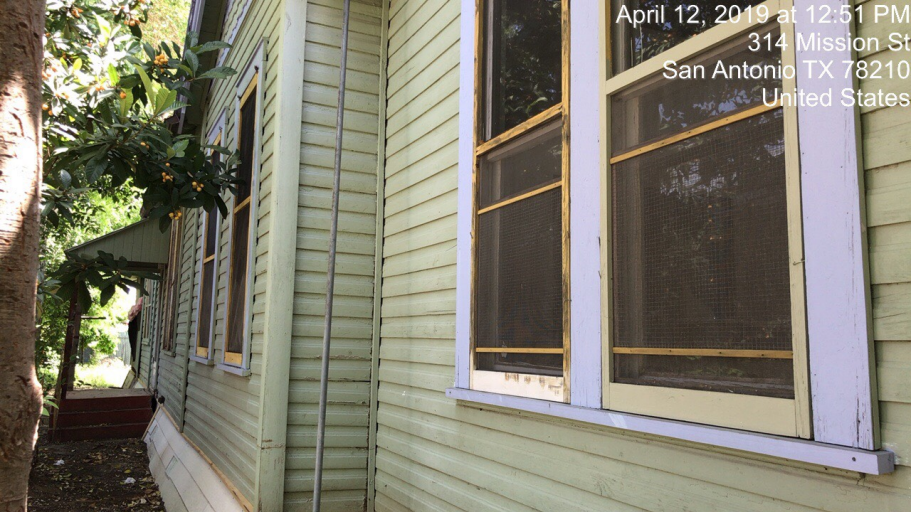
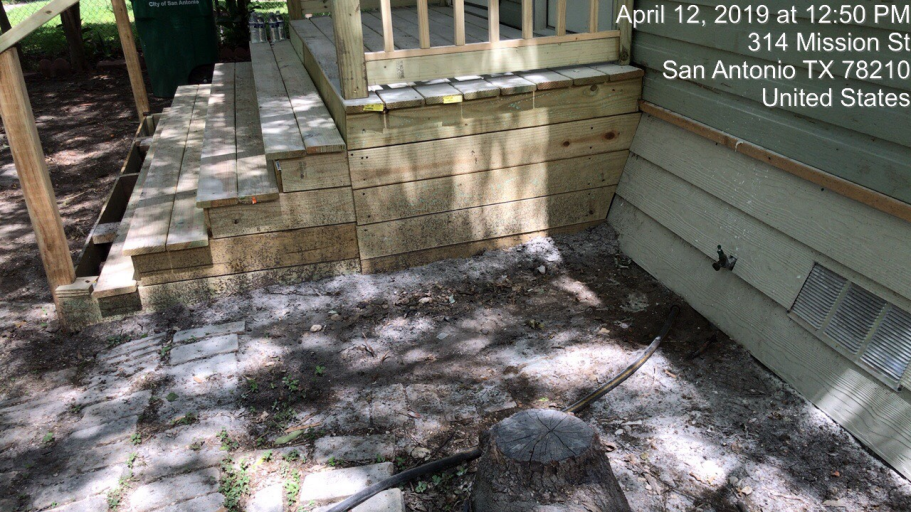
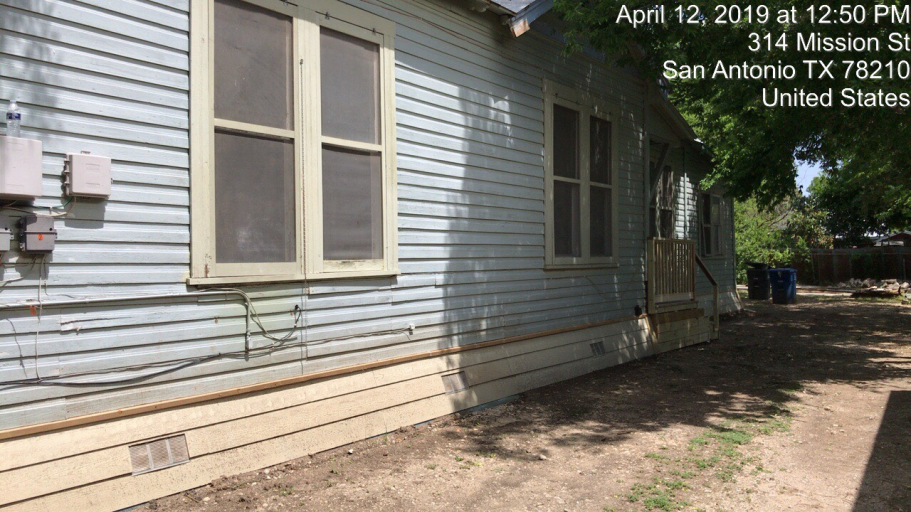
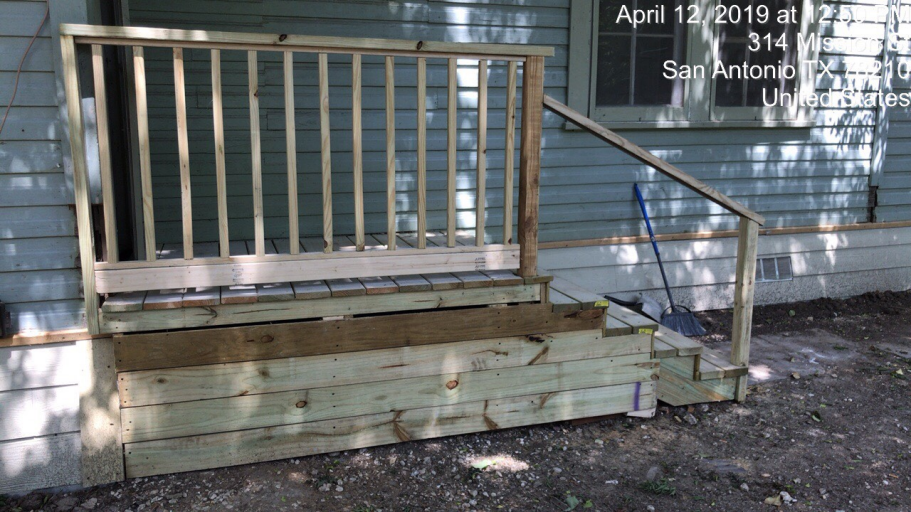
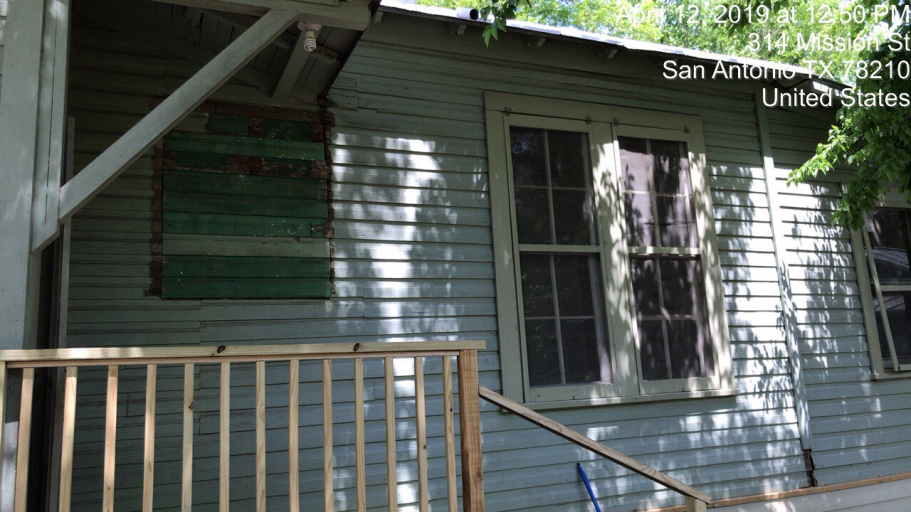
- b. **WORK WITHOUT APPROVAL:** On a site visit conducted on April 12, 2019, staff found that the front porch had been modified including replacement of the doors, decking and steps, columns, and new railing, as well as the installation of tapered skirting with Hardie board with faux wood grain texture and rear window removal. A previous applicant had received administrative approval for foundation repair with no changes to skirting in November 2018. The current applicant/owners have not been cooperative to providing additional photos or drawings to staff to prepare for the commission hearing.

- c. **FRONT PORCH** – Prior to work without approval, the front porch featured wrought iron columns, a plywood cover and wood steps over a concrete slab – which staff finds is not original to the structure. However, per the Guideline 7.B.v. porches, balconies, and porte-cocheres should be reconstructed based on accurate evidence of the original, such as photographs, if no such evidence exists, the design should be based on the architectural style of the building and historic patterns. Staff finds that the proposed wood porch reconstruction is generally appropriate as a simplified interpretation of a historic porch of this style and scale. However, staff finds that the deck should feature tongue-and-groove decking with 1 inch in height and 3 feet in width and that the skirting should match the siding of original portions of the house ; an updated drawing should be submitted to staff.

- d. **SKIRTING** – Prior to work without approval, the foundation featured exposed concrete slab with some portions covered with continuous aluminum panels. The applicant has proposed to install tapered skirting with Hardie siding with faux wood grain texture. The Guidelines 8.B. notes: ensure that features such as decorative vents and grilles and lattice panels are replaced in-kind when deteriorated beyond repair; when in-kind replacement is not possible, use features matching in size, material, and design; replacement skirting should consist of durable, proven materials, and should either match the existing siding or be applied to have minimal visual impact. Staff finds the proposed installation is inconsistent with the Guidelines. Appropriate solutions include: removal the tapered skirting to expose the simply concrete slab, install smooth Hardie skirting without a taper or faux wood grain, or continuing the wood siding down to grade.

- e. **WINDOW REMOVAL** – The applicant has proposed to remove a window opening in the rear. Per the Guidelines 6.A.i., window openings should not be filled in or removed. Staff finds the proposal is inconsistent with the Guidelines.

Staff recommends approval of porch reconstruction with the stipulation that the deck features wood tongue-and-groove decking with a profile typical of historic porches and to submit a measured drawing prior to installation.

Staff does not recommend skirting modifications or window removal based on finding d and e. Staff recommends removal the tapered skirting to expose the simply concrete slab, install smooth Hardie skirting without a taper or faux wood grain, or continuing the wood siding down to grade. All remaining unapproved items should be reversed.

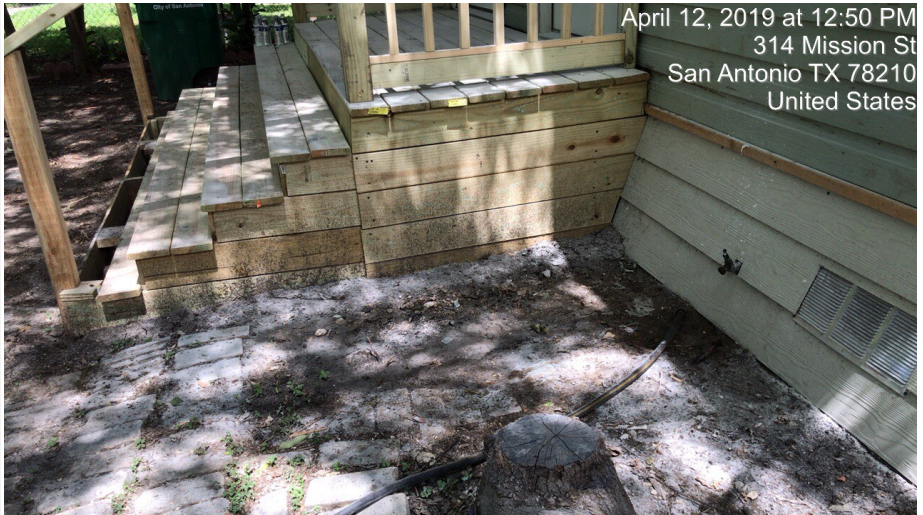
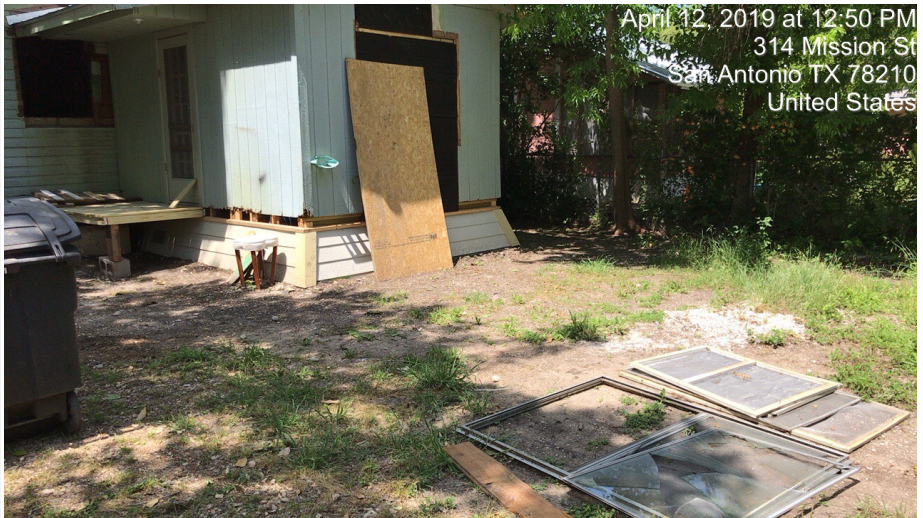
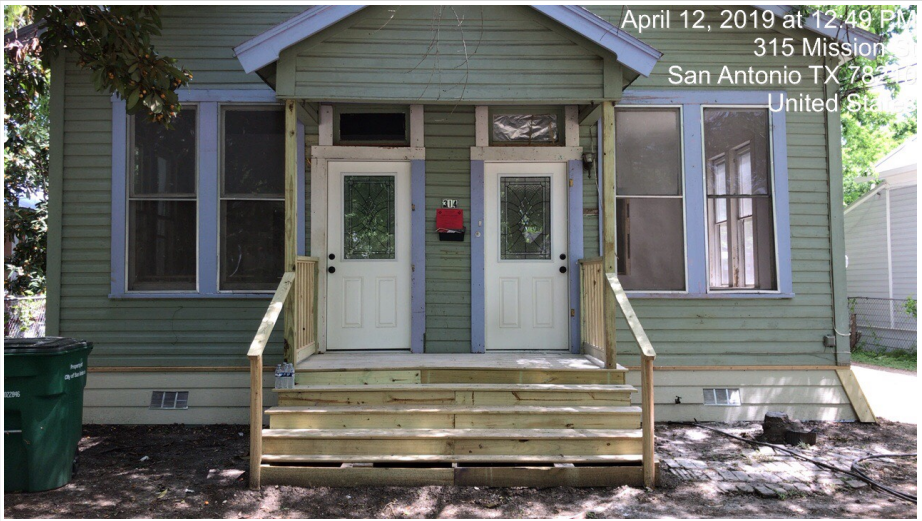
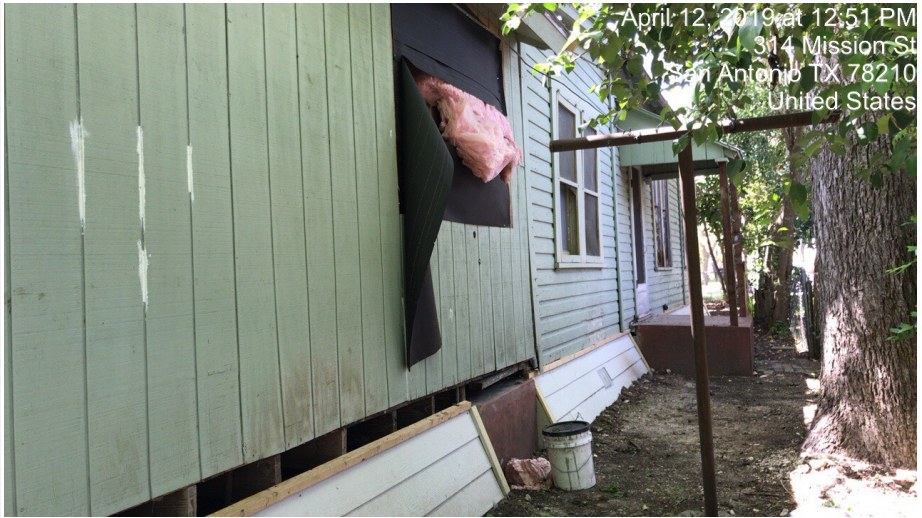
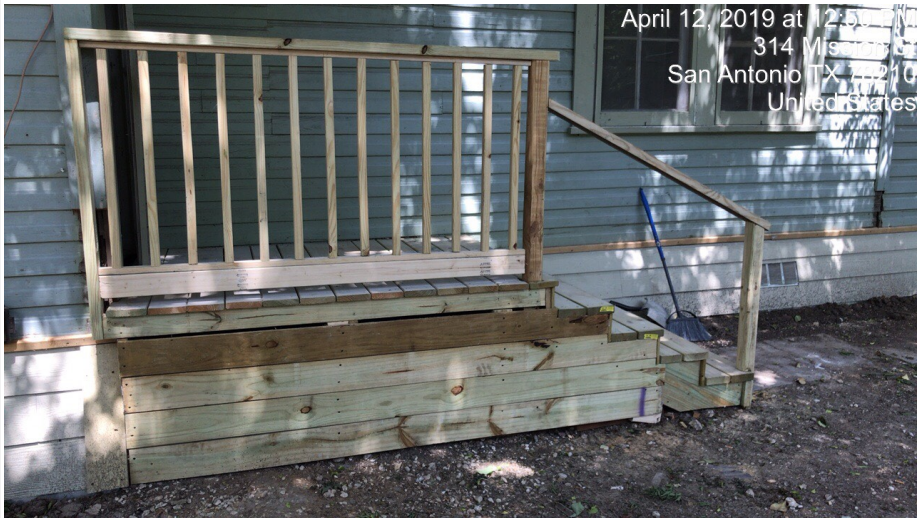
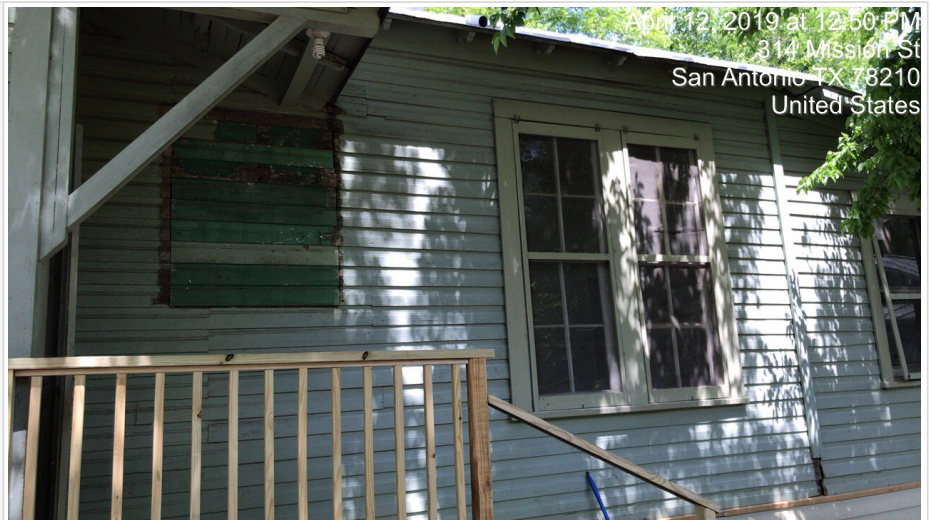
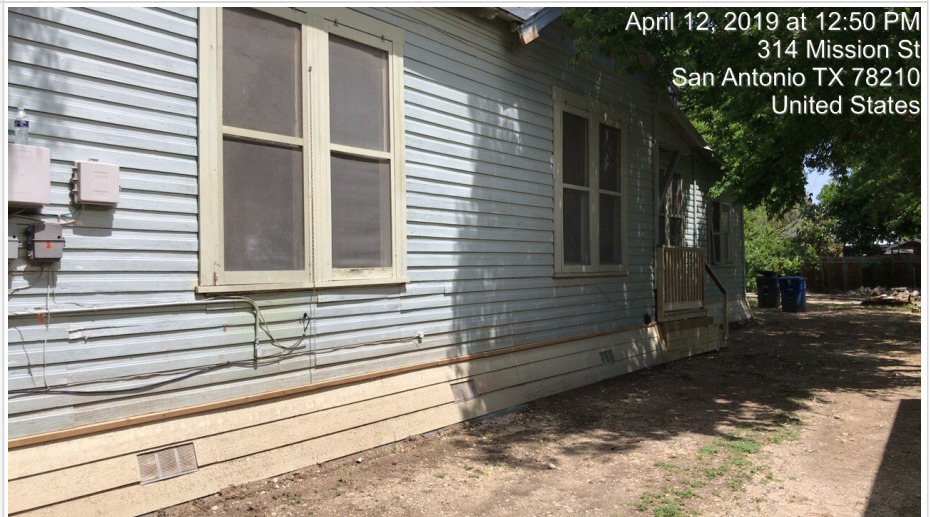
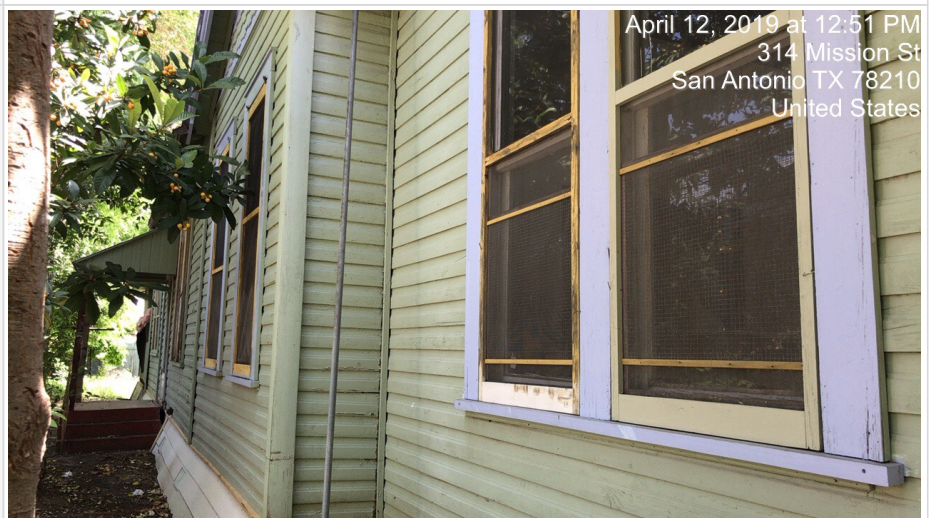
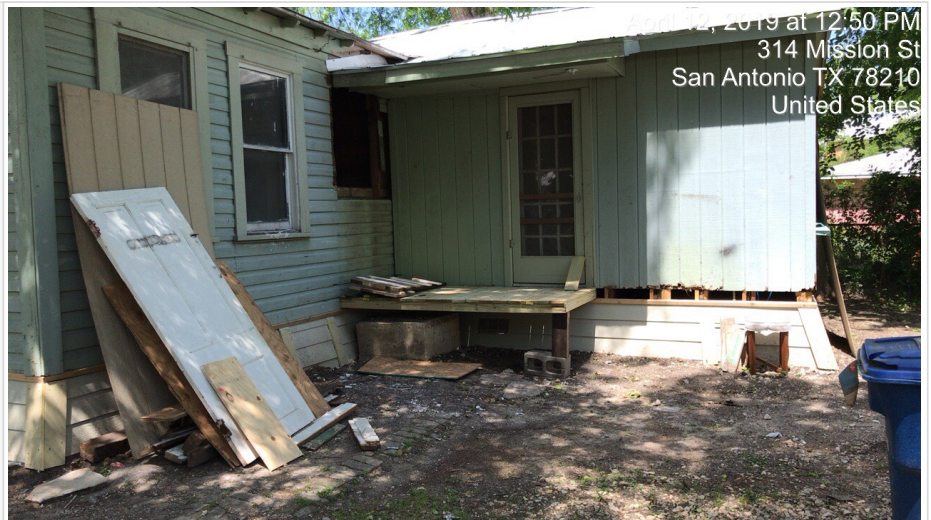
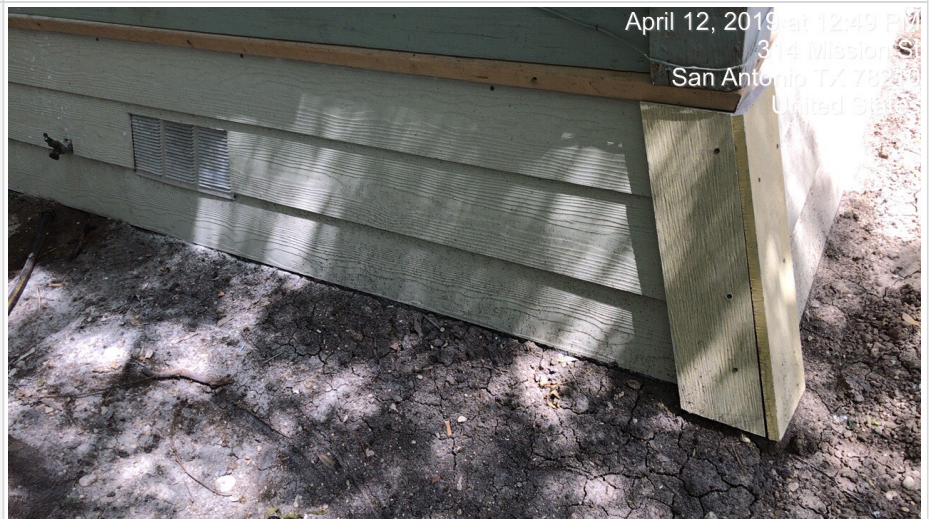
Documentation

Date	04/12/2019
Time	12:45 PM (-5 GMT)
Context	citizen report
Present Staff	Huy Pham, Adam Rajper
Present Individuals	None
Types of Work Observed	Exterior Maintenance and Alterations
Amount of Work Completed	Completed
Description of work	Door replacement of two front doors with faux ornamental lights, construction of a rear addition including removal of window openings in rear, foundation Hardi skirting faux wood grain texture.
Description of interaction	Two interior remodeling contractors were in the driveway and will forward the violation to the owner.

Violation Type	No Certificate of Appropriateness (Code 35-451a)
OHP Action	Spoke with contractor(s)
Will post-work application fee apply?	Yes
