HISTORIC AND DESIGN REVIEW COMMISSION

June 05, 2019

HDRC CASE NO: 2019-302
ADDRESS: 131 ADAMS ST
LEGAL DESCRIPTION: NCB 931 BLK 1 LOT 15
ZONING: RM-4, H
CITY COUNCIL DIST.: 1
DISTRICT: King William Historic District
APPLICANT: Daniel Sexton /Buffalo Contracting
OWNER: Beverley Bunn/BEAVER MEADOWS II LLC
TYPE OF WORK: Front door replacement
APPLICATION RECEIVED: May 14, 2019
60-DAY REVIEW: July 13, 2019
CASE MANAGER: Huy Pham
REQUEST:

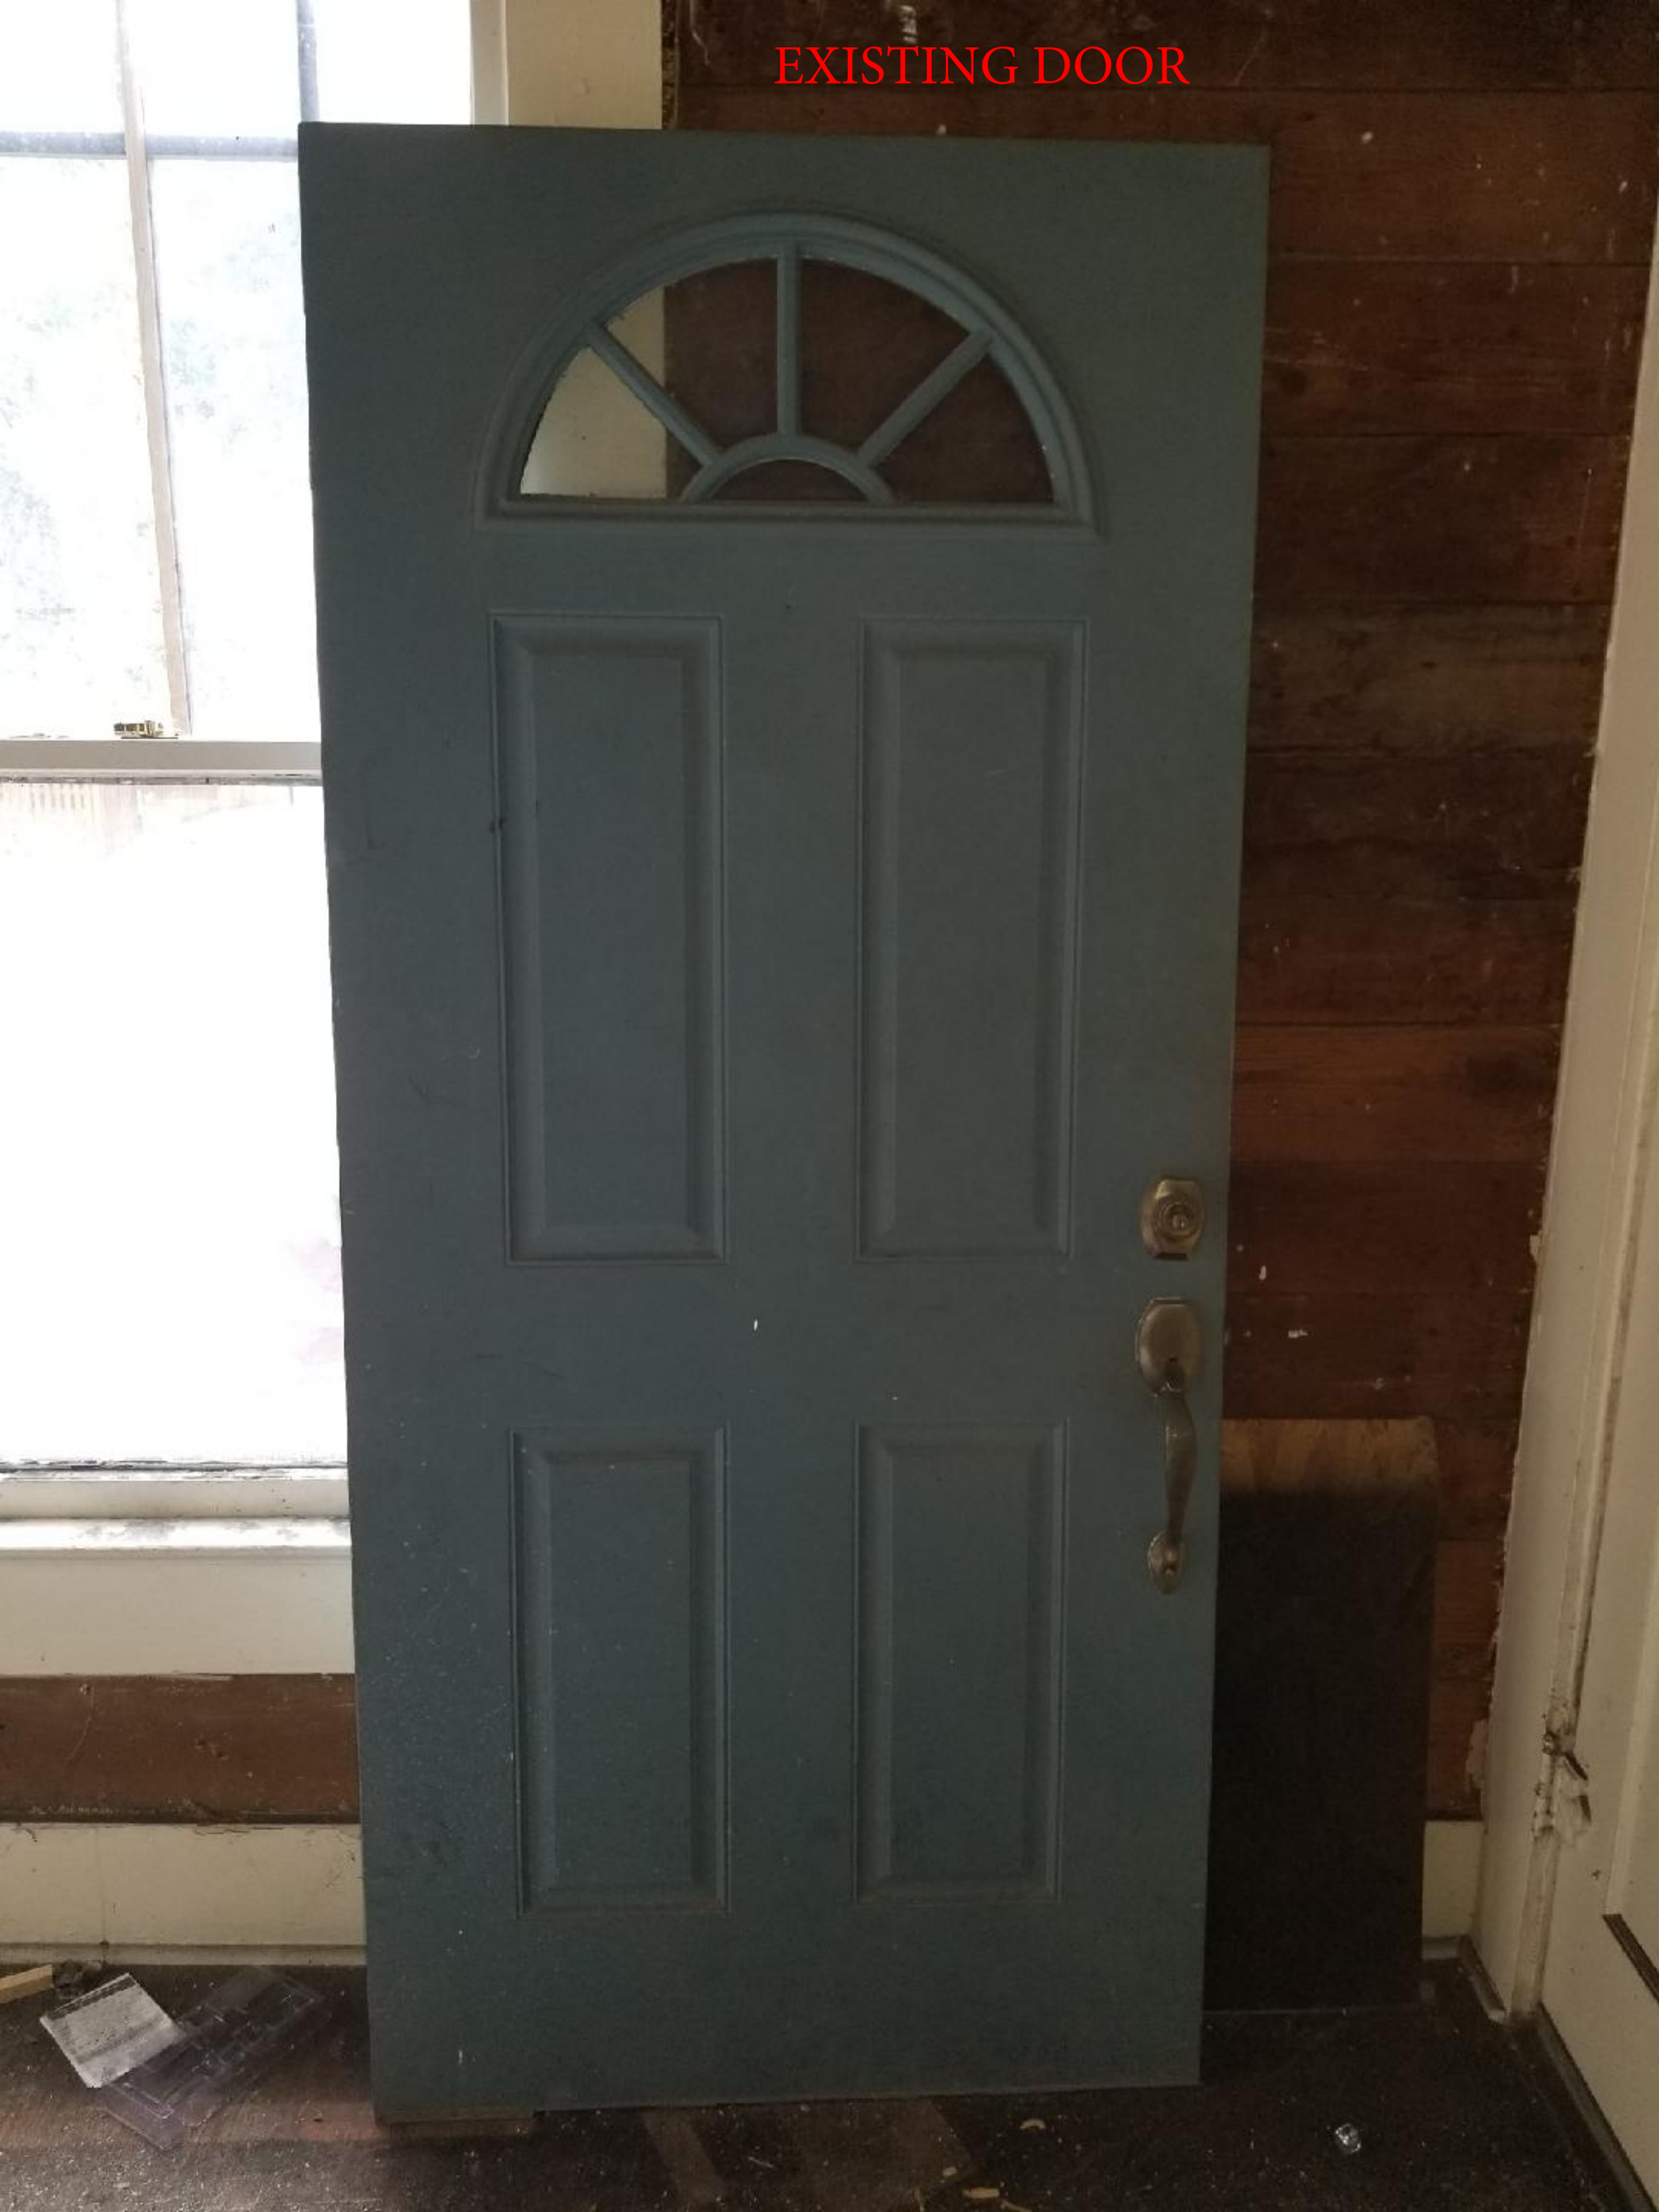
EXISTING DOOR

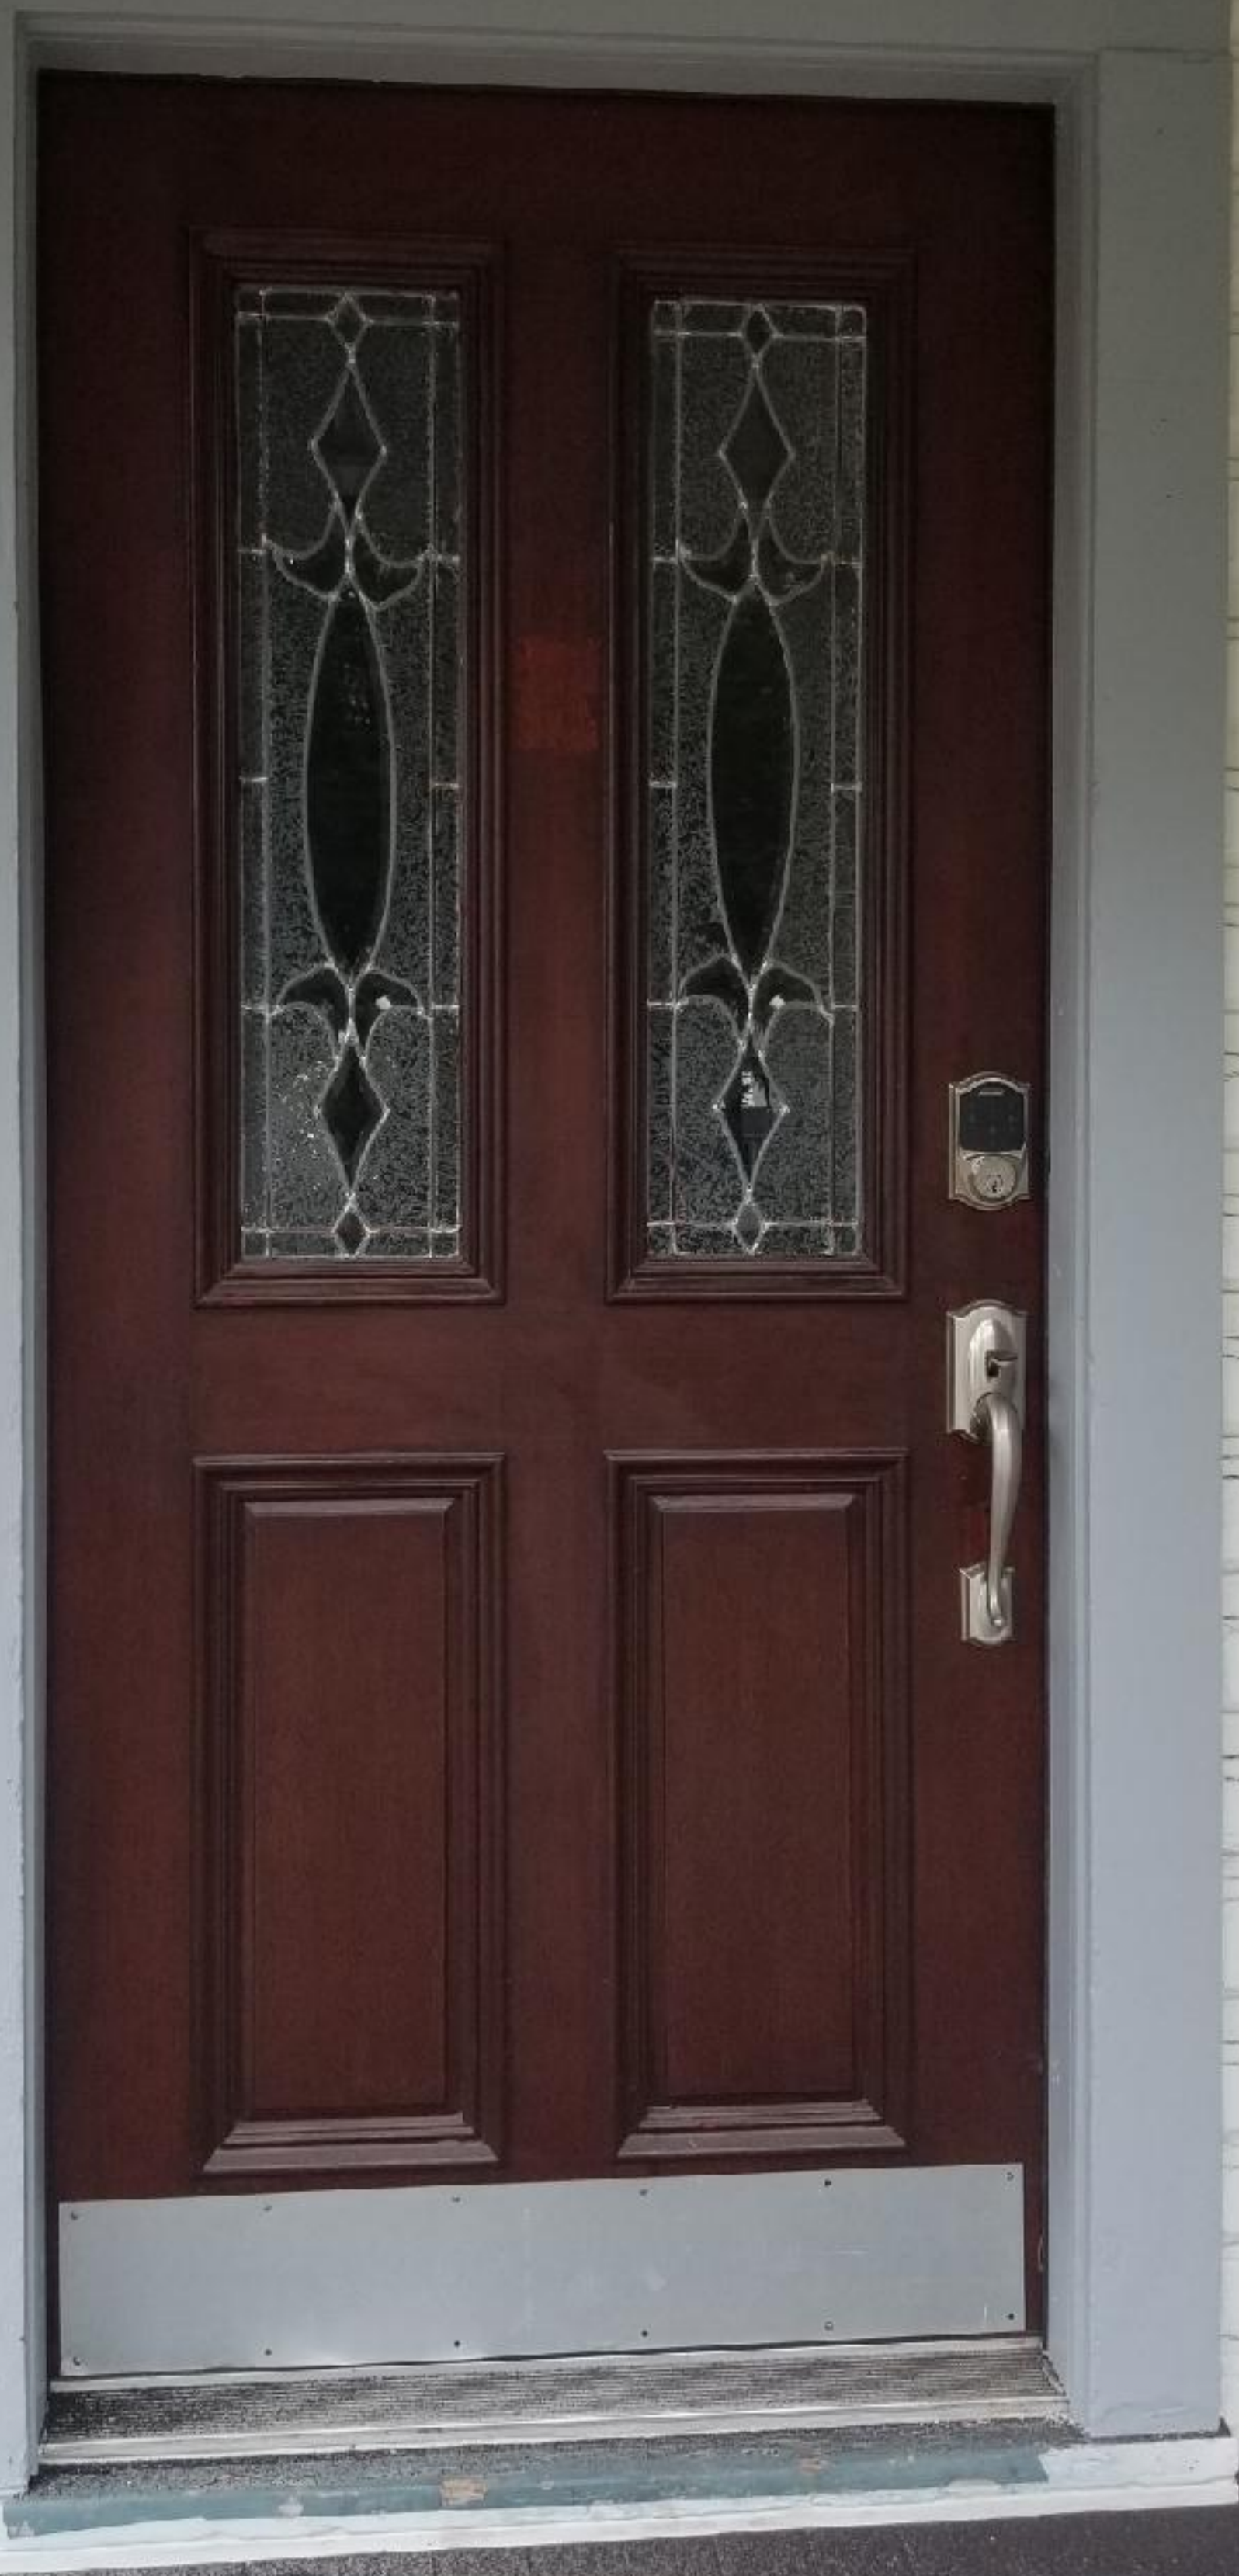
- c. **DOOR REPLACEMENT** – The applicant has proposed to replace the existing, wood fan lite door with a wood door featuring ornamental rectangular lites and a metal kick plate. Per the Guidelines for Exterior Maintenance and Alterations 6.B.i., doors should be replaced in-kind when possible and when deteriorated beyond repair. When in-kind replacement is not feasible, ensure features match the size, material, and profile to the historic element. Staff finds that the existing door is not original to the structure and may be replaced with an appropriate style door. The proposed door is a departure from the American Foursquare/Craftsman style of the structure.

PROPOSED DOOR, INSTALLED PRIOR TO APPROVAL

Staff recommends approval of door replacement based on finding c with the stipulation that a door style that is appropriate to the American Foursquare/Craftsman style is submitted to staff for verification.
