HISTORIC AND DESIGN REVIEW COMMISSION

June 05, 2019

HDRC CASE NO: 2019-310
ADDRESS: 1431 W ROSEWOOD AVE
LEGAL DESCRIPTION: NCB 2766 BLK 71 LOT 17 AT 1431 ROSEWOOD AVE W
ZONING: R-4,H
CITY COUNCIL DIST.: 1
DISTRICT: Keystone Park Historic District
APPLICANT: Paul Peralez
OWNER: Paul Peralez/PERALEZ PAUL A & RAMOS MOSES
TYPE OF WORK: Window replacement
APPLICATION RECEIVED: May 13, 2019
60-DAY REVIEW: July 12, 2019
CASE MANAGER: Stephanie Phillips
REQUEST:

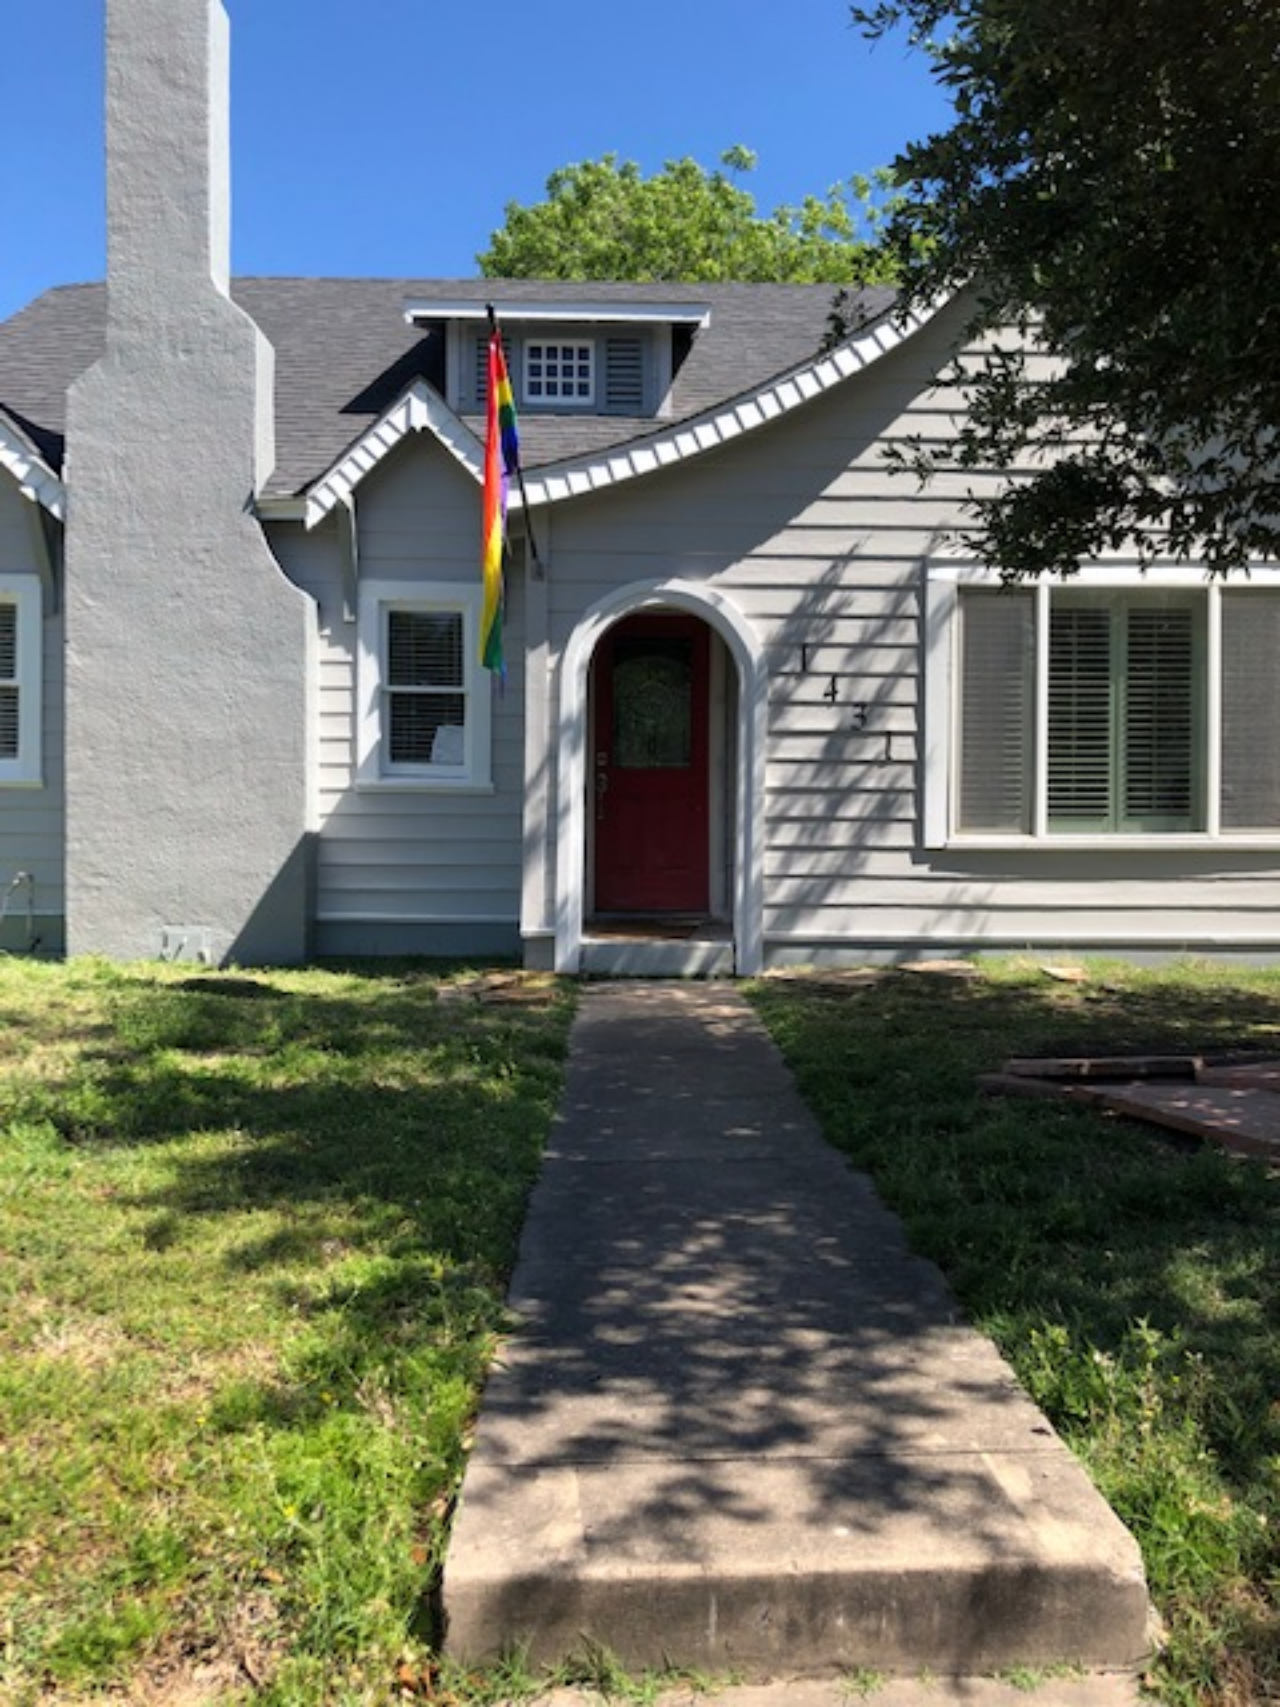
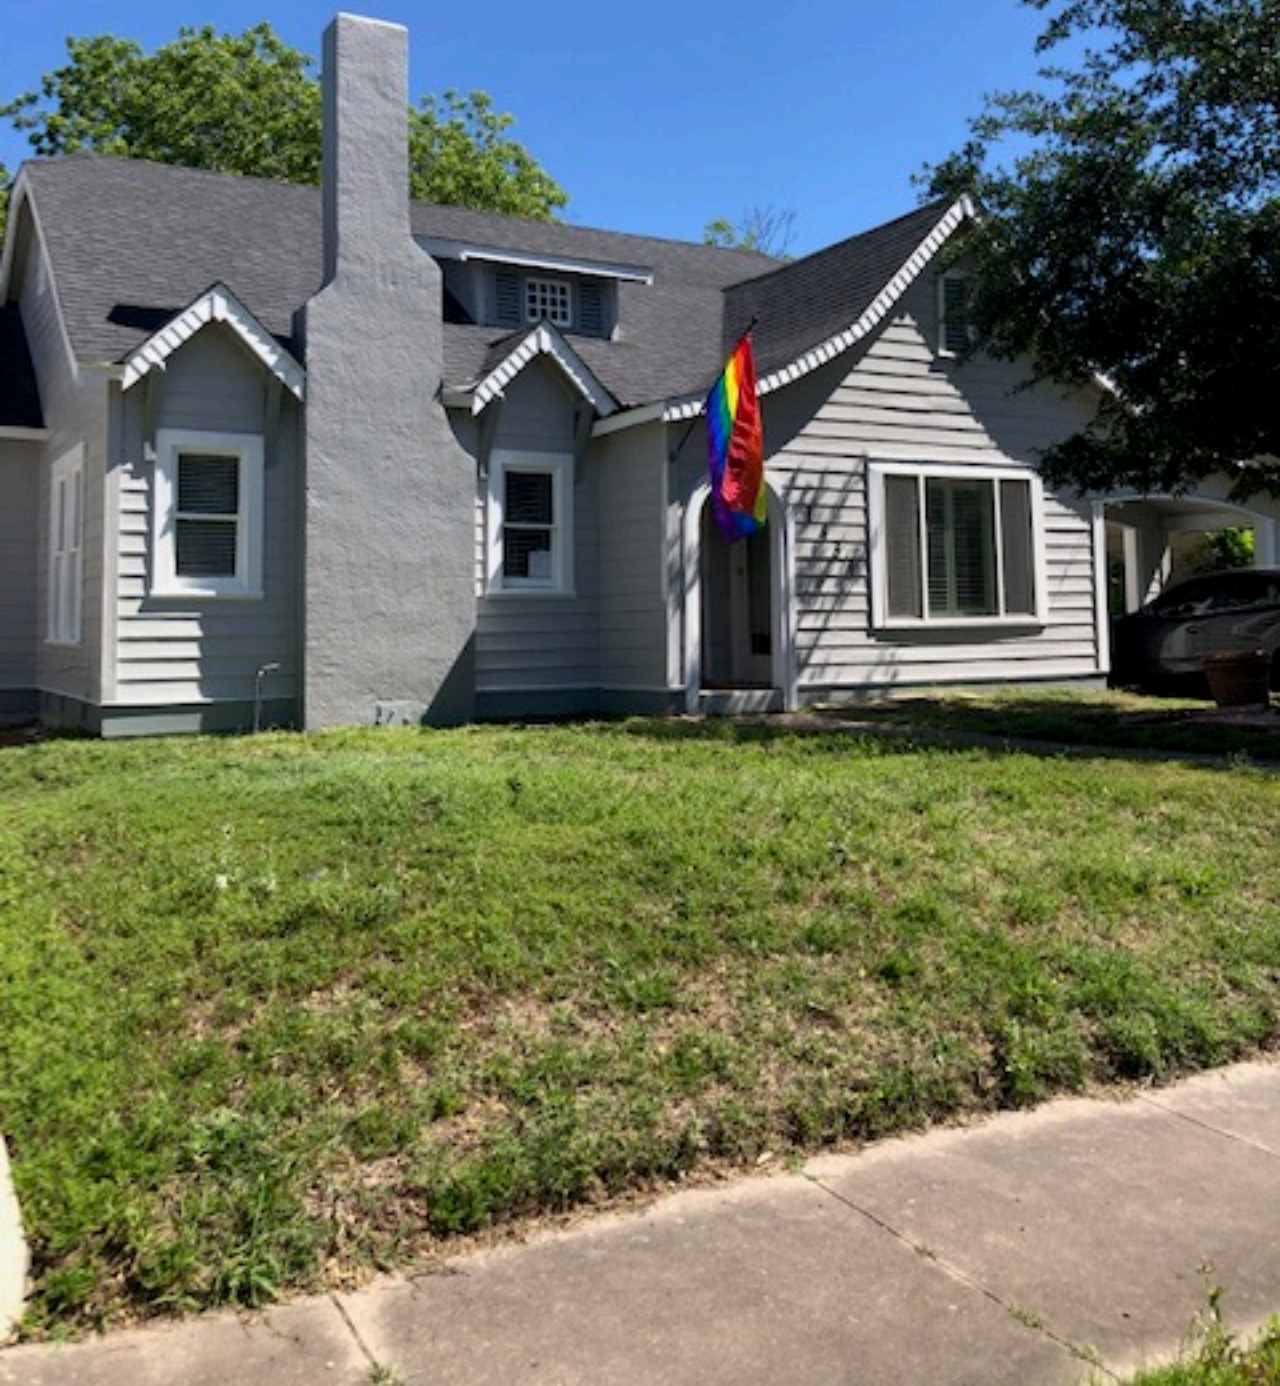
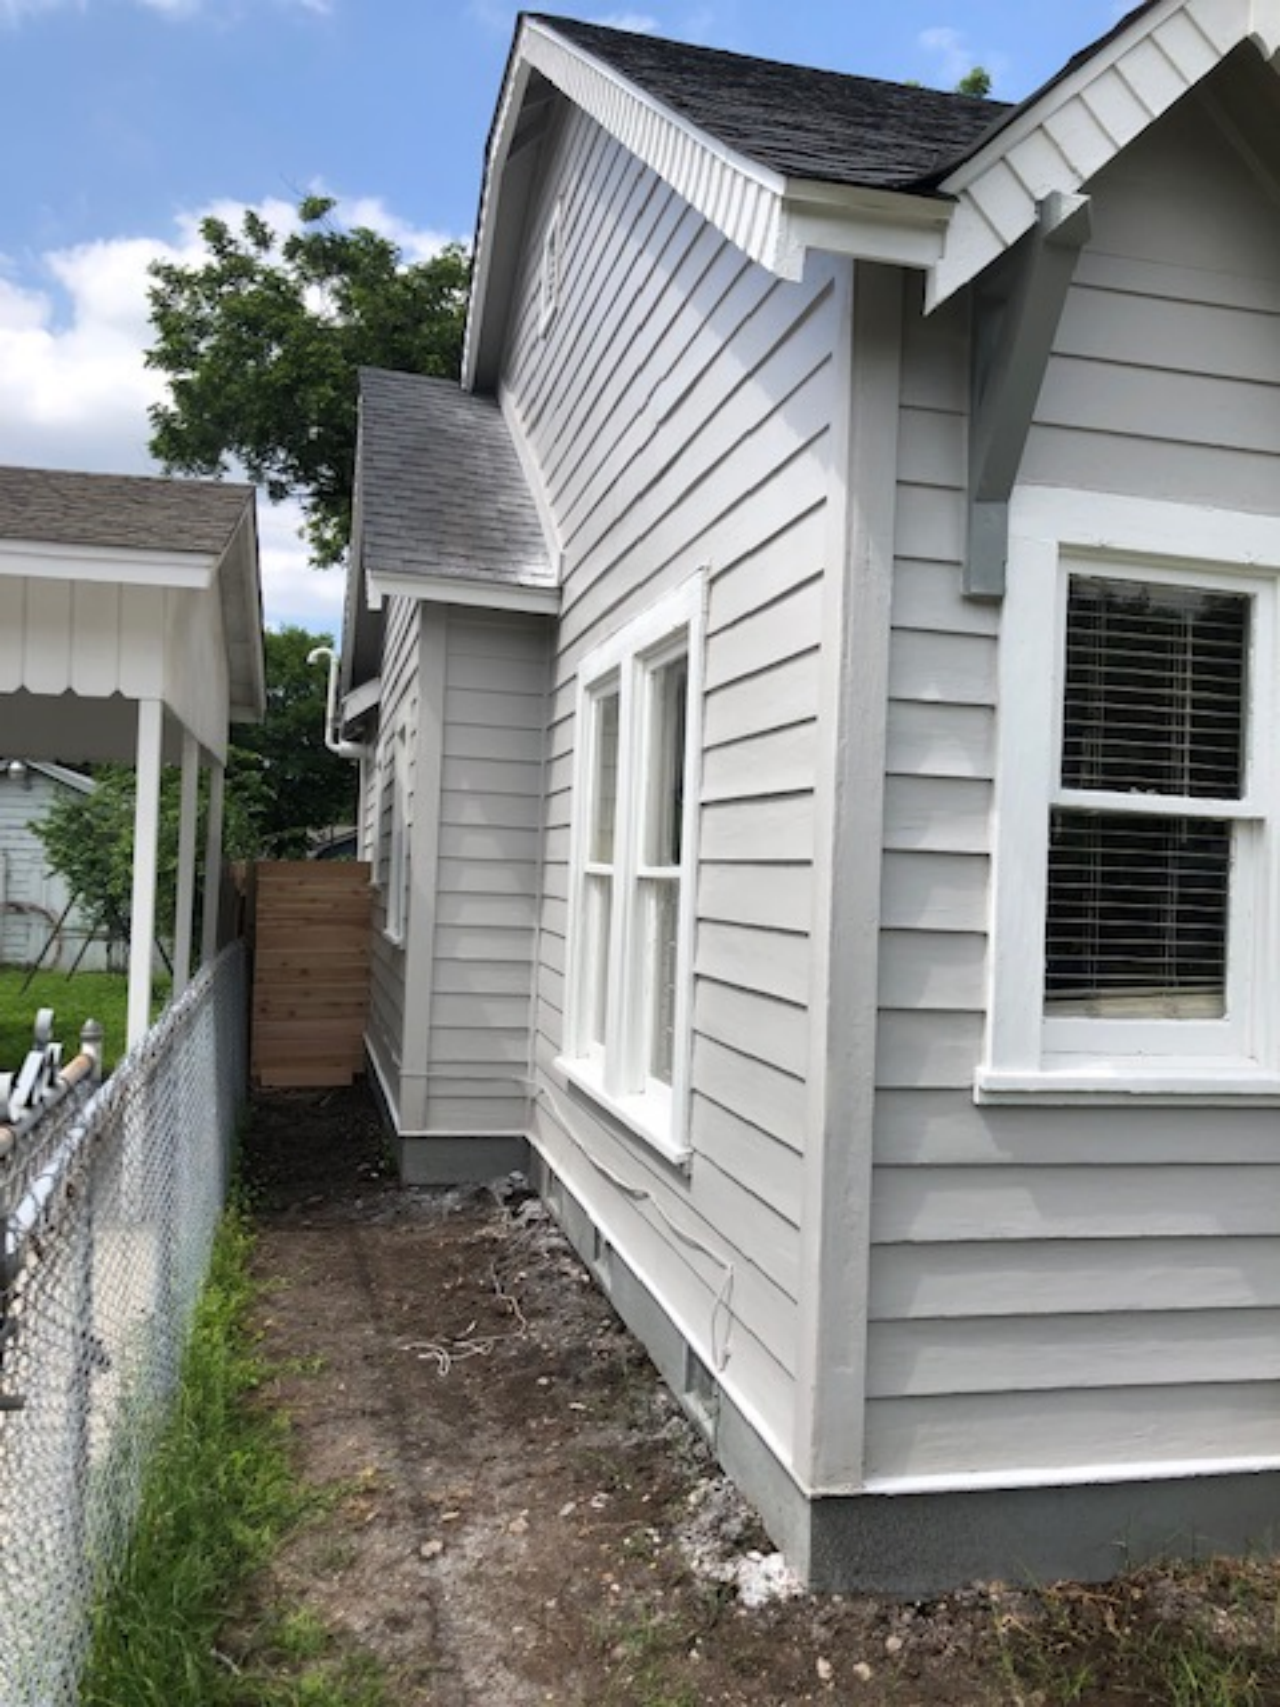
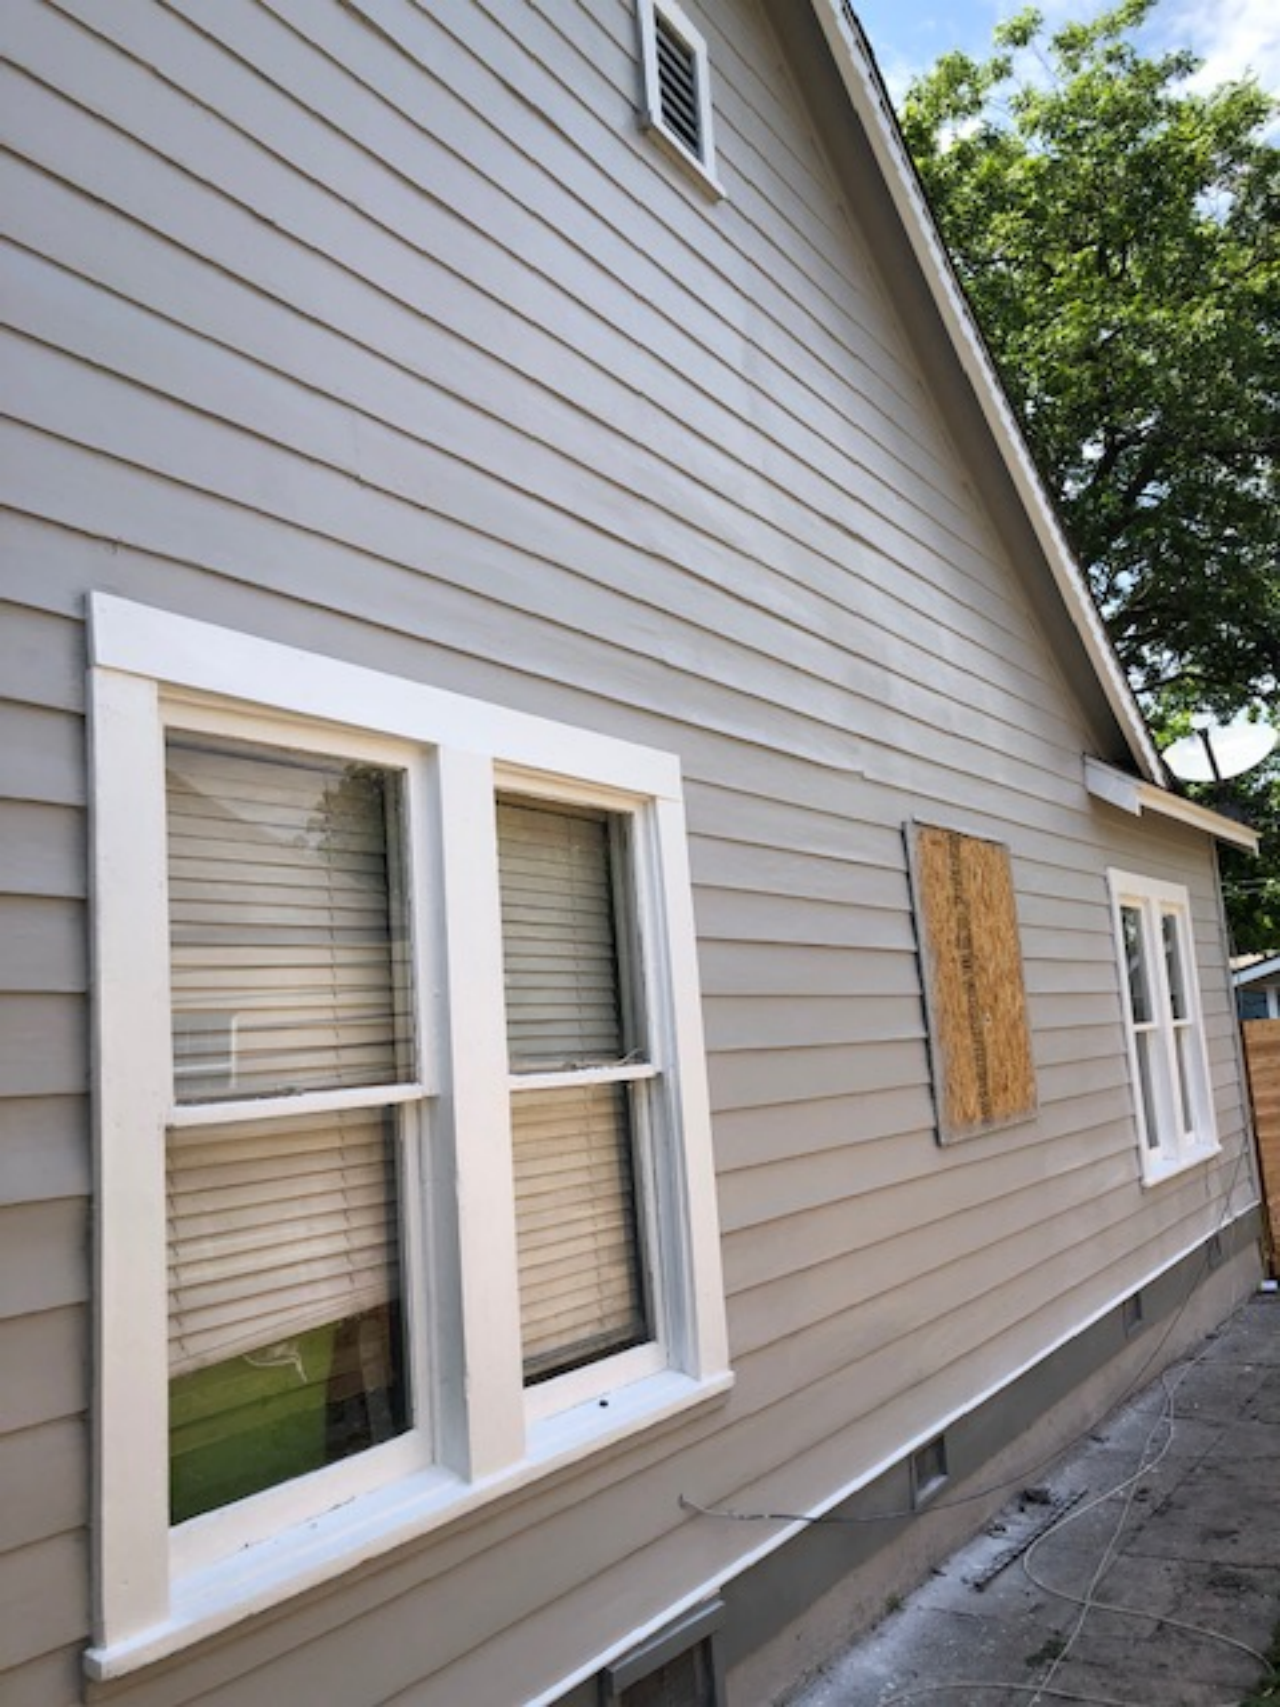
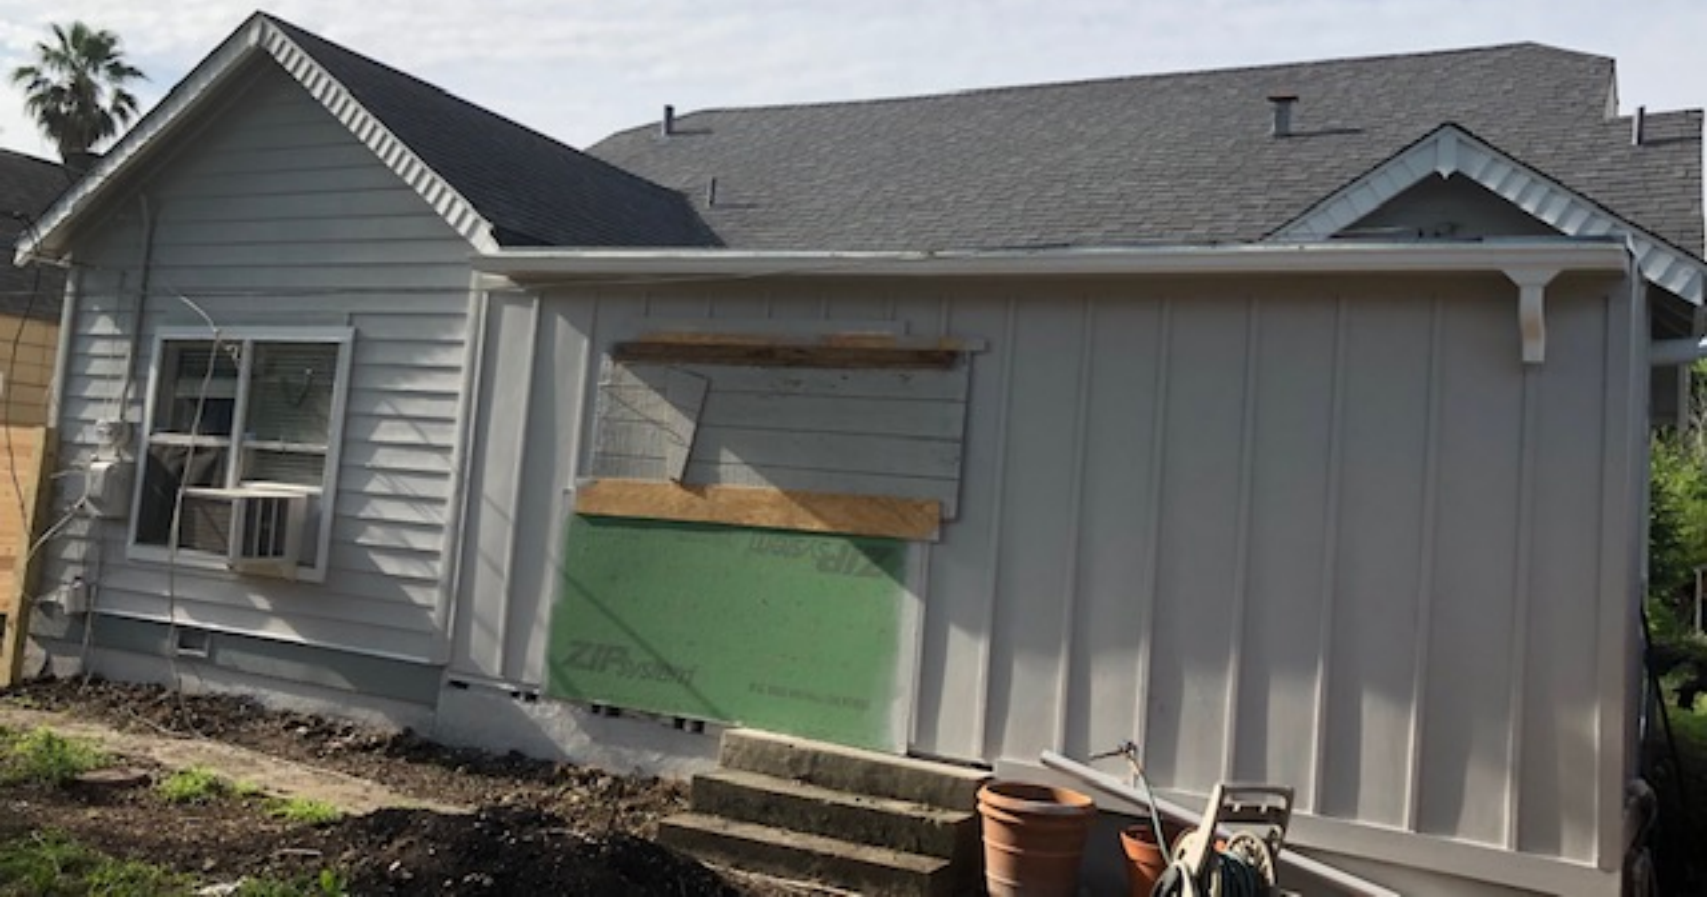
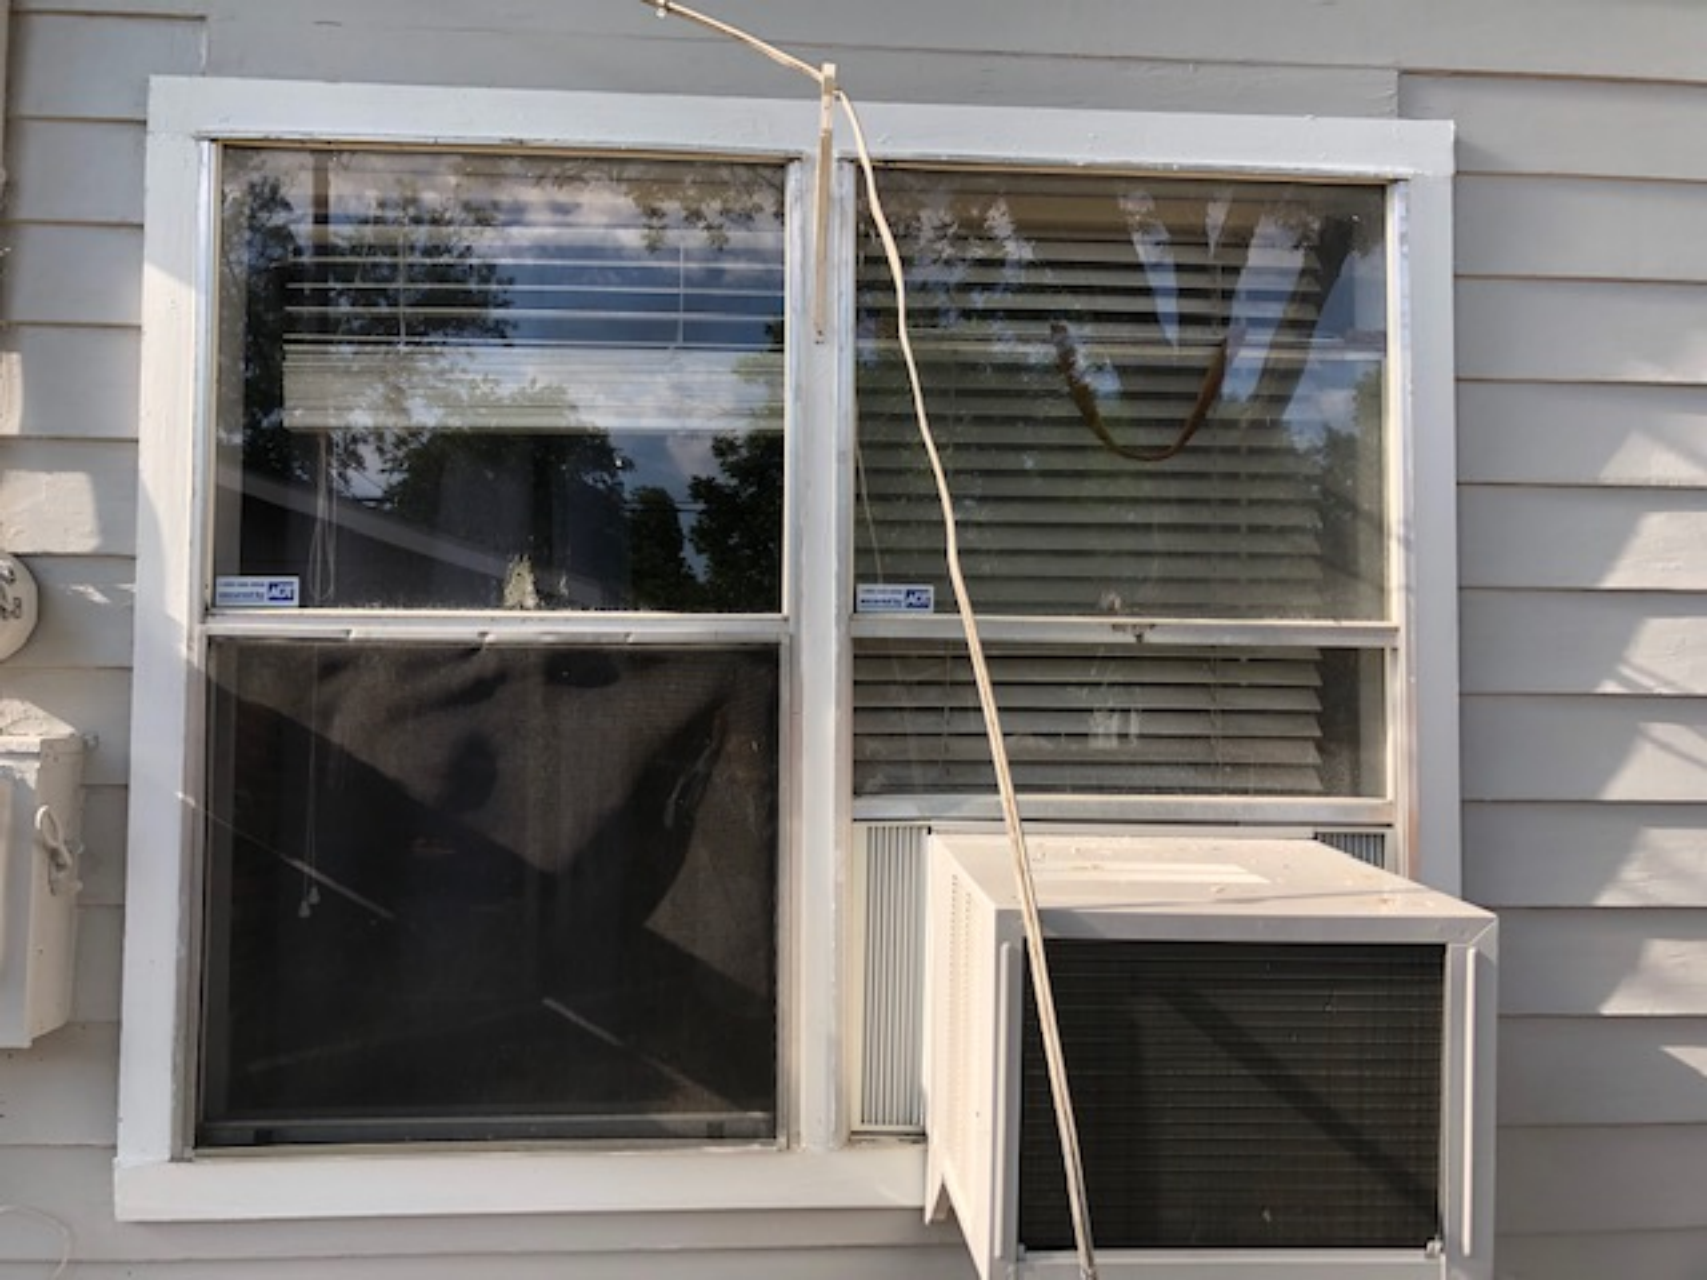
- b. **EXISTING WINDOWS: CONDITON** – The applicant provided several photographs of the existing windows taken from outside the home. Based on the photographic evidence provided, staff finds that the wood windows are in good condition and are fully repairable. In general, staff encourages the repair of historic wood windows. A wood window that is maintained over time can last for decades. Replacement window products have a much shorter lifespan and cannot be repaired once they fail.

- c. **WOOD WINDOW WINDOW REPLACEMENT** – According to the Guidelines for Exterior Maintenance and Alterations 6.A.iii., and 6.B.iv., in kind replacement of windows is only appropriate when the original windows are beyond repair. As noted in finding b, staff does not find the original windows to be beyond repair. Replacement of any kind is not consistent with the Guidelines.

Item 1, Staff does not recommend approval of the original wood window replacement based on findings a through c. Staff recommends that the applicant repair the existing wood windows in place. If there are assemblies that are deteriorated beyond repair, the applicant must submit evidence to that effect to staff in the form of a window schedule and photographs. If an assembly is deemed deteriorated beyond repair by staff, staff recommends that new windows meet the following stipulation:

- i. That the applicant installs one-over-one wood windows to match the existing configuration as closely as possible. Vinyl or composite windows are not appropriate. Meeting rails must be no taller than 1.25” and stiles no wider than 2.25”. There should be a minimum of two inches in depth between the front face of the window trim and the front face of the top window sash. This must be accomplished by recessing the window sufficiently within the opening or with the installation of additional window trim to add thickness. The final specification should be submitted to staff for review prior to the issuance of a Certificate of Appropriateness.
