HISTORIC AND DESIGN REVIEW COMMISSION

June 05, 2019

HDRC CASE NO: 2019-301
ADDRESS: 1939 W GRAMERCY PLACE
LEGAL DESCRIPTION: NCB 1931 BLK 38 LOT 10
ZONING: R-6, H
CITY COUNCIL DIST.: 7
DISTRICT: Monticello Park Historic District
APPLICANT: Bruce Graham/GRAHAM BRUCE
OWNER: Bruce Graham/GRAHAM BRUCE
TYPE OF WORK: Window replacement
APPLICATION RECEIVED: May 01, 2019
60-DAY REVIEW: June 30, 2019
CASE MANAGER: Huy Pham

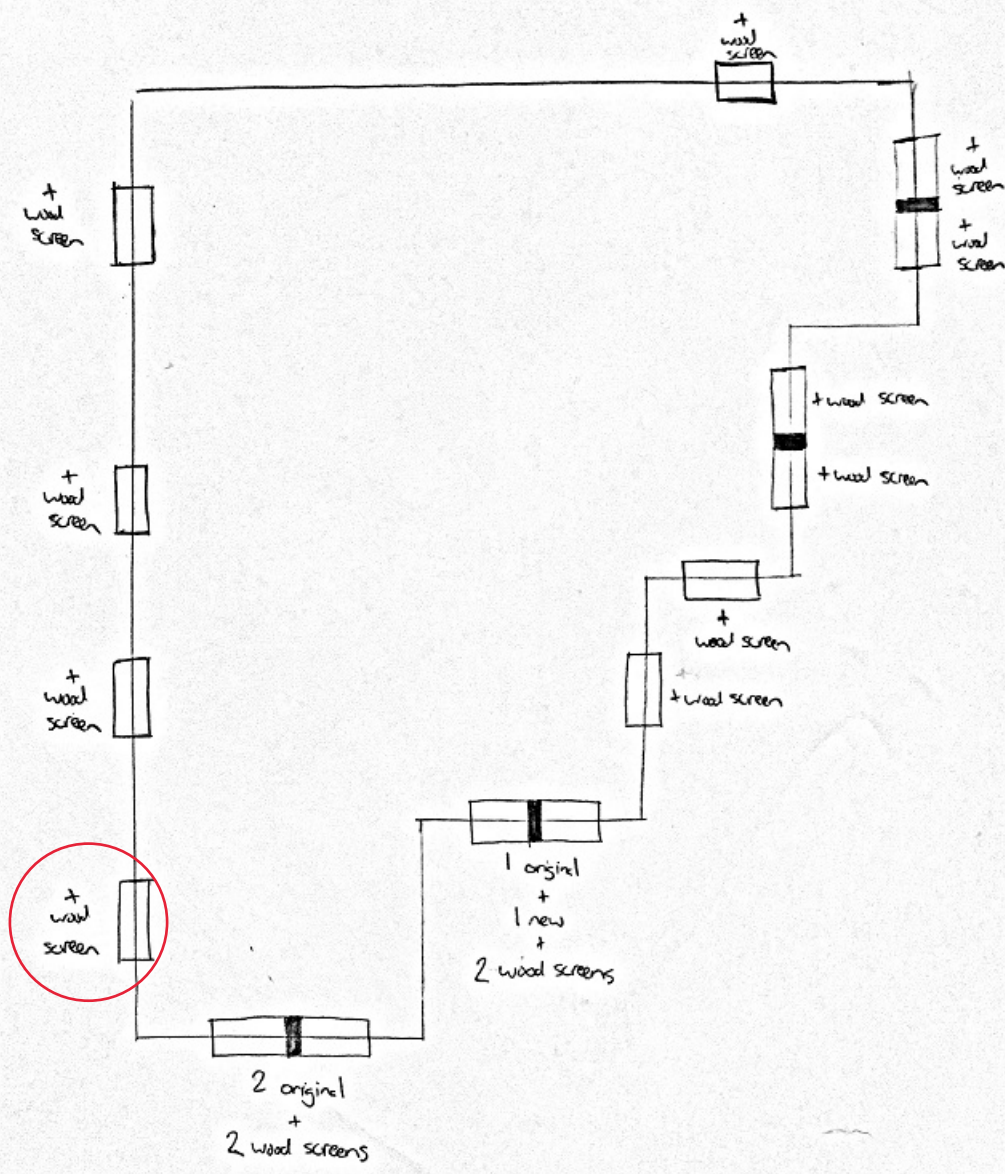
Proposal #1 is to replace the 4 front windows of the property with the 3 original windows currently on the property and a new window of equal dimension and material (*see image Proposal 1*). This ensures that the most prominent windows on the house are original windows and a replacement wood window. In addition to the replacement of these windows, wood screens will be installed in front of these windows and all other windows on the house with a similar appearance to the wood screens on the immediate block (*see image Window Example 1, Window Example 2*). This further restores the aesthetic and integrity of the house exterior (*see image Previous Window Aesthetic*), provides a cohesive exterior façade, and voluntarily replaces an item (metal screens) that was out of compliance with an approved material.

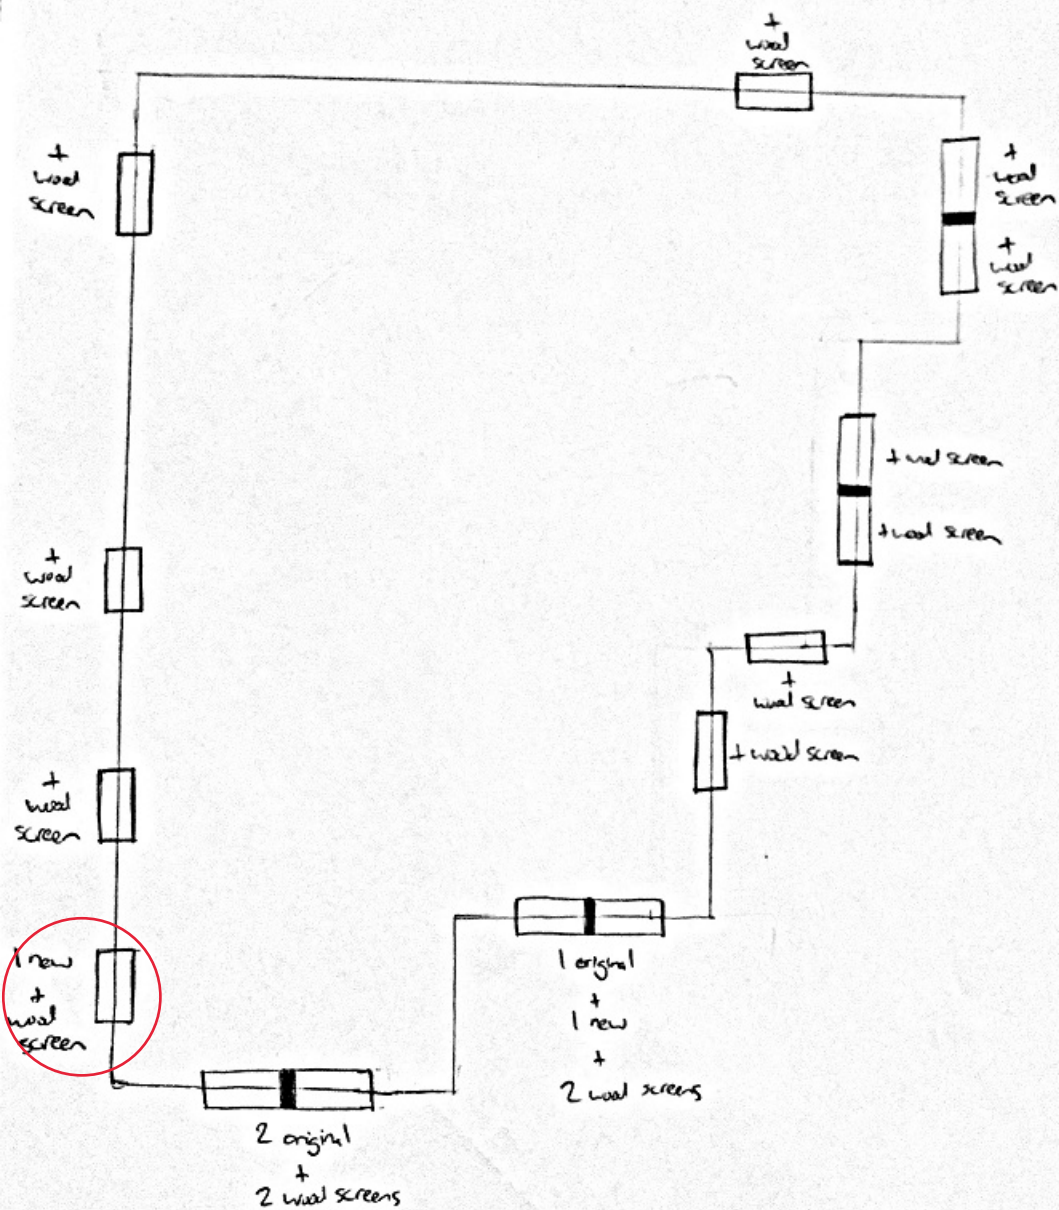
Proposal #2 is to replace the 4 front windows of the property and the window located on the southwest corner of the property with 3 original windows currently on the property and 2 new windows of equal dimension and material (*see image Proposal 2*). Original windows will be prioritized on the front of the house. In addition to the replacement of these windows, wood screens will be installed in front of these windows and all other windows on the house with a similar appearance to the wood screens on the immediate block (*see image, Window Example 1, Window Example 2*). This further restores the aesthetic and integrity of the house exterior (*see image Previous Window Aesthetic*), provides a cohesive exterior façade, and voluntarily replaces an item (metal screens) that was out of compliance with an approved material.

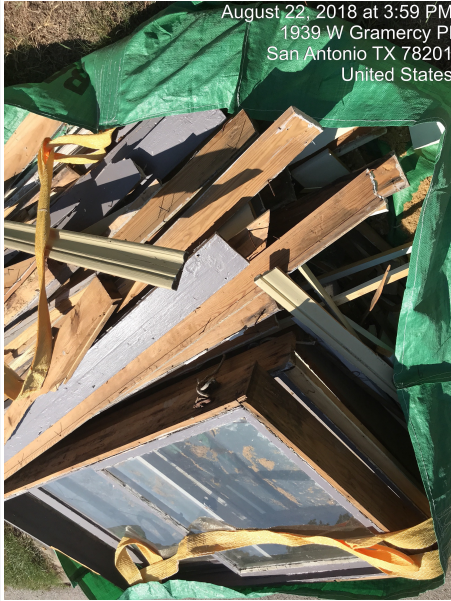
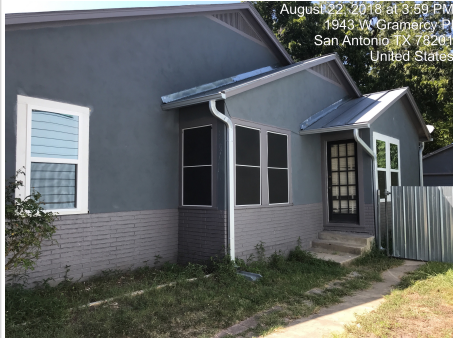
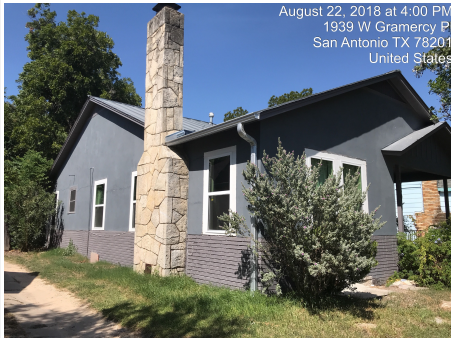
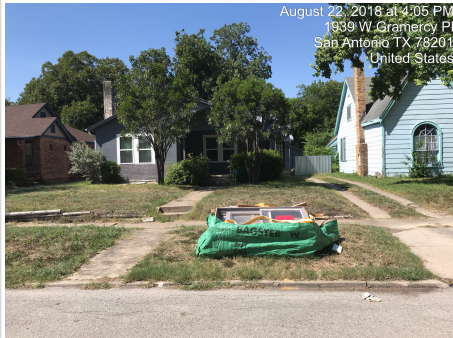
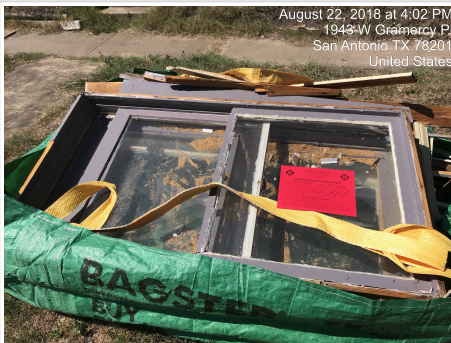
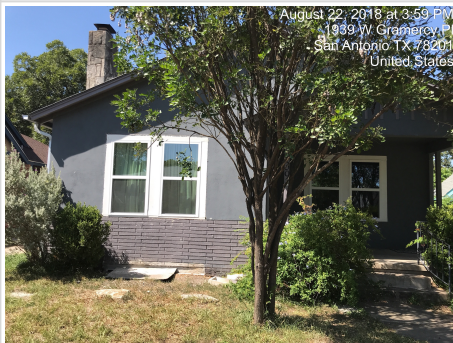
Photographs

Date	08/22/2018
Time	04:03 PM (-5 GMT)
Context	drive-by
Present Staff	Huy Pham
Present Individuals	None
Types of Work Observed	Exterior Maintenance and Alterations
Amount of Work Completed	Completed
Description of work	Removal of wood windows and installation of vinyl windows and dark mesh window screens. Some wood windows are still on site as of 4pm August 22, 2018.
