## HISTORIC AND DESIGN REVIEW COMMISSION

**HDRC CASE NO:** 2019-224  
**ADDRESS:** 515 BURLESON ST  
**LEGAL DESCRIPTION:** NCB 514 BLK 18 LOT 9  
**ZONING:** R-6, H  
**CITY COUNCIL DIST.:** 2  
**DISTRICT:** Dignowity Hill Historic District  
**APPLICANT:** Stephanie Padua/TexPro Painting and Renovations  
**OWNER:** Patricia Gonzales  
**TYPE OF WORK:** Window replacement, porch steps replacement, paint  
**APPLICATION RECEIVED:** April 16, 2019  
**60-DAY REVIEW:** June 15, 2019  
**CASE MANAGER:** Huy Pham

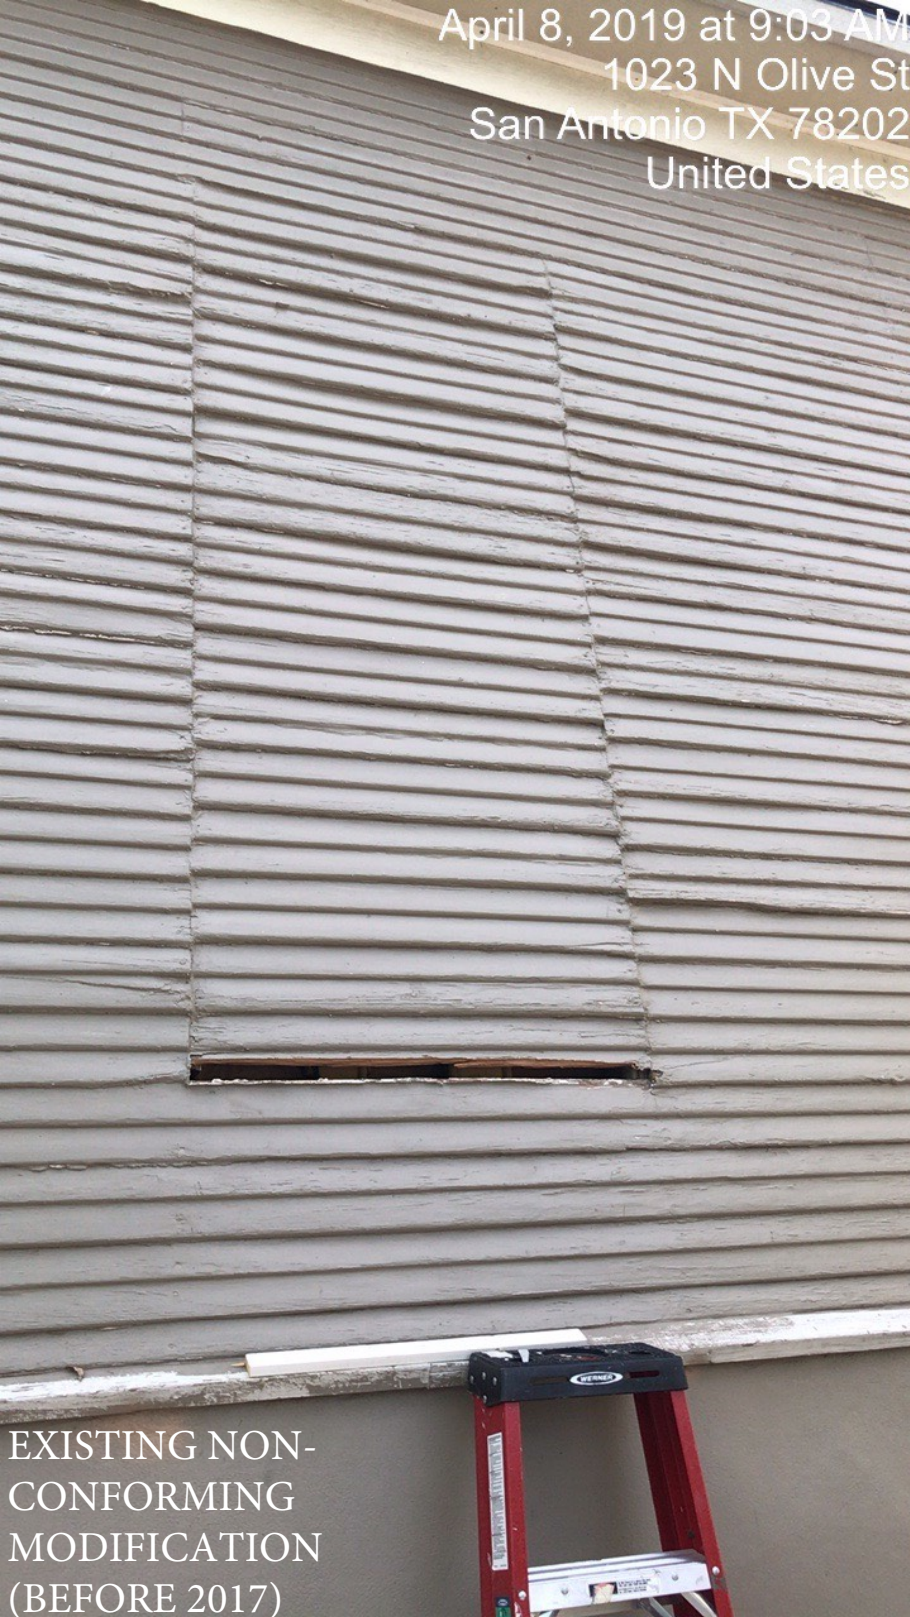
EXISTING NON-CONFORMING  
MODIFICATION (BEFORE 2017)

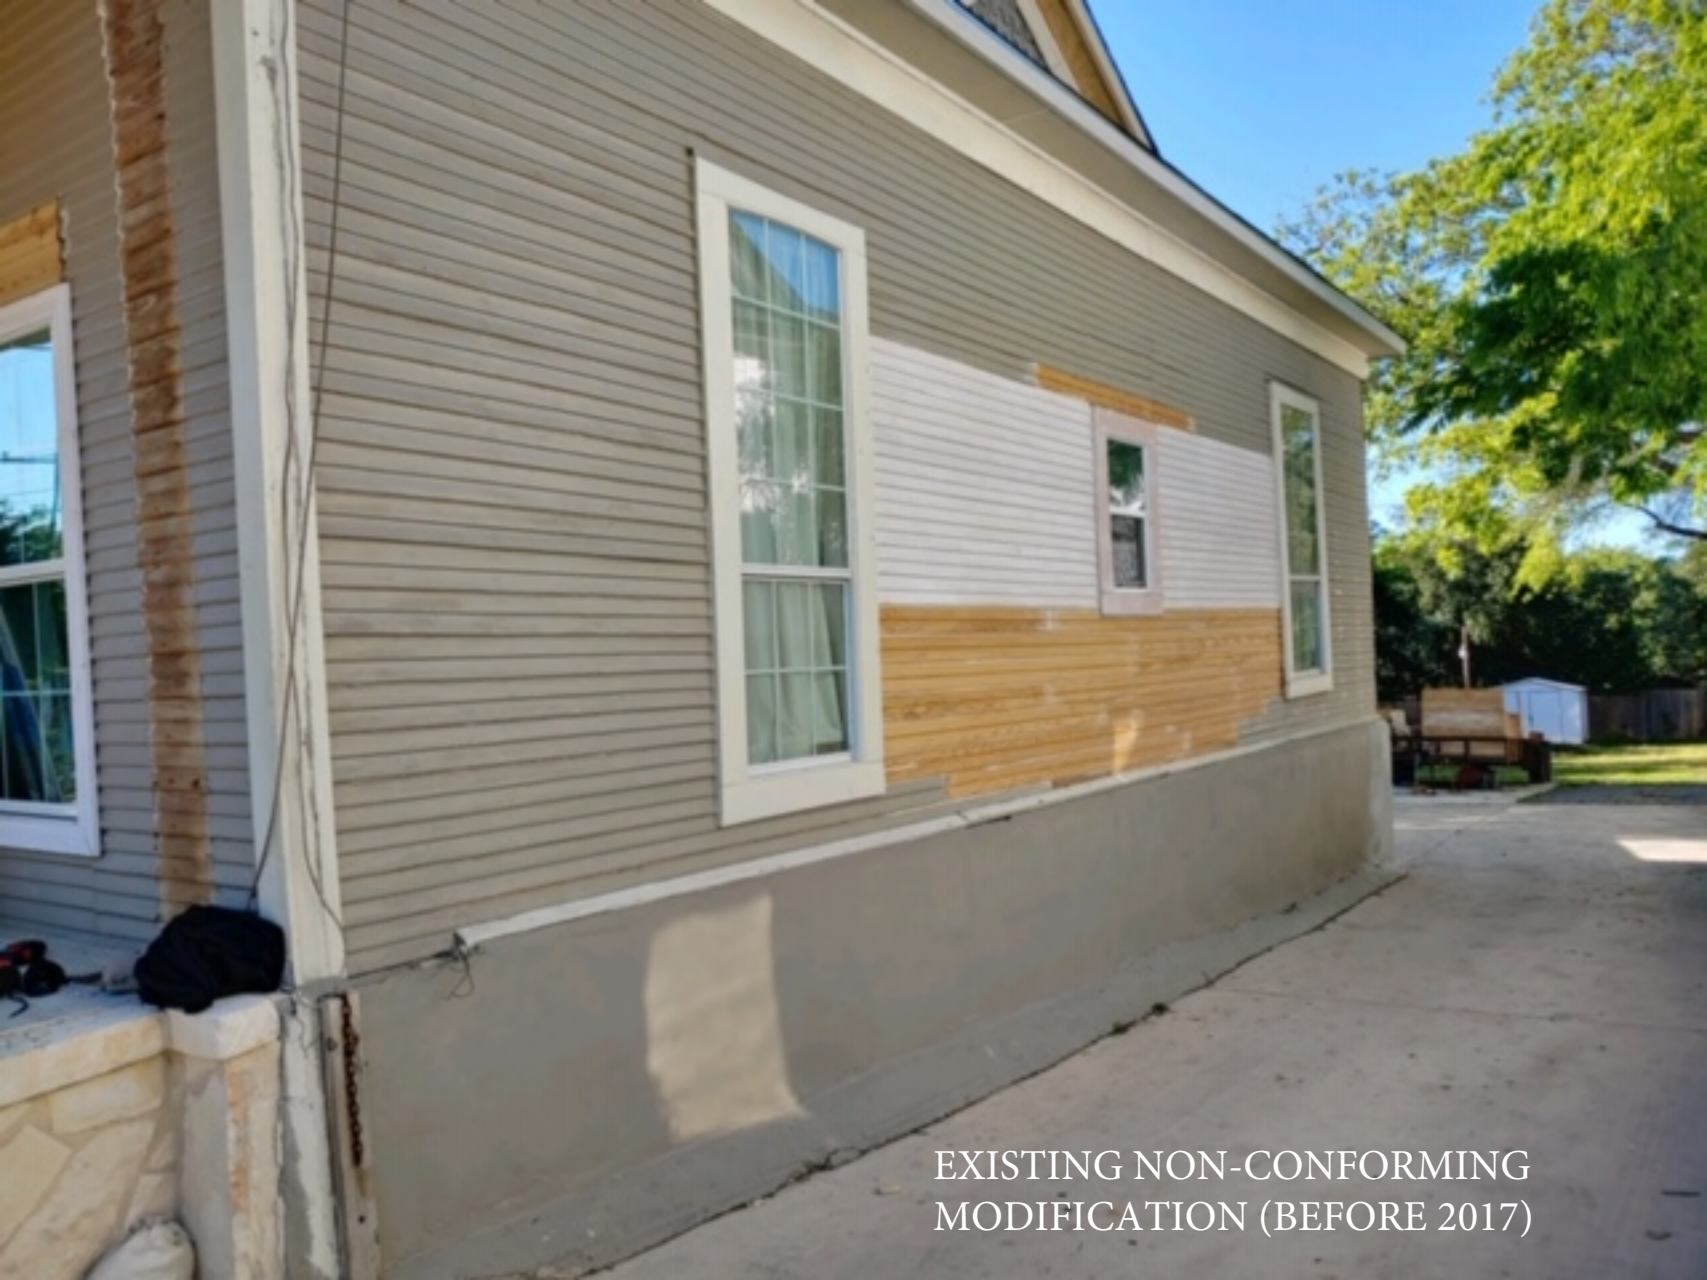
EXISTING NON-CONFORMING  
MODIFICATION (BEFORE 2017)

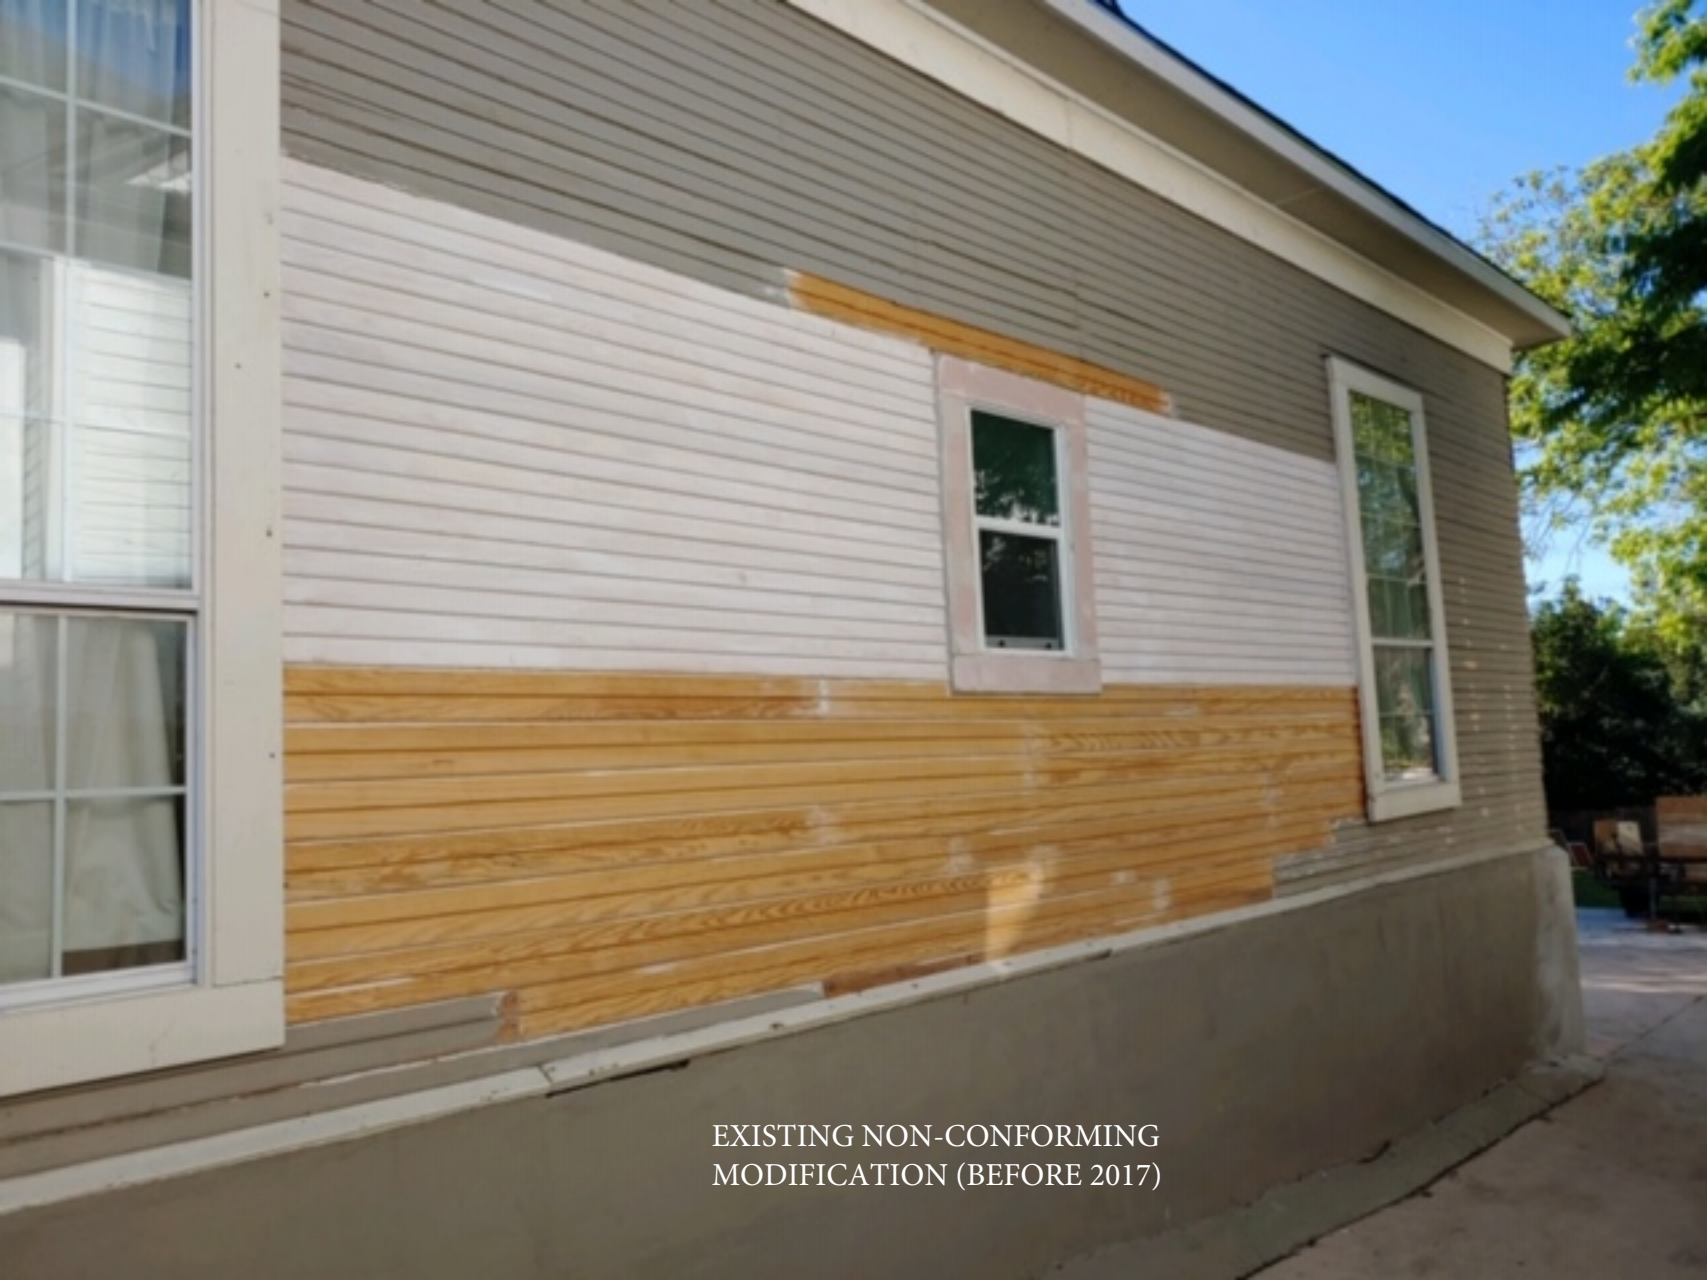
EXISTING NON-CONFORMING  
MODIFICATION (BEFORE 2017)

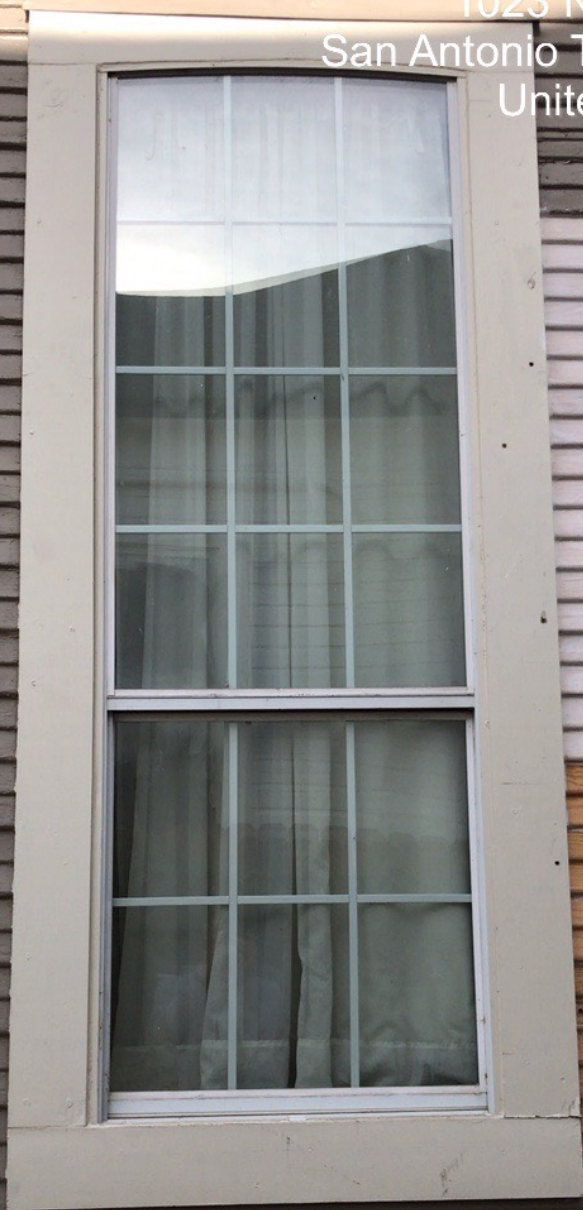
EXISTING NON-CONFORMING MODIFICATION  
(BEFORE 2017)

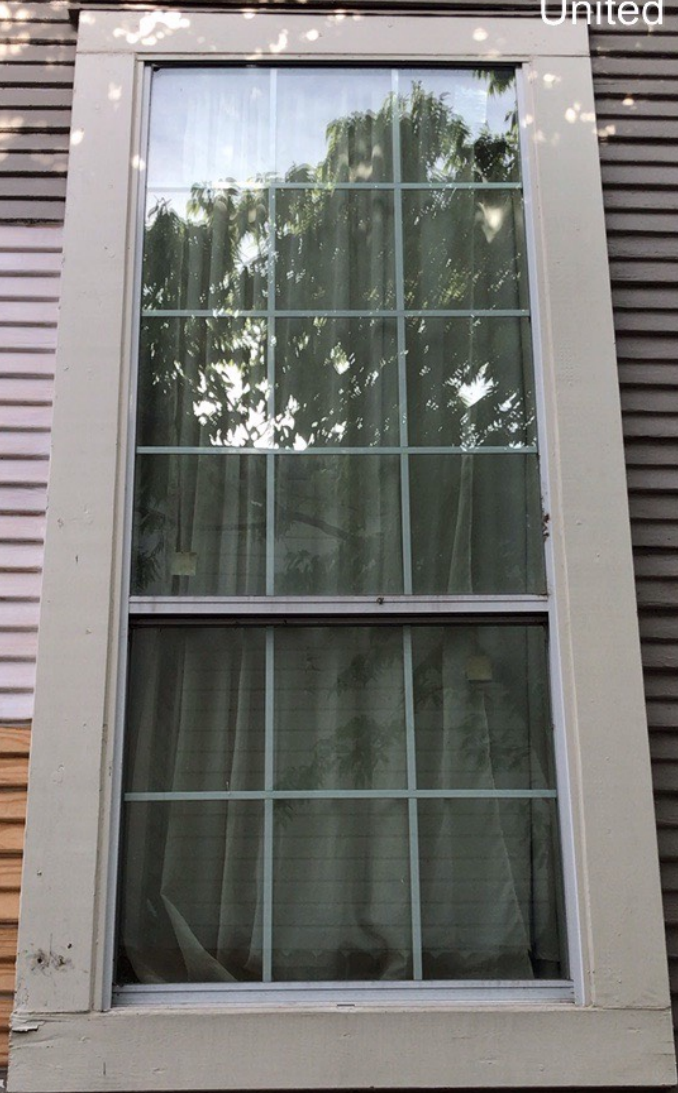
EXISTING NON-CONFORMING MODIFICATION  
(BEFORE 2017)

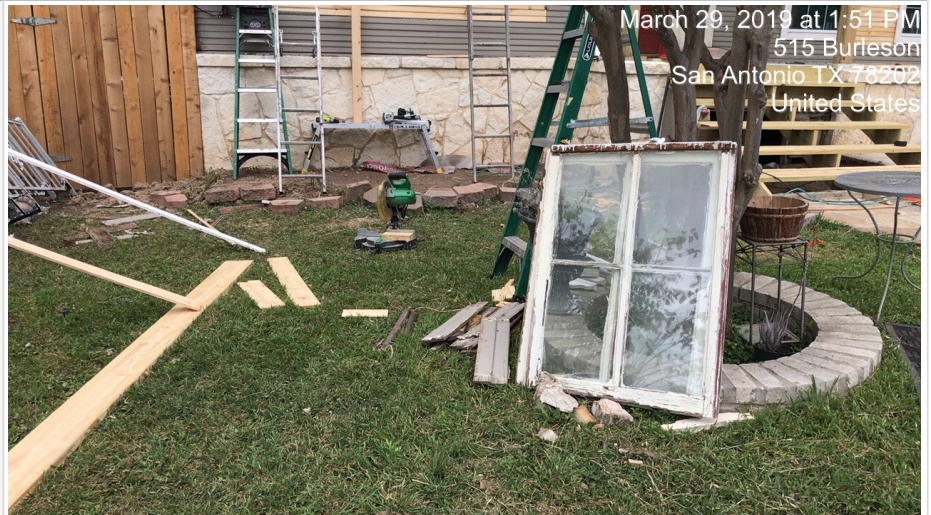
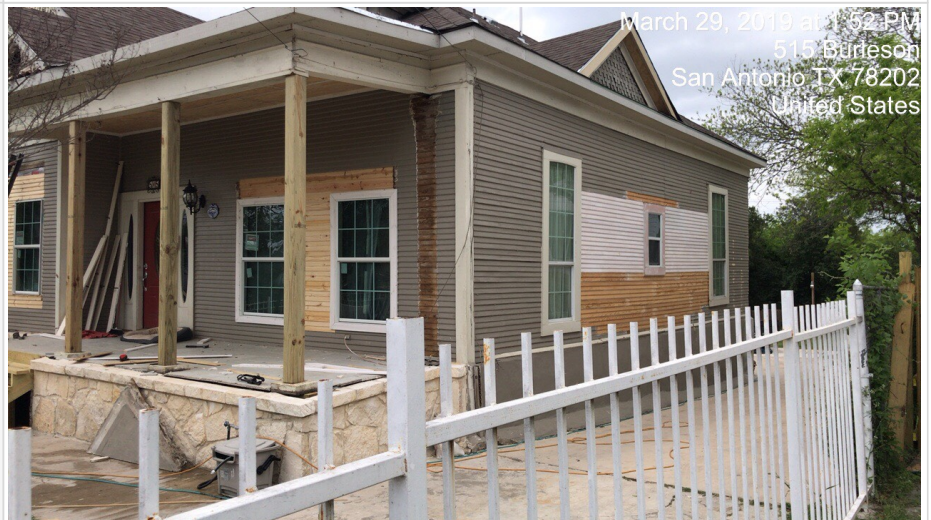
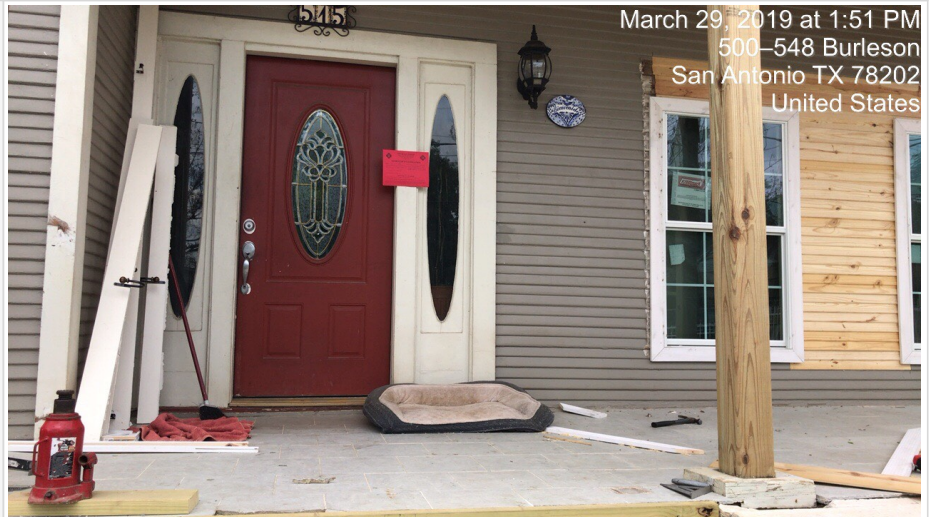
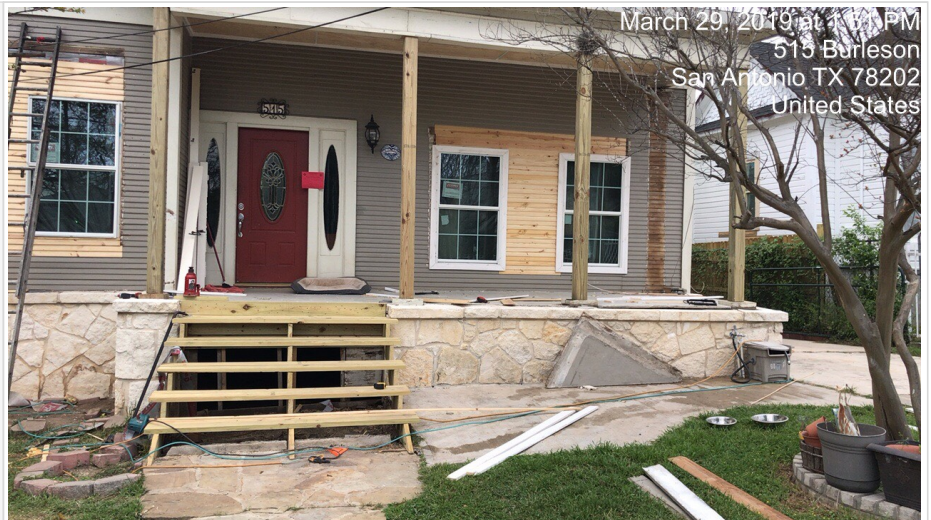
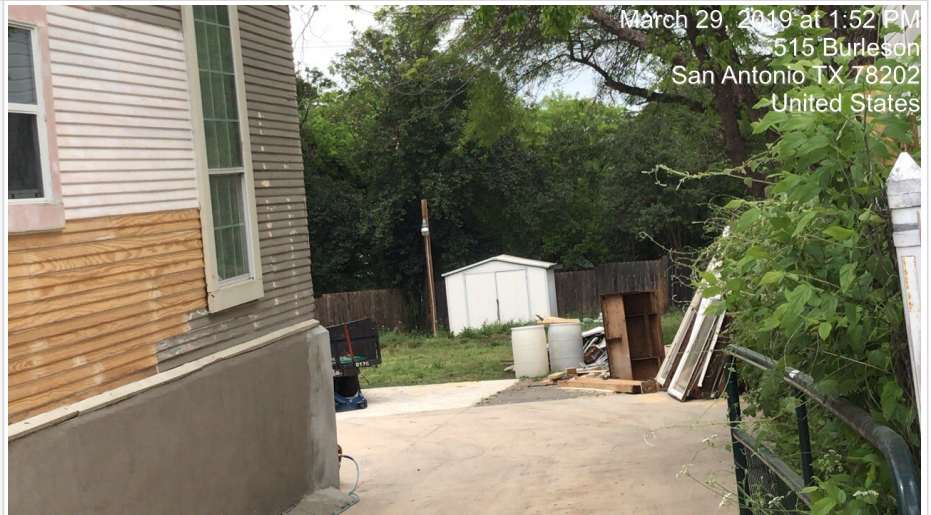
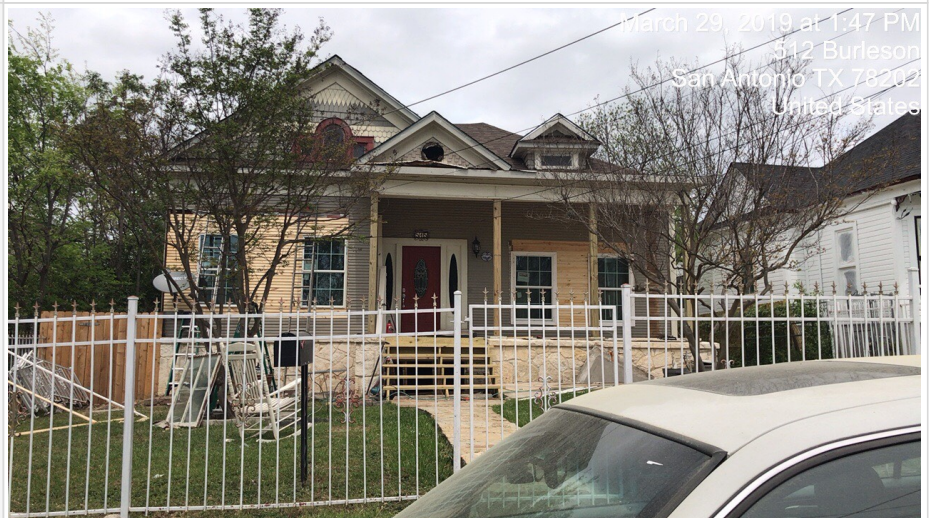
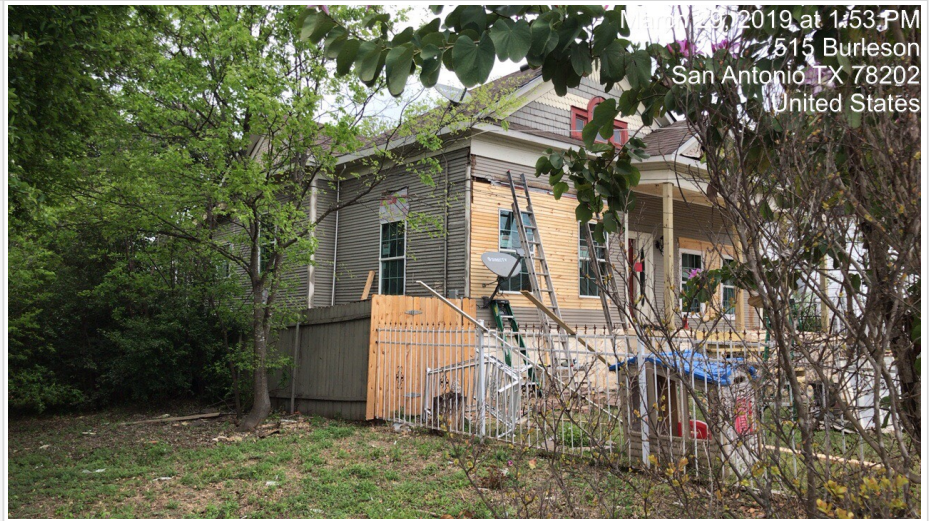
Date	03/29/2019
Time	01:47 PM (-5 GMT)
Context	drive-by
Present Staff	Huy Pham, Adam Rajper
Present Individuals	None
Types of Work Observed	Exterior Maintenance and Alterations
Amount of Work Completed	75%
Description of work	Window replacement on nearly all windows, front porch modifications to skirting and columns. Wood windows sashes are visible in the front yard and rear of driveway.
