HISTORIC AND DESIGN REVIEW COMMISSION

June 05, 2019

HDRC CASE NO: 2019-303
ADDRESS: 306 CALLAGHAN AVE
LEGAL DESCRIPTION: NCB 721 BLK 3 LOT N 80.04FT OF 2
ZONING: RM-4, H
CITY COUNCIL DIST.: 1
DISTRICT: Lavaca Historic District
APPLICANT: Frederic Wile/WILE FREDERIC D
OWNER: Frederic Wile/WILE FREDERIC D
TYPE OF WORK: Construction of a rear accessory structure
APPLICATION RECEIVED: May 18, 2019
60-DAY REVIEW: July 17, 2019
CASE MANAGER: Huy Pham
REQUEST:

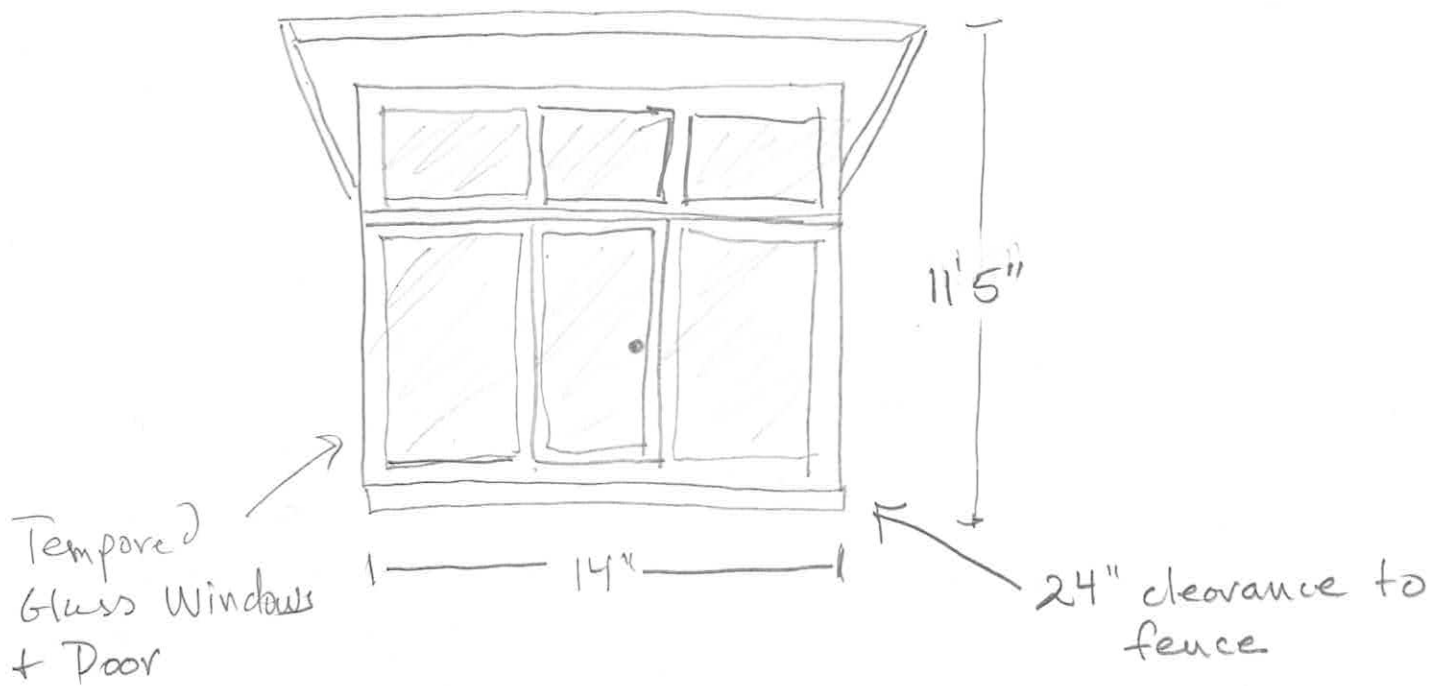
Wile Backyard Shed
North Elevation
306 Callaghan

$3/12$ Roof pitch

Metal Roof to
match main
House

27" clearance
to back fence

Board is batten
on center Siding to
match Rear
of house Siding
(see pictures)

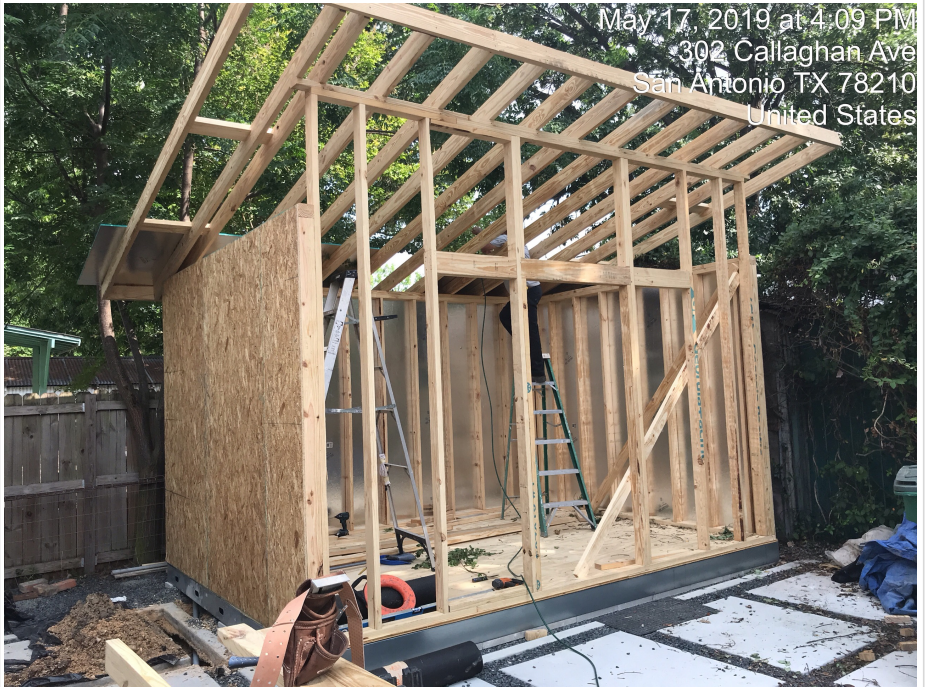
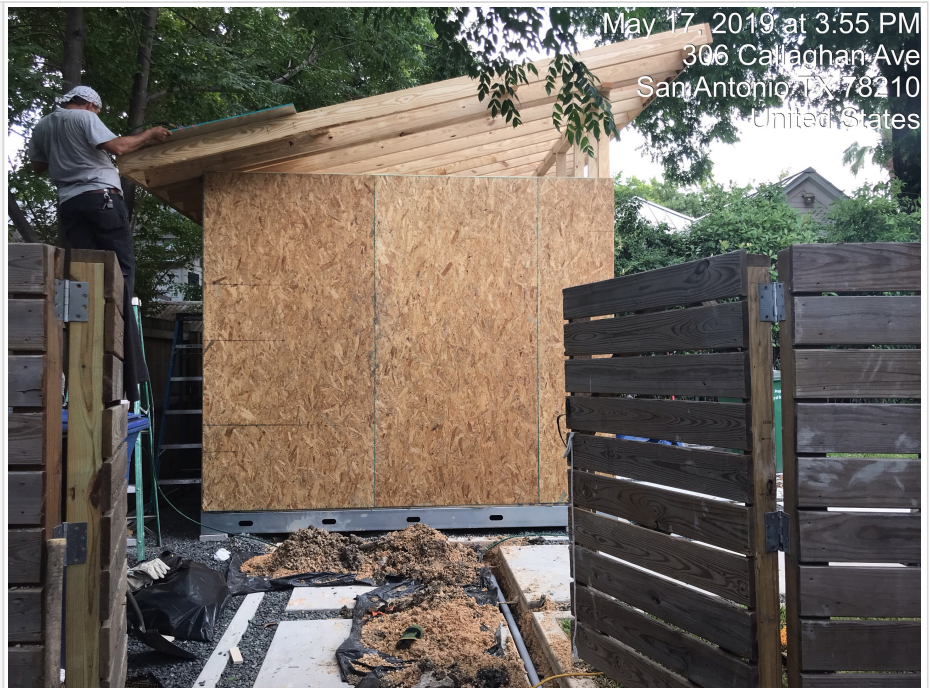
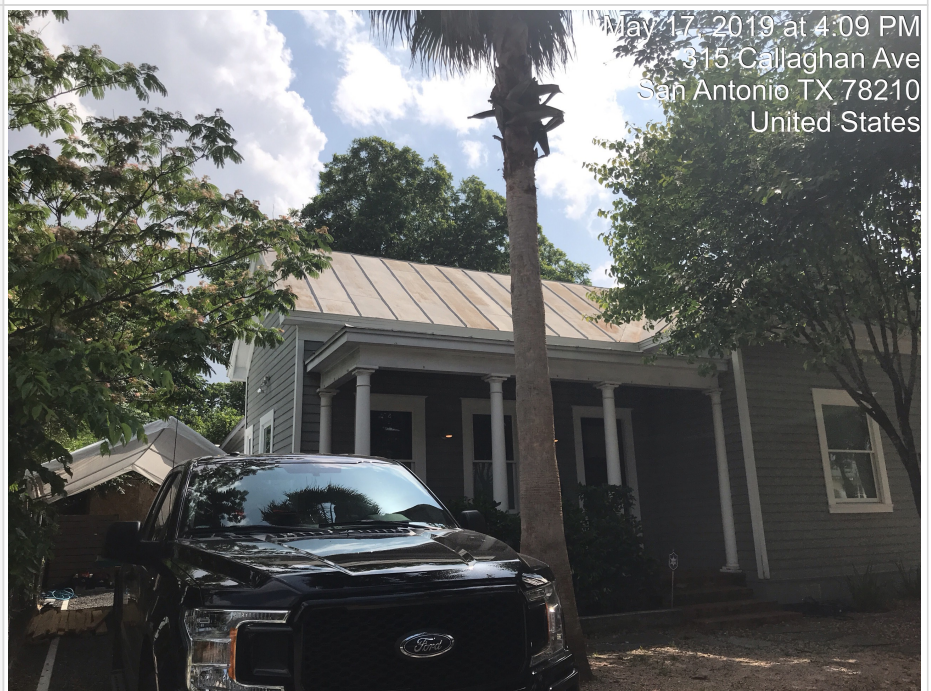
Photographs

Date	05/17/2019
Time	04:01 PM (-5 GMT)
Context	drive-by
Present Staff	Huy Pham
Present Individuals	Contractor(s)
Contractor/Realtor Companies	Joe Fickle
Types of Work Observed	New Construction, Site Elements
Amount of Work Completed	50%
Description of work	Initiated construction (framing) of rear accessory structure with shed roof up to 11ft tall, in the rear yard at the end of the driveway. Per the contractor, the structure will have standing seam metal roof and wood lap siding to match the primary historic structure with a centered door with sidelights facing into the property.

Violation Type	No Certificate of Appropriateness (Code 35-451a), Beyond scope of Certificate of Appropriateness (Code 35-451h)
OHP Action	Posted "Notice of Investigation", Spoke with contractor(s)
Will post-work application fee apply?	No

Description of interaction	Staff spoke to lead contractor Joe Fickle who was cooperative to forward the violation notice to the owner. Staff advised the contractors that they may continue to protect the framing with Tyvec and other coverings but all work is subject to reversal if not eventually approved. This property has approval for rear yard pool with site furnishing.
----------------------------	--
